JOHN MOORE HERITAGE SERVICES

ARCHAEOLOGICAL WATCHING BRIEF

**AT FERRY NAB,
FERRY LANE, MEDMENHAM**

NOVEMBER 2012

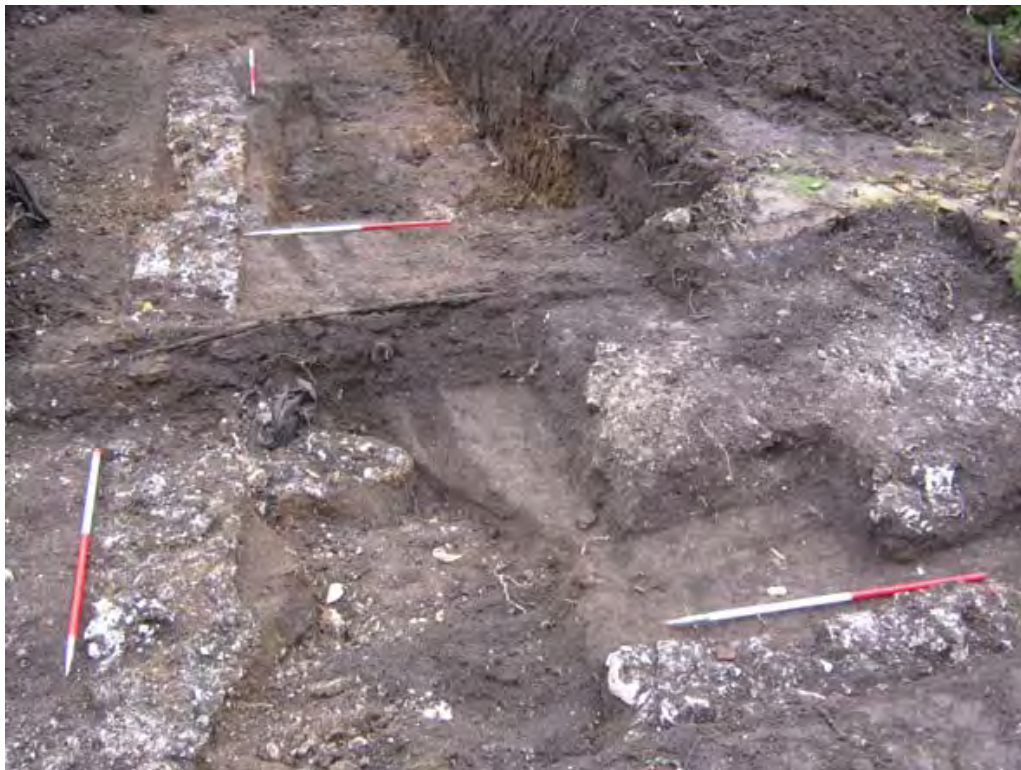
Figure 3. Intervention area showing walls 402 and 411, looking south.

The wall 402, which measured at least 7m in length and 0.55m wide, was truncated at both north and south ends, although the presence of the return wall 411 to the west, measuring at least 3.3m in length and 0.55m wide (Figs 2, 3 & 4), indicates that the wall was probably part of a building, rather than an external wall. Both walls 402 and 411 stood c. 0.55m high. Extensive truncation by trees and the former hedge had damaged the northern extent of the wall. Pottery recovered from wall 402 indicated a 12th-century date, whereas pottery from wall 411 indicated a date after the late 11th century.

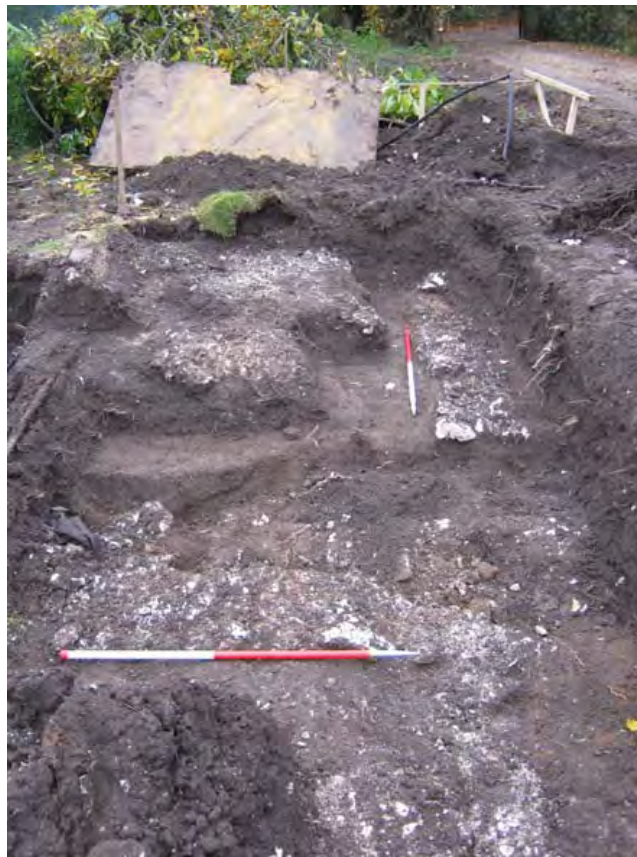
Figure 4. Wall 411, looking west
