JOHN MOORE HERITAGE SERVICES

**AN ARCHAEOLOGICAL WATCHING BRIEF AT
MONKS MEDE, BURTON LANE,
MONKS RISBOROUGH, BUCKINGHAMSHIRE**

NGR: SP 8122 0430

JUNE 2013

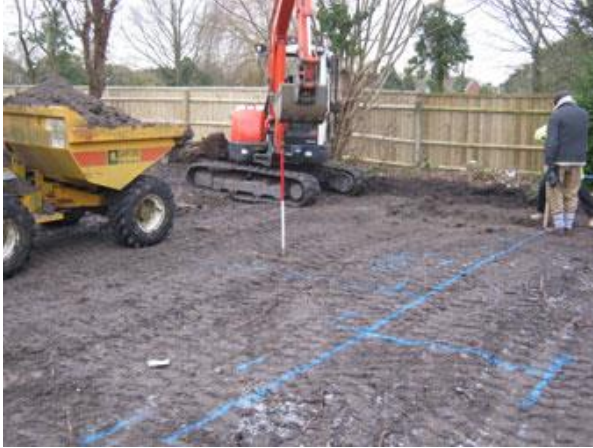
Plate 1; Showing site stripped of topsoil before footing excavation

The watching brief was carried out in snowy conditions with good co-operation from the contractor carrying out the groundworks. The site was stripped of topsoil on arrival which would explain the lack of any building materials and medieval pottery when compared with the evaluation (Plate 1).

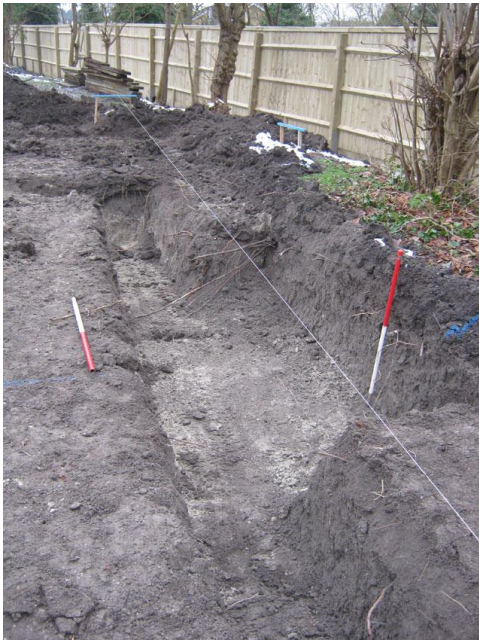
Plate 2; Ditch 104 looking south

Ditch 104 was located at the far western end of the excavations orientated on an approximate north-south direction with concave sides and unknown base. It was filled by dark greyish silty clay (105) with one sherd of medieval pottery on the upper surface of the fill. The excavations did not fully impact the ditch so a full profile was not obtained. In addition the ditch was only partially visible within the trench (Plate 2). The ditch was sealed by subsoil (101).

A large north-south ditch 104 was partially uncovered but was not sectioned as it was not fully impacted on by the new footing trench. Although the ditch was only partially revealed in the section it can be discerned that it was at least 1m wide. One sherd of medieval pottery was found during trowling over the upper surface of the fill providing a *terminus post quem* for when the ditch silted up. On the adjacent site (Mumford 2004) a large ditch was uncovered thought to be a boundary ditch aligned north-west south –east. It contained 10th century pottery and residual Roman building material. Another north-south boundary ditch was discovered in Trench 2 (Mumford 2004) which was 2.4m wide and 0.80m deep. It also contained 10th century pottery with residual Roman building material. The large ditch discovered at Monks Mede was later in date and may represent the continuing use of an existing 10th century enclosure in the high medieval period. This enclosure does not seem to have extended as far north as at the site of the proposed new church hall (Coles & Hammond 2002).

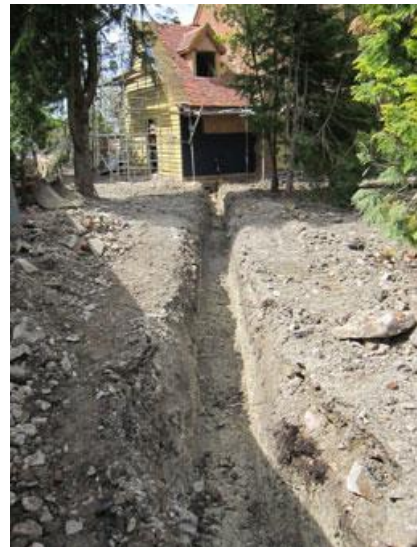
Plate 4; Service trench looking south-west

The service trench was excavated to a length of *c.* 20m and depth of *c.* 0.70m from existing ground surface (Plate 4). The trench was inspected for archaeological features and finds. As a result no archaeological features could be ascertained and no finds were recovered. The trench was narrow and the attending archaeologist said identification of archaeological features in such a trench was difficult, but gave a confidence rating of medium to high that there were no archaeological features present.
