JOHN MOORE HERITAGE SERVICES

**HISTORIC BUILDING RECORDING  
AND ARCHAEOLOGICAL WATCHING BRIEF  
ON  
THE WOOLPACK, HORSEFAIR, BANBURY**

**NGR SP 4537 4047**

**AUGUST 2013**

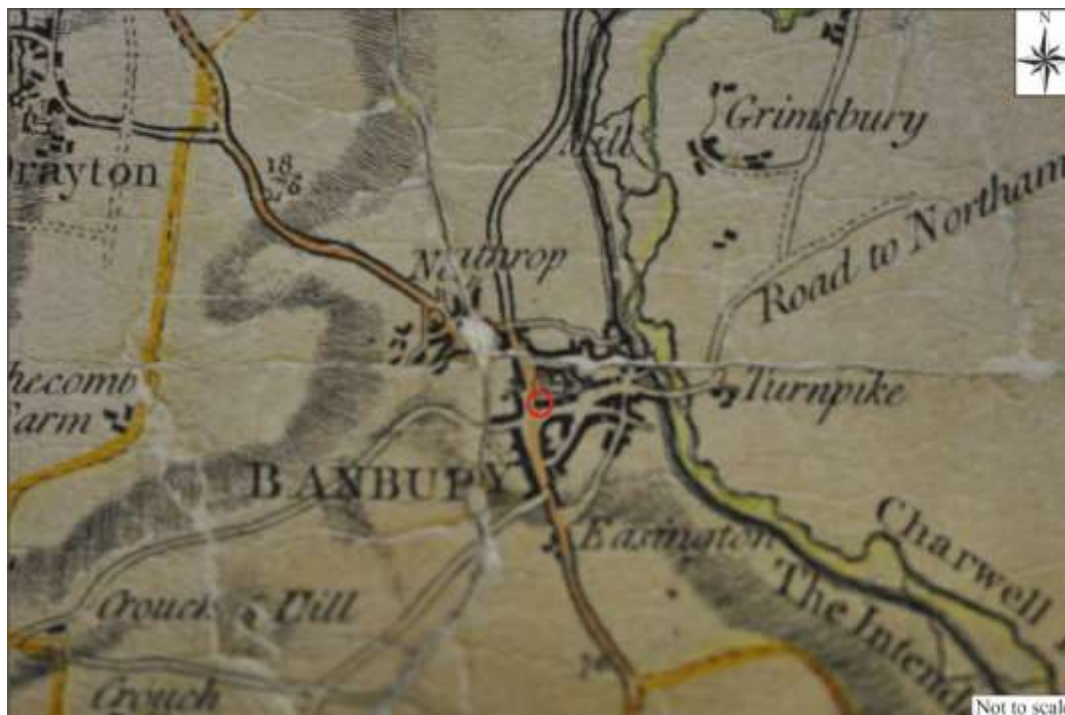
Figure 2 Jefferys Map of 1767

Surviving maps of Banbury commence in the later part of the 18<sup>th</sup> century. Jefferys map (Fig. 2) dated 1767 (ORO CP/103/M/1) shows a church in an island surrounded by roads around most of the sides of which has buildings facing out on to the roads. The line of Horsefair is drawn incorrectly on these maps. The Davis map (Fig. 3) of 1793 (ORO 942/33 DAV) shows a similar picture with the church block and buildings facing out from this area. The Bryant map of 1824 (Fig. 4) shows this part of Banbury in the same vein, but for the first time shows the proper line of Horsefair. Similar arrangements are shown on the map of 1832 (ORO CH CXII/4) and 1833 (ORO CH XXIV/72).

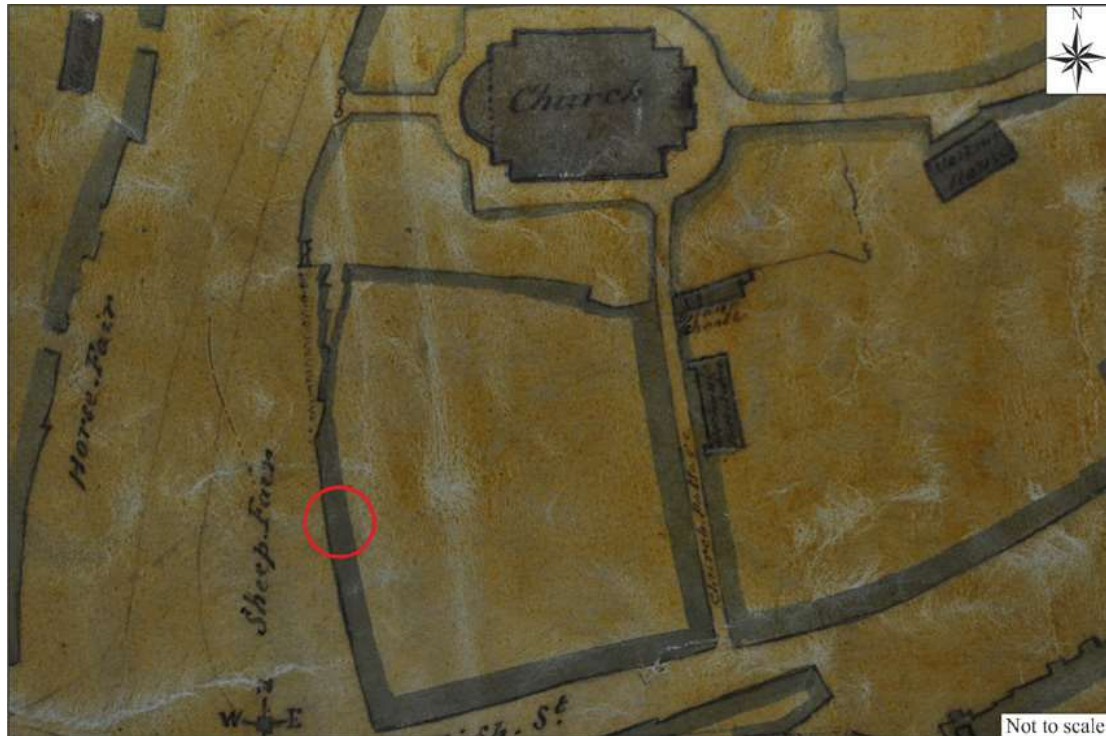
Figure 5 Map of 1838

The map of 1838 (ORO PAR 21/17/M/1) shows the most detailed map for its streets of Banbury by that date (Fig. 5). Though the streets are drawn well, the buildings are not and a grey line is drawn along the street fronts to represent the locations of the buildings. It is noticeable also that a part of Horsefair outside the Woolpack is called the Sheepfair and this would explain the association of the public house with the wool trade.

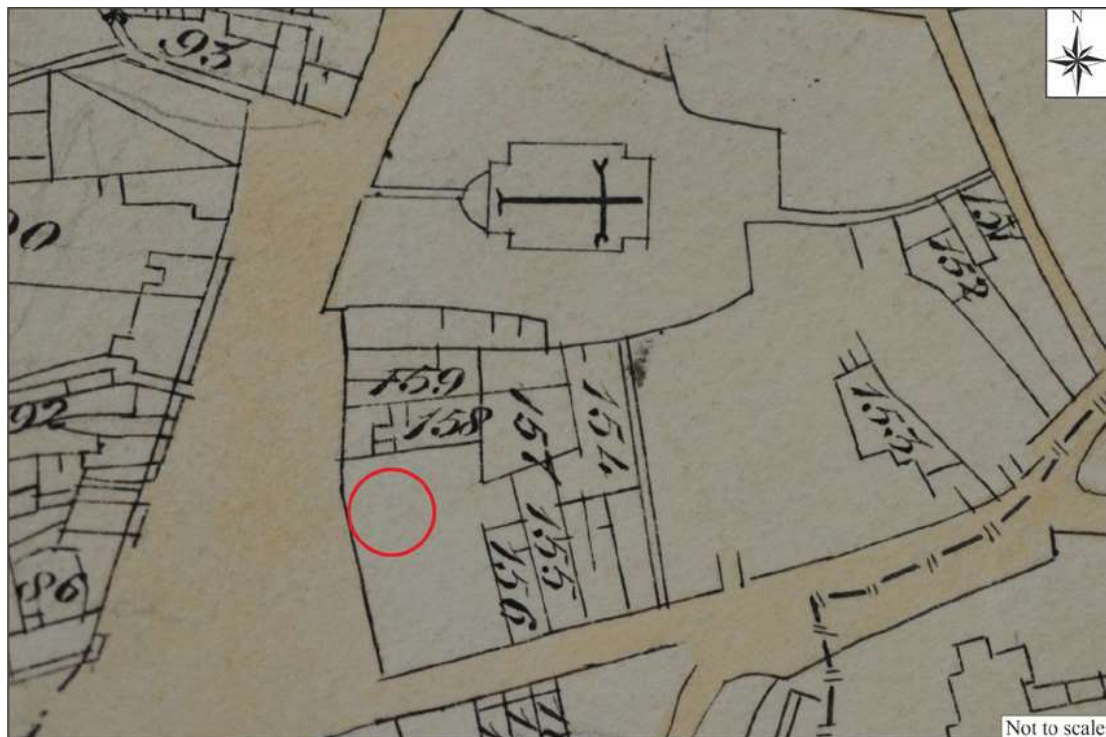
Figure 6 Tithe Map of 1852

The Tithe Map of 1852 (ORO 30/M) shows Banbury in some detail (Fig. 6), however, the location of The Woolpack and other buildings adjacent to it are omitted. This is probably an indication that this building and those around it resided on a tithe free piece of land. Many of the properties in the island in which the church is located are marked in this fashion and perhaps is a basic indication of where the church land at Banbury was generally located.

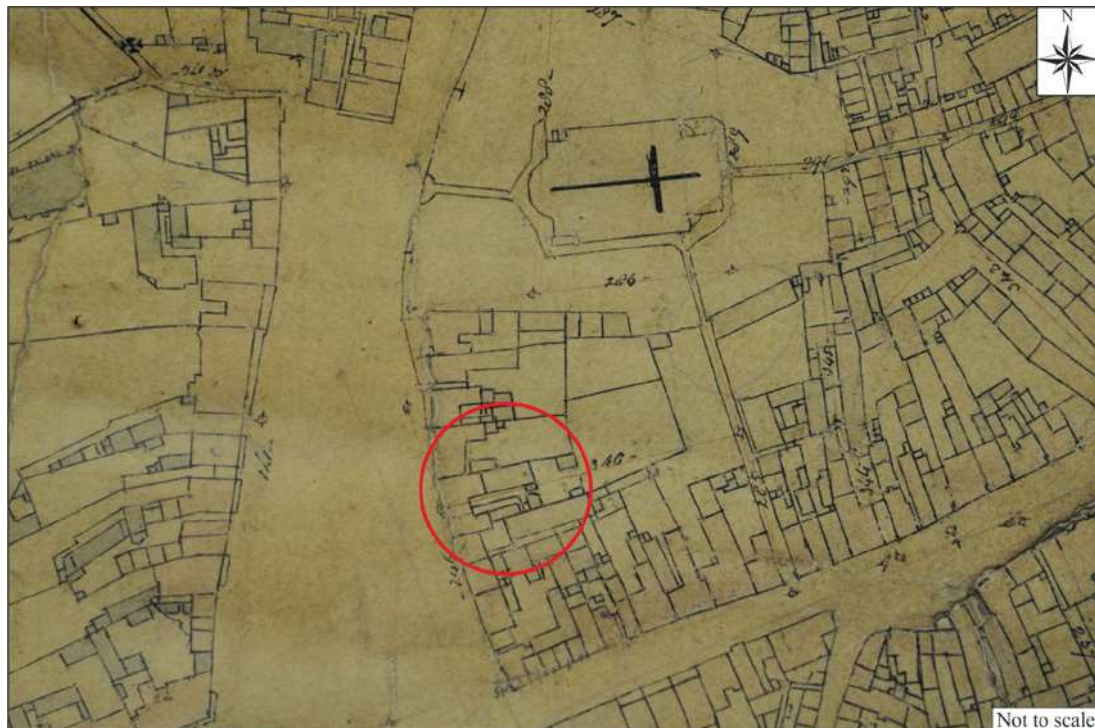
Figure 7 Davis and Davids Map of 1853

The map of 1853 (Fig. 7) by Davis and Davids (ORO L XVII-i-1) is as detailed as the parish map, but fortunately shows all of the properties in the central of town. Here the old L-shaped structure is shown in pink as a dwelling (standard convention) while even though the east wing does extend beyond the domestic dwelling it is marked in grey as an agricultural, industrial or out building. This map thus explains certain significant factors concerning the development of the building. There is a further group of four other structures marked as outbuildings constructed in the rear of the property. Stones map (Fig. 8) of 1861 (ORO CH XXIV/22) may be based on the earliest small scale 1833 Ordnance Survey map (not shown 1in to 1mile).

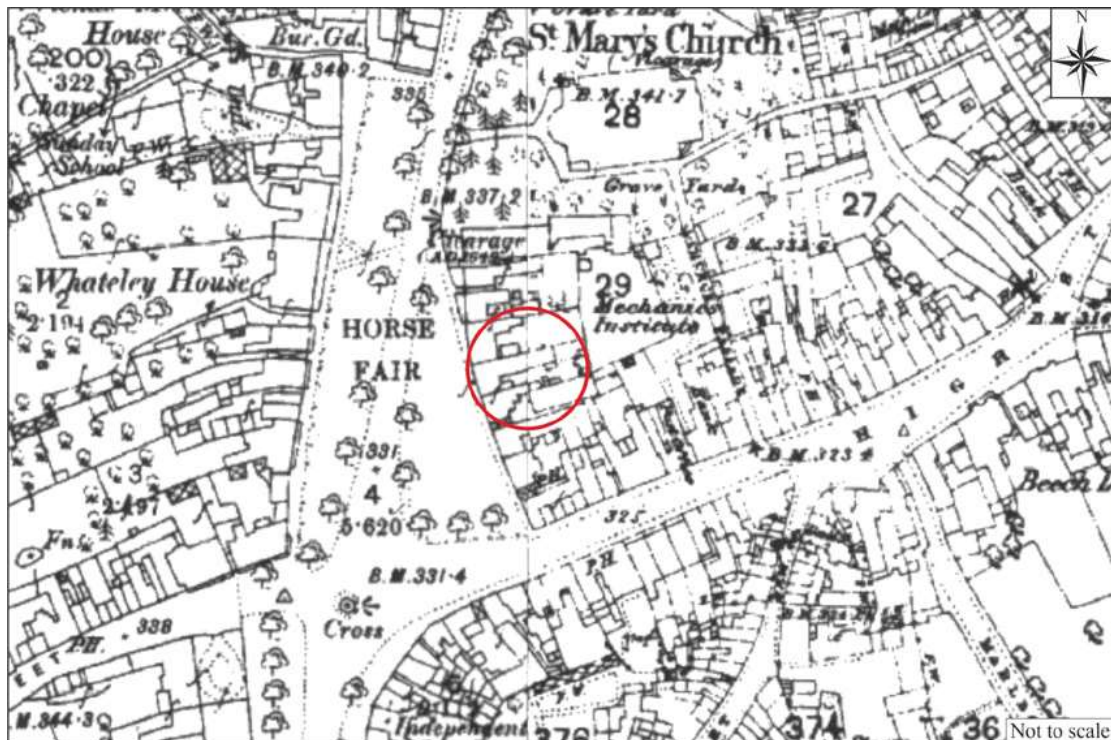
Figure 9 OS map of 1882

The last three maps are those produced by the Ordnance Survey. The first series map of 1882 (Fig. 9) shows the L-shape building but no division of the structure. It is possible that at this date the large outbuilding possibly originally a barn associated with the wool trade may have been transformed into an extension of the domestic accommodation by this time, although this cannot be confirmed. The second series Ordnance Survey map of 1900 (Fig. 10) shows the long building shaded with a different apparent division of the property at the front of the building. There are no boundaries drawn in the rear part of the properties implying that The

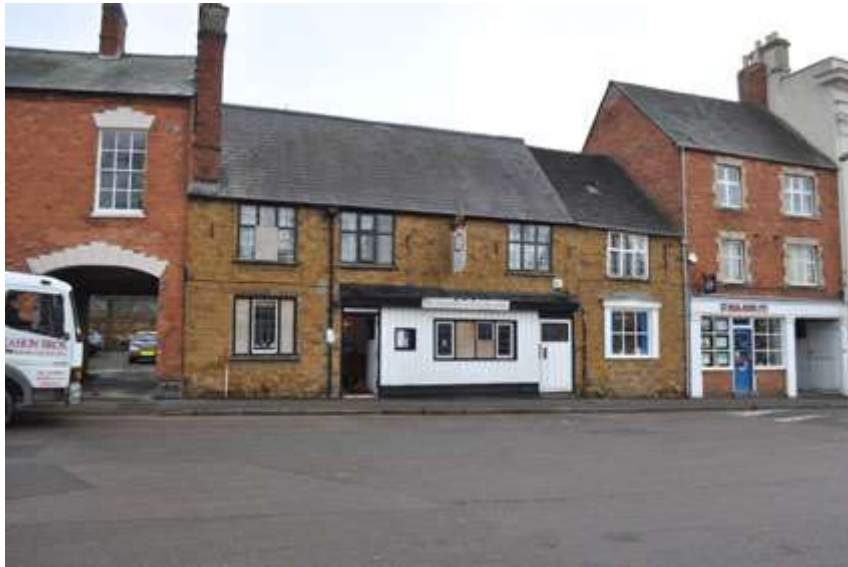
Plate 1 Front façade

The façade of the structure is west facing and built of local oolitic iron stone (Plate 1). There are two floors. On the lower floor there is an area of wall covered in vertical lap boarding that has a door at either end, both with upper window panel. Between these doors is a central mullion window with four lights. There is a plinth at the base of the boarding and a shallow protruding cornice above. Either side of this there is a window, on the left a mullion window with three lights, and on the right a window with six lights. The window on the right is now not part of the present premises, but in the past it must have been. An observation was made when the wood lap was removed that there were two bricked up openings, one located around the right hand door and window and the other around the left hand door, with a limestone column between. Between these were the remains of a limestone wall. The first floor contains four windows (one of which is now not part of the premises) each with two mullions and a transom. The windows are spaced so that there is a central blank wall on which the sign of the public house was attached on an iron bracket. The original façade was, therefore, originally symmetrical in its design with two openings or passageways. This is presumably not for the

use of the public house, but may be a necessity for the public house to function in a further capacity, as part of the Banbury post-medieval wool trade.

The roof indicates that this frontage now serves more than one property, and the roof is split with the right hand quarter being at a slightly different angle. The other roof covering  $\frac{3}{4}$  of the building is covered in slate. A brick chimney with water tablets is visible on the left hand side.

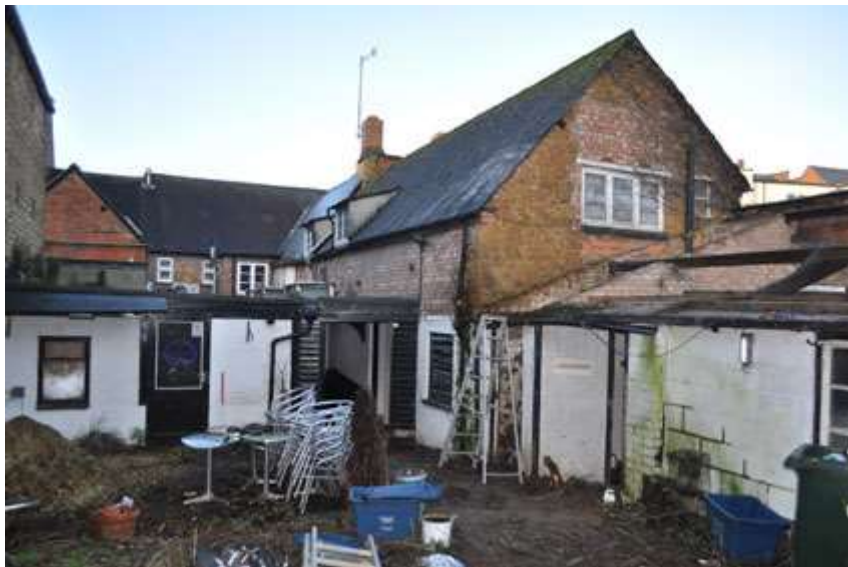
Plate 2 Rear façade

The rear wall of the building is complicated due to the complicated L-shape of the old structure and the later insertion (Plate 2).

On the right hand side there are indications of a gable end of brick infill and limestone blocks. An opening on the ground floor has been filled in while on the upper floor are the remains of a mullion window with three lights, but set in an area of brick infill. The ground floor on the left had a modern flat roof with two doors, the right one with boarding either side and on the left a window. Roof lights are evident on the flat roof, while above this on the left is a red brick gable. Between the rear wing and the neighbouring gable is a wall with a fragmentary limestone piece with modern brick insertions. The wall contains three windows all new.

The south facing façade of the rear wing contains two components (Plate 2). A right-hand component which contains a series of breezeblock lean-to structures with corrugated roofing, and a left-hand façade which is the upper floor of the rear wing. The upper wall of the rear wing is in brick, there are two dormer windows and a further group of windows at the west end. The roofs are steeply pitched, some covered in slate and others in corrugated asbestos. There are a group of chimneys located centrally along the range, one in stone and one in brick. There is a further chimney obscured on the north side of the roof.

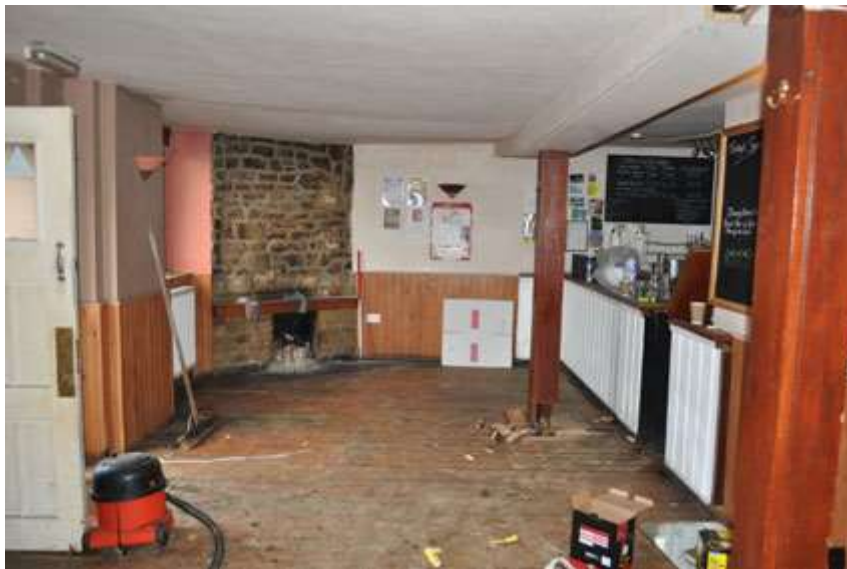
Plate 3 Front bar

The front bar (Plate 3) has a west wall with a central door flanked by two mullioned windows. There is a modern fireplace in the northwest corner, but it is not apparent what this masks. There is a bar located in the east wall on the north side with modern fittings, and a central passageway from this bar that extends to the back of the public house. All walls contain modern lap panelling. There are two freestanding posts in the room; one at least is an older beam that is clad in later timber. There are also chamfered beams in the ceiling that are also clad by later timbers.

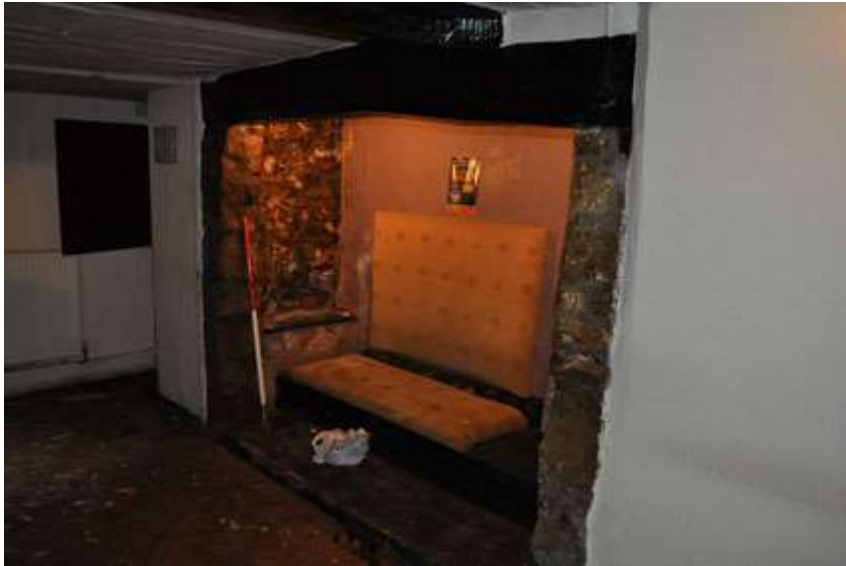
Plate 4 Inglenook in back bar

The passageway extends from the east door of the front bar to the back of the ground floor of the public house. There is an L-shape passage from the main long central passage leading to the southern front door that provides direct access to the back bar. A door of this L-shaped passage leads into the cellar, a modern above ground construction. Immediately on the north side of the main through passage are a pair of black painted panel doors that leads to the base of the west stairwell. Next along the north side of the passage is the back bar, which has a modern bar on the west side. There is a large inglenook (Plate 4) with chamfered timber lintel on the east side that has seen some unnecessary alterations that detract from its status. The ceiling has a black painted chamfered beam and a planked wooden ceiling (Plate 5). The passageway between the bars contains some stonework, and there is fragments of timber framing between the back bar proper and the central passageway.

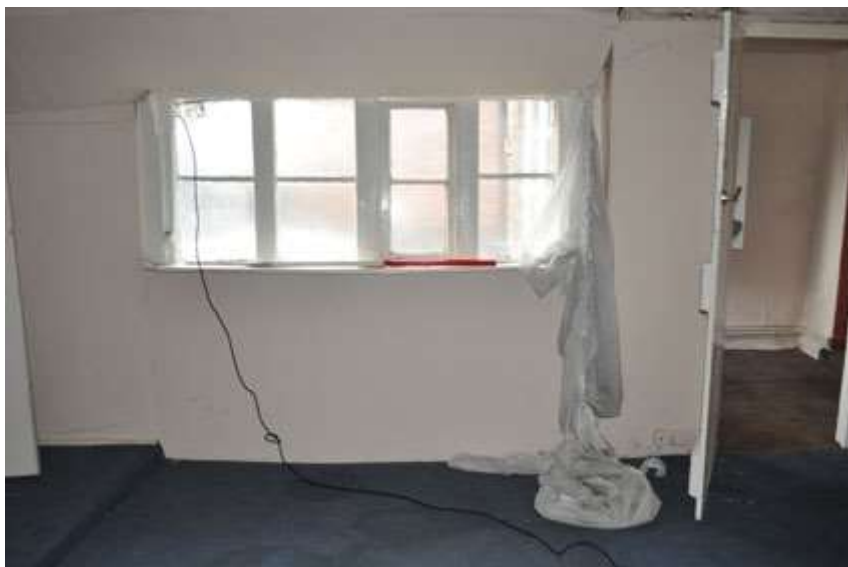
Plate 7 Mullioned window first floor

Access to the north front room is obtained at the end of the passage through a panelled door. In the west wall is a mullioned and transomed window with seat below. In the northwest corner is the breast of a chimney that has been blocked up. The exposed timbers here appear to be covered in plaster and then painted.

Access to the central front room is obtained through a hardwood covered panel door. There is a mullioned and transomed window in the west wall, with seat below and a cockspur handle. On the east side of the room there is a black beam running below the ceiling. It is possible that this is a covered timber, but it is not confirmed.

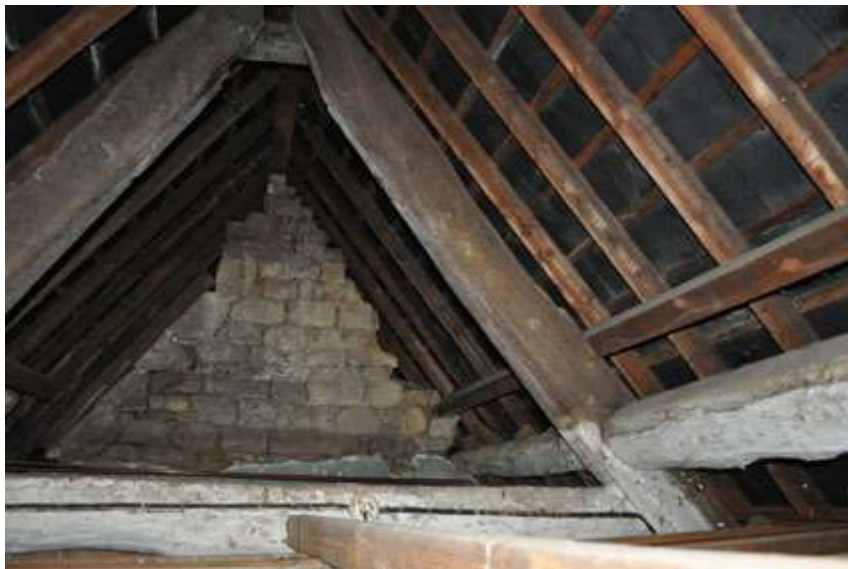
Plate 8 A-frame and chimney remains in attic over back bar

Three attic spaces were observed. The west attic space at the front of the building had king post and struts from a tie beam. The timbers in this area of the roof did not look exceptionally old and may well have been replaced from the 19<sup>th</sup> century or later. The middle part of the roof, contained old timbers in an A-frame and perlins (Plate 8). At either end there was evidence of a chimney stack, which is indicative of the modern front bar using part of an inglenook in the front bar. The east roof space also uses A-frames but this is 19<sup>th</sup> century in appearance.
