**ARCHAEOLOGICAL EVALUATION REPORT
AT THE FORMER EAST BERKSHIRE COLLEGE,
BOYN HILL ROAD, MAIDENHEAD, BERKSHIRE**

NGR SU 877 807

OCTOBER 2012

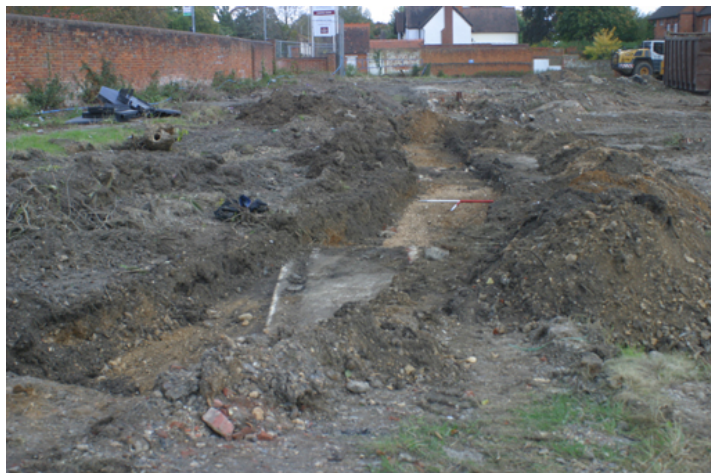
In Trench 1 the gravel (1/2) was overlain by demolition and redeposited topsoil (1/1) up to 0.3m thick; in Trench 2 the cultivation soil (2/2) and gravel (2/3) was overlain by hardcore (2/1) for access up to 0.2m thick; and in Trench 3 the redeposited

Trench 1; overview looking east

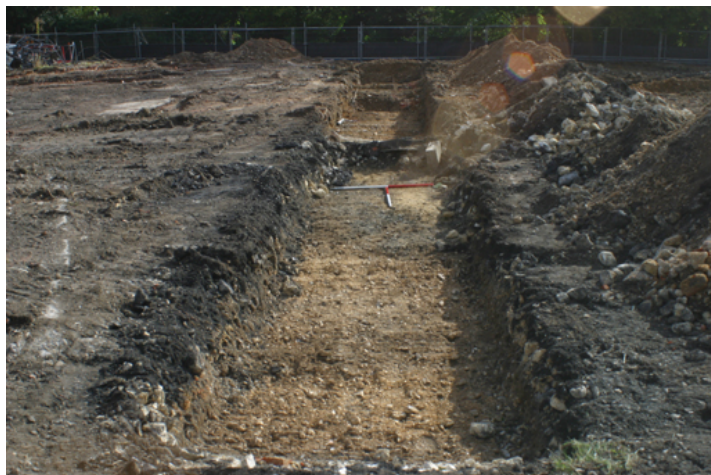
In Trench 2 there was a thin layer of brown silty sand loam (2/2), a former cultivation soil, which extended approximately 2m from the north end of the trench, up to 0.1m thick; late 19th- or early 20th-century brick (not retained) was present in the deposit. In Trench 3 this layer was encountered as a redeposited layer (3/2) in which a small quantity of poorly preserved architectural ceramics (not retained) were present. These would appear to be remains from Cliefden Cottage or Redriff, seen on the 1876 and 1899 OS maps. This deposit extended from the base of the topsoil (3/1) to the gravel (3/3), a depth of *c* 1.1m, and did not include any *in situ* cultivation soil.

Trench 2; overview looking south

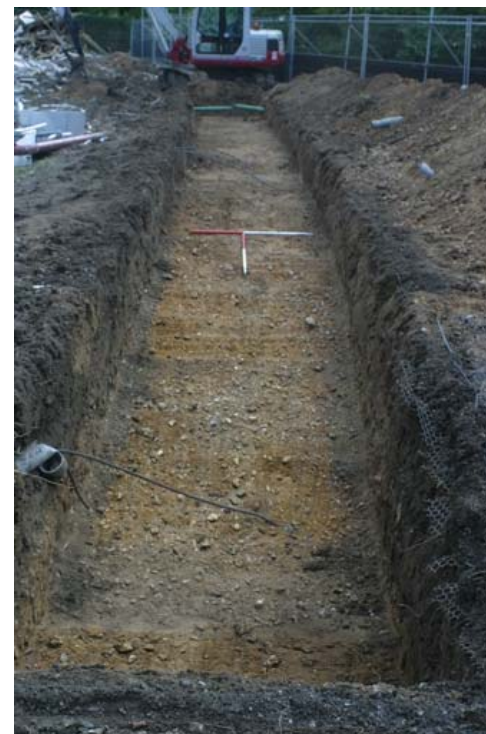
Trench 3; overview looking south

cultivation soil (3/2) was sealed with topsoil (3/1) approximately 0.15m thick.
