**JOHN MOORE HERITAGE SERVICES**

**THE BLACK HORSE HOTEL,  
11 CORNMARKET,  
THAME,  
OXFORDSHIRE**

**HISTORIC BUILDING ASSESSMENT**

**MARCH 2005**

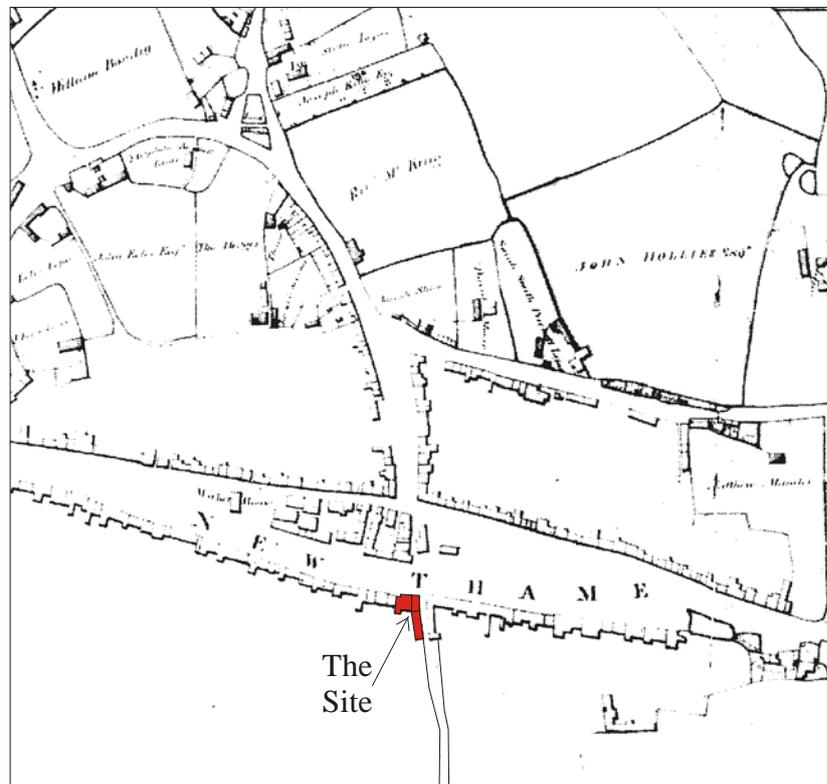
Figure 2: The 1823 Enclosure Map

The earliest available map showing the property was the 1823 Inclosure Map (Figure 2). The map shows the property as comprising three separate buildings: a large front block with an elongated building adjacent, stretching back along Rooks Lane; abutted by a further rectangular building at the rear.

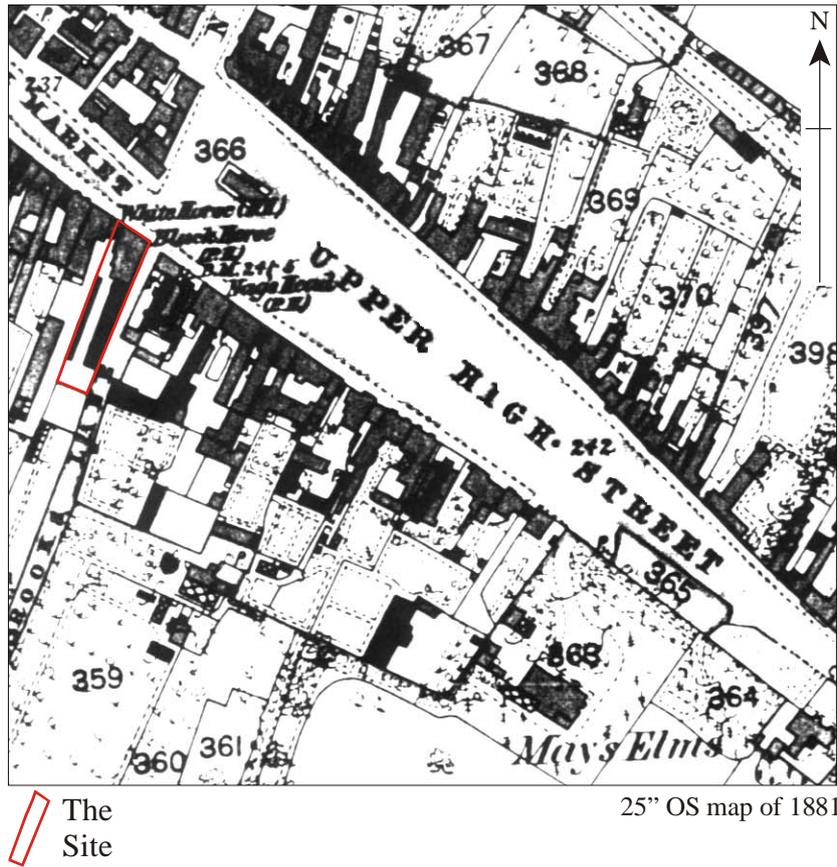
Figure 3: The Site at the time of the 1881 edition Ordnance Survey map

By the issue of the first edition Ordnance Survey map (henceforth OS), the site showed the front buildings as a single block (Figure 3) with a long rectangular block to the rear fronting onto Rooks Lane, and a further narrow building opposite, abutting the property boundary to the west. The second edition OS map (1897) shows the same configuration but portrays the long building on the Rooks Lane frontage as comprising five abutting units. A further building had been added to the south also abutting the property boundary (Figure 4).

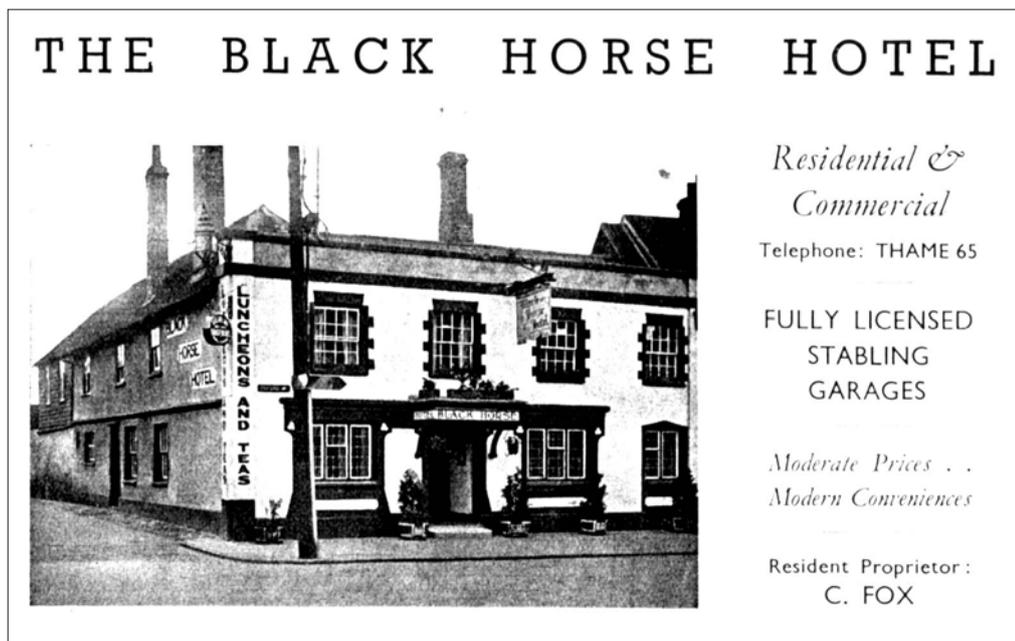
Figure 5: Postcard of the property c. 1940

As shown on the OS maps, the property was known as the Black Horse Hotel since at least 1881. Mention is made of the property operating under the name of 'The Fleur de Lys' as early as 1838 (Clarke 1978). Kelly's Directory of 1911 describes the property under the proprietor William Dunk as providing good commercial accommodation including 'motor garages' and stabling. The provision of such amenities continued into the late 1930s, early 1940s as shown on a postcard from that era (Figure 5).

The main building facing onto Cornmarket is under a render of rusticated stucco over brick. The Georgian character of the front elevation is retained with the exception of the pediment that is shown in Figure 5. The main building is two-storeys in height, with the ground floor entrance comprising a 20<sup>th</sup> century door with windows of the same date to either side. The windows remain within the original 19<sup>th</sup> century surrounds. The 16-pane sashes to the first floor are typical of the mid-Georgian period. Within the property, it is clear that many modifications have been carried out. Elements of the early buildings that once occupied the site can be seen in the form of spine beams with elaborate chamfer stops. The jowl post at the junction of the building

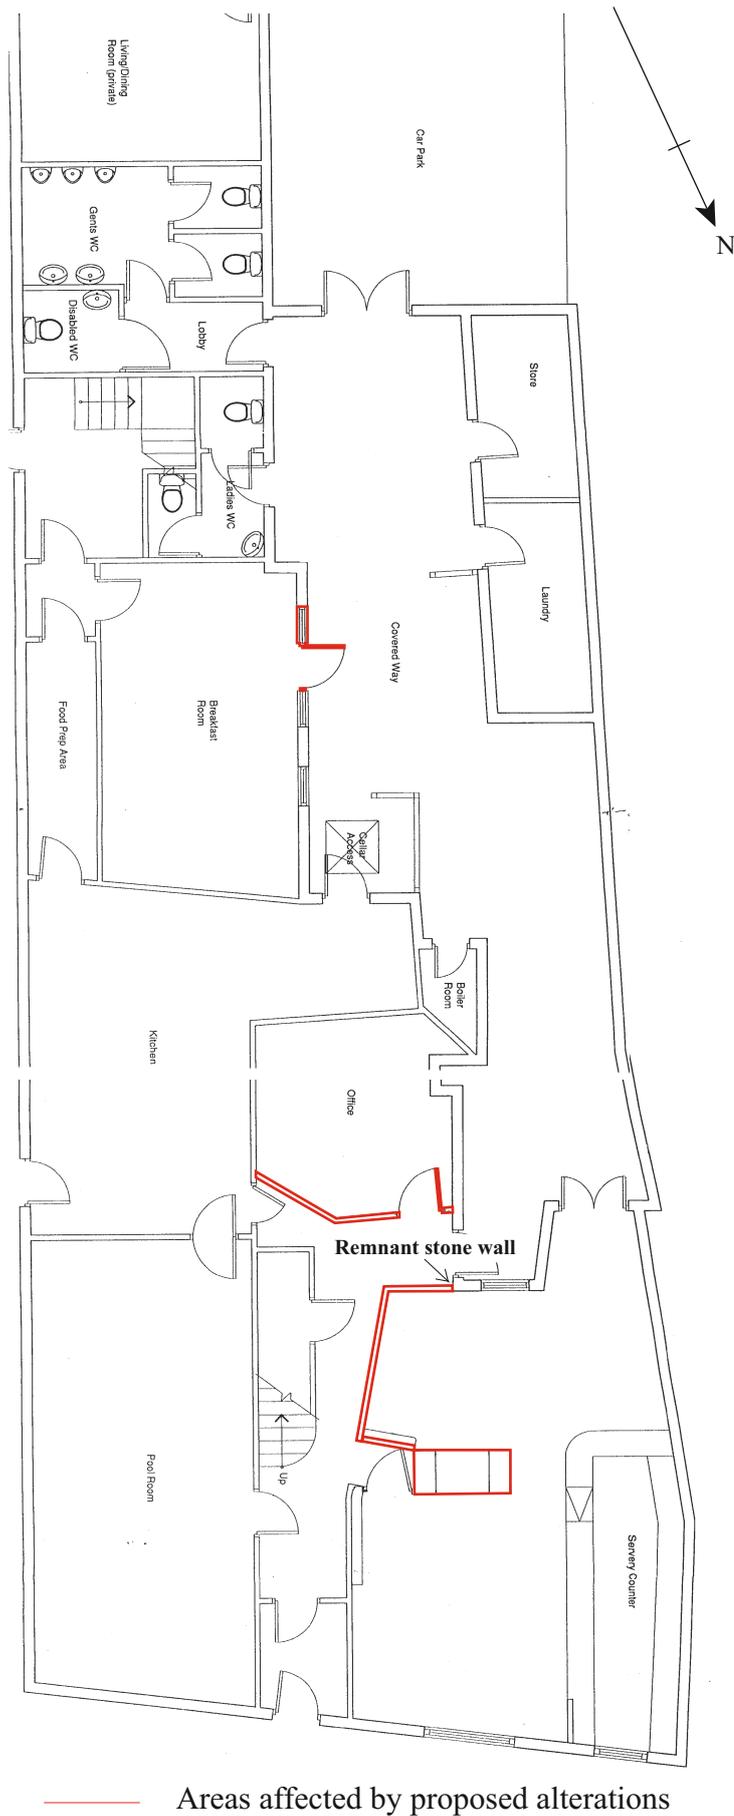
Figure 6: Site plan showing proposed areas of alteration

The wall to be removed had been inserted in the present location. Remnants of an earlier more substantial rear (stone) wall to the building are still *in situ* (position indicated on Figure 6), in addition to a drainpipe, now painted over (Plates 2 & 3). The location of the drainpipe suggests that this wall was at one stage a rear outside wall of the property. The inserted angled partition wall abuts this thicker stone remnant (Plate 2).

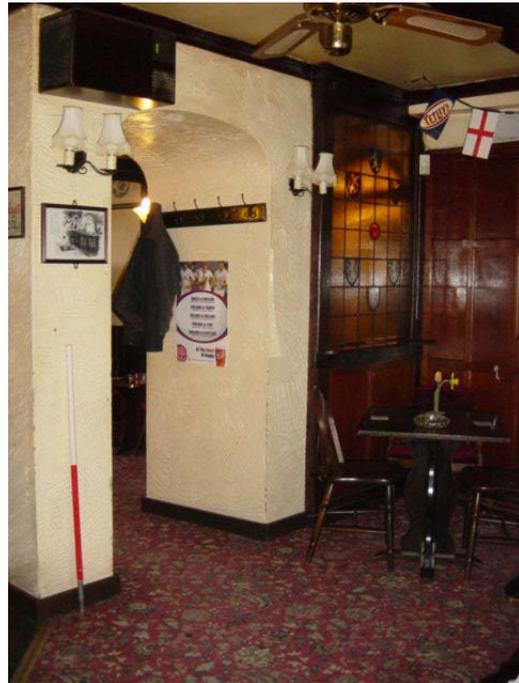
The arch intended for removal once housed the fireplaces to the lounge and bar. Alterations to remove the fireplaces were carried out in a 1984 programme of works. The glass panel and infill between the arch and the partition wall are late 20<sup>th</sup> century insertions into what was originally a doorway between bar and lounge (Plate 1).

Plate 1: The arch created when fireplaces were removed and adjacent 20th century inserted glass panel

Within the Bar, the panelling, glass partition and modified arch within the early chimney piece were all late 20<sup>th</sup> century alterations to the Georgian hotel. At the rear of the property, within the ancillary buildings, a high degree of refurbishment can also be seen: the current Breakfast Room is a 1930s development.

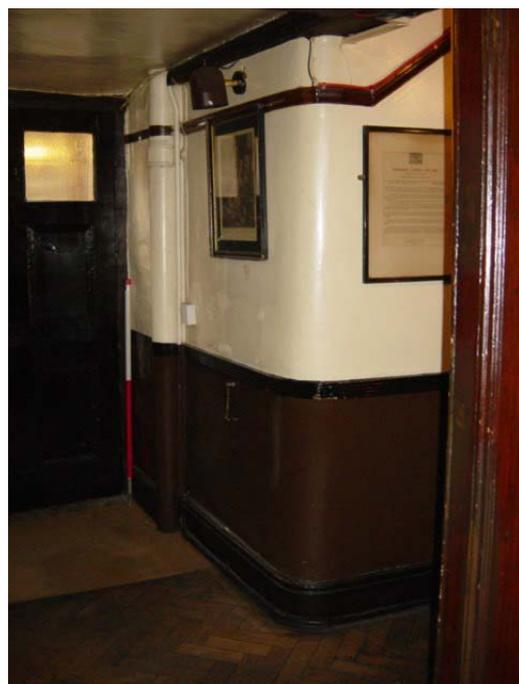
Plate 2: Rear of partition shown abutting earlier wall remnant and drainpipe.

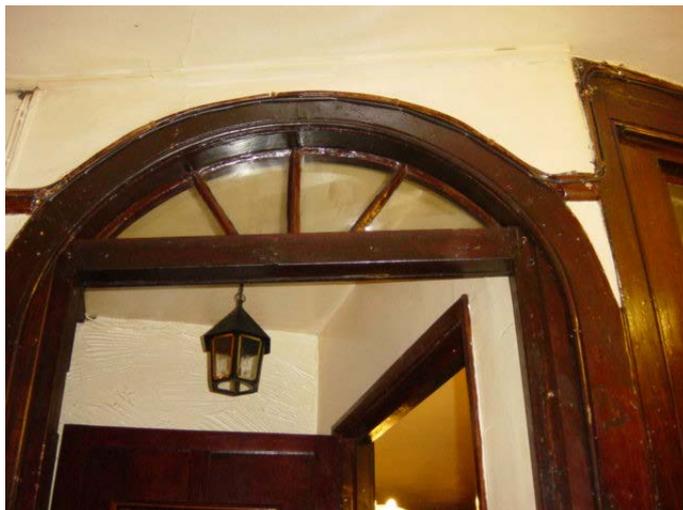
Within the partition there is a fanlight (Plate 4) above the access between bar and corridor, this appears to be Georgian in origin and it is probable that the partition wall was inserted in conjunction with the staircase, the wall at an angle to allow space for the staircase and access to the rooms at the rear of at the rear of the property.

Plate 4: The fanlight above access to the bar from the passage

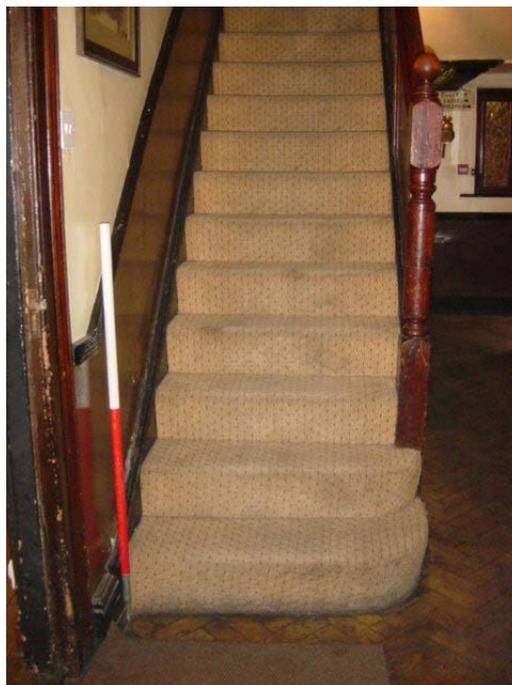
Plate 5: The Staircase

The style of the staircase indicates a 19<sup>th</sup> century origin for its insertion. As mentioned above, it is likely that the staircase was inserted as part of a programme of re-modelling including the construction of the partition wall in its current location.

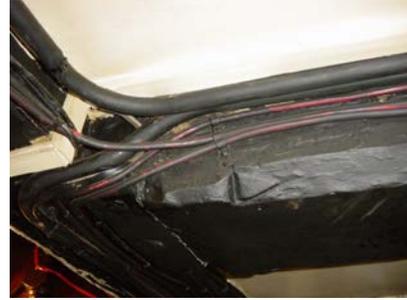
This wall is an insertion: the position of the partition cuts across a much earlier spine beam with ornate chamfer stop, leaving only a short length exposed (Plate 6). The beam forms part of the remains of an earlier phase of buildings on the site. In its original state, the beam would have been situated in a room with a chamfer stop at either end, indicating the true length of the room. In the present situation one end is visible extending into the corridor, clearly cut across by the inserted partition. Within the office, the beam continues and remnants of the ornate stop (Plate 7) can be seen at the rear of the room (the original end of the room). Further timber framing is also visible in the wall between office and kitchen, and the ceiling joists are *in situ* (Plate 8).

Plate 7: Detail of the chamfer-stop at the end of the spine-beam, this would have marked the original end of the room now shortened by the insertion of the late partition wall

The site within which the Black Horse Hotel is situated, at 11 Cornmarket, Thame comprises the remains of an early Burgage plot. The earlier buildings occupying the site, probably of 16<sup>th</sup> century origin still survive incorporated in re-builds and modifications carried out to the premises over time. The majority of the current layout was created in the Georgian era, with much of the main building onto Cornmarket constructed at that time. The long building to Rooks Lane, originally of timber-frame construction was incorporated into the Georgian rebuild. As part of this phase of building, the partition wall to the passage and staircase were inserted. The first partition wall to the office may also have been inserted at that time. However, the insertion of the current doorway and window, and the angling of the wall towards the kitchen were all 20<sup>th</sup> century developments, suggesting that little, if any, of the earlier partition survive. The partition in any case, is a late addition, reducing the length of the earlier room. Removal of the remains of this much modified wall line would re-establish the true extent of the room in accordance with the chamfered spine beam.

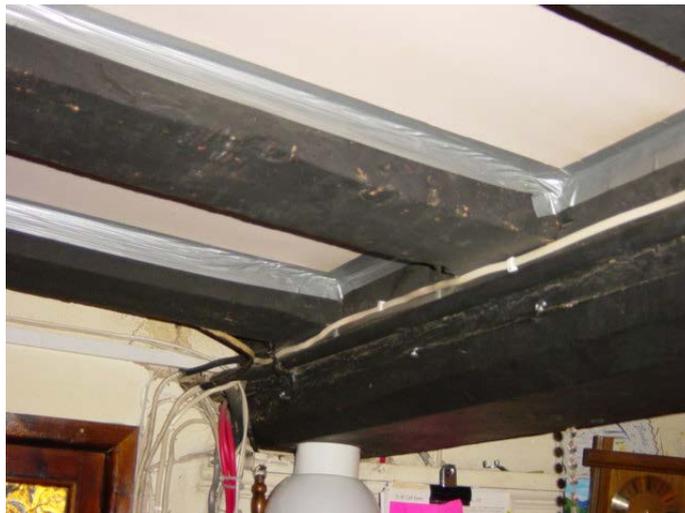
Plate 8: The continuation of the early spine-beam into the office, with ceiling joists *in situ*

It is clear that the site was occupied from as early as the 16<sup>th</sup> century and that some elements of that date survive in the current building fabric. The current proposals for the establishment do not affect these early remains. The removal of the Office wall would do much to enhance the early features in that area by allowing the true length of the original spine-beam to be viewed in conjunction with the ceiling joists.

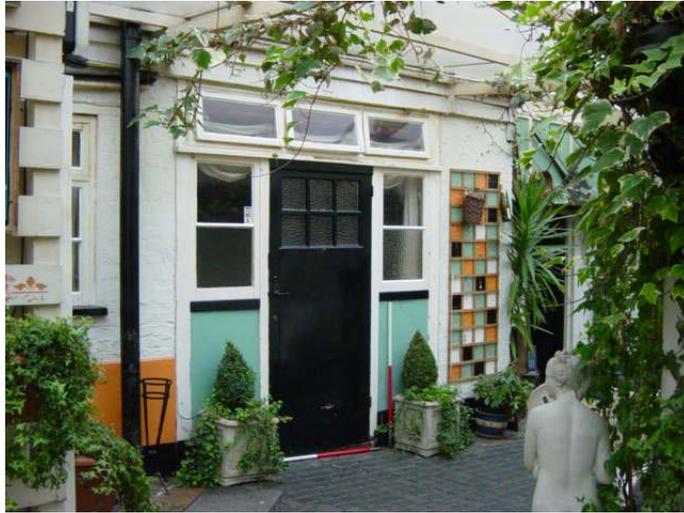
The doorway and window arrangement to the current Breakfast Room are of 1930s origin, and as such are part of a later development to the Hotel complex.

Plate 9: The 1930s doorway to the Breakfast Room

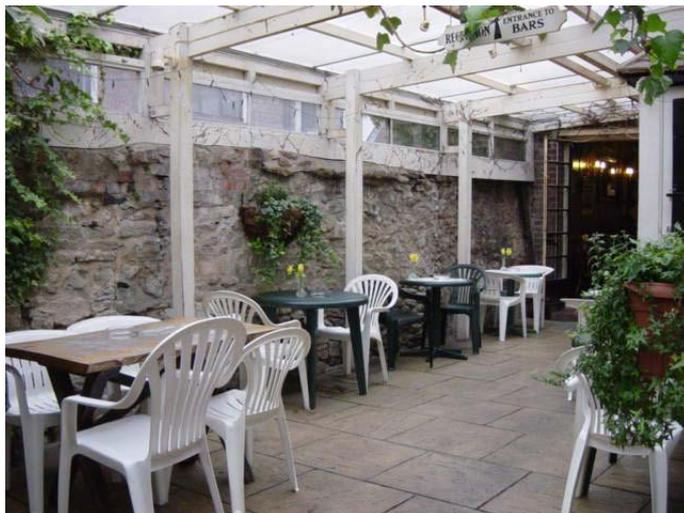
This wall (Plate 10), between the Hotel grounds and the adjacent property to the west is the remains of an early boundary to the Burgage plot.

Plate 10: The remains of an early boundary marking the limit of the Burgage plot
