JOHN MOORE HERITAGE SERVICES

**AN ARCHAEOLOGICAL WATCHING BRIEF AT**  
**ABBEY FARM BARNS,**  
**STATION ROAD, EYNHAM**  
**OXFORDSHIRE**  
**NGR SP 4318 0913**

*Rivar Ltd.*

**FEBRUARY 2013**

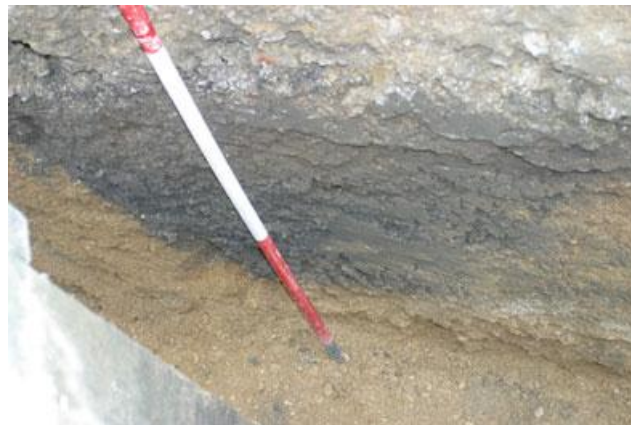
Figure 3. Ditch 3008

There were two features dating from the 11<sup>th</sup> century onwards: the ditch 3008 (Fig. 2; S1; Fig. 3) and the pit 3014 (not illustrated). The ditch 3008 was located in the southern service trench, extending into Plot 3 within the barn as ditch 203. The ditch was oriented at rough right angles to the road (3015) located along the whole of the northernmost of the two service trenches. The ditch 3008 was filled with dark brown to black clay sand and gravel – (3007) – yielding a single sherd of Cotswold-type ware.

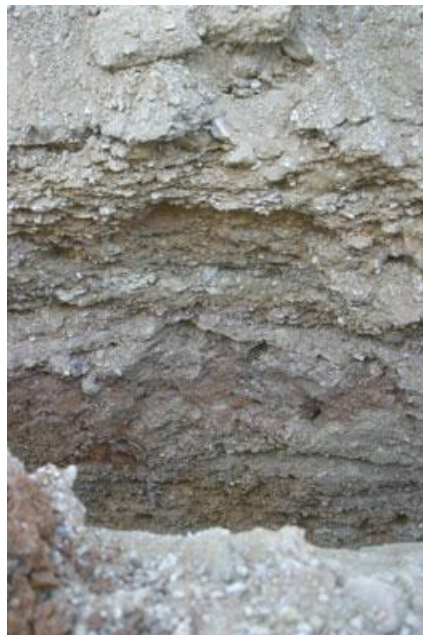
Figure 4. Road (3015).

To the north, the road comprised layers of gravelly clay sand with less frequent clay sand layers interspersed (3015), the latter functioning as bedding layers prior to a new layer of metalling (the former) being laid down (Fig. 2; S 2; Fig. 4). There were at least 14 such layers, although as this was the side of the road, one should expect fewer repairs than towards the centre, where the road may well prove to be thicker, due to potentially being cambered, as well as more heavily rutted and consequently subject to more repair.

It was not possible to explore the relationship between the road (3015) and the ditch 3008/203 as the ditch was only present in service trench and the barn; the road (3015) was only present in the northernmost service trench.

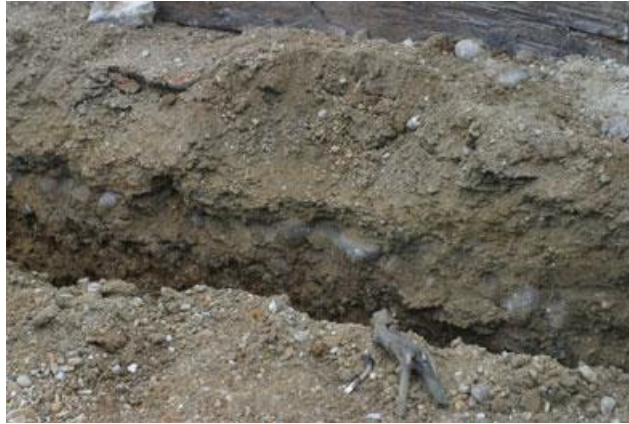
Fig 5. Cobbling 3006 associated with barn.

The features were overlain by the compacted dark brown to black gravelly clay sand (3001), which probably represents a post-medieval metalling of the access road; cut into this layer in front of the barn north entrance was a layer of rounded medium-sized cobbles (3006), the width of the barn door (Fig 2, S1; Fig. 5). This can clearly be associated with the barn. Sealing the post-medieval metalling (3001) and the later cobbles (3006) was the modern access road surface, compact yellow grey gravelly clay sand with occasional large flat stones measuring  $80 \times 60 \times 30\text{mm}$ .

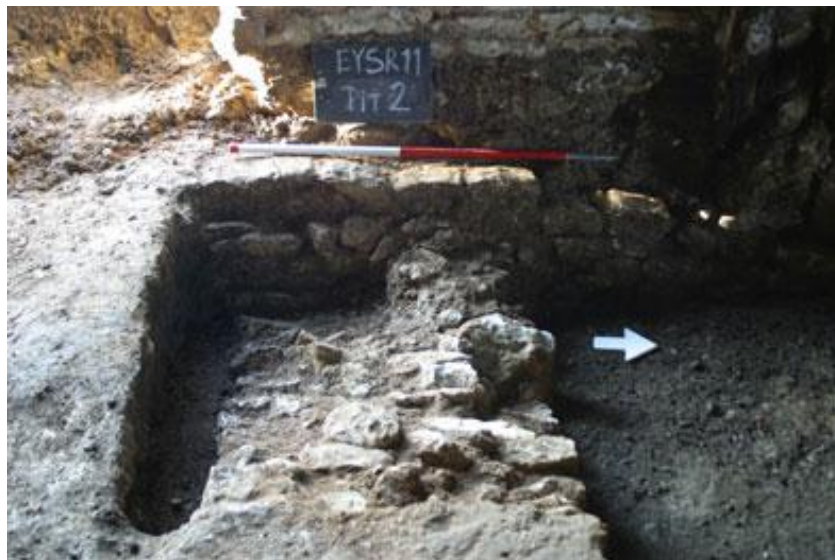
Figure 8. Wall 107 in Pit 2

On the south side of Pit 2 (Fig. 7; P6; Fig. 8) the deposit (101) was cut by the construction cut 106, into which the east/west wall 107 was built; the construction cut could not be seen. The wall 107, which comprised at least two courses of limestone fragments, the uppermost visible pieces pitched vertically with more random rubble infill and no apparent mortar, was built tight to the construction cut (Fig. 8). South of the wall 107, the deposit (101) was identified as (102), but no finds were recovered from it.

To the west, the wall 107 was cut by the construction trench 103, into which the earlier north/south wall 104 was built. The wall 104 was made of roughly worked to roughly dressed limestone pieces with sandy lime mortar; evidence for some string-coursing was present. The construction cut fill was dark grey clay silt (110) and yielded a large sherd of Medieval Oxford Ware.

Built on top of the wall 104, the wall 105, which was roughly coursed with roughly worked stone was un-bonded, but appeared to be the footings for the present barn. Butting up against the wall 105 was the levelling deposit (108).

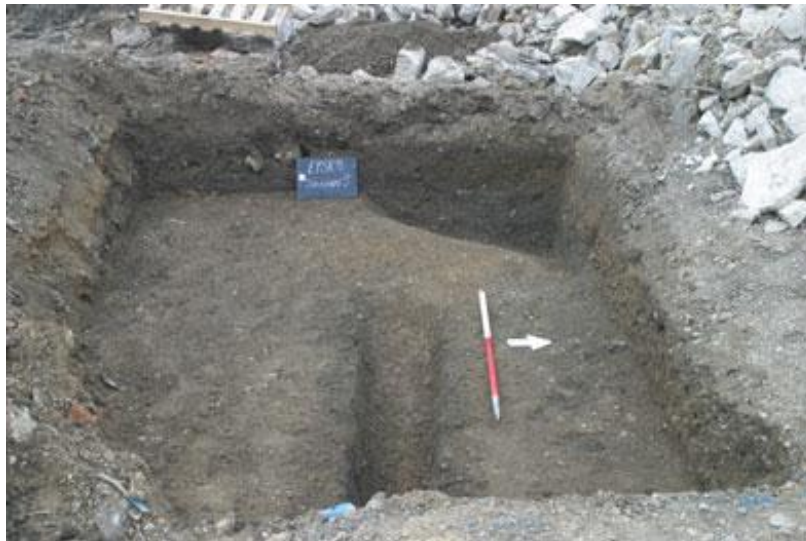
Figure 9. Soakaway 5

The soakaway 5 (Fig. 7; P7c; Fig. 9), which measured 3.7m × 2.7m, was located at the rear of Plot 6. The natural gravel (614) was revealed. Cut into the gravel (614) were two amorphous apparently shallow features 635 and 641. The pit 635 was located on the northwest side of the soakaway and contained two fills (Fig. 7; S12 & S13): the lower ?slumping fill of mid grey brown gravelly silt (634), which was sterile, was overlain by firm mid grey silty loam (633), yielding four sherds of pottery in a range of fabrics. To the east the possible ?linear cut 641, oriented northeast/southwest with a possible return

to the northwest, was filled with dark grey sandy silt (640); pottery dating from after the 11<sup>th</sup> century and roof tile were recovered from the fill (640). Sealing both of these features was a deposit of mid grey green sandy silt, with occasional stone (632), c. 0.35m thick, extending beyond the edges of the soakaway. Pottery dating from after the late 11<sup>th</sup> century was recovered from what was potentially a cultivation soil. A thin layer of mid grey blue sandy silt with occasional well-worn stone (631), c. 0.11m thick, sealed the cultivation soil; it too yielded pottery dating from the 11<sup>th</sup> century onwards. The precise nature of the upper layer is uncertain, but probably also represents a cultivation soil.

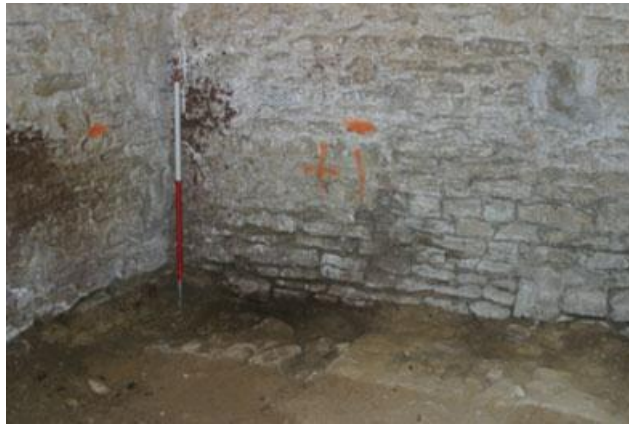
Figure 11. Wall 402, with mortar lintel (403) and stone blocking (404)

250 × 250 × 150mm and bonded with hard sandy yellow mortar (Fig. 11). The wall was clearly visible over half the length of the room; the eastern half was visible as a shadow, although later reduction in the northeast corner confirmed that the wall was present here.

At the west end of the wall was a break, *c.* 600mm wide, with a spread of firm white sandy mortar rubble (403); overlying this were loose fragments of limestone in clay packing (404). The mortar layer (403) appears to have represented a mortar lintel at the entrance to a room defined on its north side by the wall **402**.

The entrance was blocked by the rubble (404). It also appeared that the present west wall of the accommodation unit was overlying the corresponding western jamb blocked by (404); it was not possible to discern whether the wall returned to the south or continued to the west; ground reduction in the adjacent Plot 1 was limited and did not reveal any remains of archaeological significance. It was clear, however that the present north wall **405** of the structure did not overlie the wall **402**.

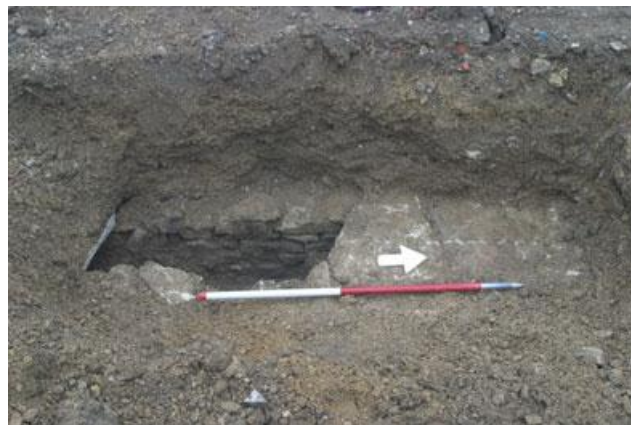
Figure 17. Stone drain 805.

To the south and in the garden Soakaway 2 which measured approximately 2.5m × 2.5m was excavated under archaeological control to the top of the natural gravel (800). Cut into the gravel, on the west side of the soakaway was the linear cut 806 for the stone drain **805**, oriented north/south (Fig. 14; P12; Fig 17). The drain was over 2.5m long, and approximately 0.5m wide with a depth of 0.37m comprising four to five courses of roughly laid stone, and capped with stone flags **804**. The cut 806 was backfilled with mixed natural gravel (802). The drain was partly backfilled with soft pale brown silt (803). The whole was sealed by mid brown loam (801) and modern farm soil (800).

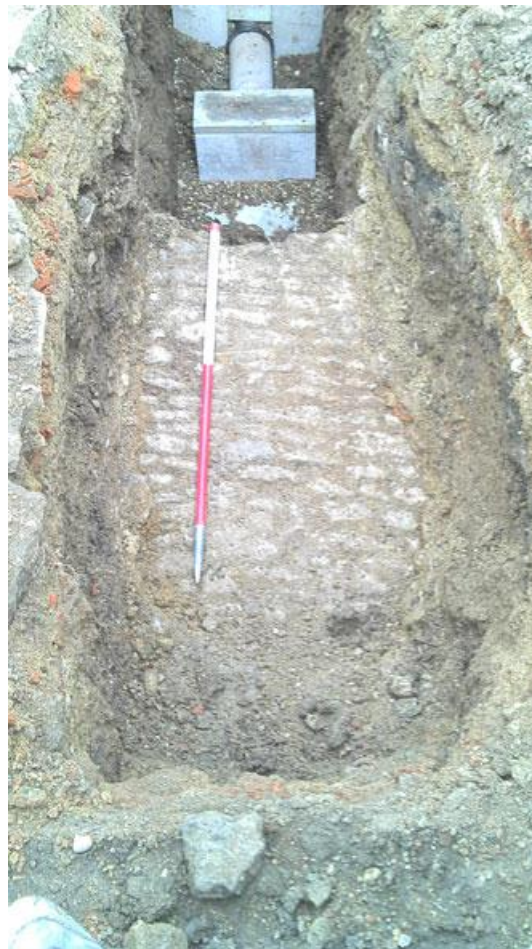
Figure 19. Road surface 2004

At the east end of the trench was a cobbled road and an associated area of metalling. Cut into the natural gravel (2009) and the eastern edge of the cultivation soil (2008) was a shallow cut 2011, filled with grey clay and gravel (2010) overlain by a well-laid road surface 2004 set into grey clay (2012) comprising limestone fragments laid on the long axis (Fig. 19). Bordering the road on the west side was a deposit of clay (2012) with further to the west was a layer of limestone fragments (2007) which were not set as the road, although formed a surface; these presumably functioned as a metalled yard, abutting the road.

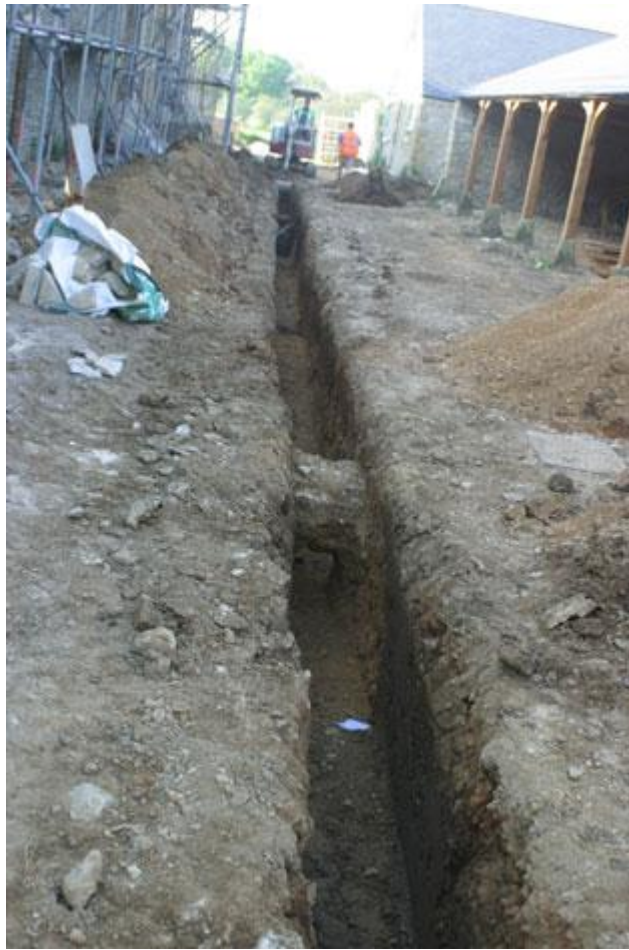
Figure 20. Service trench looking south.

The earliest dated feature was at the south end of the service trench (Fig. 18; P 14a), a large pit 1008, filled with black brown, clay silt with charcoal flecking (1007). It measured at least 2.5m wide and 0.7m deep; pottery dating from late 11<sup>th</sup> century was recovered from the fill. On the west side of the trench was the gravel extraction pit 1010 (not illustrated), filled with sticky black brown gravelly clay silt (1009), which yielded a sherd of 11<sup>th</sup>-century pottery. Cut into the top of the pit 1008 was a shallow scoop 1006 (see Table 4). The construction cut 1003 for wall **1002** was cut into the fill of pit 1006; the wall was made of rough-hewn uncoursed limestone fragments bonded with yellow brown silty clay (1004). The date of this wall is uncertain, although was thought to be reasonably recent, predating the construction of the south end of the barn. To the north was a large gravel extraction ?pit 1015 which had been subsequently recut by pit 1013, which was cut by pit 1017 (Table 4; Fig. 18; S30).
