JOHN MOORE HERITAGE SERVICES

AN ARCHAEOLOGICAL WATCHING BRIEF

AT COGGES MANOR FARM,

WITNEY,

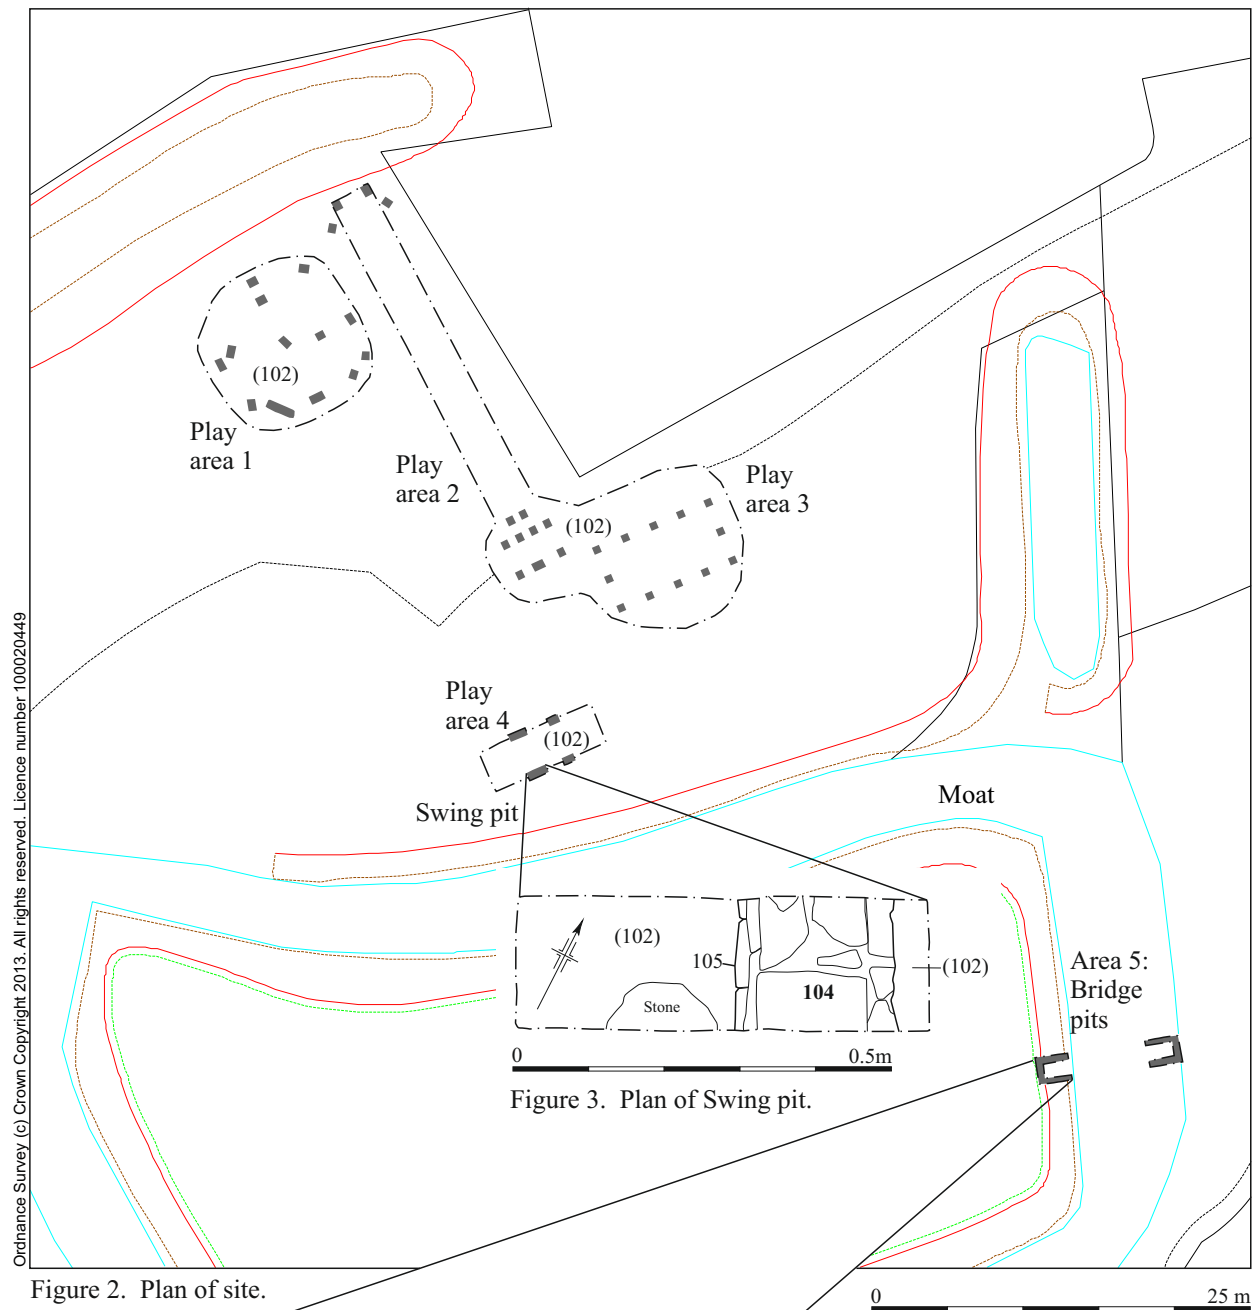
Figure 2. Plan of site.

During the first phase of the watching brief, which focussed on the play area, there were four discrete areas monitored. Area 1, in which the Congo climbing frame was located (Fig. 2), was in the northwest part of the site on a slightly elevated platform. Following ground reduction of *c.* 150mm, 13 post pits were dug for the climbing frame; seven of these were excavated to a depth of 600mm and the rest to a depth of 400mm.

All the post-pits were cut into a layer of mixed pale grey brown sandy humus with 30-60% limestone fragments (103), which was present all over the impact Areas 1-4. The deposit was at least 500mm thick. No finds were recovered from the deposit. Overlying the pale stony deposit was a dark grey brown clay humus and limestone fragment layer (102) between *c.* 150mm and *c.* 100mm thick. This deposit formed an interface between the stony layer (103) and the overlying dark brown clay humus (101) topsoil, 100mm thick. No finds were recovered from either layer.

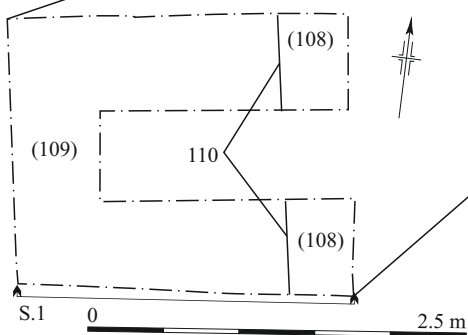
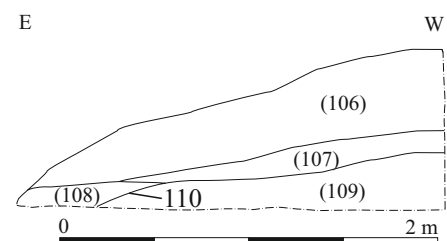
Figure 4. Plan of western bridge pit.

On the east side of the moat two squared U-shape pits were dug into the banks of the moat. Both pits were excavated to the natural gravel (109), which was cut by the moat 110, although only the western pit was excavated into the moist black humic clay backfill (108) of the moat. Overlying the edge of the moat fill (108) was a layer

of stony mid brown sandy silt (107). The subsoil (107) was sealed by topsoil (106) on both sides (Fig. 4 and Section 1).

The bridge pits only revealed moat fill, the subsoil and topsoil.

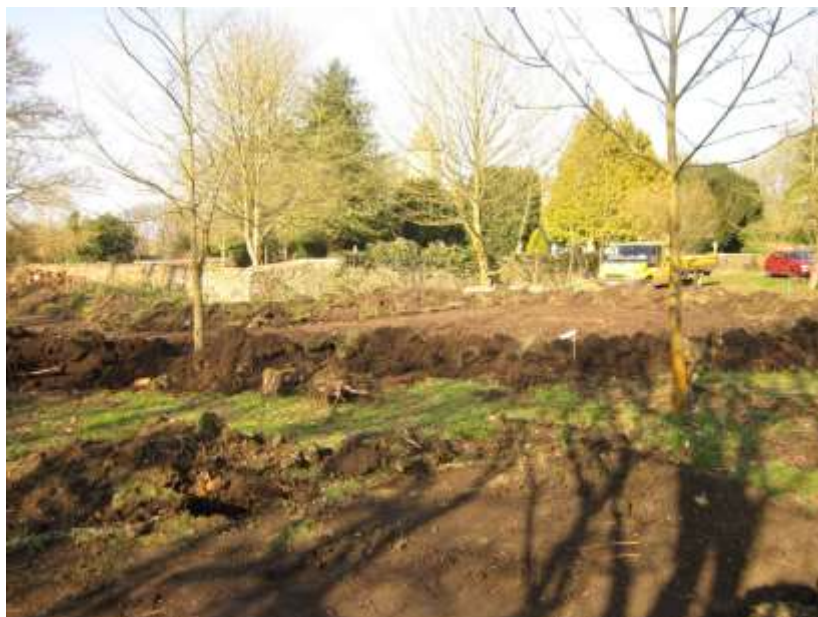
Plate 1. Areas 4 (foreground), 3 (centre-right) & 2 (centre-left).

To the east, Area 2 (Plate 1), where the ground level of the area of the zipwire was reduced by *c.* 150mm to the layer (102), with six pits, *c.* 600mm deep, excavated through this deposit. No features were present and no finds were recovered.

To the south in the area of the climbing barn, Area 3, following limited ground-reduction of *c.* 150mm, 12 pits were excavated to a depth of *c.* 400mm. No features were present and no finds were recovered.

To the southwest in the area of the basket swing, Area 4, following limited ground-reduction of *c.* 150mm, revealing layer (102), four pits were excavated to a depth of *c.* 400mm. No features were present in three of the pits and no finds were recovered. In

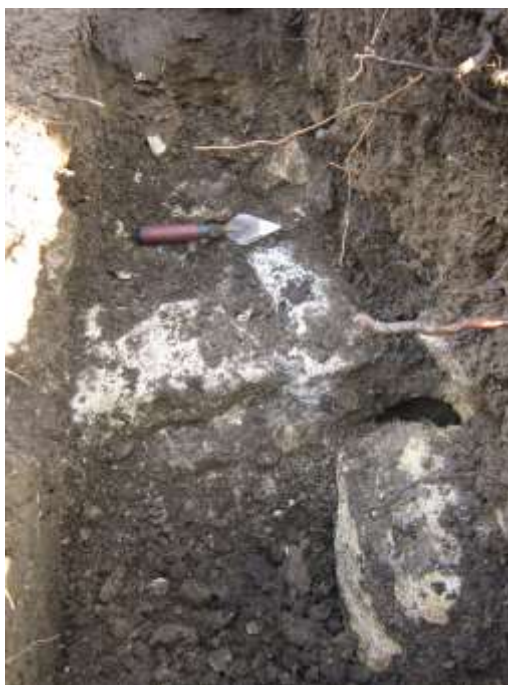
Plate 2. Wall 104

a single southwest pit (Fig. 3) was a roughly northwest/southeast oriented ?wall **104**, comprising rough, unworked limestone fragments, not greater than 200mm×100mm×?40mm, which were insofar as could be observed not laid in courses and not bonded by mortar. The cut 105 for the wall is inferred. The wall was not disturbed and following laying of geotextile, the four pits were moved to the southwest to accommodate the wall.

The only archaeological remains present comprised a northwest/southeast oriented wall, the precise nature of which could not be established, and which objective in any case lay outside the remit of the intervention. In any event, further deposits of stony material appeared to be cut by the wall or potentially abut it.

The impact of the works was extremely limited and only revealed the top of a probable wall.
