A FURTHER ARCHAEOLOGICAL WATCHING BRIEF

HOLY CROSS CHURCH,

SLAPTON,

BUCKINGHAMSHIRE

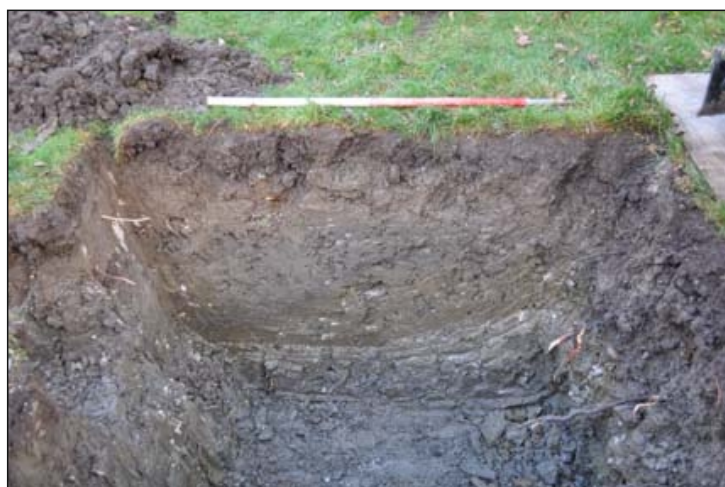
Plate 3. Profile of ditch in soakaway 2

In soakaway 2 was the apparent profile of a substantial ditch 015 (Figs. 1, 3 & 4, Plate 3). Cut 015 was probably a boundary of an enclosure or partial enclosure. The full cut was not uncovered but must have had a width of some 3m and a depth of 0.8m. The date of the cut was not adequately identified, but it is suggestive that the church once stood in a sub-circular ditched enclosure and that the limits of the graveyard had been expanded. The lower fill (014) was a highly compact green grey clay measuring up to 0.35m in depth. The upper fill (013) was a compact grey blue clay measuring up to 0.5m deep. The fill (013) was also apparent in the end of the overflow run of soakaway 2. The upper ditch fill produced the remains of a glazed floor tile with a green glaze, that was different to those surviving in the church, and would indicate that the church once had an un-patterned green glazed tile floor in either the nave, aisles or tower. A 14th century date is also likely for this tile. The tile would indicate that the ditch had silted up by the 16th or 17th centuries, presuming that the tile had been set in a church floor for a number of years.

The ditch had no evidence of re-cutting, but that does not mean that it was not cleaned out or recut and that we only have the final back fill. The ditch could be at least as old as the church site, could be significantly older, or could even be defensive for the Civil War, though the latter is probably less likely. On the current evidence we cannot ascertain a proper date, and it could even have been used at more than one of these horizons.

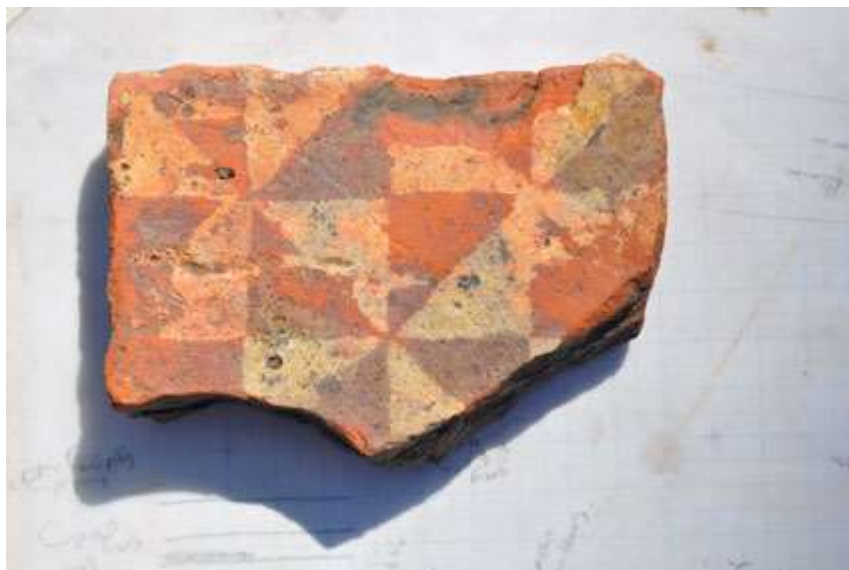
Plate 4 Fragment of medieval floor tile recovered from Watching Brief 2

Watching Brief 2 recovered a further piece of floor tile (plate 1), which was essentially classed as unstratified but probably came from deposit (004), and measured 111mm x 79mm x 22mm. The design was simple and based on a square, which was divided diagonally. The two halves of the square were coloured in

different glazes, one a yellow glaze with a green hue and the other a green-brown glaze. The latter has become weathered and lost in places.
