JOHN MOORE HERITAGE SERVICES

**AN ARCHAEOLOGICAL WATCHING BRIEF AT
JAMES FARM, SOUTH STOKE ROAD,
WOODCOTE, OXFORDSHIRE**

NGR SU 6432 8217

JUNE 2013

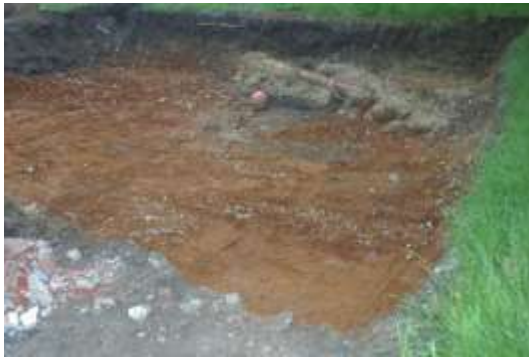
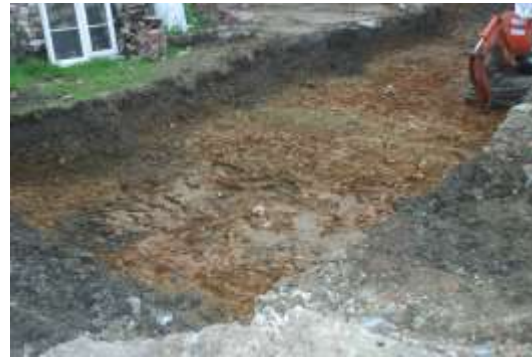
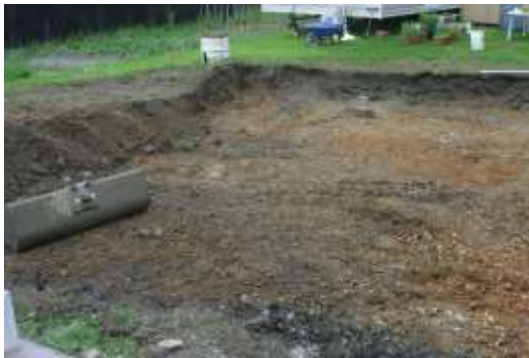
The lowest layer (103) was of heavily compacted, bright light red clay with sand patches and a large portion (ca. 45%) of flint, consistent with the geology of the area. This layer, cut into to a depth of 0.40 m., was identified as the natural (Plates 1-3).

Plate 1 - General view of site, east side

Plate 2 - General view of site, west side

Plate 3 - General view of site, north side

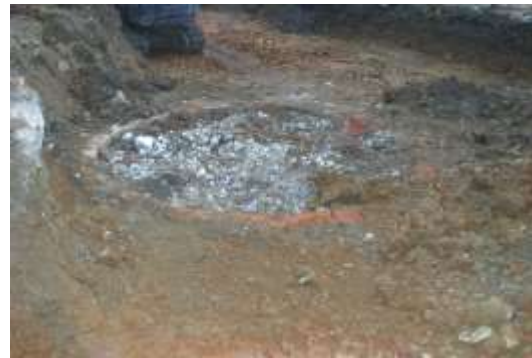
Plate 4 – Modern Cistern [107]

The second feature cut into (103) was a modern cistern [107], to the north of the existing building. Cistern [107], rounded (2.30m in diameter) and brick-lined, was filled with a soft dark-brown sandy silt fill, consisting mainly (70%) of modern building material rubble, with a large portion (15%) of chalk (Plate 4). The feature was not excavated.
