**AN ARCHAEOLOGICAL WATCHING BRIEF**

**GRANGE FARM, SHIPTON LEE,  
QUANTON, BUCKINGHAMSHIRE**

**FEBRUARY 2014**

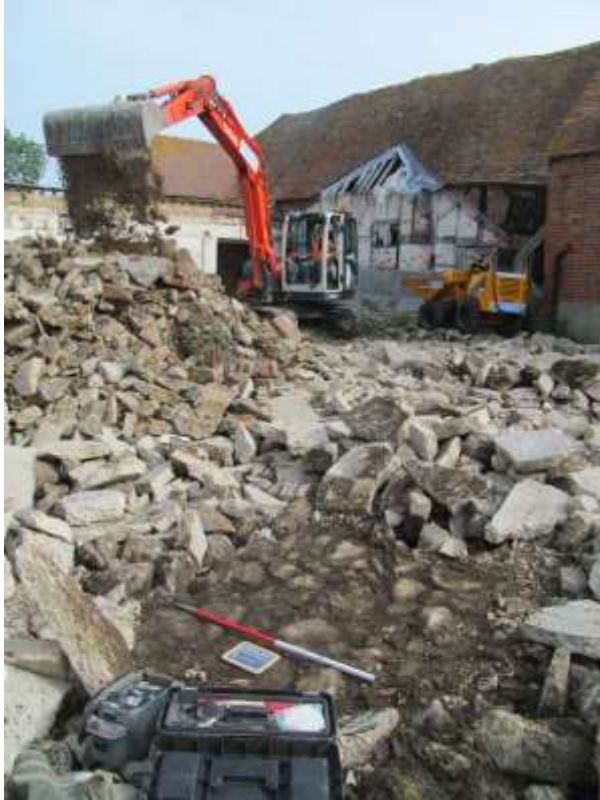
Plate 1. General view - cobbled surface 1001 in foreground.

The first operation was the removal of the cobbled surface (1001) belonging to the Inner Courtyard (A5) which revealed the cobbles themselves to be large boulders and river pebbles with the occasional limestone block (Plate 1, foreground) which had been lain directly onto a dark grey clay-sand (1002).

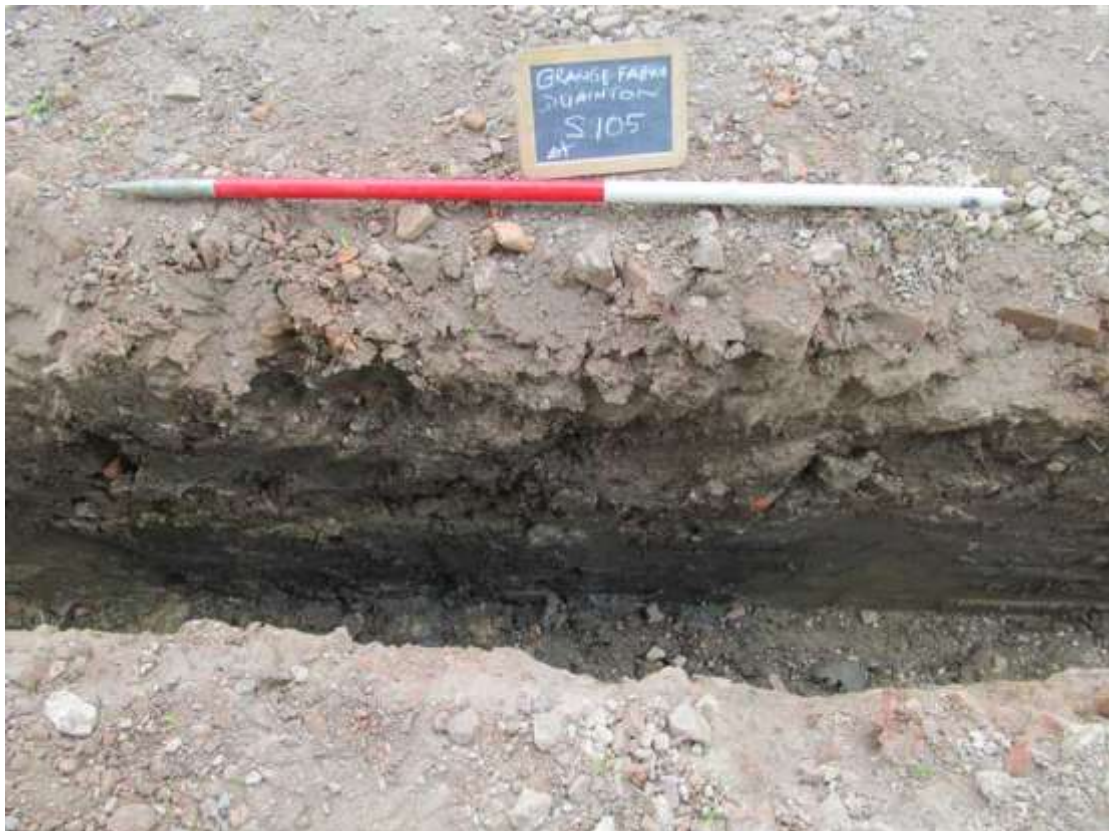
Plate 2. Section S.105, Ditch B.

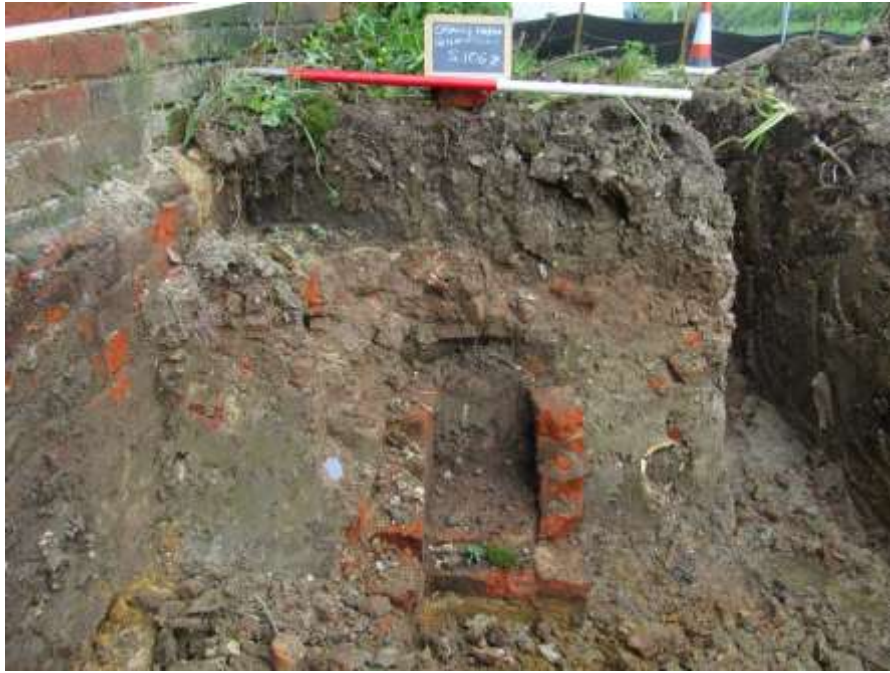
Plate 3. Section S.106, brick culvert 1032

The next section of the service trench to be excavated was from the starting point mid-way along the Stable Block (B4) along the north face of the Grange up to Access Point B at the northeast corner of the building. When a spur was cut to enter the Stable Block (B4), the brick built culvert 1032, previously observed at the northwest corner of the building, was pierced a second time providing a section through the layers abutting the outside wall of the building 1041. Section S106 (Fig. 3, Plate 3) revealed that a modern garden had been laid over the old ground surface, consisting of layers (1025) and (1026) of topsoil and subsoil, being 0.14m and 0.32m in depth respectively. These layers were on top of a thin layer of mortar 'trample' (1027) which lay over a made ground layer of dark brown-greyish silty clay (1028) which contained building rubble and bricks at around 0.41m thick. These layers sealed the brick built culvert which was of a single skin of bricks 1032 with a square, 'U' shaped profile, set upon a thick bed of lime mortar (1033). Inside the culvert, to create a base, reused roofing tiles 1030 were laid upon a mortar bed (1031). The culvert was filled with a tenacious dark brown silty clay (1029).

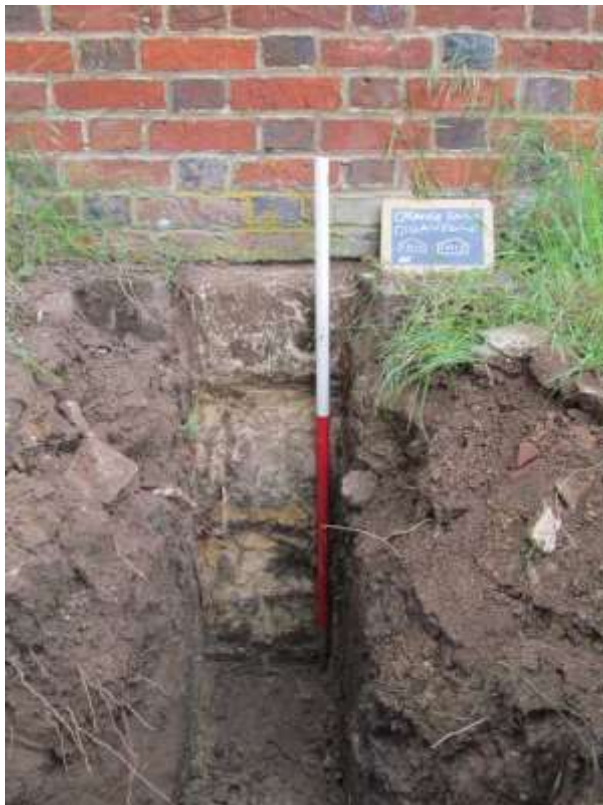
Plate 4. Section S.103, Dovecote Foundations.

Finally, for this first phase of the operation, the services trench entered the Dovecote (B3) by its west wall where the foundations were revealed in section S103 (Fig. 3, Plate 4). The brick foundation courses 1011 were laid upon three courses of large, squared and faced limestone blocks (220mm x 55mm) 1012 below the ground surface. These, in turn, sat directly upon the mid brown-greyish clay natural (1009). This building method was observed elsewhere in other buildings across the range as will be detailed later in the report.

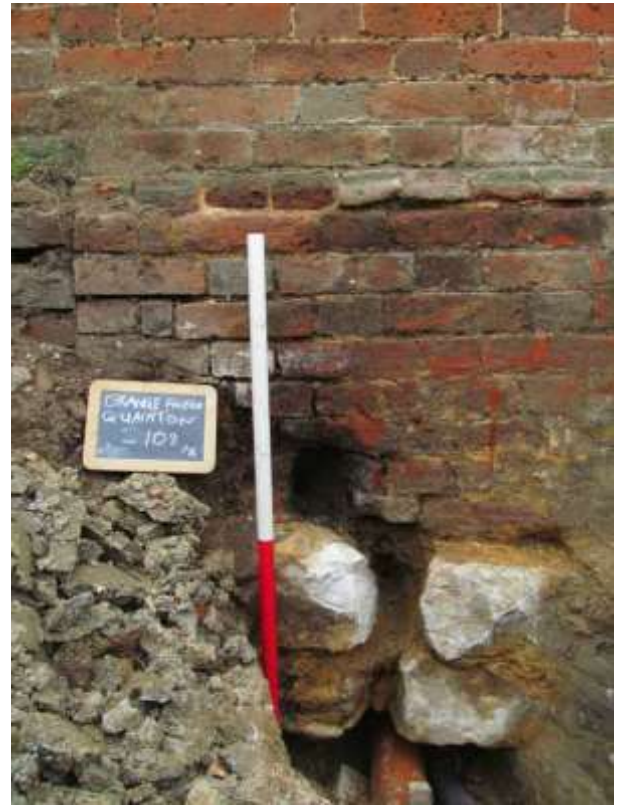
Plate 5. Section S.108,  
Building B4 foundations.

At this point where the services entered the Stable Block (B4) another Section, S108 was made so as to observe the foundation layers. Here, the bricks of the outer wall of building B4 had been laid in Flemish bond 1041, the last eight courses of which had been stepped out from the vertical of the wall to create a series of foundation courses which looked like a 'step' when viewed in profile. In turn, these courses had been laid upon two courses of faced and squared limestone blocks 1042 similar to those which had been seen at the Dovecote (B3) previously (Plate 5). This suggests a unity of building practices applied to these two buildings.

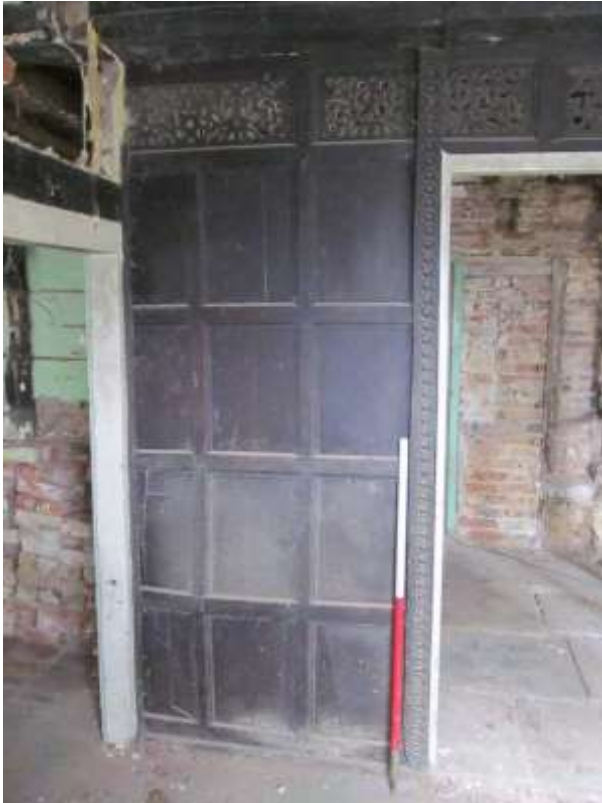
Plate 6. Building 2b, flagstones and wooden screen

Buildings B2b, B2c & B2d attached to the west of the Farmhouse (B2a), each have a number of interesting features. B2b has a small area of flagstones preserved along with a carved wooden screen at the north doorway (Plate 6). The dividing wall between B2b and B2d is much thicker than any other wall in the entire complex, being made of large, roughly squared and faced limestone blocks. It also contains some 'herringbone' brickwork (Plate 7).

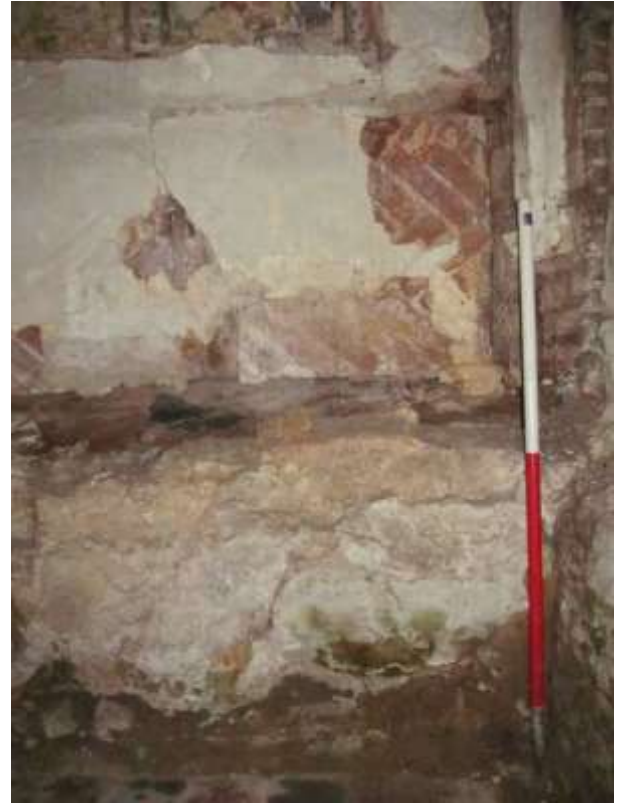
Plate 7. Wall between Building B2b & B2d
