JOHN MOORE HERITAGE SERVICES

DESK-BASED ASSESSMENT

**LAND OF CHURCH LANE,
CHURCHAM, GLOUCESTERSHIRE**

JMHS Project No: 2891

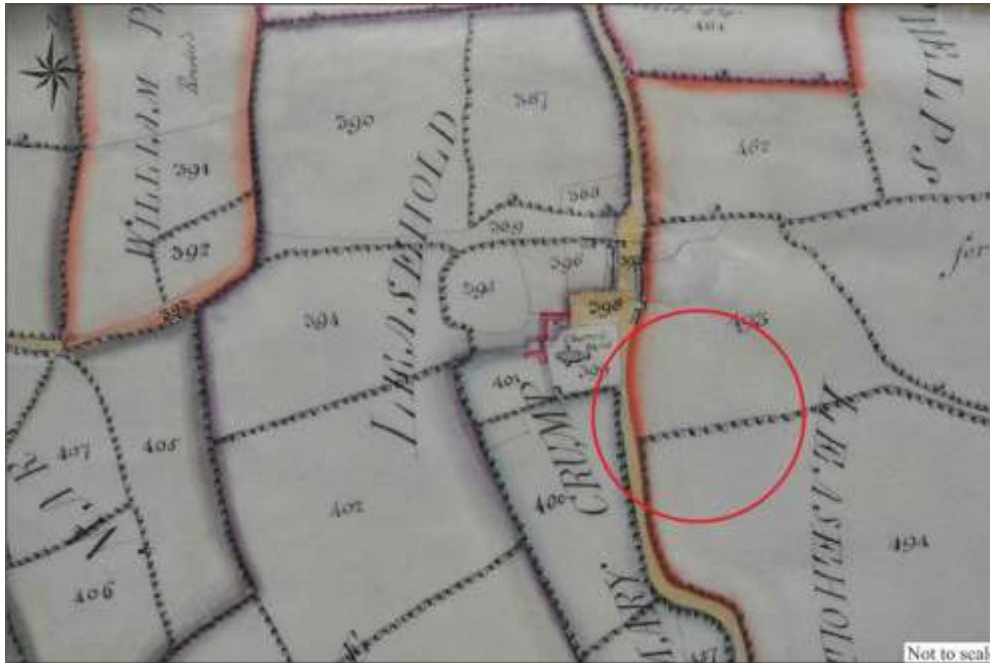
Figure 3 Map of 1803

The second oldest map was the Inclosure map of 1803 (GRO Q/R1/43), which shows the church of Saint Andrew with buildings located to the north and west of the graveyard (Fig. 3). The buildings to the east and the southeast,

which covers the proposal site, are numbered 493 and 494, they are drawn as open fields (and this general trend is evident throughout the majority of the map series). What can be ascertained at that time is that the land was leasehold to a William Phelps, and perhaps more importantly the area was called Coneygree. The name is derived from English Coninger, which refers to a rabbit warren. The date of this warren is unknown, but in 1086 there were reference to three enclosures at Churcham for the abbot's hunting. One of these could be an enclosure for rabbit breeding, in this case hunting with ferrets.

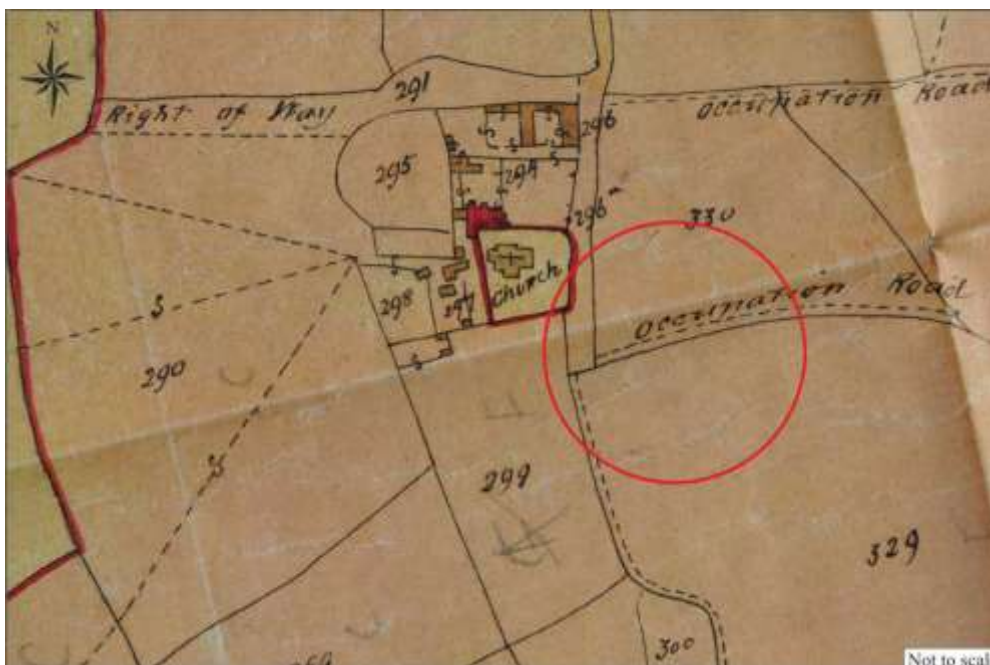
Figure 4 Map of 1867

The tithe map of 1844 (GRO GDR/T1/53) shows a similar field arrangement. A group of maps dated c. 1867 (GRO D1740/P7, D1740/P9) which were plans of Churcham Church show the same field arrangements (Fig. 4).

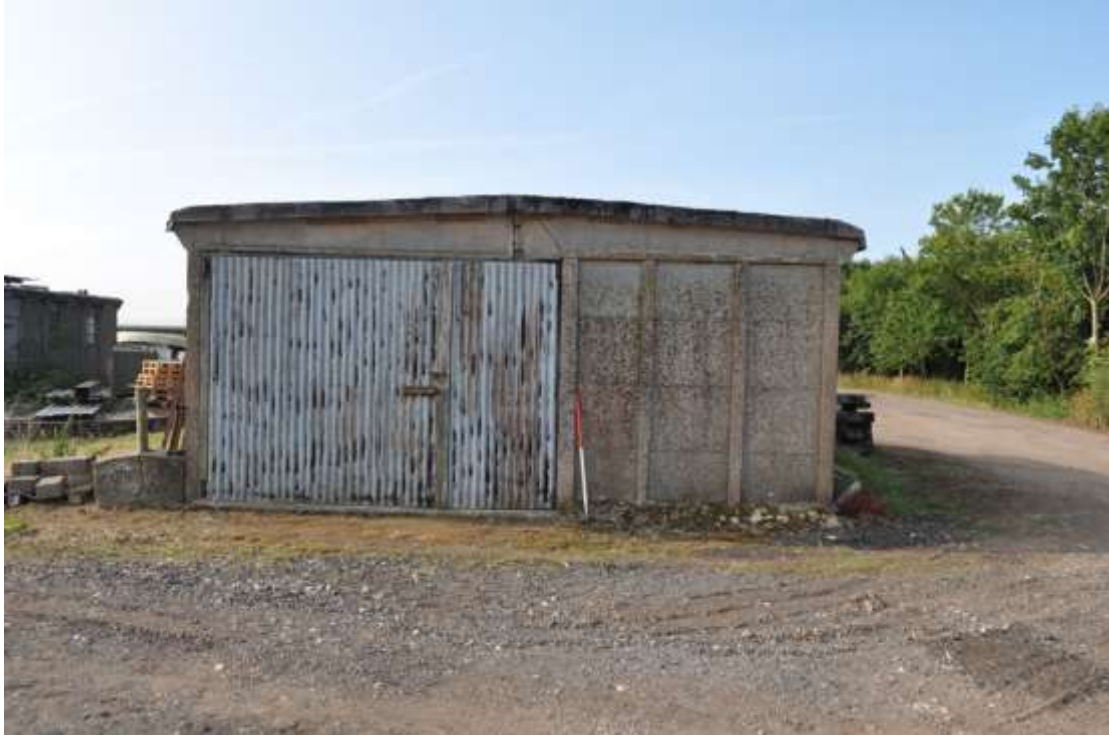
Plate 1 Building 1

On the southern three quarters of the site there are the remains of ten buildings which were constructed during the Second World War. Building 1 is a pre-fabricated reinforced concrete structure orientated north south (Plate 1). The door on the north side has been enlarged and the concrete on this side is breaking up. Buildings 2 and 3 are two long buildings running parallel to each other, also orientated north to south.

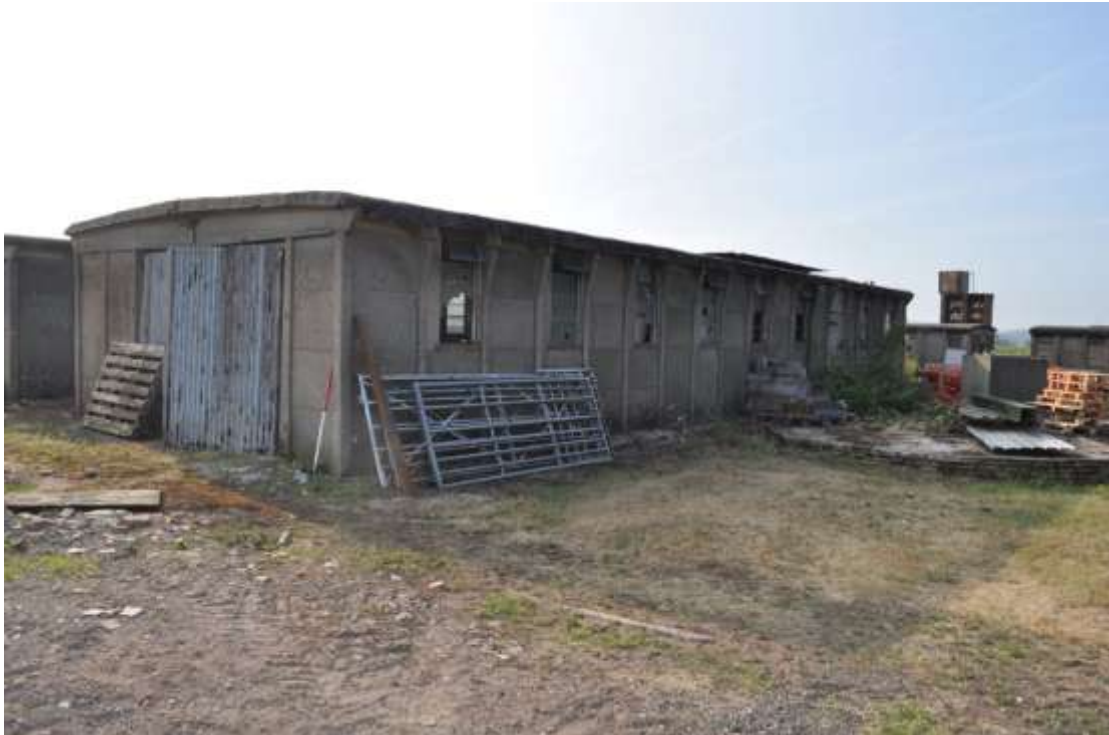
Plate 2 Building 2

Building 2 (the west of the two long buildings); concrete panels are missing from the southern gable end (Plate 2). Building 3 has had large doors fitted, which have damaged the north gable end causing concrete to deteriorate (Plate 3). The brick dwarf walls around the concrete foundation are crumbling.

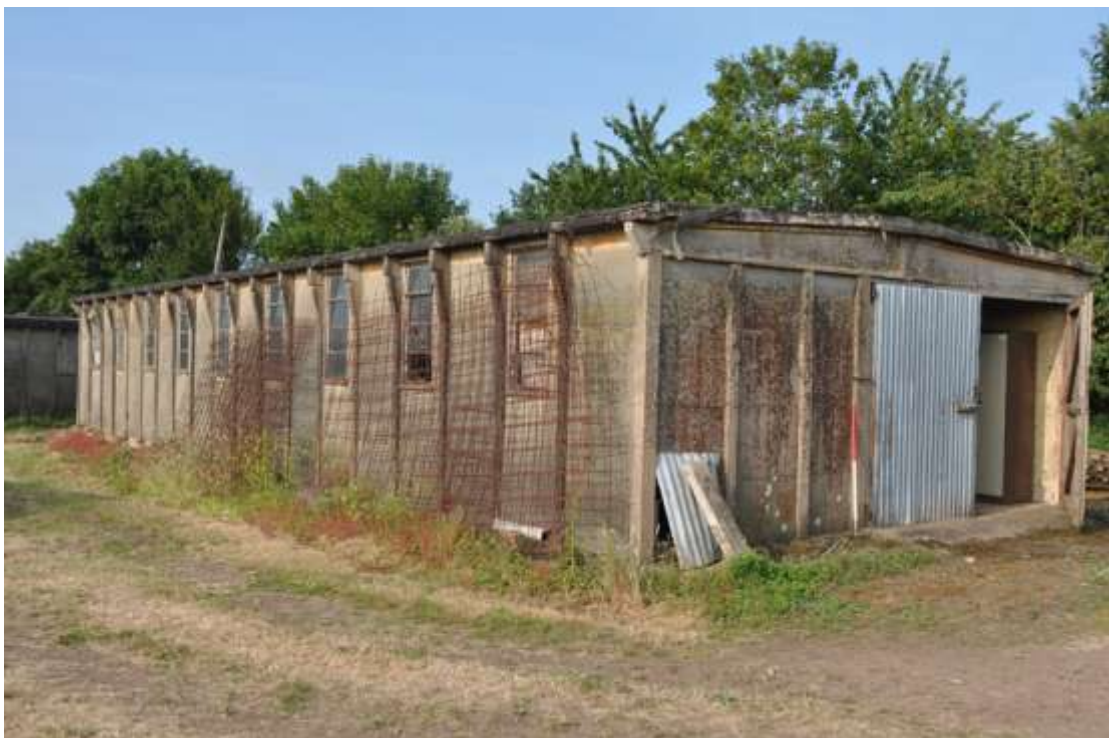
Plate 4 Building 4

Building 4 is also a long building orientated north to south (Plate 4). The interior has a brick interior wall sealing part of the southern part of the building off. The foundations are deteriorating as is the concrete slab underneath. Buildings 5 and 6 are short buildings orientated on the same alignment (Plate 5 and 6). Building 5 (the west building) has brick interior walls.

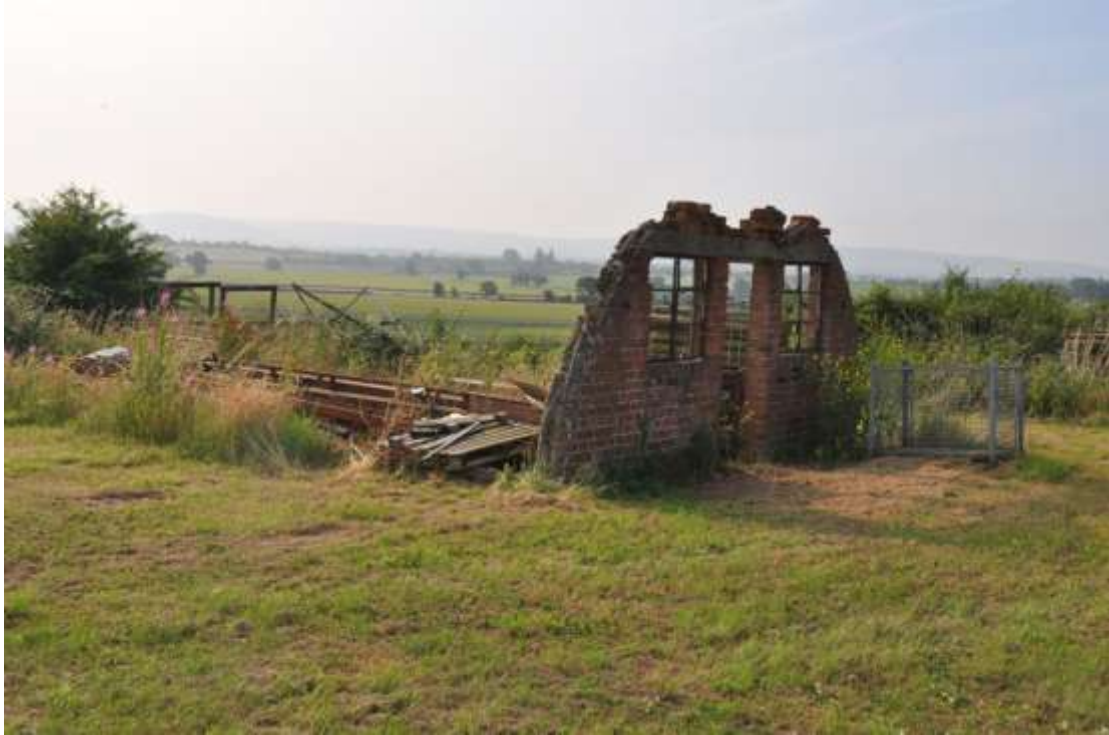
Plate 7 Building 7

Building 7 is part of a Nissan Hut, the main structure is gone and only the concrete base and bricks in the west wall survive (Plate 7). Building 8 survives only as a foundation, and a brick tower supporting a water tank. Building 9 is an east-west building of reinforced concrete (Plate 8). Much of the concrete is badly degraded.

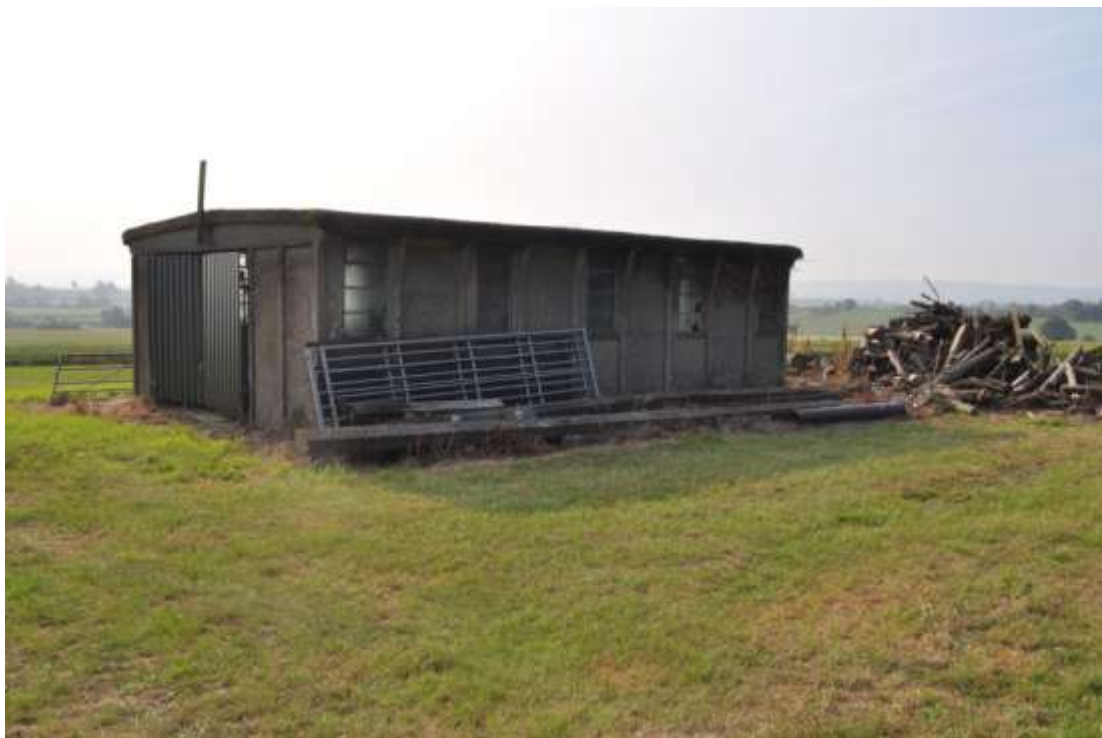
Plate 9 Building 10

To the south of these nine buildings there is an earth bank, which is to be retained. There is a large sondage excavated on the north side of the bank. No early archaeological features are evident in this structure but there is an indication here of the depth of the makeup layer across the northern and central part of the site. To the south of the bank there is a further reinforced concrete structure Building 10 (Plate 9) which it is proposed will be maintained and refurbished.
