JOHN MOORE HERITAGE SERVICES

BUILDING ASSESSMENT

THE OLD STABLE BARN, THORPE FARMHOUSE,

ASTON UPTHORPE, OXONFORDSHIRE

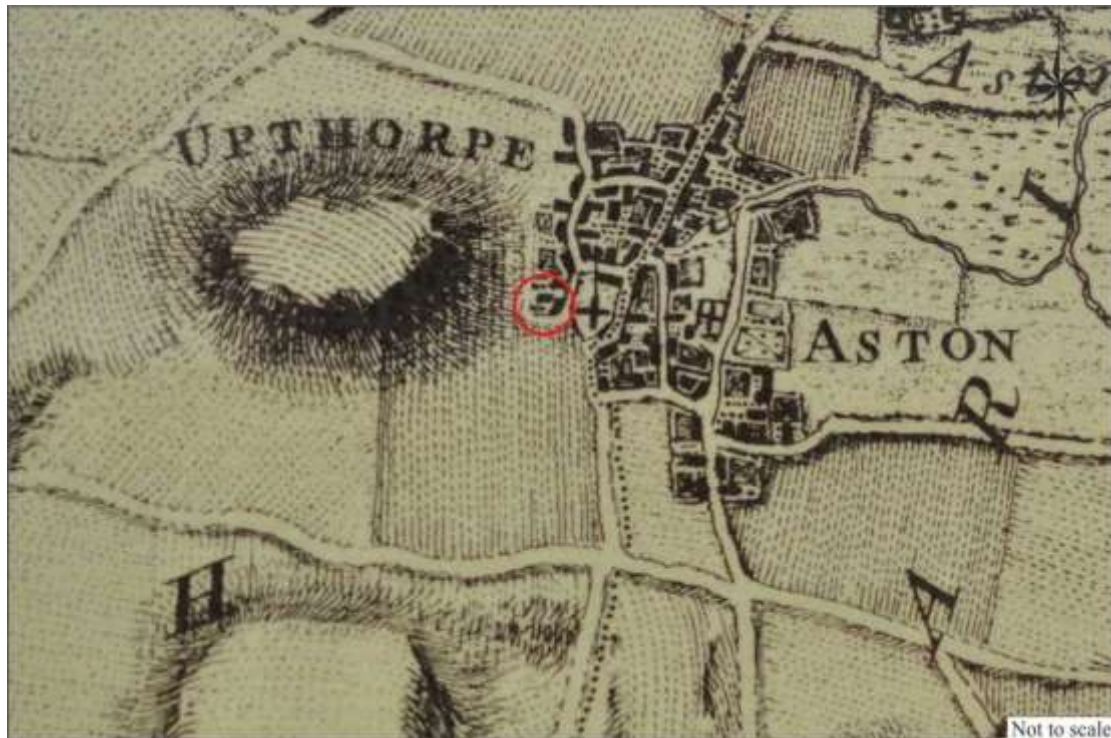
Figure 2 Rocque's map of 1761

There are a number of pre-Ordnance Survey maps of the village of the 18th and 19th century. The earliest of these is Rocque's map of 1761 (BRO PM78), which shows the farmhouse opposite the church, with a farmyard to the northwest, with a range of buildings on the south side and a range of buildings on the north side, but nothing on the west side of the farmyard. The building range on the south side extends further than that on the north side (a feature apparent in later maps), which implies that this mark

on the map represents the current threshing barn and the stable barn, and is indicative of the basic timber frame of the stable barn being at least of an early or mid-18th century date.

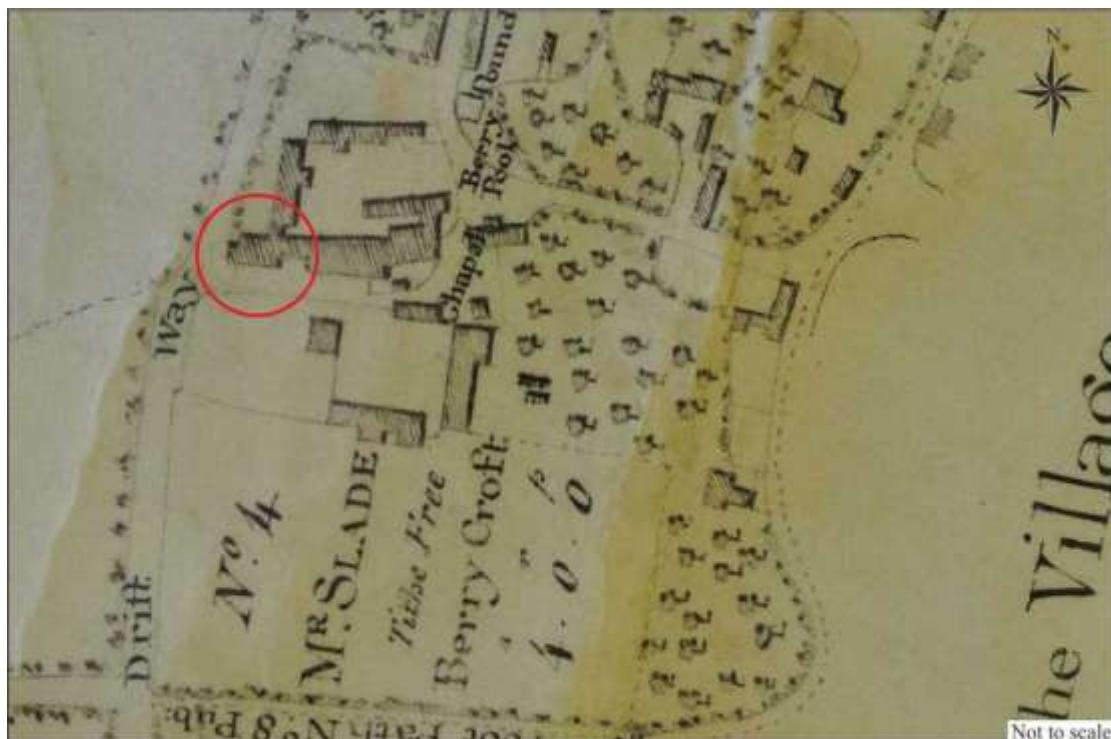
Figure 3 Inclosure map of 1793

The Inclosure Map of Aston Upthorpe is dated to 1793 (BRO CPC/20B/20/1B), is one of the most detailed maps of the village to survive. This shows the chapel alongside the church, with the threshing barn and stable barn as part of a long line of linked buildings. There are two other building ranges on the north and west sides of a large yard, with the northeast side of the yard remaining partially open, perhaps due to prevailing south-westerly winds and the wind flow around the threshing barn. The field to the south is called Berry Croft and there is a pond to the northeast of the farmhouse called Berry Pool. Such place-names as those using the term Berry are often derived from beorg, a hill, or burg or burh, a fortification. In this instance it is the case that the site is probably being used in reference to the manor site as a defended location, probably dating back archaeologically to the early medieval period.

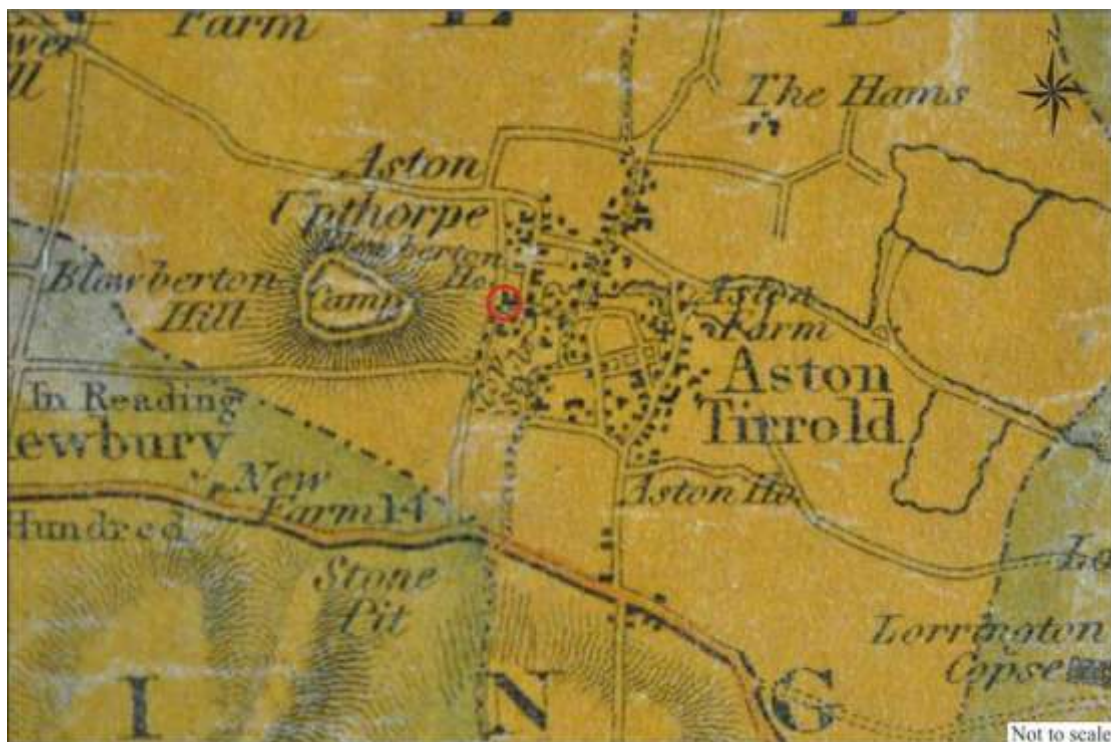
Figure 4 Greenwood's map of 1829

Greenwood's map of 1829 (BRO D/ERu P5) shows buildings in the location of the farmhouse, threshing barn and stable barn, but the detail is not refined enough.

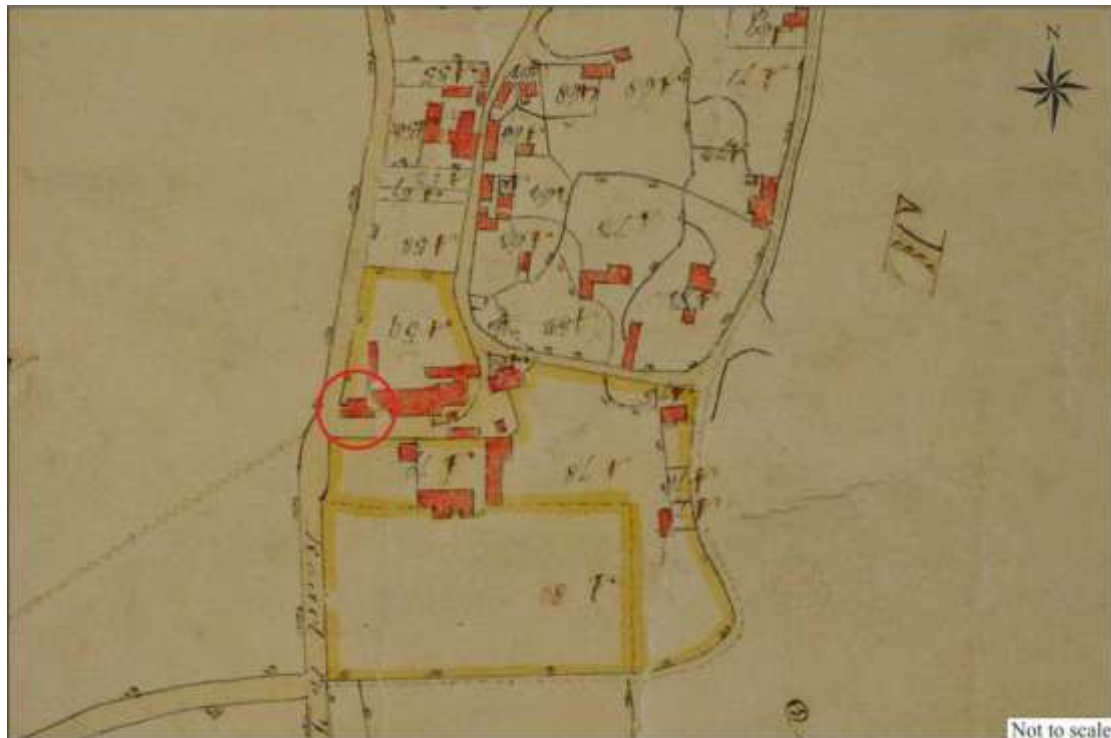
Figure 6 Tithe Map of Blewbury dated 1838

The Tithe Map of Blewbury of 1838 (BRO D/P20/27B) includes the hamlet of Aston Upthorpe, which reflects the ancient early medieval ties. The plot is labelled as 159 and shows the farmhouse, threshing barn and stable barn, with a further building located on the west side of the yard, which has now gone. The building on the north side of the yard has already been removed.

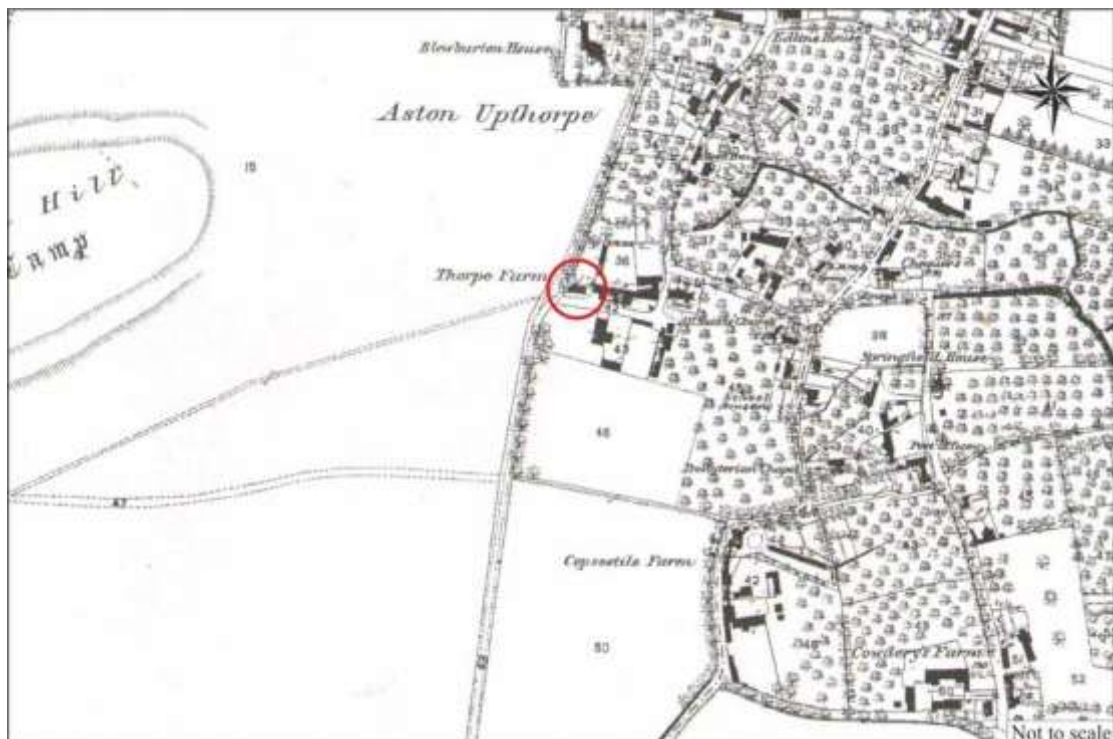
Figure 8 OS First Series map (1: 2,500) of 1877

The first series Ordnance Survey map at 1: 2,500 of 1877 (Berks XXI.4) shows the

chapel, farmhouse, threshing barn and stable barn as they exist now. To the north of these there is a building on the west side of the yard. The second series map of 1899 (Berks XXI.4) shows the same basic arrangement, but with the building on the west of the yard there is a west wing. The third series map of 1912 (Berks XXI.4) shows a similar arrangement of buildings to that of the earlier two Ordnance Survey maps.

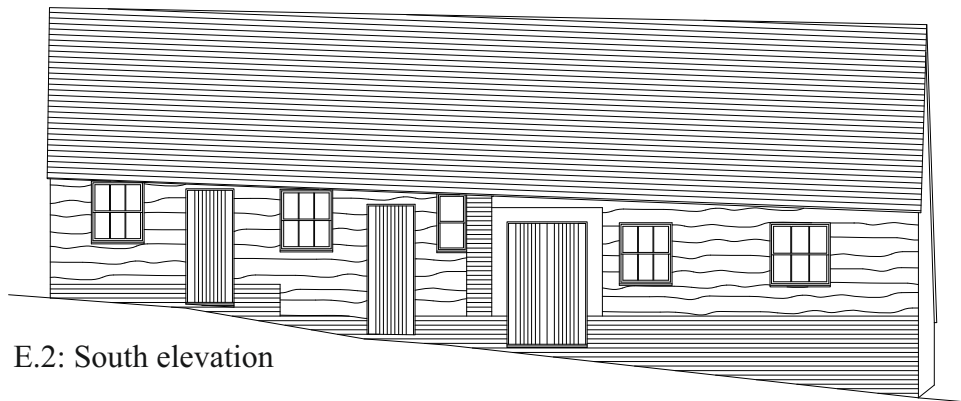
E.2: South elevation

The south elevation (Fig. 12, E2) is the main or front elevation of the building, which contains a stepped dwarf wall along its base and a central brick column or pier. The wall above this is covered with traditional weatherboarding. In the right hand part of the façade there are double plank door at the left hand side of the column and with two six light timber framed windows. These are of unequal sizes. On the left hand weatherboard part of the façade there are two single plank doors, both of which have a six light window to their left, similar if not identical to those in the right hand part of the façade. To the right of the right door there is a smaller window casement with two lights.

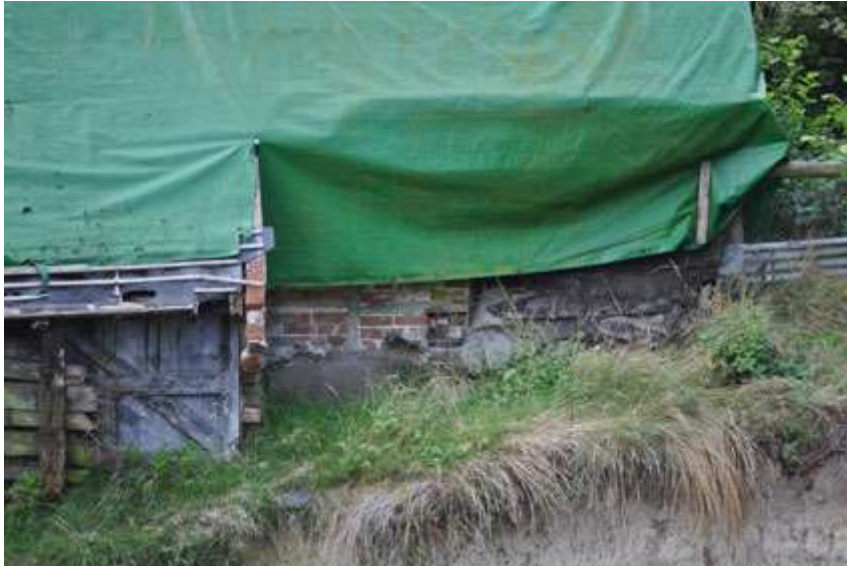
The north elevation (Fig. 12, E1) has a staggered wall with the aisle running for three of the four bays of the barn; the west bay has no accompanying aisle. The visible walls here are mainly weatherboarded externally, but internally are brick. There is a small section of the structure where there is no aisle that contains timber framing in-filled with brick (plate 1).

Plate 1 Timber framing and brick infill wall in north wall

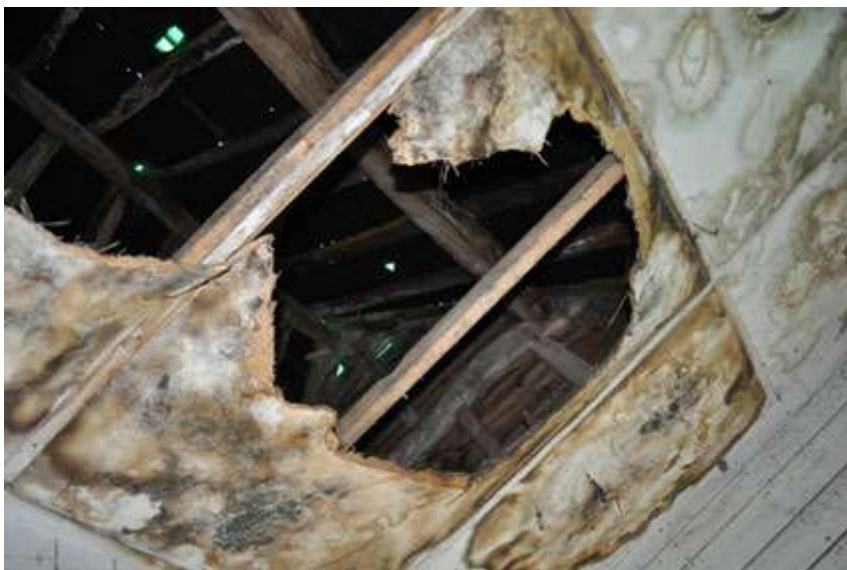
Interior unit S1: is one of the stable eastern components that uses the left hand stable door of the east elevation (Fig. 12). The south wall is of brick and has a weatherboard upper part with a six light window. The west and north walls have vertical planks and high plain skirting and an animal feed trough located in the angle between them, while the east wall has a stable door and weatherboarding. The ceiling is made of board, which is rotting and above which the remains of common rafters and purlins can be noted. The east end truss is visible through the holes in the ceiling which contains a cross beam at purlin height with queen struts (Plate 2). There is further timber framing in the space between the queen struts. Above the collar beam is a (king) post reaching to the ridge beam.

Plate 2 Unit S1 view of the end gable roof truss

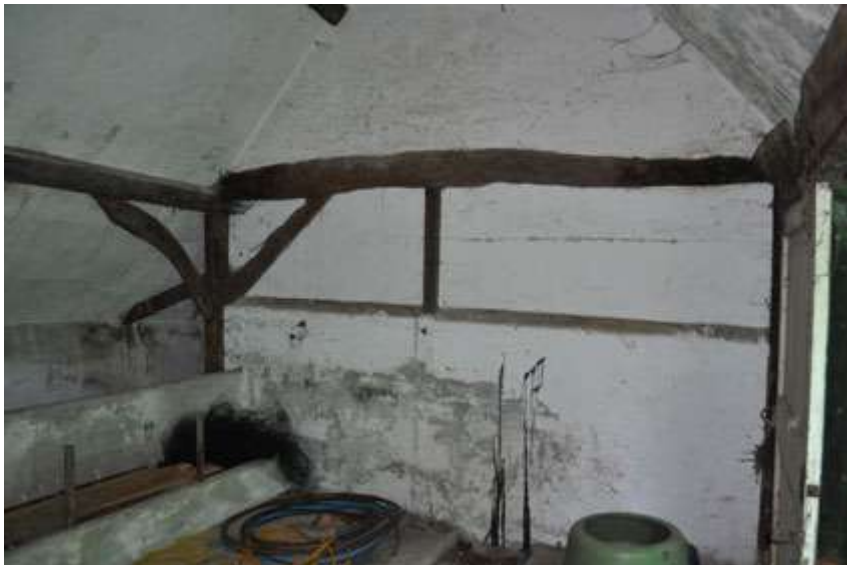
Interior unit S3: is entered through a double plank door in the south wall, set within a dwarf lower wall and a timber frame upper wall. There is also a six light window casement. In the corners of this unit there are a series of four posts that support tie beams and wall plates, and contain braces (Plates 3 and 4), most are straight, but one contains a wave created by the natural bends of the wood. This feature is one that implies that the timber framing or parts of the timber framing could pre-date the 18th century. The tie-beams, although there is some chamfering, mainly take on the shape of the cut timber, which is also an indication of a date for the frame possibly being earlier than the 18th century. In the east wall of this unit there is timber framing with whitewashed infill. The ceiling rises up into the loft space of the stable barn just above the purlins. There is a food trough against the north wall. The west wall ceiling space is supported by a tie-beam, but the wall below this is stepped out of line with the main timber frame (Fig.11, Section 1). There are steps and a plank door on the south side.

Plate 3 Unit S3 part of the timber structure

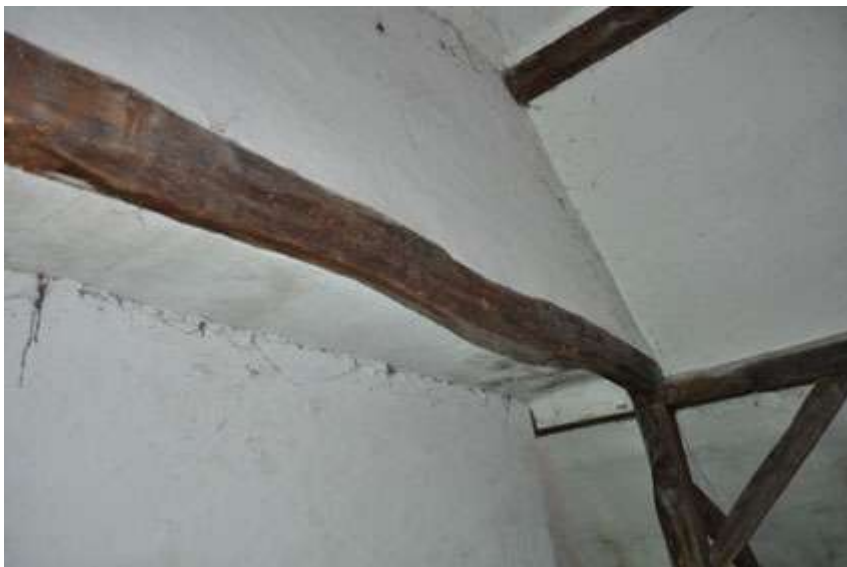
Plate 4 Unit S3 part of the timber structure

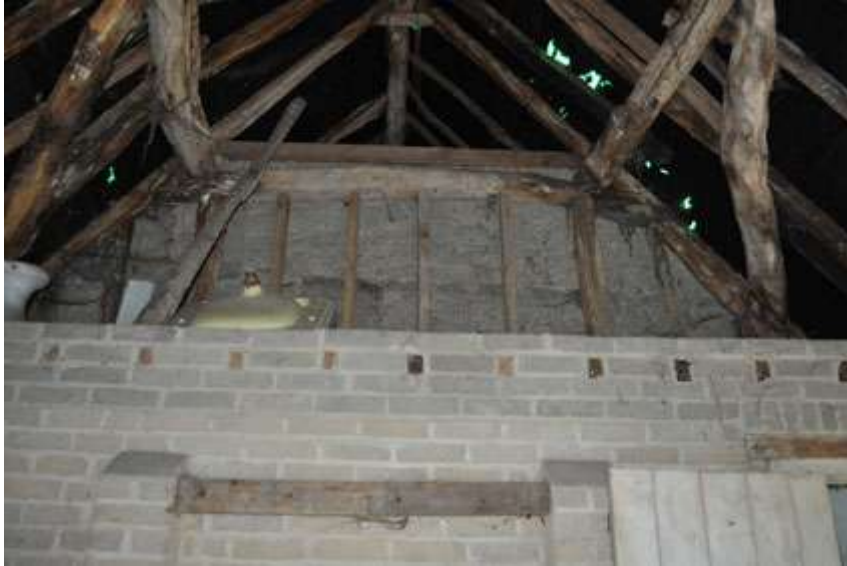
Plate 5 Truss between units S3 and S4

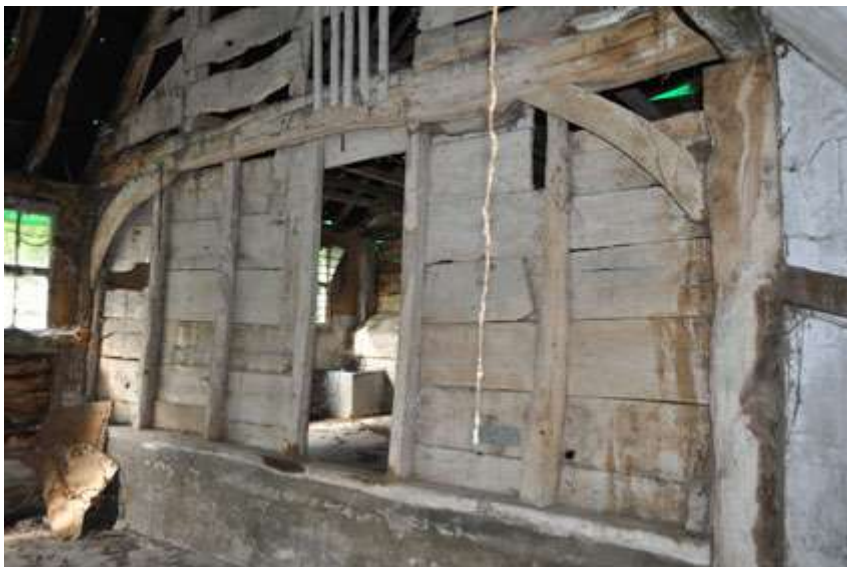
Interior unit S4: is entered through a plank door on the south side. The south wall is of brick in its lower courses and weatherboarding above. The wall also had a six light window internally to the right of the door. The east wall is a breezeblock wall with a plank door in its right hand end. Above there is evidence of timber framing extending up into the roof space fitted into a queen post truss with cross beam on which the purlins sit (Fig.11, Section 1 Plate 5). Here the purlins, common rafters, braces and ridge beam are not cut by saws but are worked timbers but which take on the waves and bows of the wood and in some place bark remains (Plate 8). Though the roof timbers are mainly visible here in S4 and S6, it is apparent that this type of construction runs the length of the stable barn. The west wall has a dwarf base with a timber frame above with weatherboarding. The timber framing contains two posts of the stable barn main frame, a tie-beam with curving braces, and queen post truss, with cross-beam (Plates 6 and 7).

Plate 6 Timber frame between units S4 and S6

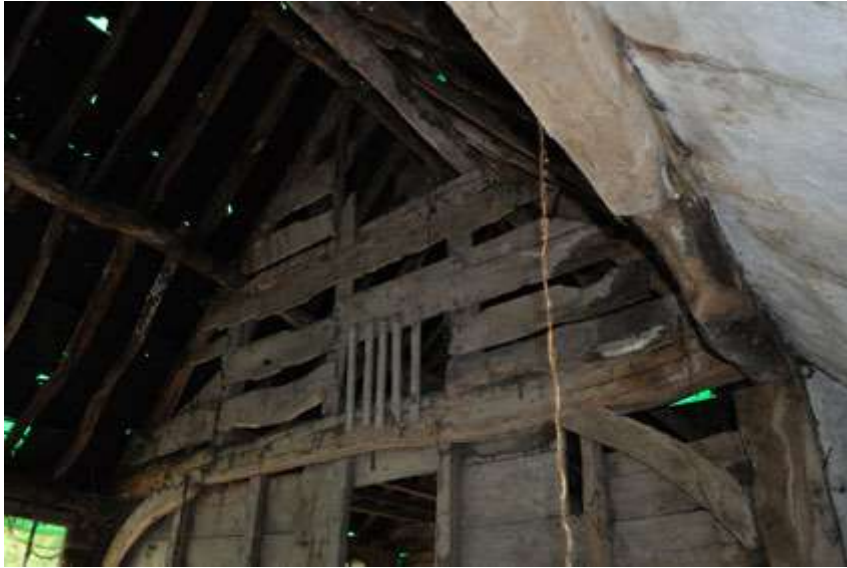
Plate 7 Timber Truss between units S4 and S6

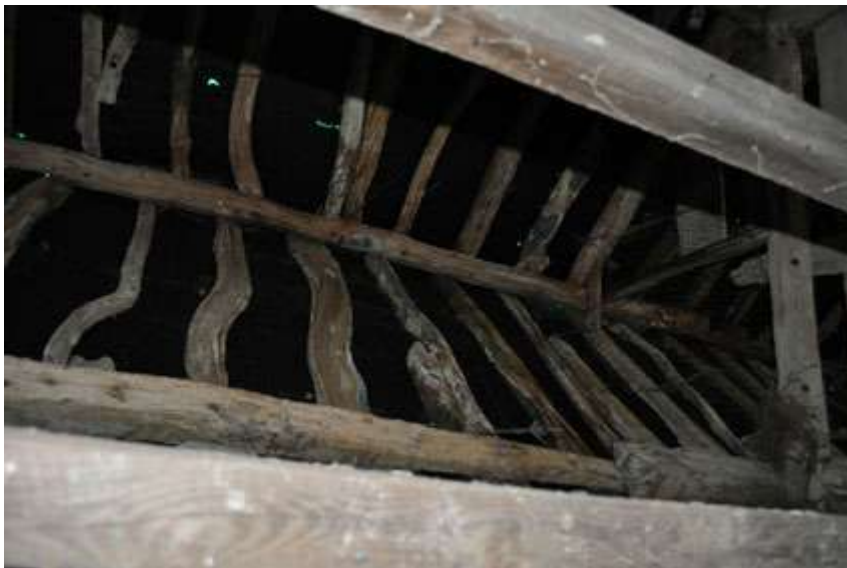
Plate 8 Common rafters and ridge beam

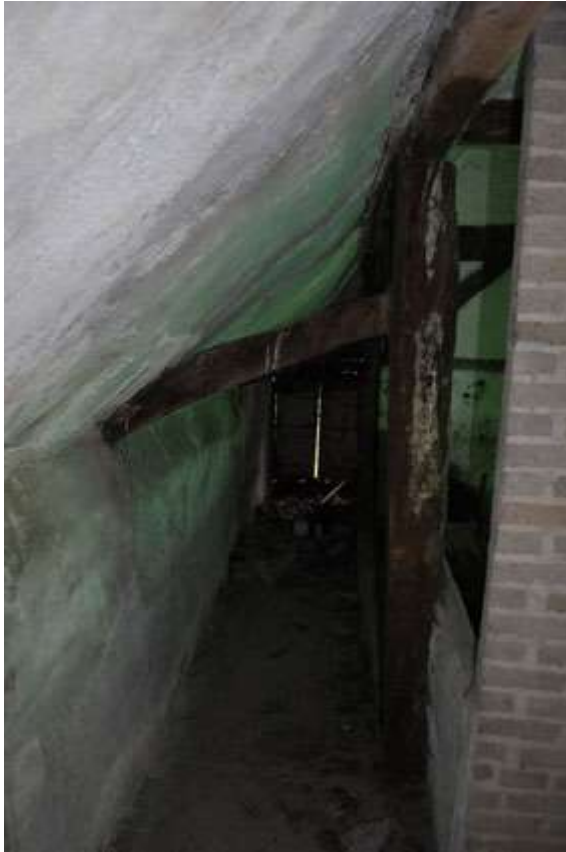
Interior unit S5: is a continuation of space S4 and covers the northern aisle (Plate 9). This is a long narrow space with braces from the main bay posts of the stable barn to an internally whitewashed wall, built beside the weatherboard outer wall. The ceiling space has also been plastered or rendered and whitewashed.

Plate 9 Braces in north aisle

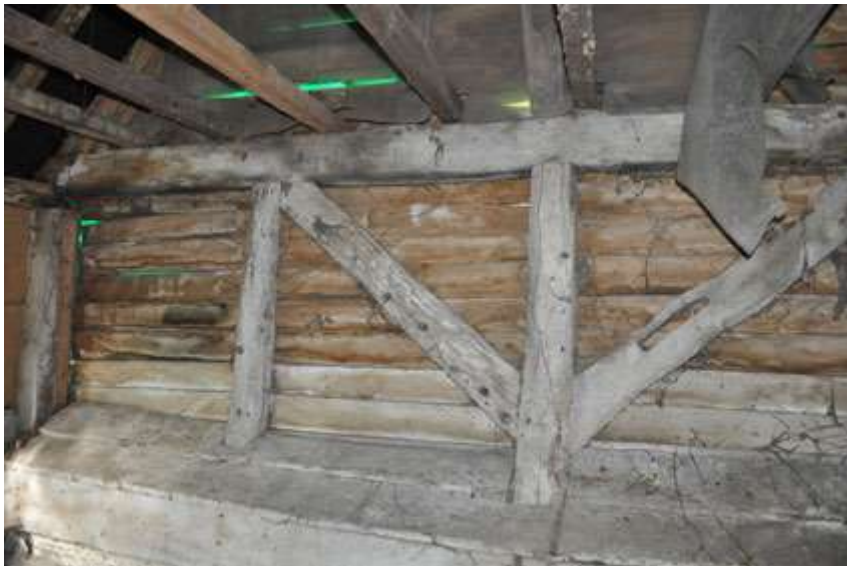
Interior unit S6: is entered through a plank door in the south wall, which is a dwarf brick and weatherboard wall with a six light window casement. The east wall which lies between this unit and unit S4 is a timber framed structure with tie-beam and truss with queen posts as described above. The west wall is the end wall of the structure, which has a dwarf wall of flint and brick quoins, which is evident outside. Above this there is a box timber frame wall with braces on the central post, with a weatherboard lap exterior (Plate 10). The end truss has a collar beam with queen struts, set differently to the other visible trusses, in this case the collar beam is above the line of the purlins, with an interrupted beam crossing the truss at roughly the same height from the purlins. There are a series of rafters from tie-beam to tie-beam, which are of a more recent later 18th century to 20th century date. The common rafters, purlins, ridge

Plate 10 Timber frame in west wall
