**AN ARCHAEOLOGICAL WATCHING BRIEF**

**ST. EDBURG'S HOUSE, OLD PLACE YARD**

**BICESTER, OXFORDSHIRE**

**SUMMARY REPORT**

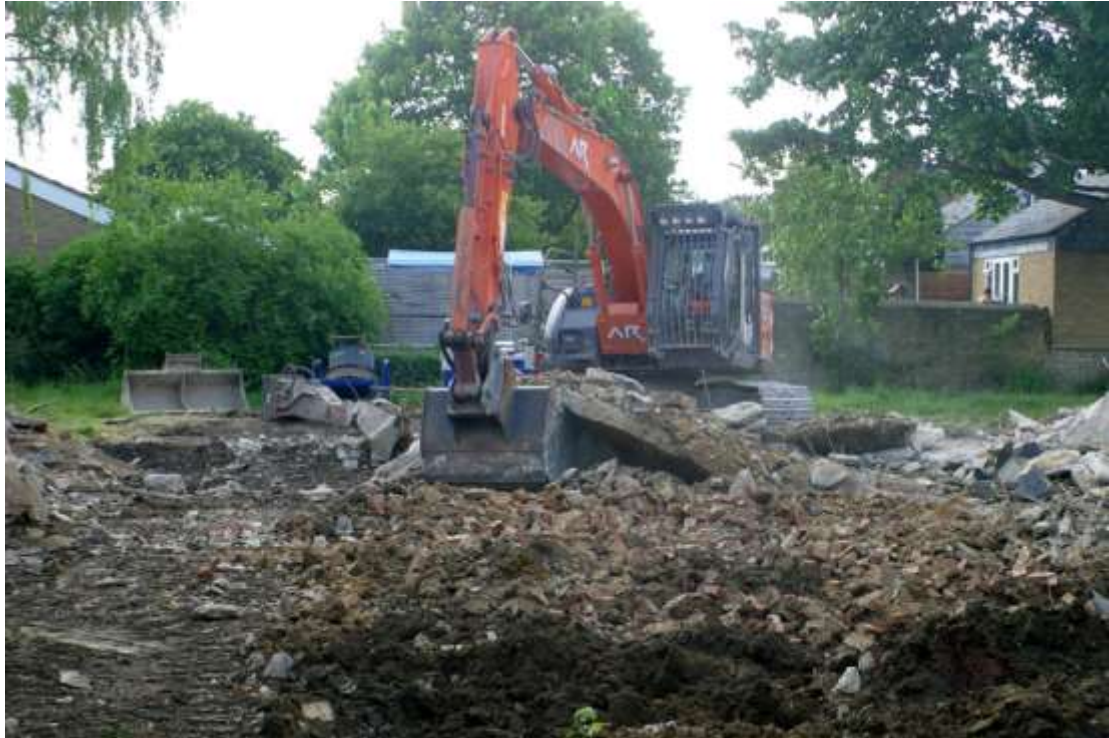
Plate 1: Demolition works in south part of monitored area, looking west.

Demolition works at the former St. Edburg's House were executed by 20 tonne excavator fitted with 1.8m wide trenching bucket (Pl. 1). The removal of the concrete slab and foundations was gradually carried out from south to the north with the last as the area of the east extension.

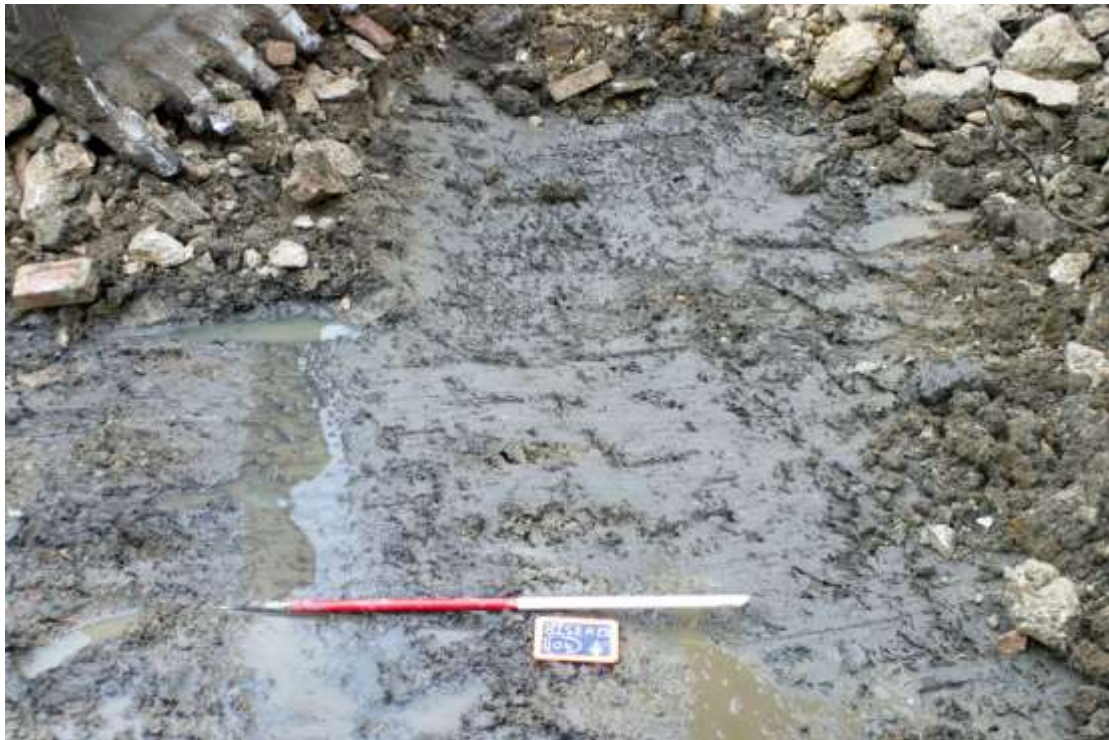
Plate 2: Alluvial deposit (104), looking south.

The lowest deposit exposed in the south part of the monitored area was mid brownish grey clayey silt (104) containing charcoal flakes, small sub-angular stones and three animal bones (Fig. 1, Pl. 2). This was interpreted as an alluvial deposit.

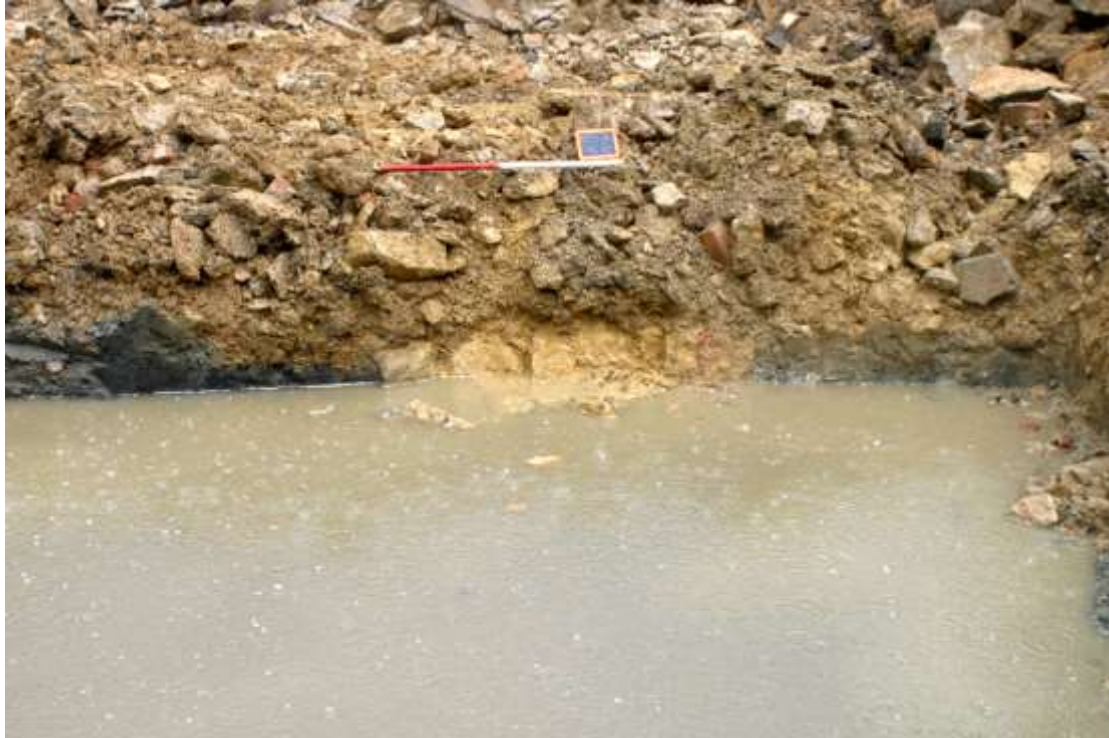
Plate 3: General overview of wall 106 and alluvial deposits (105) and (107), looking east.

The lowest deposits recorded within this area were alluvial deposits (105) and (107). Deposit (105) was organic 0.2m – 0.3m thick (as excavated) dark grey silty clay, containing c. 2% of charcoal flacks, waterlogged plant material and ten animal bones. Deposit (107) was c. 0.3m thick (as excavated) light greenish grey silty clay, with c. 1% of charcoal. The direct stratigraphic relationship between those two deposits was unclear, due the fact that both deposits were cut by construction cut 121 of linear wall **106** (Fig. 1, Pl. 3).

Wall **106** was c. 5m long, 1.6m wide and c. 0.4m high (approximately 67.50m above OD), aligned east to west. It was built of roughly squared limestone of maximum dimensions 350x200x150mm, bonded with light yellowish sandy lime mortar. Wall **106** was overlaid by deposit (103) (Pl. 3). Rubble related to the wall **106** was observed further to the east in central part of monitored area mixed with deposit (103).

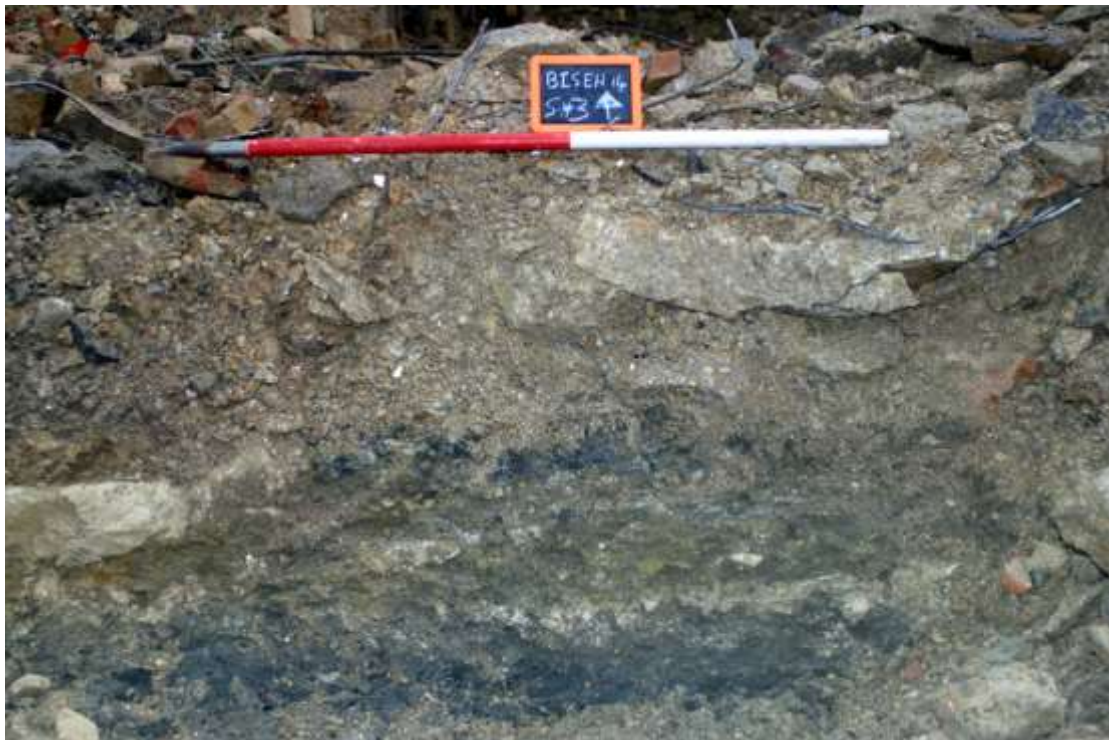
Plate 4: View of floor and occupation deposits (108), (109), (110), (111) and (112), looking north.

On the north edge of the area of the lift shaft were exposed five occupation and/or floor layers overlaying deposit (105) (Pl. 4). The lowest layer (112) was compact light yellowish white sandy lime mortar floor or bedding surface, 0.06m thick and 0.70m long in section. The following layer (111) was 0.1m thick and 1.3m long (in section) firm mid greyish green clayey silt with 5% of small sub-angular stone. This layer might represent bedding for floor surface (110). Floor surface (110) was 0.08m thick and 1.3m long (in section). It was made up of well-sorted small sub-angular stones bedded in mid grey silty sand. Deposit (110) was overlaid by 0.1m thick firm mid greenish grey sandy silt (109) with c. 5% of small poorly sorted sub-angular stones and c. 2% of charcoal flecks. This deposit represents an occupation or floor layer as well. The uppermost deposit within the sequence of occupation and floor surfaces was 0.08m thick soft blackish grey sandy silt (108), containing approximately 5% charcoal content. This deposit might represent a tramped floor surface related to last stage of the existence of the priory. Deposit (108) was overlaid by 0.3m thick concrete slab; top at 68.52m above OD.

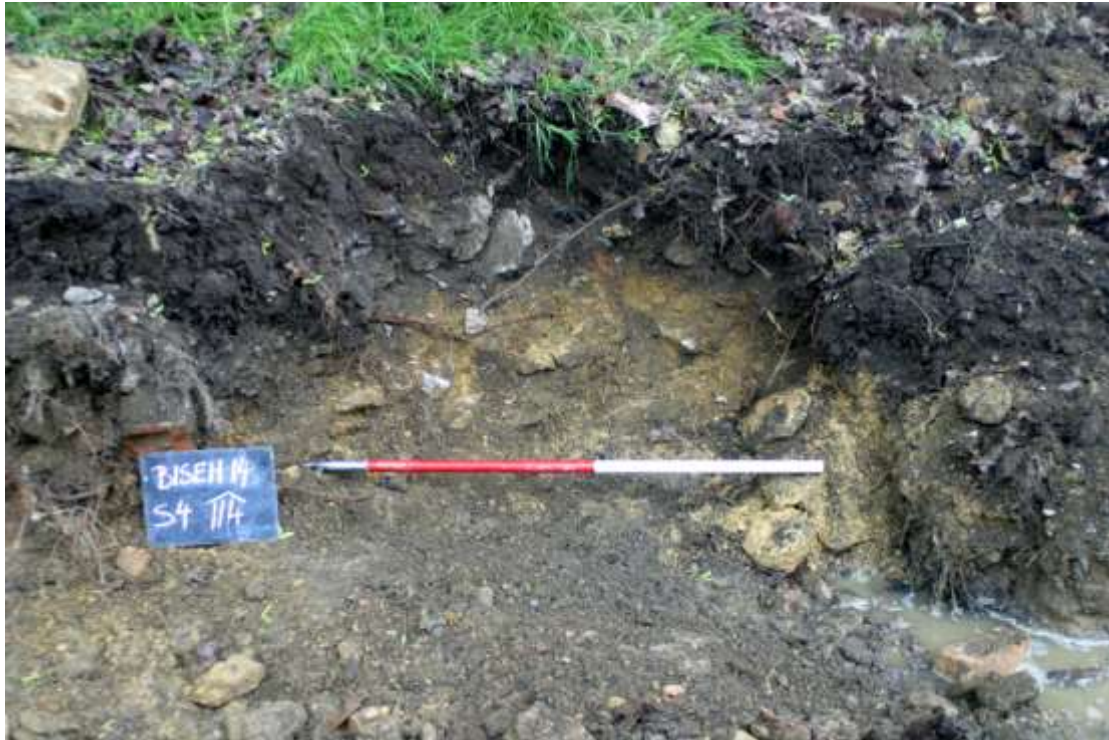
Plate 5: Remains of wall **114**, looking east.

Wall **114** was set within construction cut 113 with sharp break of slope and vertical sides, orientated in east – west direction (Fig. 1). It cut into deposit (105), this stratigraphic relationship was clearly visible in section. Wall **114**, as seen was 0.6m long, 1.6m wide and 0.3m high (top of the wall 68.45m above OD), mainly built of sub-angular limestone of maximum dimension 320x200x190mm and bonded with light yellowish brown sandy lime mortar (Pl. 5). Rubble from this wall, which contains sub-angular and roughly worked stones, was mixed with deposit (103) (Pl. 6). Overlaying wall 114 was 0.24m thick mid greyish brown sandy loam containing occasional sub-angular stones and ceramic building material. This layer possibly represents a demolition layer and it might be post-medieval in date. Layer (115) was covered with 0.2m thick layer of topsoil (Pl. 5).

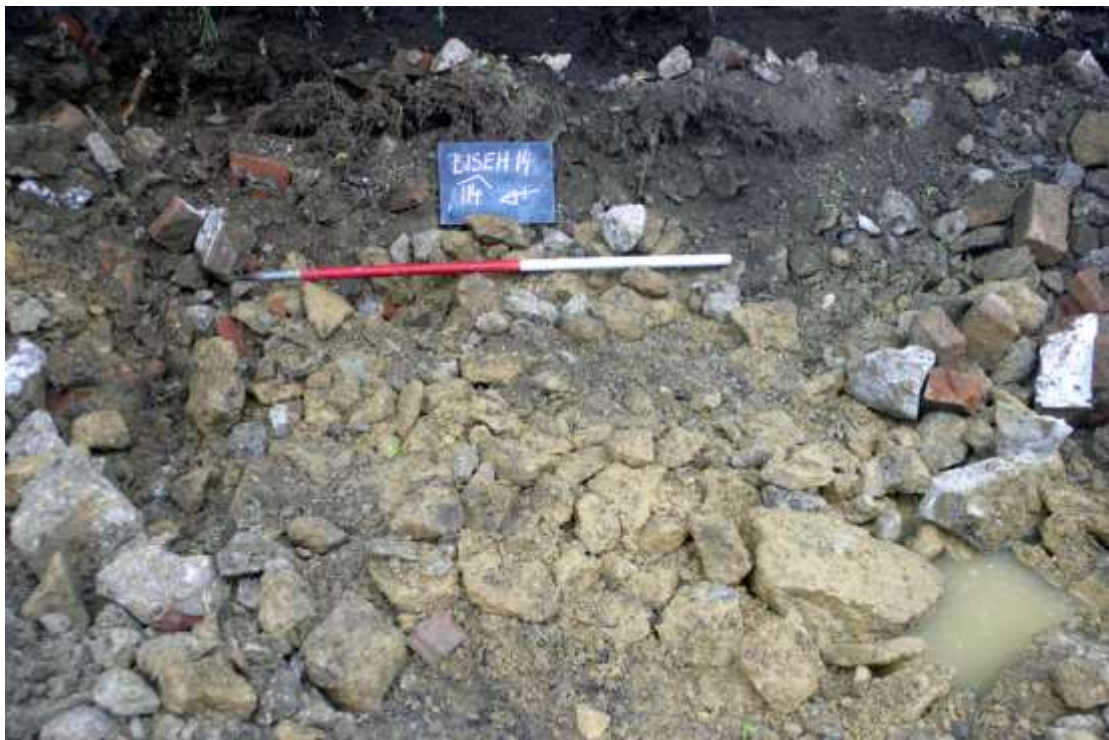
Plate 6: Stone rubble from the wall **114**, looking east.

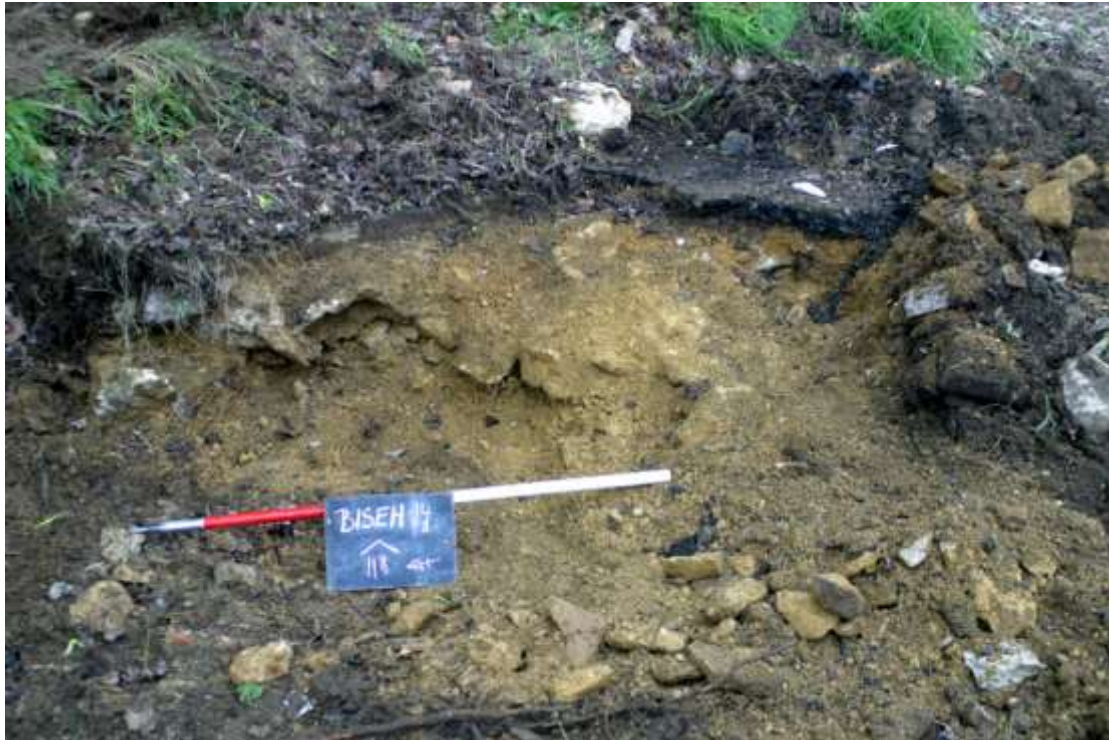
Plate 7: Remains of wall **118**, looking east.

Wall **118** was on the same alignment as wall **114** located 3m to the south, set within construction cut 117 (Fig. 1). It was 1.2m long (as seen) 1.8m wide and 0.28m high (top of the wall 68.48m above OD). Wall **118** was built of sub-angular limestone of maximum dimensions 300x250x180mm, bonded with yellowish sandy lime mortar. It was overlaid by an asphalt footpath, concrete curb and topsoil (101) (Pl. 7).

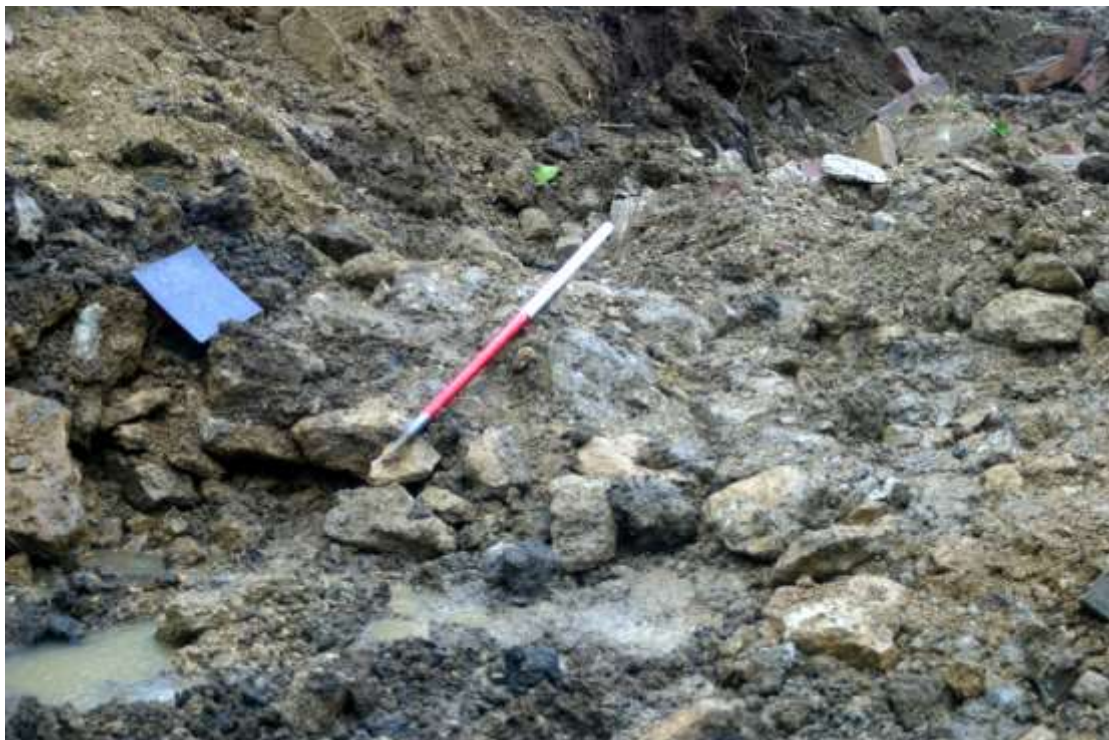
Plate 8: Remains of wall **120**, looking southwest.

In the area of the east extension, after removal of concrete foundations, alluvial greenish grey silty clay (107) was exposed. Cut into this deposit (107) were surviving remains of limestone wall **120**, which was set within a not clearly visible construction cut 119. Wall **120** was 1m wide, 1.4m long (as excavated), 0.25m high (top of the wall 67.87m above OD) and aligned north to south (Fig. 1, Pl. 8). The rest of the area of the east extension was covered by deposit (103).

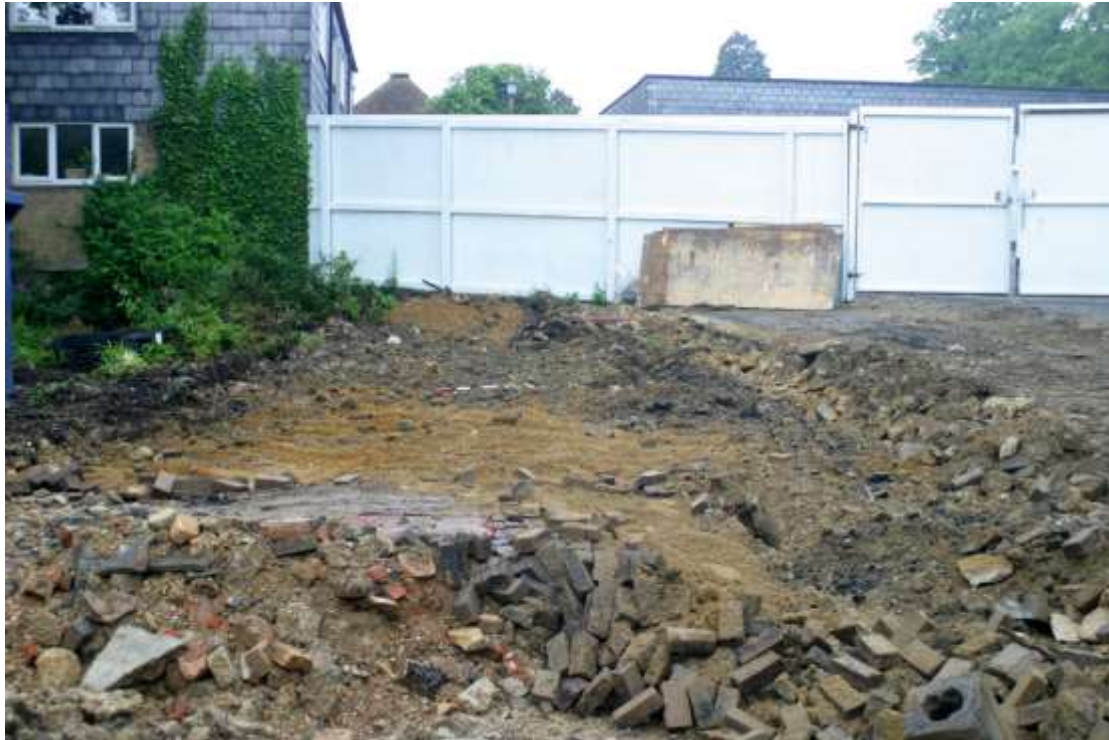
Plate 9: General overview of driveway after removal of paving blocks, looking west.

In the area to the west of footprint of the former building (Fig. 1), part of the driveway was removed, which was originally covered by paving blocks. Only sand bedding for the paving blocks and topsoil were exposed within an area of 13.5x6.5m (Pl. 9). To the north of footprint of former building paving blocks, which originally were part of the floor of a garage which was demolished before the start of archaeological watching brief, were removed (Fig. 1). Only the rubble bedding of the floor was exposed in this area.

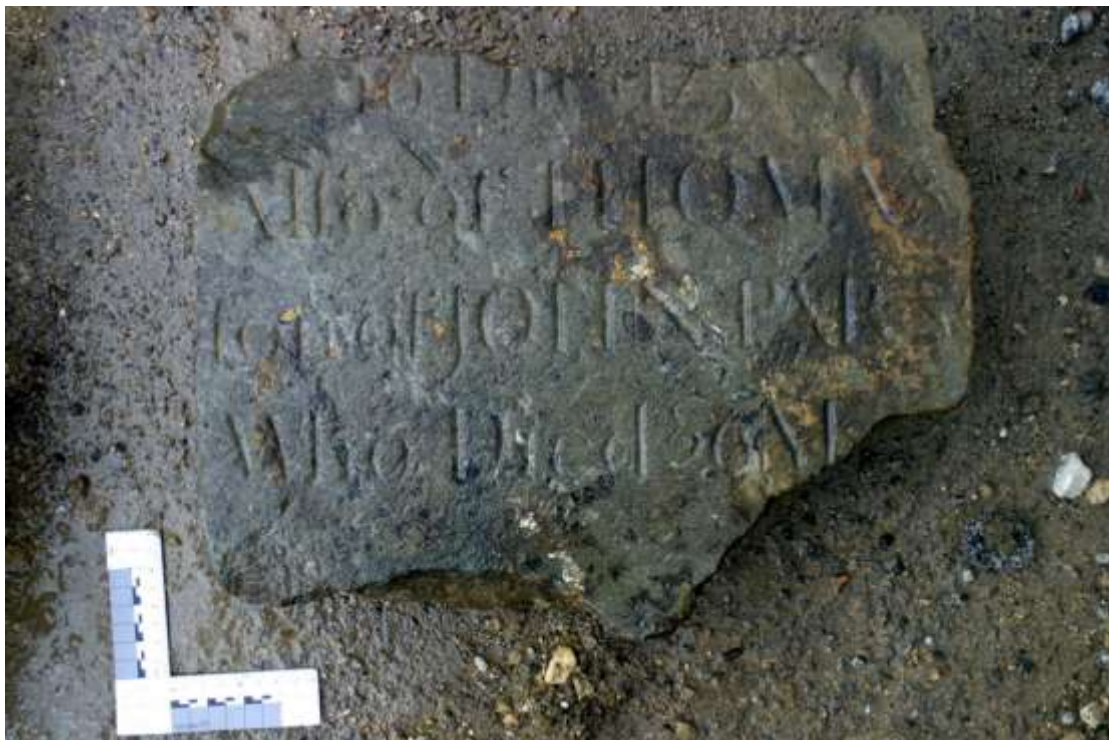
Plate 10: Fragment of gravestone.

Apart from the animal bones, one unstratified fragment of gravestone was recovered from demolition rubble. It was 300mm high, 380mm wide and 85mm thick with four lines of carved text (Pl. 10). First line of inscription has been poorly preserved and illegible, the following three lines were identified as follow:

[.]o D[.....]  
Wife of THOMAS  
Son of JOHN PARS[ON]  
Who Died 20 N[ov]

Although exact date is not preserved within the inscription on gravestone, it seems to be late post-medieval in date and may have originated from the non-conformist chapel on Chapel Street. A similar part gravestone was recovered from the Bryan House excavations.
