JOHN MOORE HERITAGE SERVICES

**1 CRISPIN PLACE,
WALLINGFORD, OXFORDSHIRE**

ARCHAEOLOGICAL WATCHING BRIEF

AUGUST 2014

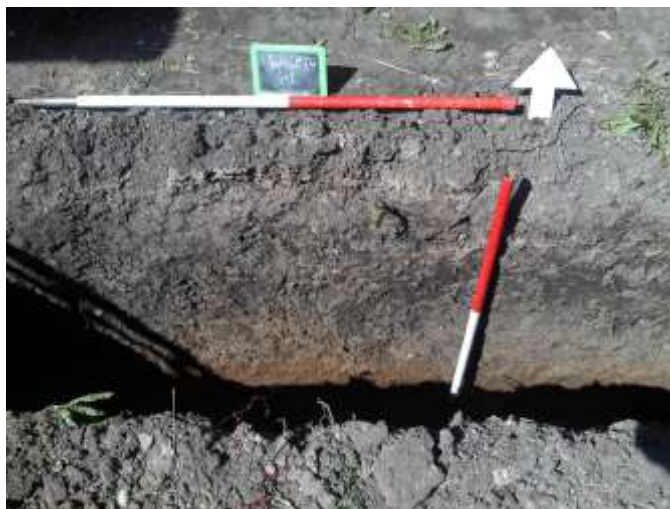
Plate 1. Section 1

The lowest layer was a natural, coarse, mid-orange sand with frequent, small sub angular stones (04). Above (04) was a firm, 0.2m thick mid to dark grey, sandy silty loam with moderate sub angular stone (03). Deposited above context (03) was a 0.5m thick layer of dark grey to black, sandy silty loam (02). Context (02) was a firm layer containing moderate amounts of small sub angular stone. The topsoil (01) was a 0.2m thick, loose, grey loamy silt with moderate small angular stone. Several services and

modern brick rubble soakaways were noted during the excavations. The remains of a garden pond which had been filled with rubble and concrete were identified in the south east corner of the foundation trench. No other features or artefacts were identified.
