**BUILDING ASSESSMENT**

**OUTBUILDINGS AT COLTHORN FARM,**

**OXFORD ROAD, OLD MARSTON, OXFORD**

**APRIL 2014**

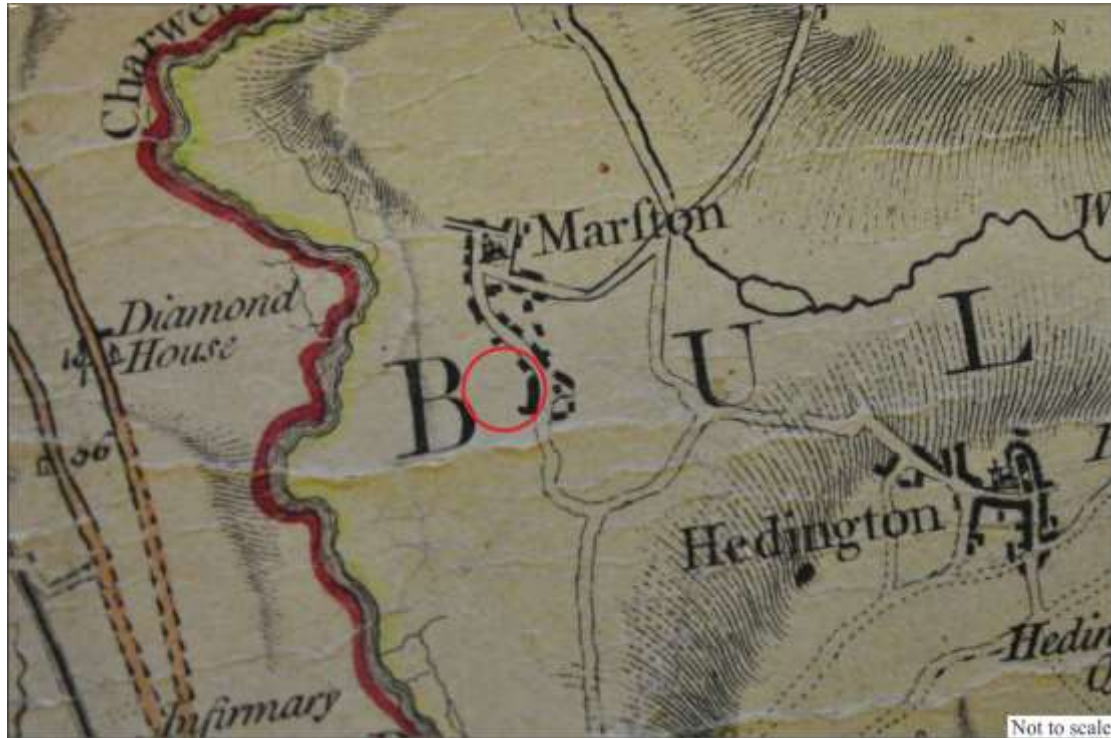
Figure 2 Jefferys' map of 1767

Two 18<sup>th</sup> century maps exist for Marston. The earliest is Jefferys' map of 1767 (OHC CP/103/M), which shows structures along the line of Oxford Road (Fig. 2). However, it is not possible to associate any of these specifically with the area of Colthorn Farm, although it could be feasible that some of them do. The same can be said about the other 18<sup>th</sup> century map by Davies in 1797 (OHC CH XX/2), (Fig.3).

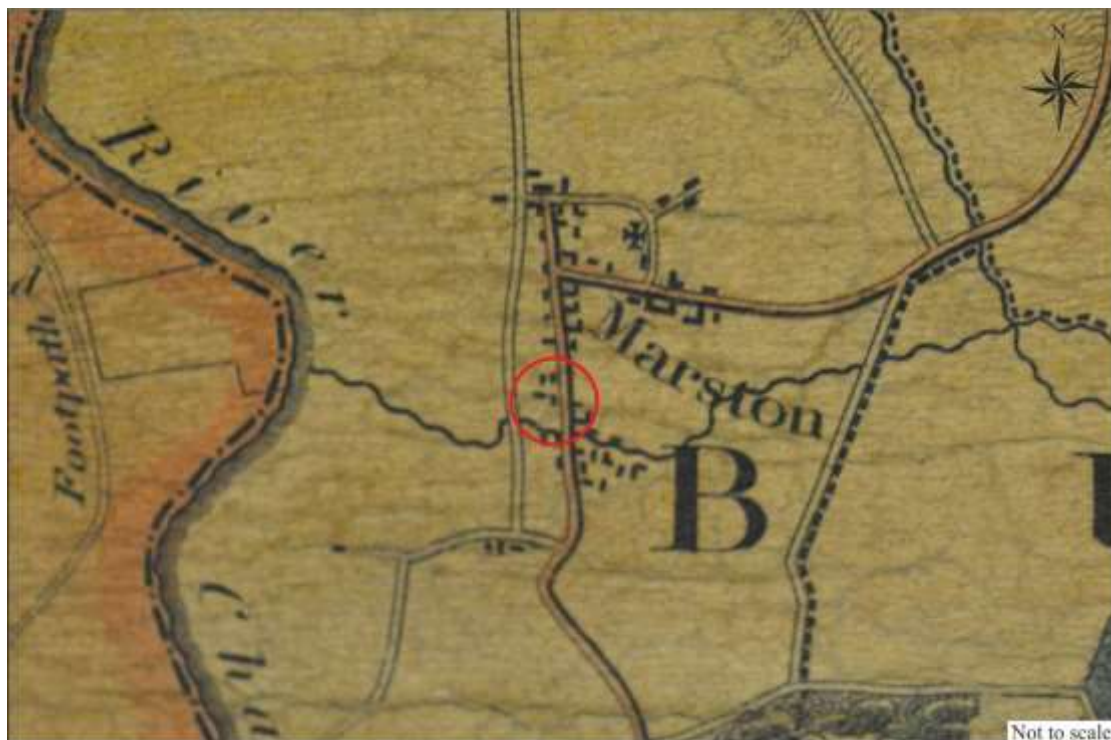
Figure 4 Bryant's map of 1824

On Bryant's map of 1824 (OHC P345/M/1) there are some buildings shown in the vicinity of Colthorn Farm, but it is impossible to be precise about their locations (Fig. 4).

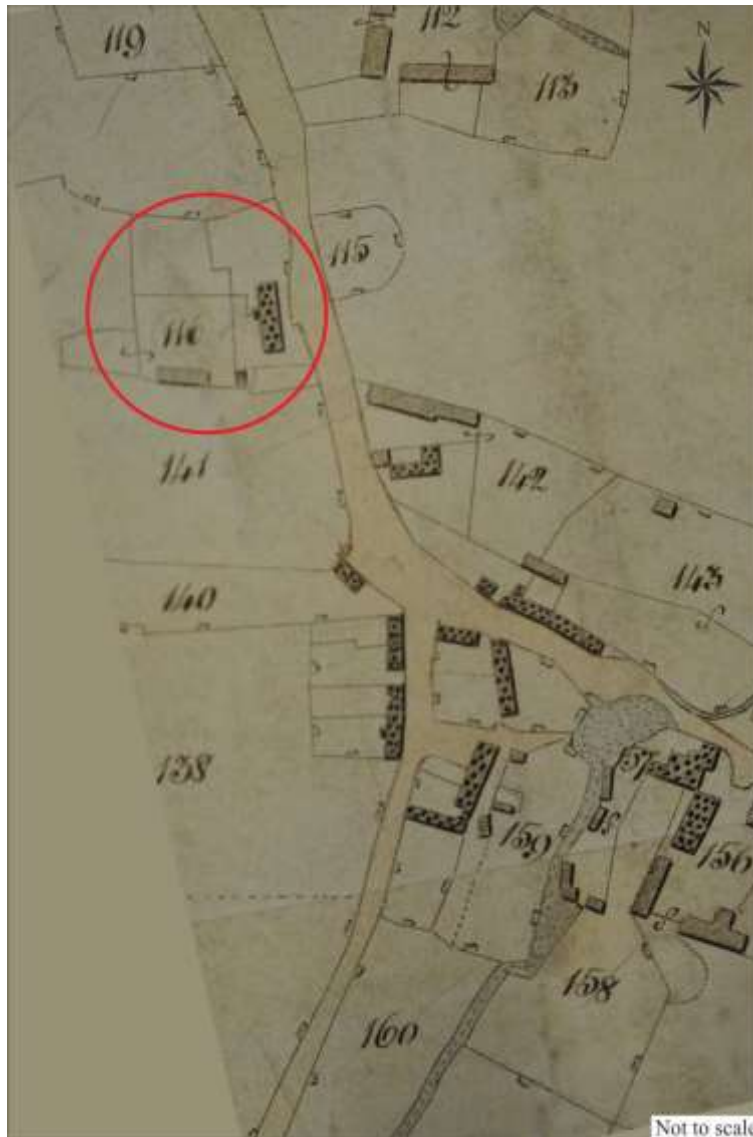
Figure 5 Tithe Map of 1845

The Tithe Map of 1845 (OHC 263/M) shows a house in the location of what was the original farm building fronting onto the Oxford Road (Fig.5). This is in the location of a stone built property that still stands. To the rear and on the south side of the current property there are two structures, orientated east to west. Accepting the building as the original farmhouse fronting onto the Oxford Road, then these structures do not appear to be located in the places of later structures. There is always the possibility that one of them is meant to indicate the stone structure at the centre of the north range, but that this is simply wrongly located. Though this scenario is indeed possible at this time it is impossible to demonstrate.

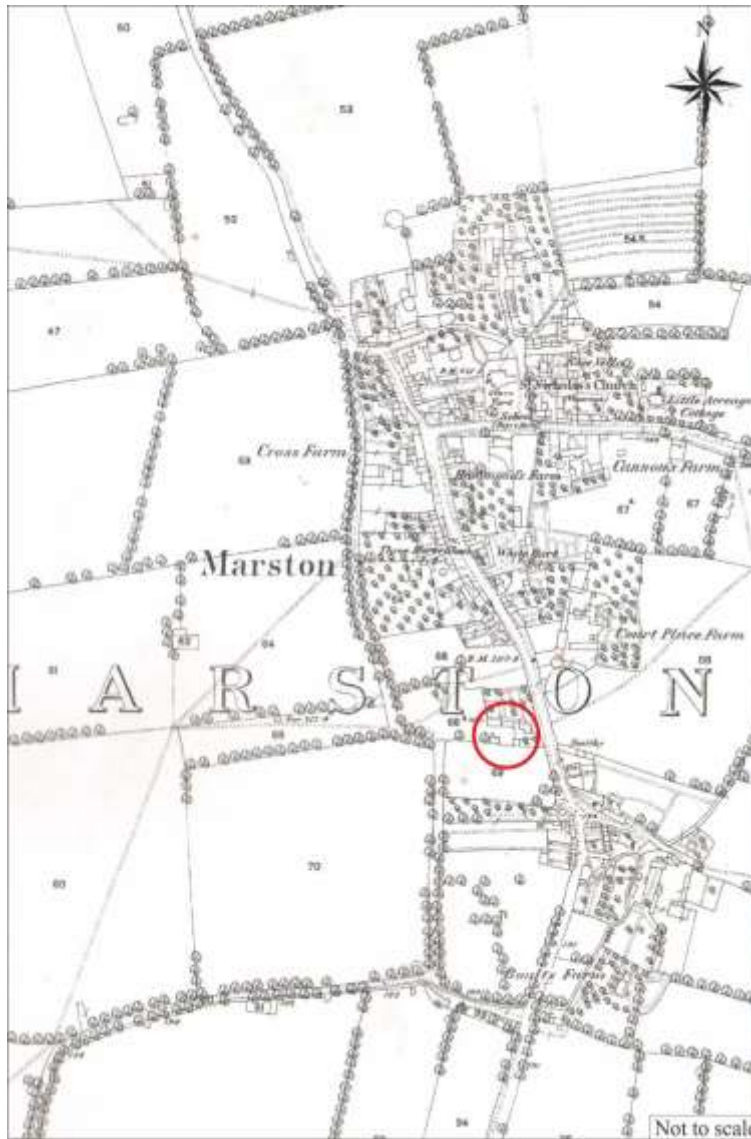
Figure 6 Ordnance Survey First Edition map at 1: 2,500 of 1878

The subsequent series of Ordnance Survey maps at 1: 2,500 will enable us to form an opinion on when the current structures on the site were established. The map of 1878 shows the outline of the original farmhouse fronting on to the Oxford Road (Fig. 6). There are two buildings still on the south side. On the north side of the farm yard there are two buildings marked, which appear to correspond to two of the components that survive on the north side. These include a probable cowshed with three walls of stone and a brick shed that butts up to it. The map of 1899 shows the old farmhouse fronting onto the Oxford Road and a series of buildings on the south side that represent the structures on the south side of the courtyard. This building was constructed at some time from 1876 to 1899. The two east to west buildings on the north side are still there and there is a further building roughly in alignment with them at the west end but not joined, besides a small addition on the south side. The same arrangement can be identified on the map of 1921, and also on the map of 1937. The latter map, however, has an addition of a new structure constructed at the west end of the north buildings. This implies that the corrugated iron structure was constructed from 1921 to 1937. The last map of a detailed scale was in 1973, which shows that a new structure has been added on the south side, which represents the barn constructed probably in the 1960s, but undoubtedly at some time from 1937 to 1973.

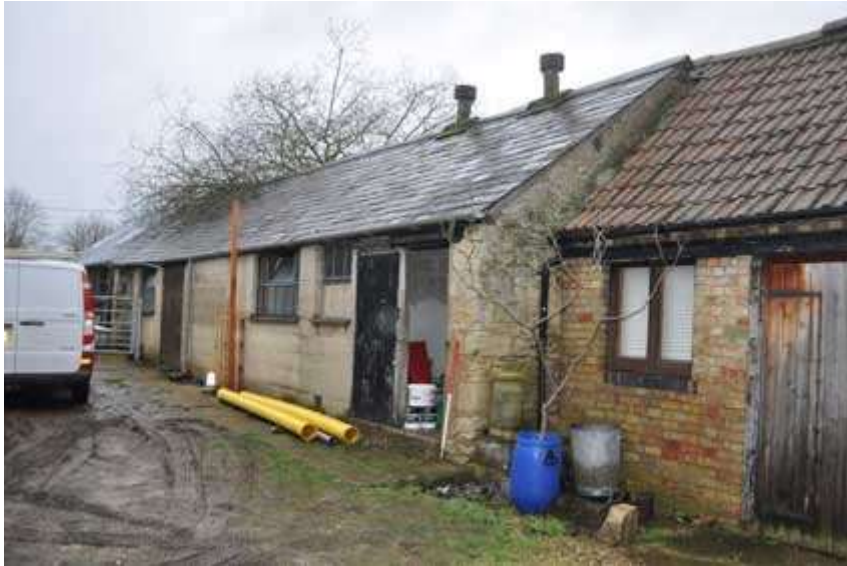
Plate 1 Northern range central block, a reworked cow-shed

The central part of the north range has to be the oldest component. It contains a structure that was constructed of limestone walls on three sides, and was previously open on the south side (Fig. 7, Plate 1). The timbers in the roof space are saw cut and the roof is of slate. All of this may be 19<sup>th</sup> century, and possibly a later addition. The south side of this building has now been infilled with breezeblock walls creating a

number of units internally. The wall contains a sliding door at the east end and two windows immediately to the west of it. At the west end there is a stable door with a window to the east, then a further door and window.

Of the north range of buildings, the eastern part of the structure, the cart-shed of c. 1860, this will be maintained. Of the central part of the structure a cow shed of c. 1850 or before, with internal alterations of c 1960-70, this will be demolished. The west part of the structure will be demolished; this part of the structure has no architectural merit.

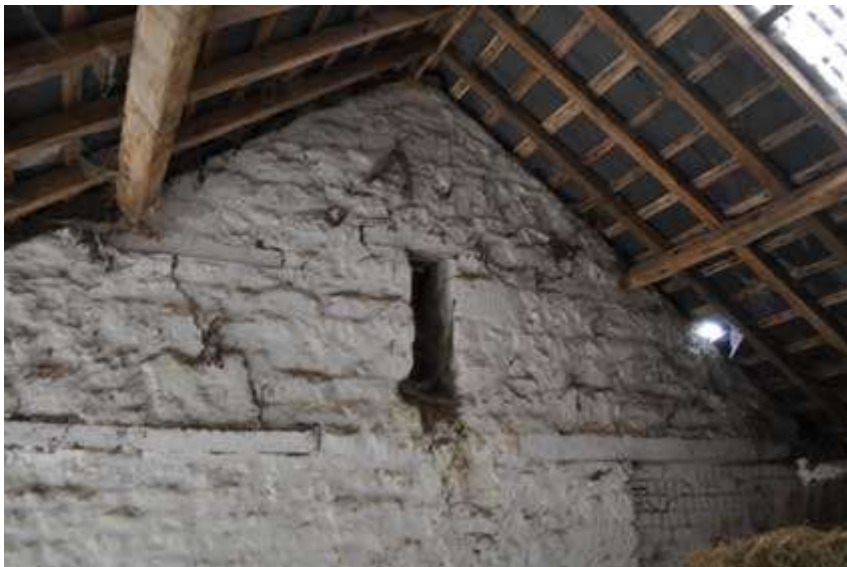
Plate 2 Detail in west gable of central cow-shed

The stone wall forming the west gable is visible internally and contains a blocked doorway on the north side (Fig. 7, Plate 2). Timber lintels have been imbedded into the wall to bind and strengthen the wall. Centrally in this wall there is a ventilation slit. In the east gable there is also evidence of a blocked doorway on the north side. The two entrances indicate that previously there was a passageway running behind a range of feeding stalls that no longer survive. Some of the trusses contain struts, but they have no evidence of chamfering.

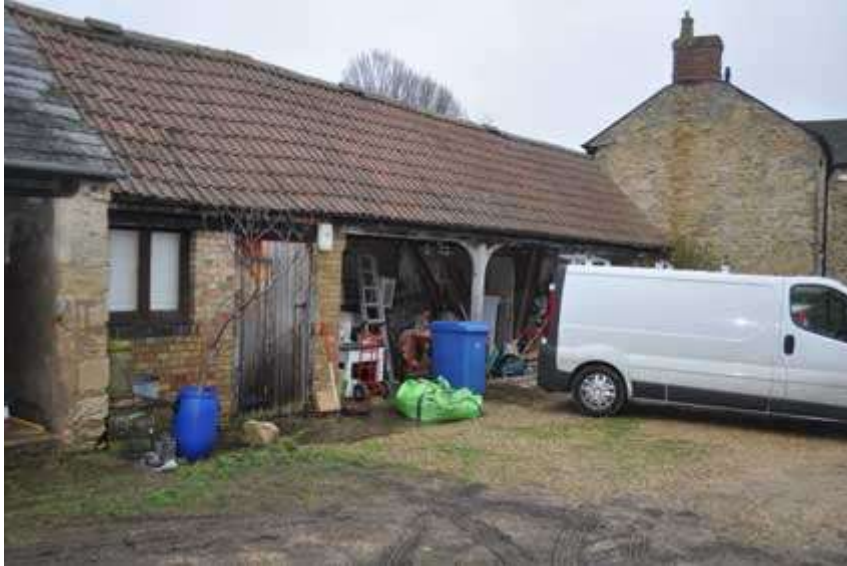
Plate 3 Northern range eastern part

The east part of the north range is of brick and is butted up to the limestone wall of the central range (Plate 3). There are two component parts to this part of the structure; the west part is an enclosed room with a door on the east side and a window on its west side on the south façade. The other is open on the south side with two supporting posts on stone pads and curving braces. The roof space is open with trusses that contain king posts and struts (Plate 4). This part of the building is covered with modern 20th century pan tiles.

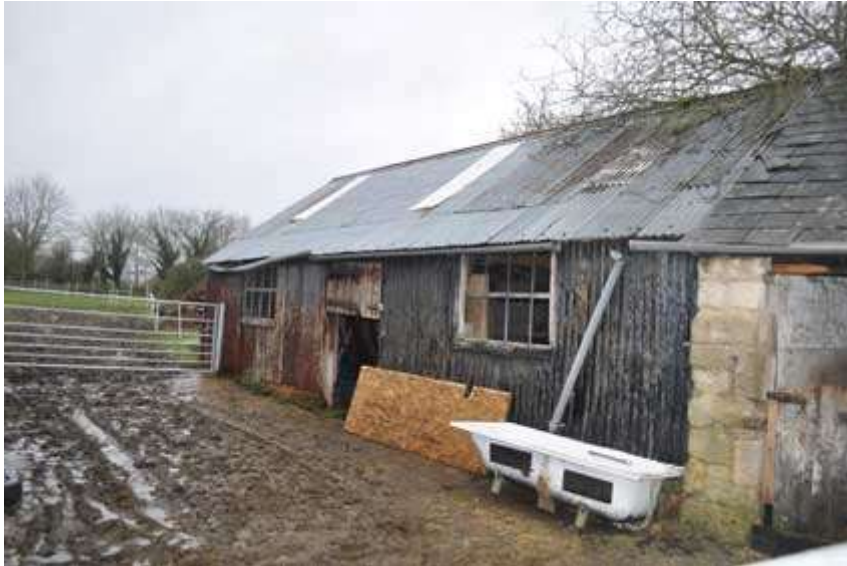
Plate 5 North range, west end of south façade

The west component of the north range is of a later construction and is also butted up to the limestone wall of the central range (Plate 5). This part of the structure is L-shaped with an extension on the north side. The structure has a dwarf brick wall over which there is a timber frame encased in corrugated iron. The south façade has a central stable door with two flanking windows.

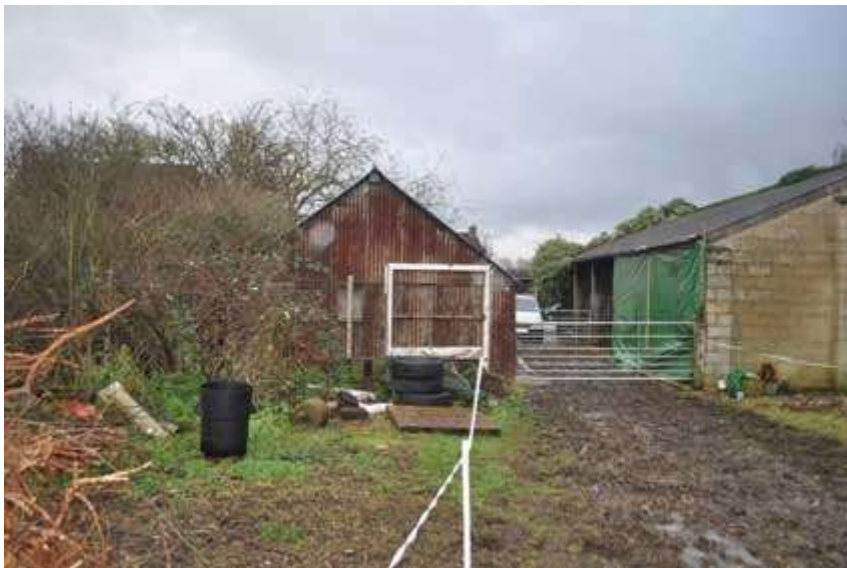
Plate 6 North range, west gable

The west gable has a blocked up window (Plate 6), while the extension on the north side has dwarf brick walls with windows forming all of the wall space, except for a plank door on the west side, and corrugated cover on the east side. Internally there is a single standing central wooden post helping to support a flat lean-to roof of white asbestos sheeting (Plate 7). A plank door is located between the two component parts of this area of the structure. Internally in the main unit of this western part of the structure the trusses contain struts only (Plate 8). In the east wall, which is formed by the limestone wall of the central range, there is a bricked up doorway with timber lintel on the north side.

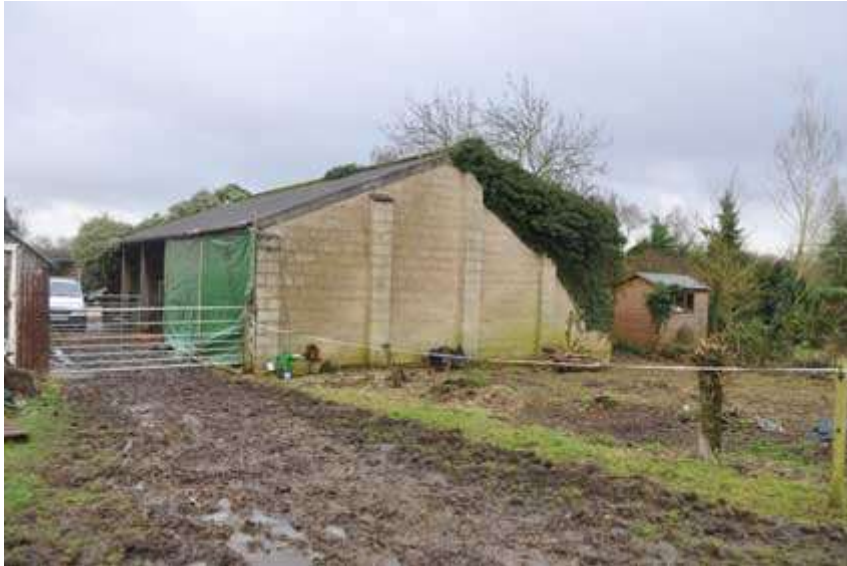
Plate 9 West end of south building

The southern building has three sides constructed of a breezeblock walling on the east, south and west sides (Plate 9). The structure is mainly open on the north side, where it faces across to the north range. The east and west walls have some four supporting piers. The open north side has four bays defined by uprights supported on breezeblock pads. Internally the trusses are steel framed structures that support a corrugated asbestos roof (Plate 10). There is an internal division separating the east bay of the barn from the other three and also a makeshift panelled area in the southwest corner.

The proposed alterations in planning will mean the following for these standing structures. The south range will be completely demolished. Historically and architecturally this will not be missed.
