**AN ARCHAEOLOGICAL WATCHING BRIEF**

**FAWLER MANOR, KINGSTON LISLE, OXFORDSHIRE**

**OCTOBER 2014**

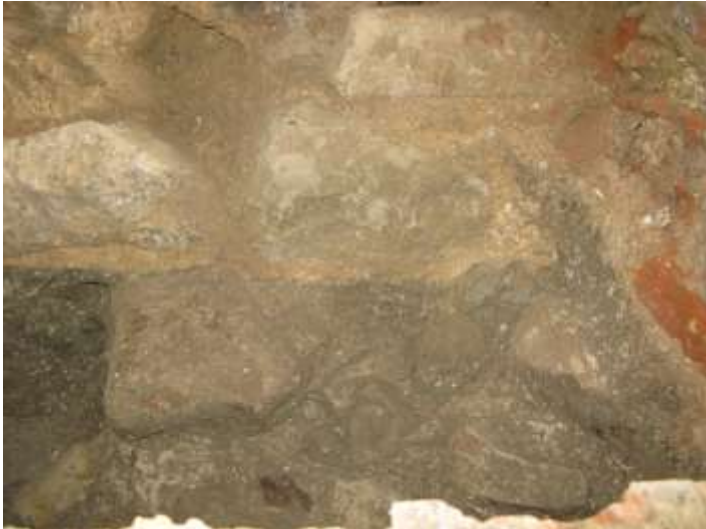
**Plate 1 – Foundations**

chalky clay natural deposit. Excavation also revealed the foundation stones of the east wall and it was noted that they were of roughly dressed large limestone blocks laid onto a 0.04m thick lime mortar.

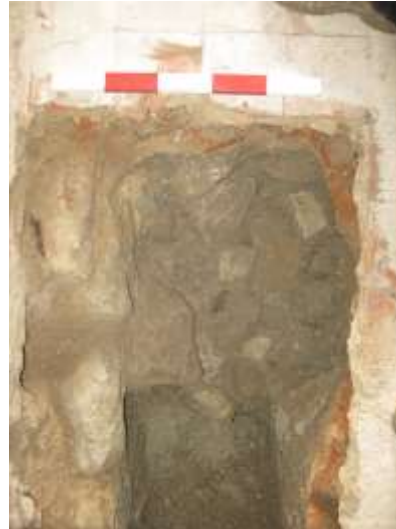
**Plate 2 – Rubble Layer**

The southern half of the trench also contained a large quantity of roughly hewn limestone and darker stone blocks which were within the compacted clay soil, but which were below the line of the foundations. These, however, did not appear to form any type of structural feature and may have simply been rubble from the construction of the original farmhouse.

Removal of the rubble showed more of the same dark clay layer extending down to the natural geology.

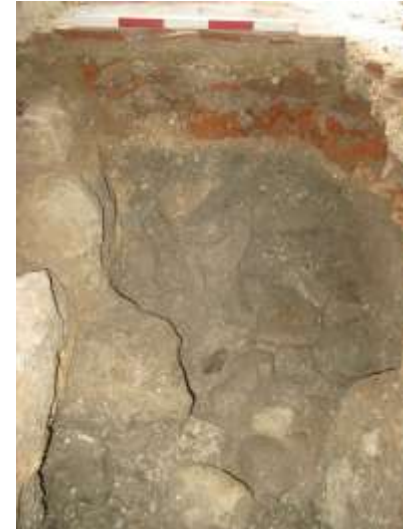
**Plate 3 – Floor Layers**

The present floor surface, directly below the current window and abutting the wall comprised of modern orange coloured quarry tiles, lain in a sand mortar on top of unfrogged red brick rubble to a maximum depth of 0.30m. This extended 1.00m to the west into the room from the eastern wall. The rest of the room at the time of the visit was, as exposed, compact dark grey clay soil with abundant small chalky stone inclusions. Removal of the tile and rubble layers revealed that they sat upon the same compacted soil as in the rest of the room.

Excavation through the clay soils was to a maximum depth of 0.85m from the present floor surface, showing this clay layer was 0.48m thick and overlay a creamy white
