JOHN MOORE HERITAGE SERVICES

**BUILDING ASSESSMENT**  
**ON**  
**THE HARCOURT ARMS**  
**STANTON HARCOURT, OXFORDSHIRE**

**JULY 2015**

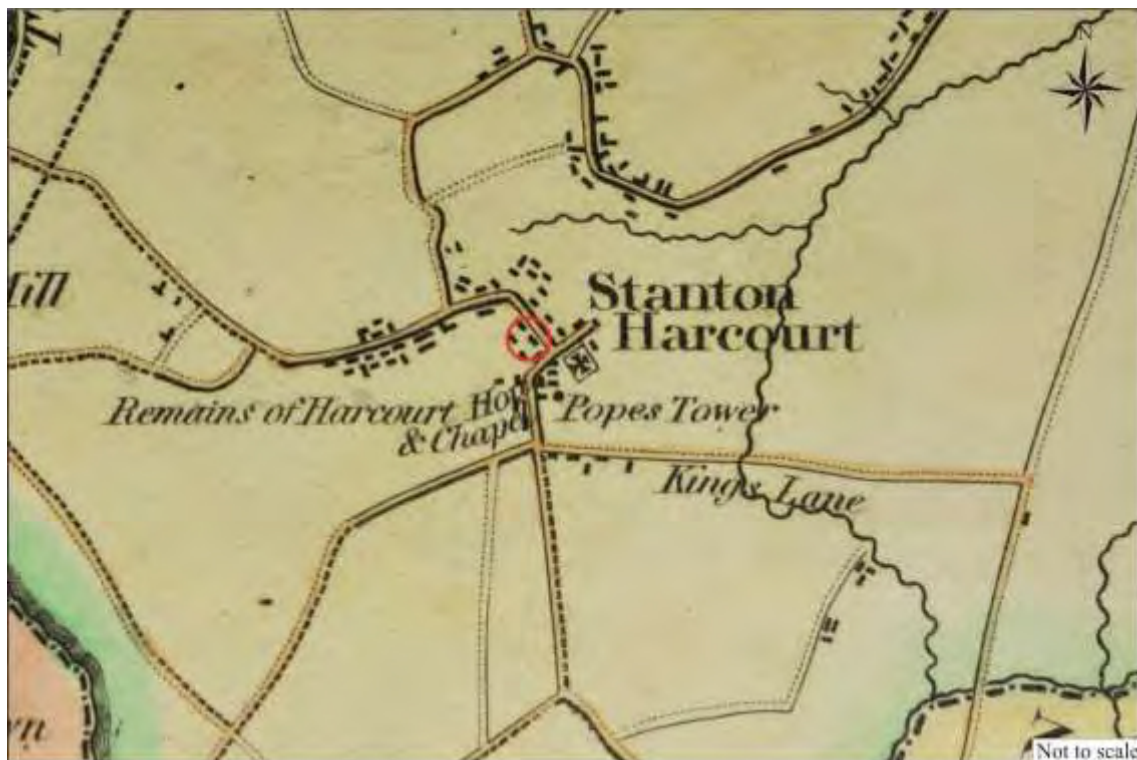
Figure 2: Bryant's map

The earliest map that depicts the Harcourt Arms is Bryant's map (Fig 2) from 1824 (P345/M/1). The map shows the building as a rectangular structure surrounded by other buildings on the side of the road.

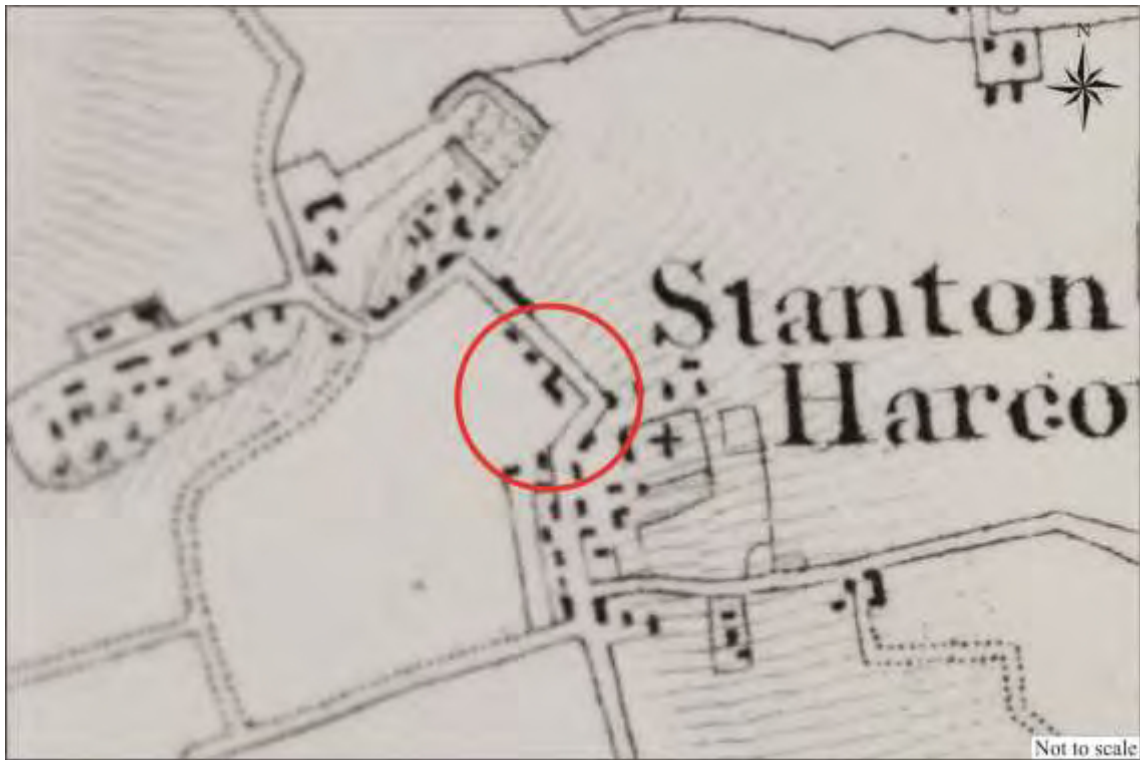
Figure 3: 1830 Ordnance Survey map

The next map to show the Harcourt Arms is an Ordnance Survey map from 1830 (Fig 3), which shows the building as having an L-shape (O138/9/M/1). This indicates that the first and second brick extensions were constructed by 1830. Greenwood's map (Fig 4) (CH/XLVII/1) of 1834 shows the building as a rectangle and is probably derived from that of Bryant's map; while a composite Ordnance Survey map (Fig 5) from 1850 (CH/XXIV/4) show the L-shaped structure the same as the Ordnance Survey map of 1830.

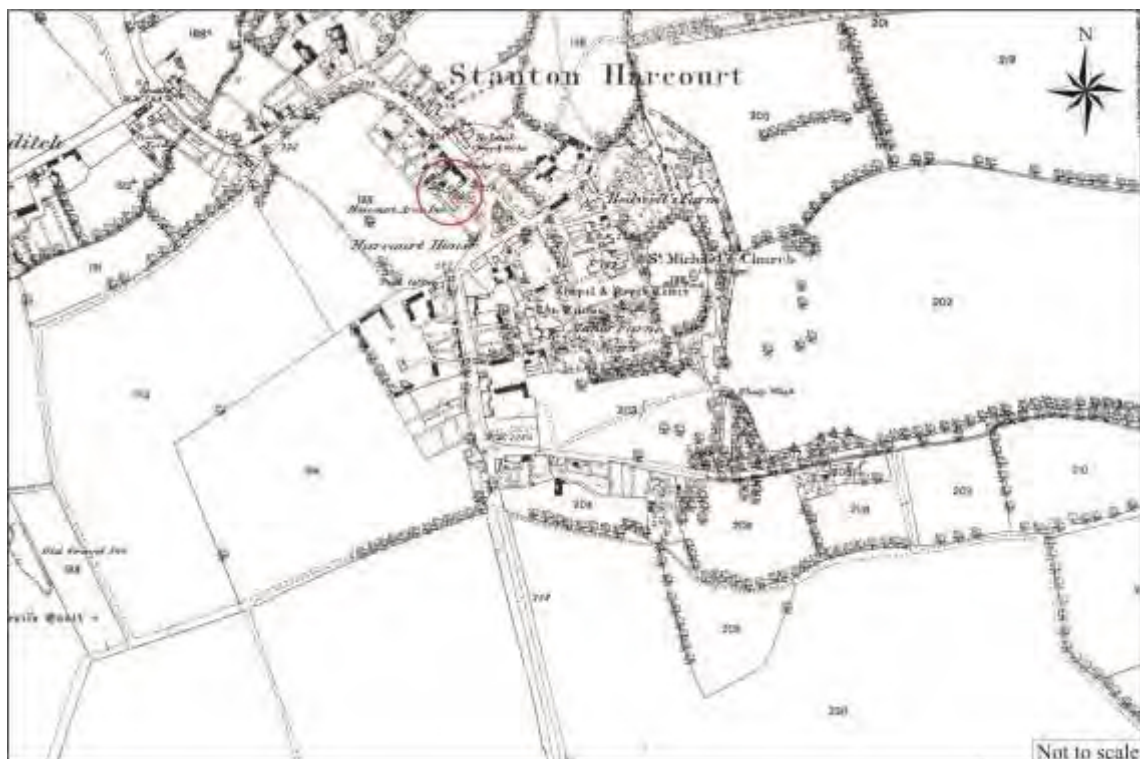
Figure 6: First Edition Ordnance Survey map 1876

The first edition Ordnance Survey map (Fig 6) from 1876 depicts the building as a T-shaped building (Oxon XXXVIII.3). This means that the three main component parts are shown. There are also additional buildings shown within the land attached to The Harcourt Arms. There are buildings to the northwest and the northeast. The second edition Ordnance Survey map (Fig 7) of 1899 (Oxon XXXVIII.3) shows the same as the first

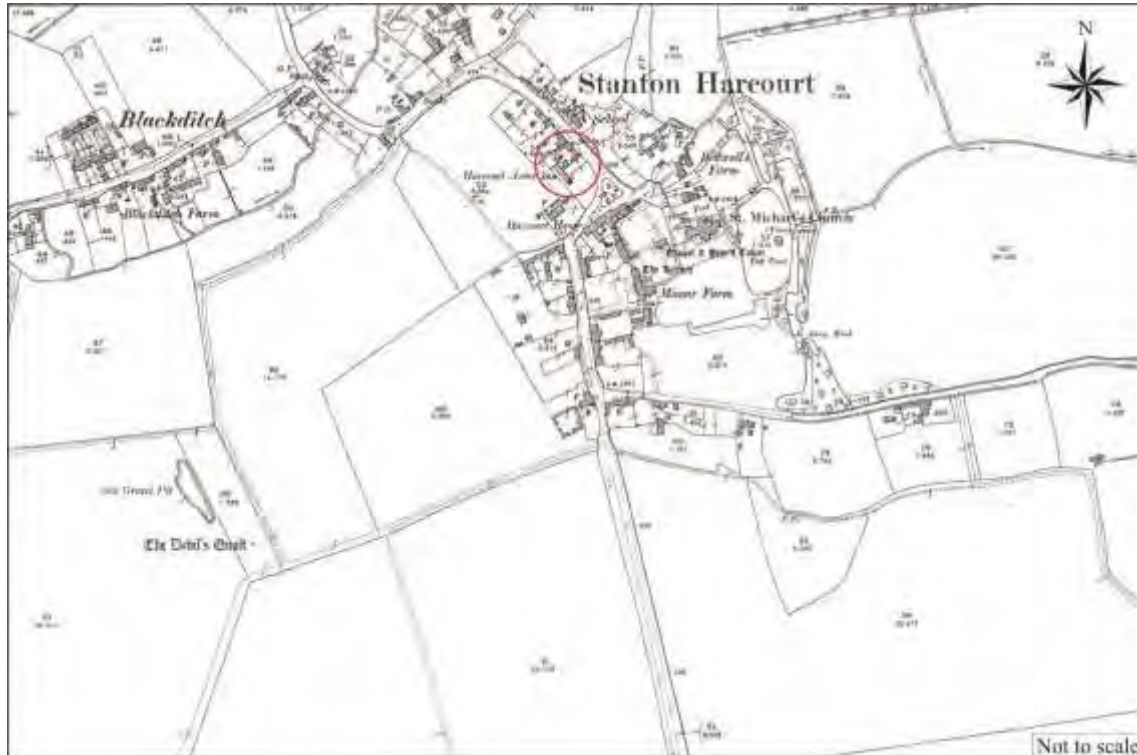
Figure 7: Second edition Ordnance Survey map 1899

edition with the addition of a small building on the south corner of the southwest end of the building. The third edition Ordnance Survey map (Fig 8) of 1913 (Oxon XXXVIII.3) shows the same as the second edition.

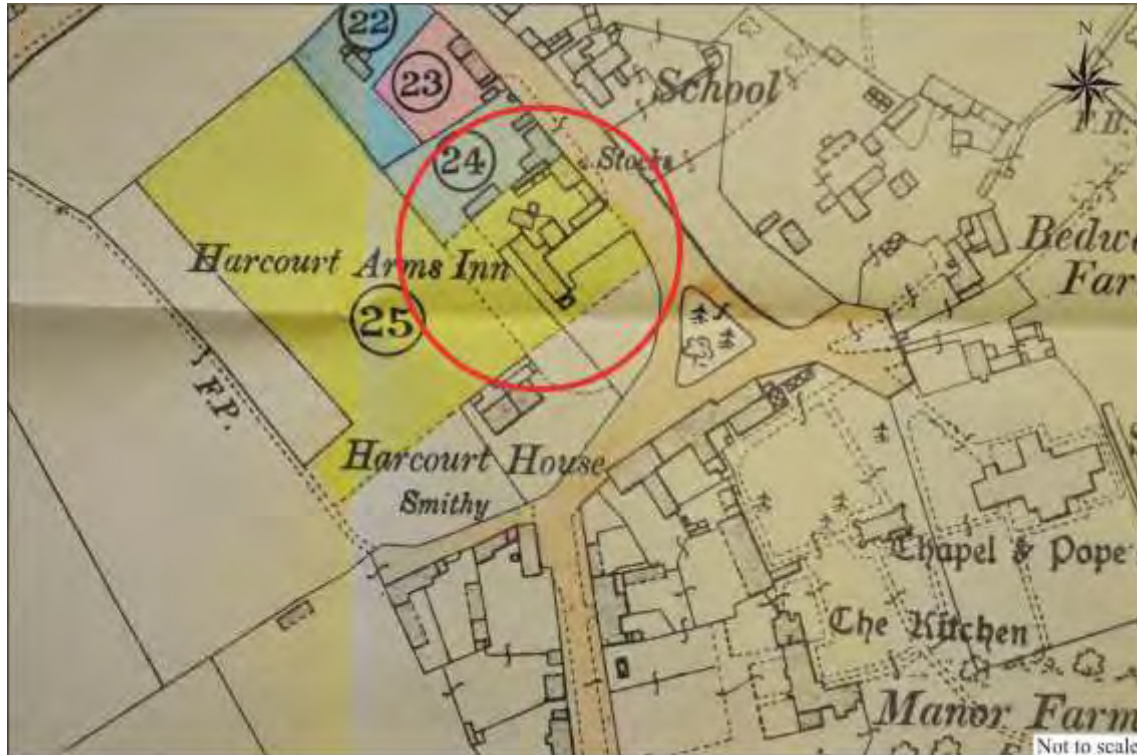
Figure 9: Plan of Harcourt Arms from 1924 Auction book

In 1924 the Harcourt Arms was put up for auction. Within the description of the property there was a map (Fig 9) showing the layout of the building as the same as the third edition Ordnance Survey map (OXO SC.84 P3 1924).

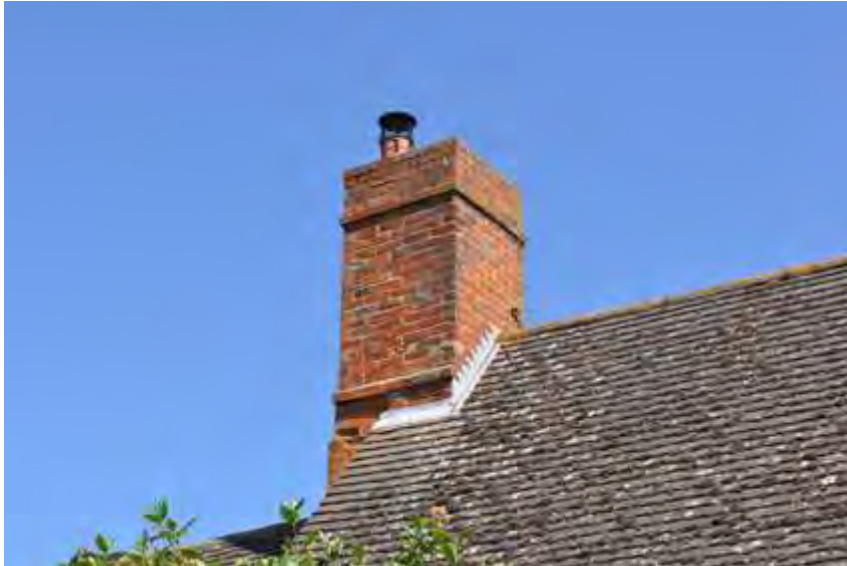
Plate 1: Northwest chimney

The main range of the Harcourt Arms is a rectangular two and a half storey stone and brick building. This part of the structure contains two different components, the stone structure at the southwest end and the brick structure at the northeast end of the building with chequered patterns. The roof for both the stone and brick parts is of limestone slate. The stone part of the building has two brick chimneys, one on the southeast end of the building and one between the stone and brick components (plate 1).

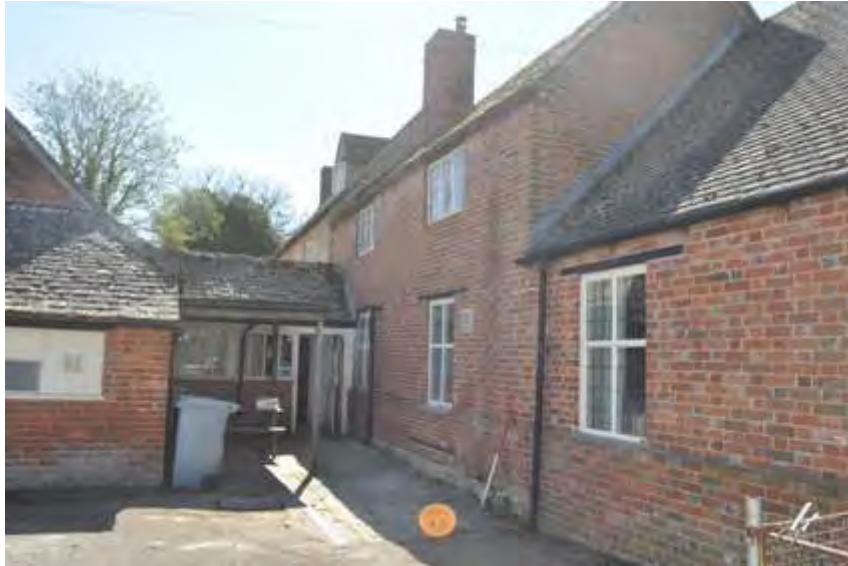
Plate 3: Front elevation of the brick extension

The front elevation of the brick part of the main range is of red and blue vitrified brick forming a chequered pattern (plate 3). This part of the structure is two storeys, with two bays. The two windows on the ground floor are mullioned and transomed with four lights, and timber lintels. The left hand window is original framed and leaded glass, with the right being a modern single panel with lead attached and is probably of a 1980s date. The two above have two mullions and are set under the eaves. At the northwest end there is a single storey addition with a single bay that has a window that matches the ground floor window immediately to its right being of the 1980s. At the southeast end of the brick part of this façade there is an attached passageway extending out to a roughly square extension.

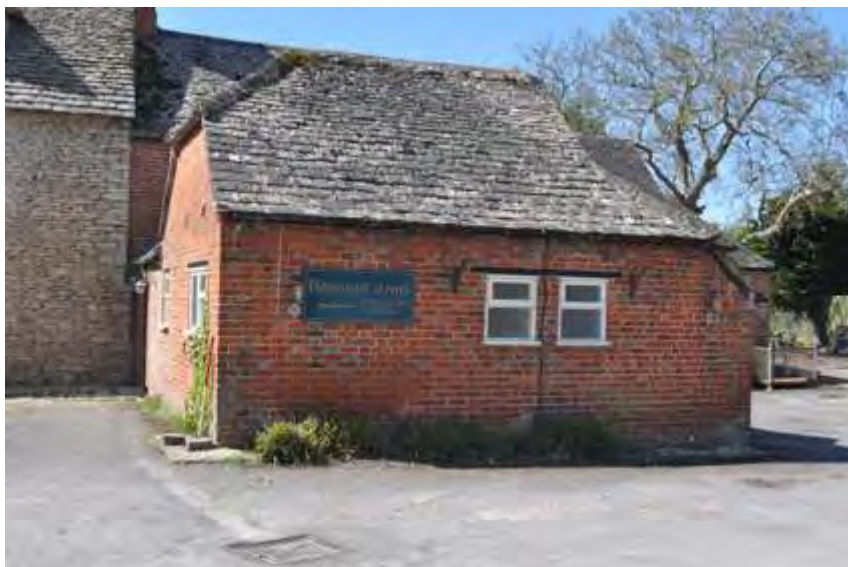
Plate 4: Front elevation of additional brick extension

The northeast side elevation of the front brick extension has two modern square-headed windows (plate 4). The roof contains a half hipped design on the southeast side and a gabled roof on the northwest side. There are a series of cut bricks at the right hand end,

suggesting reworking of the structure. The roof has a mixture of 1/3 round ridge and arisssed ridge tiles again indicating that there is a reworking of the original structure.

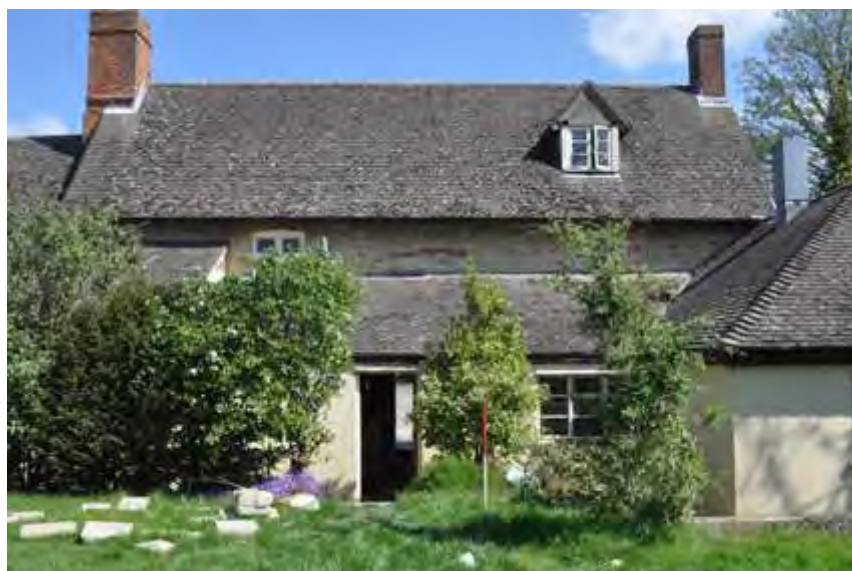
Plate 5: Rear elevation

Like the front elevation there are a number of component parts concealed along its range. The tallest part of the main range is two and a half storeys high, and demarcated by chimneystacks at either end (plate 5). This part of the building contains three bays, not arranged exactly as its counterpart on the front façade. On the ground floor the three bays contain a central door with two larger more recent window casements flanking. These are set in the wall of a lean-to. On the first floor there are two bays in a limestone wall. The windows have soldiered segmental arches. The one on the left hand side is a mullioned and transomed window, while that on the right is different with a dominant transom and six panes. The right hand window has also been shortened. In the attic space there is a dormer window. The roof is of concrete tiles.

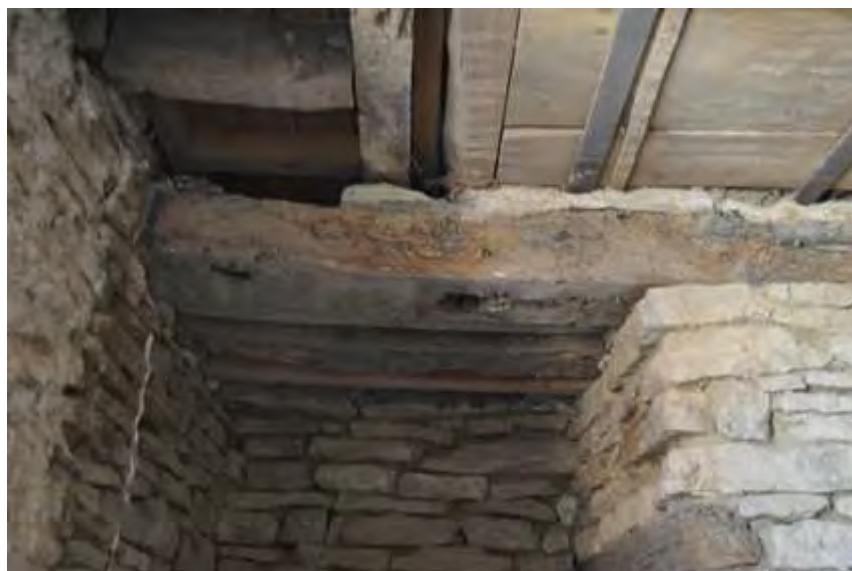
Plate 6: Timber beams at side of fireplace

The left hand door leads into room (G2) the shop. There is one wooden window in a recess in the northeast wall. There is a metal reinforcement on the inside of the window and a timber beam running across the top of the window. There is a stone fireplace in the southeast wall which is part of the southeast chimney. Across the top of the fireplace is a wooden lintel and in the recess on the left hand side (plate 6) there is another beam running across the top and partially into the chimney breast. A secondary beam is visible at the top of the recess further in. There is an additional recess in the middle of the southwest wall in the shop. A chamfered ceiling beam runs axially from the fireplace and connects with a chamfered post.

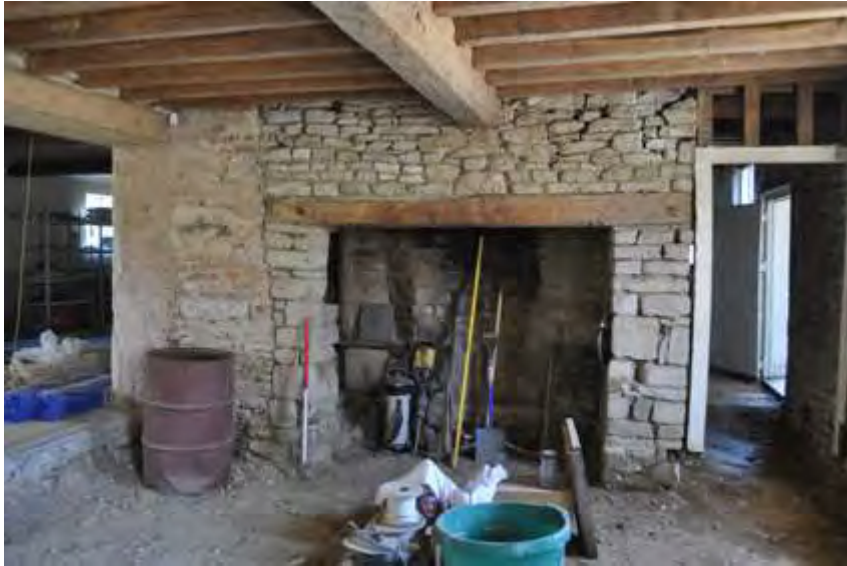
Plate 7: Fireplace in restaurant

The right hand door in the hall (G1) leads into room (G3). The restaurant in the stone building (G3) has a wood laminate floor laid over modern terracotta type tiles over a concrete floor with a partial wall extending from the south corner to the west. The northwest wall has a fireplace which is the base of the northwest chimney (plate 7). This has a wooden lintel with chamfer and rudely carved stops. To the southwest of the fireplace there is a joint between the stone building and brick extension. To the northeast of the fireplace there is a square-headed doorway. In the northeast wall one window is set within a recess which has been extended downwards to allow for a seat. There is a piece of timber lintel running across the top of the window that has been partially covered by the wooden framing of the window. There is also a chamfered timber ceiling beam running

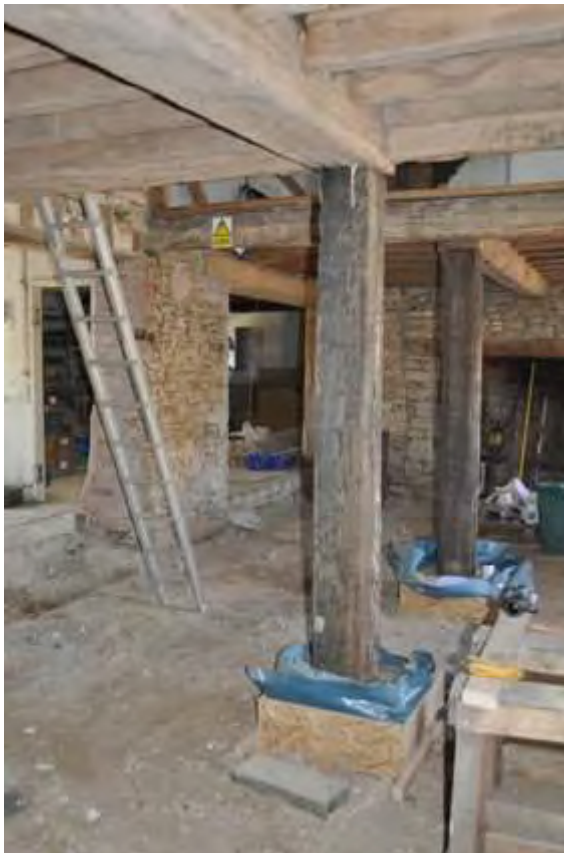
Plate 8: Timber posts and ceiling beams in stone building

from above the fireplace to a chamfered post which is located on the line of the southeast wall. In the southwest wall there is a large opening (plate 8).

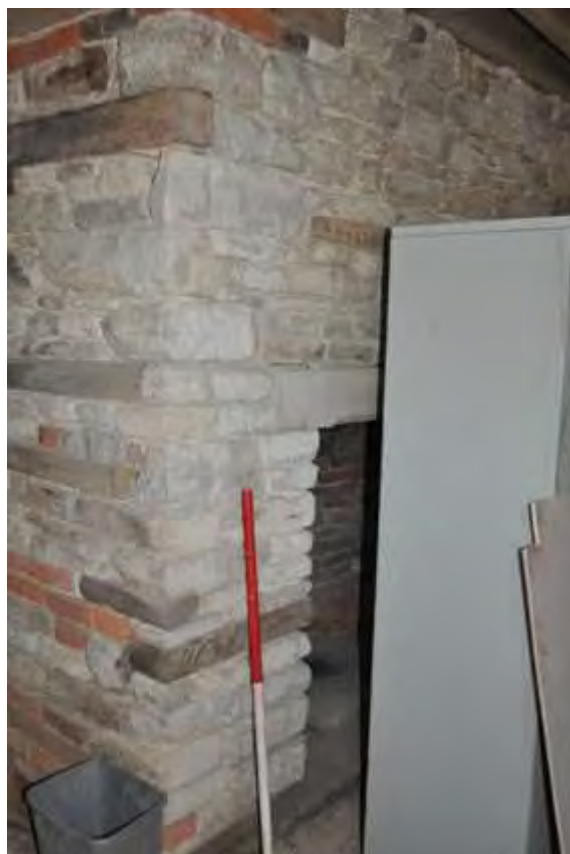
Plate 9: Fireplace in bar

that forms part of the northwest chimney (plate 9). The chimneybreast contains timber ties and reused brick. The stone lintel is new. Within room G5 there is a wooden post located where the ceiling beams cross. The post contains braces on each side connecting the ceiling beams (plate 10). The timbers are chamfered. At the northwest end of the bar there is a pier that supports steel joists on the original northwest external wall line.

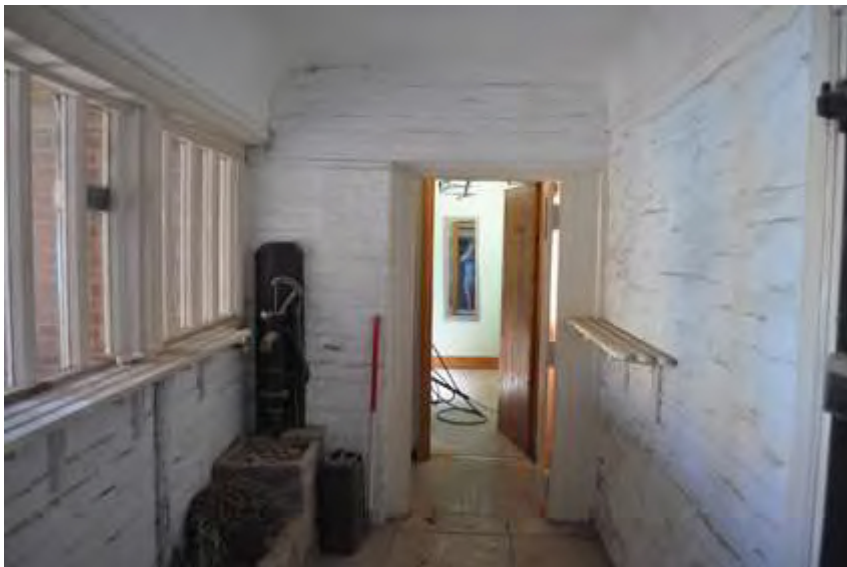
Plate 11: Well feature in hallway

The door on the northeast wall leads into a passage G6, which has a brick wall on the right hand side with a door, while on the left hand side is a door alongside a dwarf wall with panelling. There is also a hand-pump well, which has been inserted into a modern feature with stone plant bed, on the southeast wall (plate 11). This passageway leads to the toilets (G7), through a door at the northeast end of the passage. This door leads into a small lobby area with a door in the northeast wall and one in the northwest wall. There is a window in the southeast wall. The door in the northeast wall leads into the ladies, which has two cubicles, and a window in the northeast wall and one in the southeast wall. The other door leads into the gents with a single cubicle and urinals and two windows in the northwest wall. The interior of this structure appears to be a modern reworking.

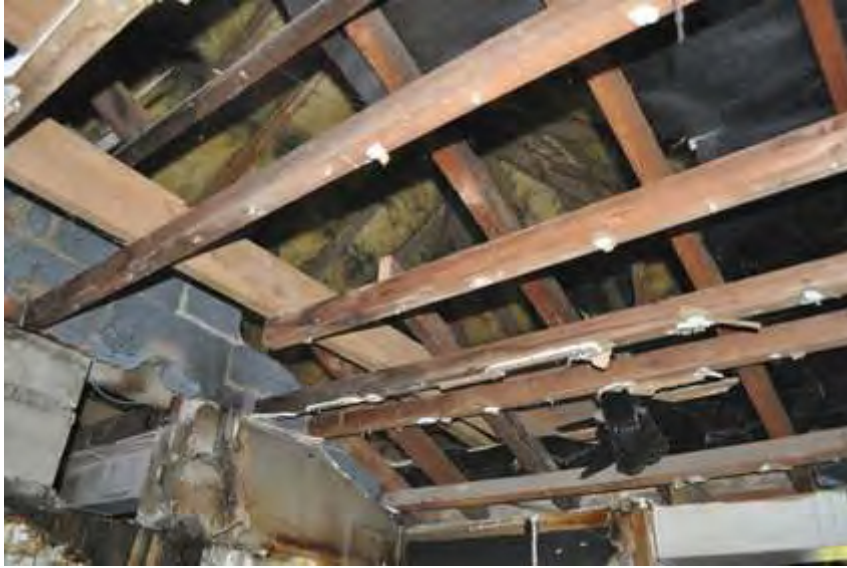
Plate 12: Exposed roof truss in kitchen

The southeast door leads into the kitchen area (G10). The room is formed by two component parts both of L-shaped design. An opening was made to connect the two rooms. Three windows are located in the southwest walls, all of a modern design. Stripping within the kitchen area has revealed additional features showing that the southwest part of the kitchen and the fridge are later additions to the main lean-to across the rear of the building. An additional door enters the room used for the fridge.

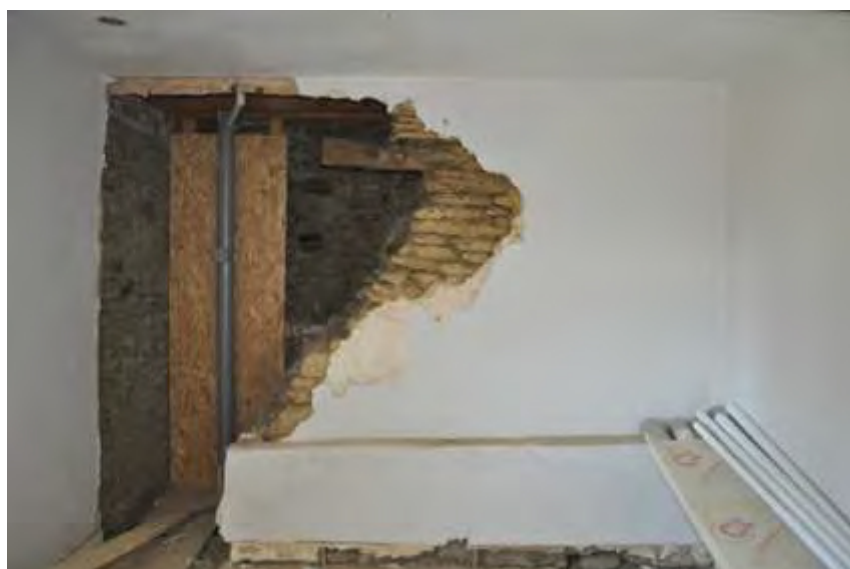
Plate 14: Chimney breast edge in bedroom 2

Bedroom 2 (F5) is located within the northwest part of the stone building with one window in the southwest wall and a vertical plank door leading into the hallway (F1) in the northeast wall. There are two transverse RSJs boxed in plasterboard. Due to work carried out within the bedroom the chimney breast from the fireplace in the restaurant (G3) is visible in the northwest wall (plate 14). As the chimney breast enters into the first floor the sides start to slope inwards decreasing the width of the chimney breast and then becomes vertical before entering the second floor.

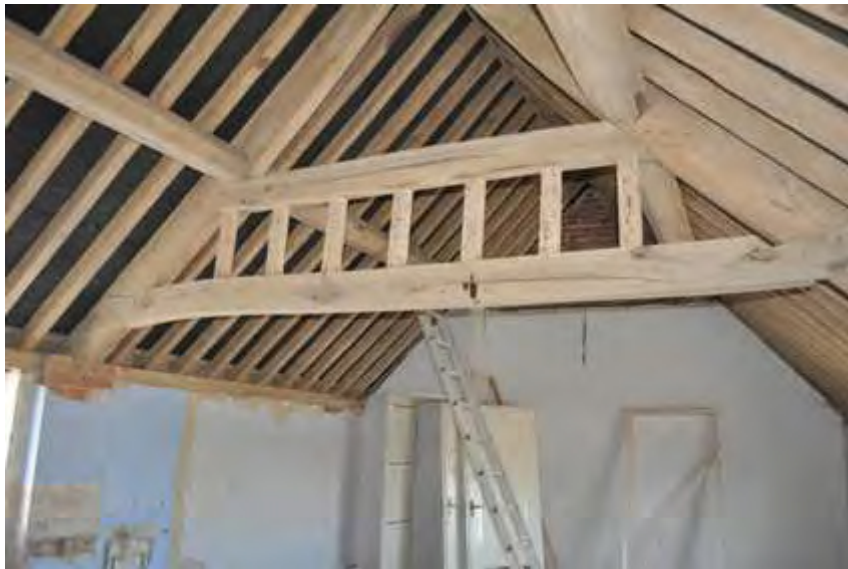
Plate 15: Timber truss in loft

The door at the northwest end of hallway (F1) runs into a further extension of the hallway. Along the northeast side of the passage extension there is a square-headed window. In the southwest side of the hallway there are two doors, while in the northwest end there is a further door. The latter door from the hallway enters room (F2) which has a single double mullioned window in the northeast wall and a cupboard in the east corner. One of the doors in the southwest wall leads into room F3; there is a window in the southwest wall. The second door in the southwest wall of the passageway extension leads into room F4; which has a square-headed window in the southwest wall and a fireplace in the southeast wall. A truss with tie-beam and collar-beam with seven struts (plate 15) was located in the roof space above F3. The collar is located immediately below the tenoned purlin.

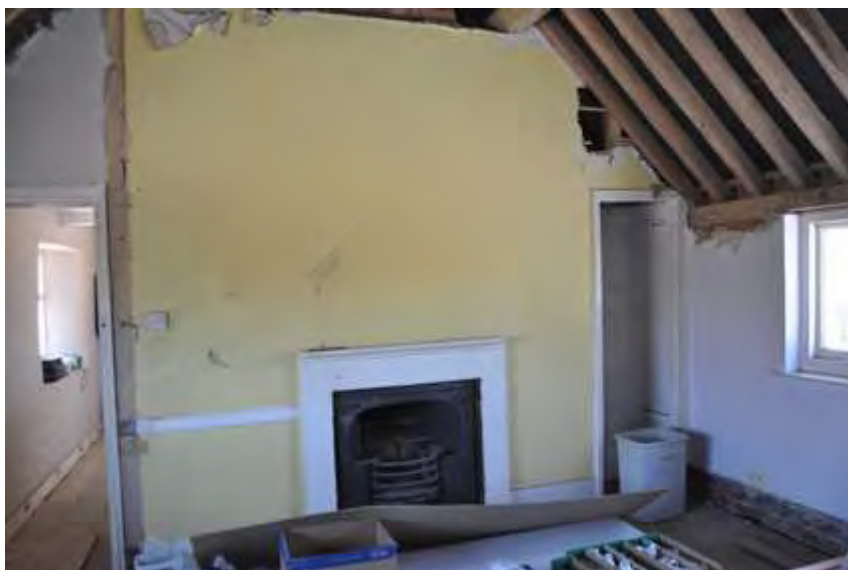
Plate 16: Fireplace in bedroom 1

The southeast wall leads to room (F6) which is located on the northeast side of the building and has one square-headed window in the northeast wall. There is also part of a chimney breast within the south corner, which is a continuation of the chimney breast in the southeast end of the narrow room (plate 16).

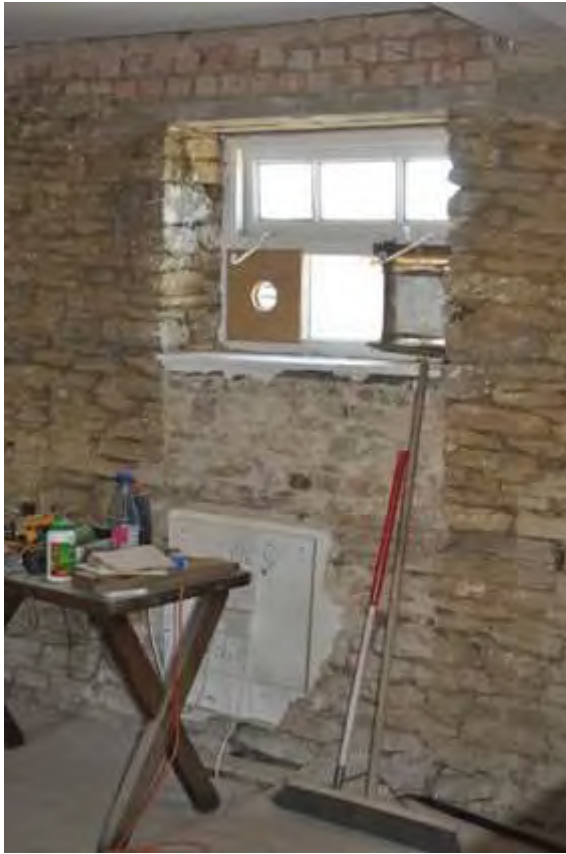
Plate 17: Partially blocked window in office.

The southwest door from the hall lobby leads to room (F7) which is located on the southwest side of the southeast part of the building and has one partially blocked window in the southwest wall (plate 17). This was undoubtedly blocked when the modern lean-to was constructed externally.

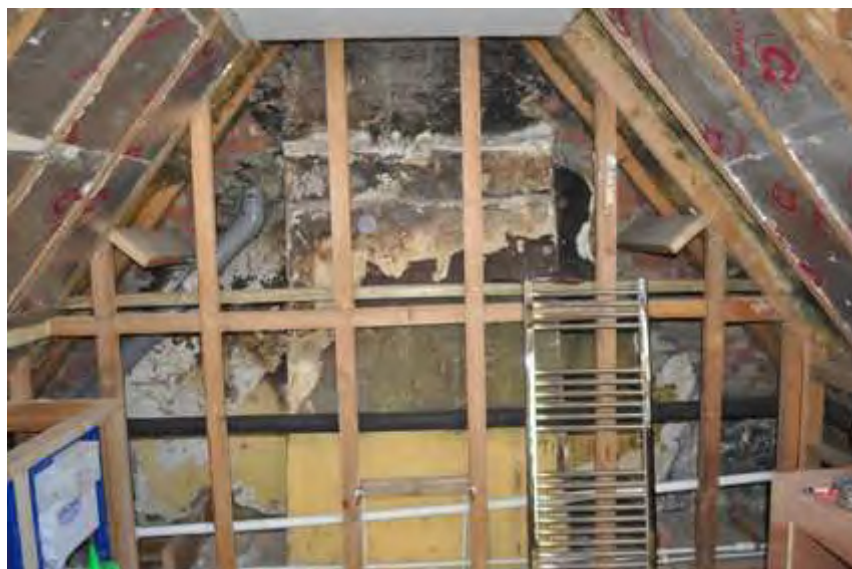
Plate 19: Chimney breast in bedroom

Attic room (S2) has one dormer window on the northeast side. Additional work has revealed that there is a chimney breast on the northwest wall of the bedroom (plate 19).
