ARCHAEOLOGICAL WATCHING BRIEF

THE FORMER CENTURION PH,

LEACH ROAD, BICESTER,

JULY 2015

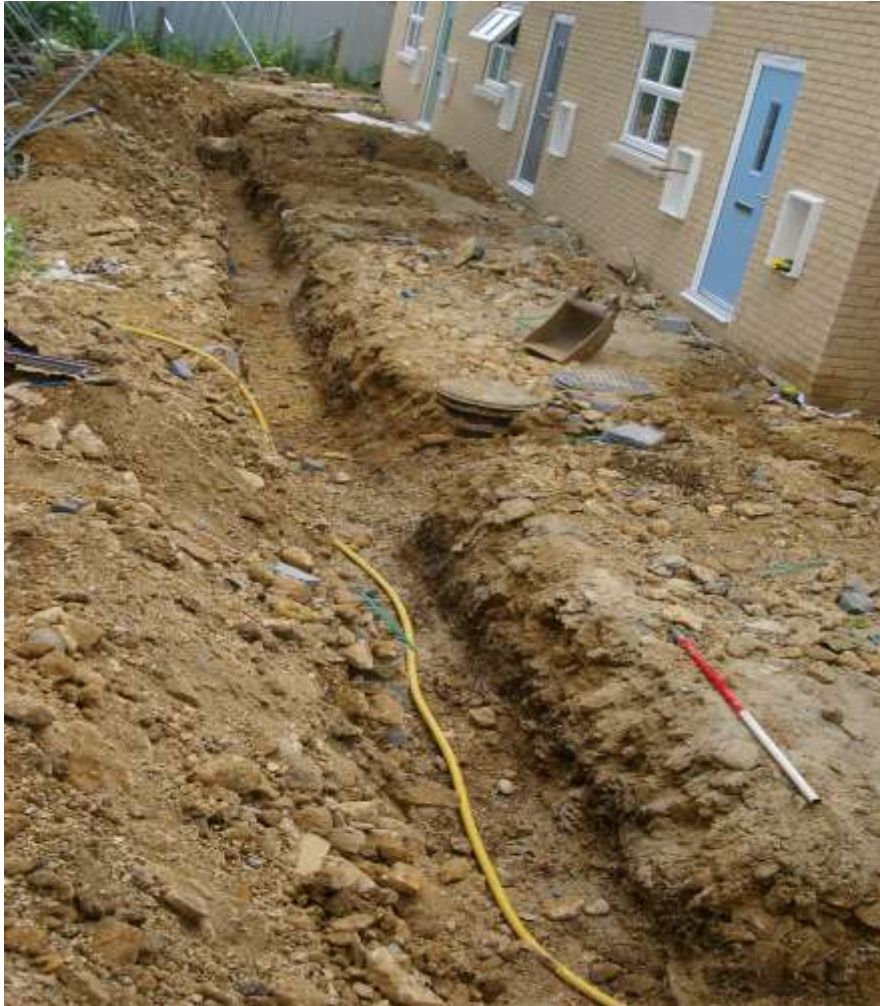
The excavation of a service trench for water pipes was monitored around the existing new build properties. The trench was 0.6m deep and 0.6m wide. Along the northeastern extent of the site the ground was undisturbed and consisted of a 0.2m thick brown silty clay subsoil overlying the natural limestone. Overlying the subsoil was a 0.1m thick layer of grey / brown topsoil, that was overlain by a 0.1m thick layer of modern rubble (see plate 1).

Plate 1. Trench in northeastern extent of site, looking southeast.

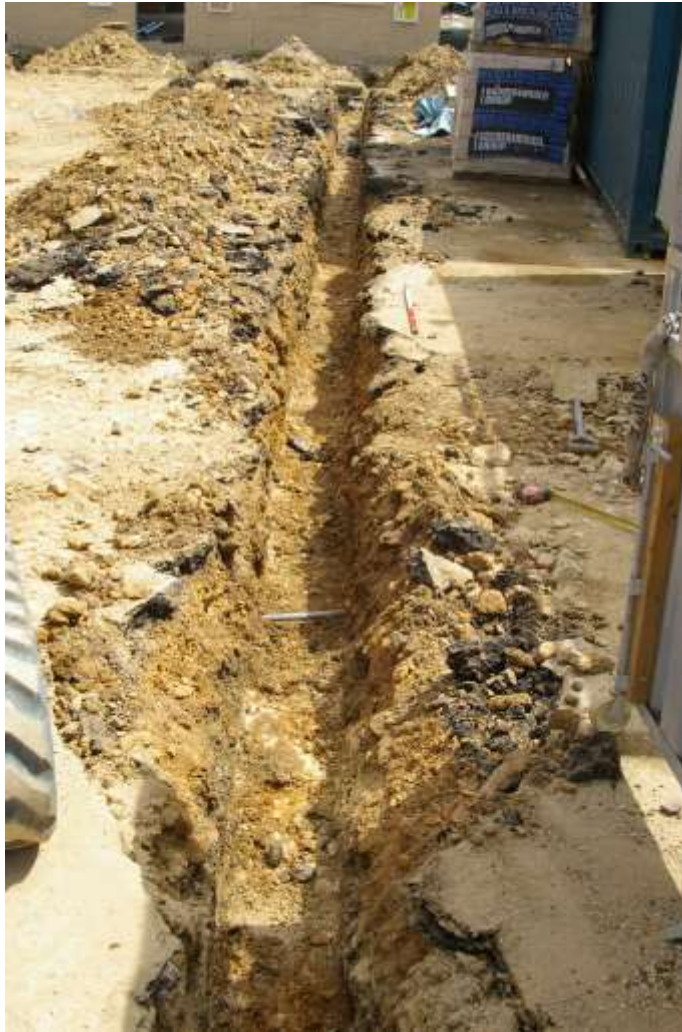
As the service trench headed southwest there was increasing levels of modern disturbance from the demolition of the former public house (see plate 2).

Plate 2. Trench in southwestern extent of site, looking southeast.
