JOHN MOORE HERITAGE SERVICES

ARCHAEOLOGICAL WATCHING BRIEF

LOWFIELDS, MANOR FARM BARNES,

HENTON, CHINNOR, OXFORDSHIRE

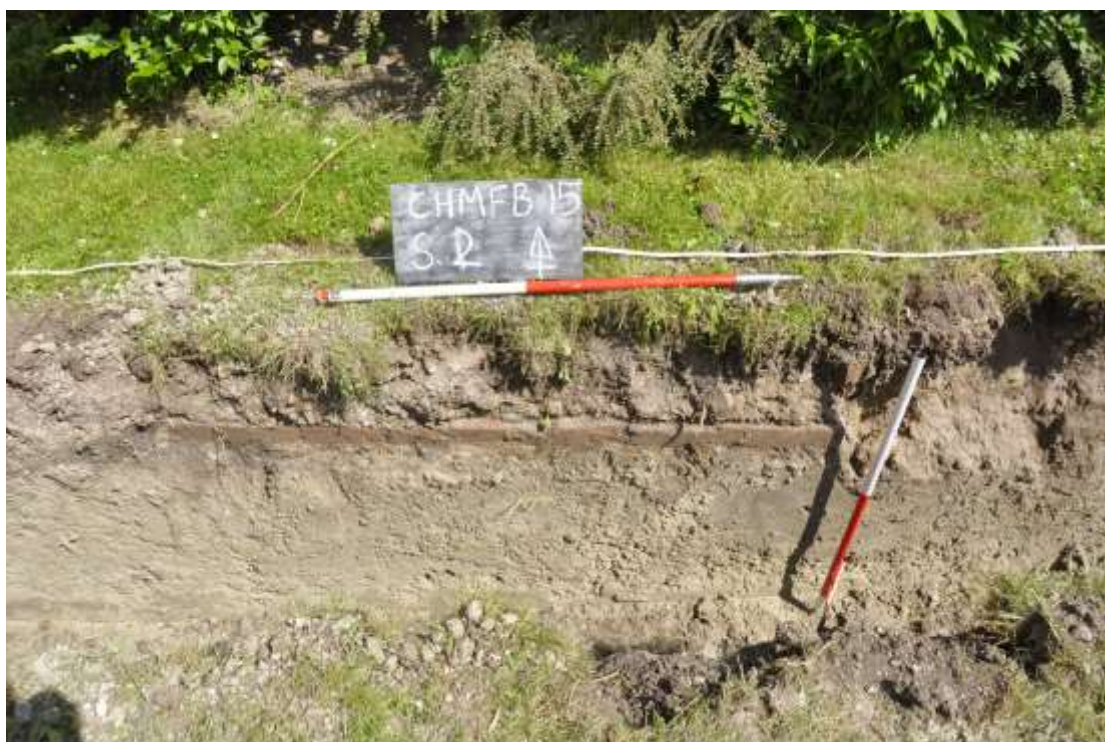
Brick wall, 8, overlay layer (5) / (11) (Fig. 2, S. 02); this was situated running east – west along the northern extent of the trench and formed part of a garden feature constructed along the northern edge of the infilled moat. Wall 8 consisted of a single course of bricks situated 0.35m down from the top of the trench that extends for 2.6m, where it stops and forms an upstanding wall six brick courses high. This garden feature was then overlain by a loose mid-brown loam garden soil (9). Finally a 0.1m thick layer of turf grass and topsoil overlay the deposits.

Plate1. Section 2 showing garden feature wall 8

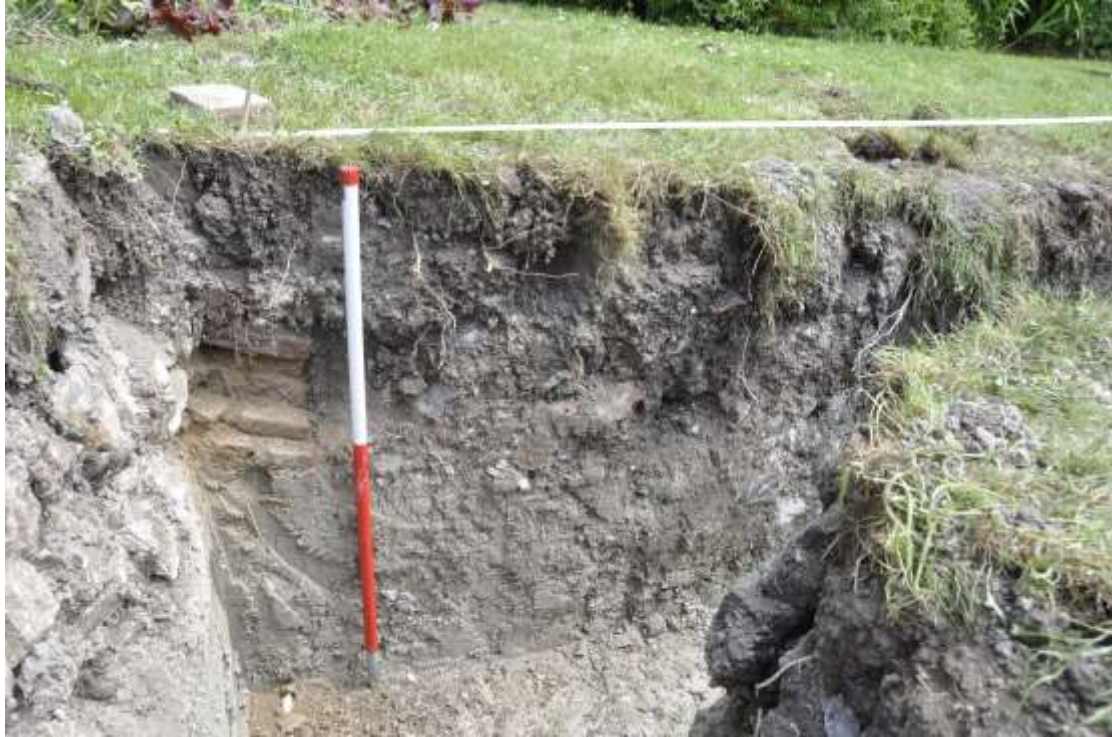
was a 0.5m thick 'landscaping' layer of made ground, a pale grey silty clay (5) and (11), that contained modern debris, including a car wheel, and wall 10, an east – west brick wall (Fig. 2, S.05). The wall was situated in the north-eastern corner of the trench and consisted of a single brick wide, five brick high bonded wall, 0.2m wide and 0.32m thick, forming a possible garden feature.

Plate 2. Section 5 showing edge of moat 12 and wall 10

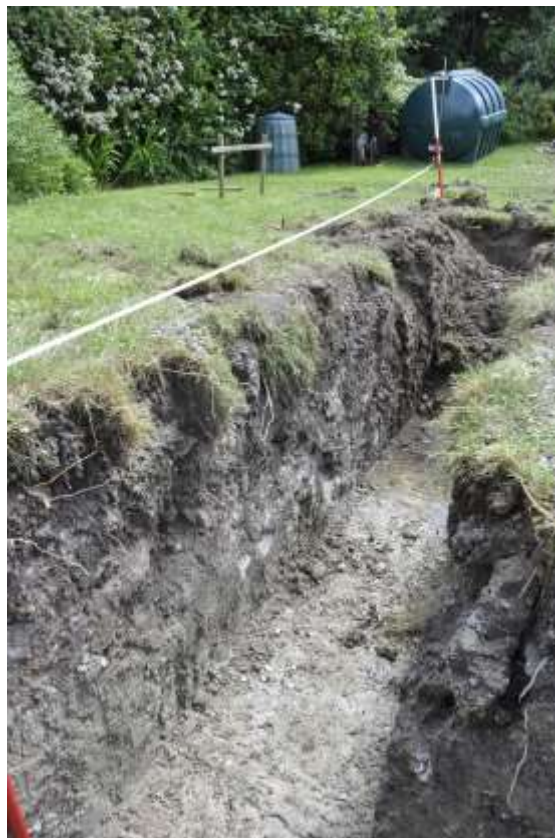
Ditch 12, had a moderately sloping side and was exposed for a width of 4.5m, 8m length and excavated to a depth of up to 1.5m, with the southern side and base of the ditch remaining unexcavated (Fig. 2). It was filled by lower fill (7), a 0.5m thick layer of mid-grey silt with dark organic lenses with no finds, formed in wet / marshy conditions. Overlying (7) was a 0.6m thick layer of deliberate backfill of chalk rubble in a grey silty clay, (6).

Plate 3. Section 5 showing moat 12

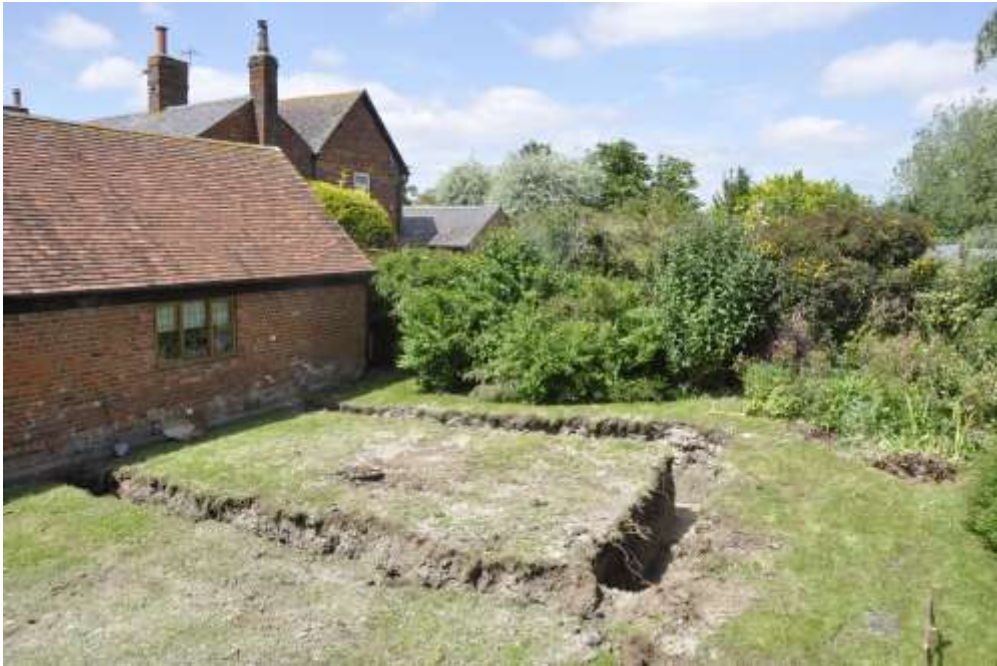
Plate 4. Trench 1

Foundation Trench 1 (Fig. 2, Plates 1 - 5), for a 5.5m wide x 8m long extension was located on the eastern elevation of the existing building and was 0.6m wide and up to 1.5m deep. It contained the northern section of a large east – west ditch cut into the natural clay and was partially backfilled with rubble, with modern garden features overlying it.

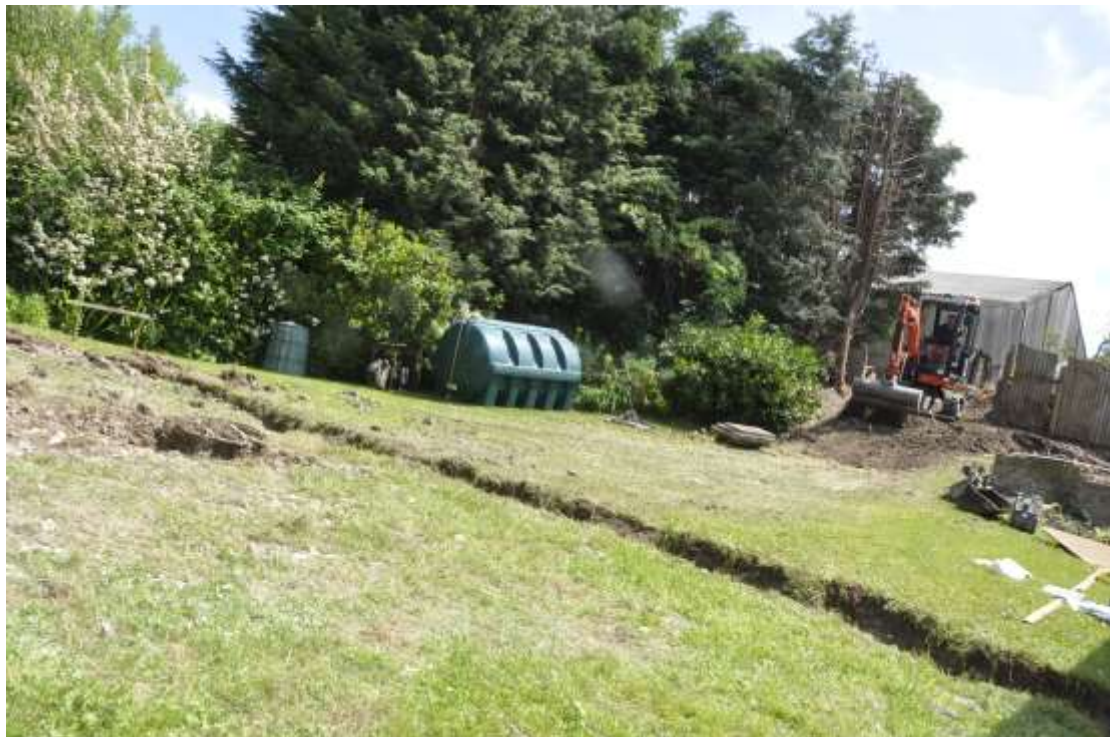
Plate 5. Showing raised ground to the south of the moat

Trench 1 was located within a linear earthwork that consisted of a slight east – west dip, with the ground rising up for *c.* 1m to the south, where trench 2 was located and formed part of an earthwork complex forming a medieval moated site.

Trench 1 revealed the northern edge of an east – west arm of the moat, that divided the area enclosed by the moat into two islands. The southern extent of the moat ran *c.* 1m north of trench 2, where the ground level increased on the earthwork, this would give a total width of the moat at *c.* 14m. Trench 1 did not reveal the base of the ditch as the level of impact stopped at 1.5m below the ground surface. Evidence for the backfilling of the moat, construction of a building and garden landscaping occurred from the Post – Medieval period onwards.

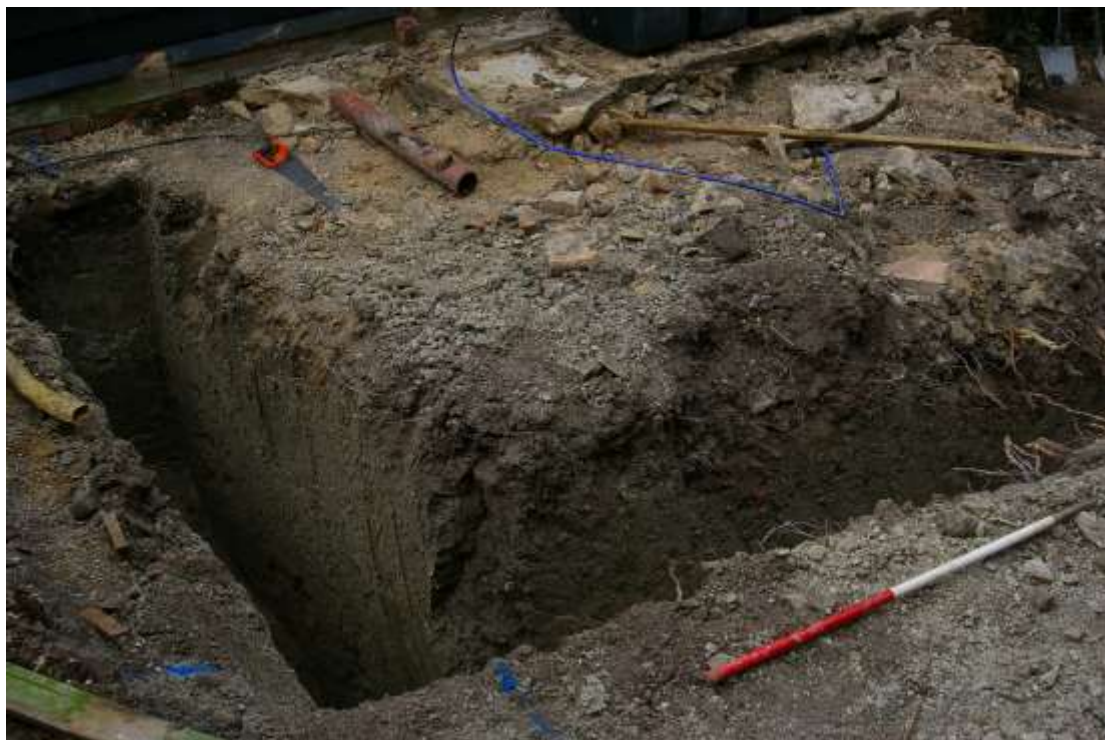
Plate 6. Trench 2

Foundation trench 2 (Fig. 1, Plate 6), for a 3.5m wide x 5.5m long extension was located along the south-eastern elevation of the existing building, it was 0.6m wide, 2m deep along the southern extent, 2.5m deep along the eastern extent and 2m deep along the northern extent.

It contained a 0.1m thick layer of brown silty clay subsoil overlying the natural clays, cut through these were two modern drains. No archaeological features were identified in this trench.
