**AN ARCHAEOLOGICAL DESK-BASED ASSESSMENT
(INCLUDING BUILDING ASSESSMENT)**

SUMMERHILL VILLA, 333 BANBURY ROAD,

OXFORD

OCTOBER 2014

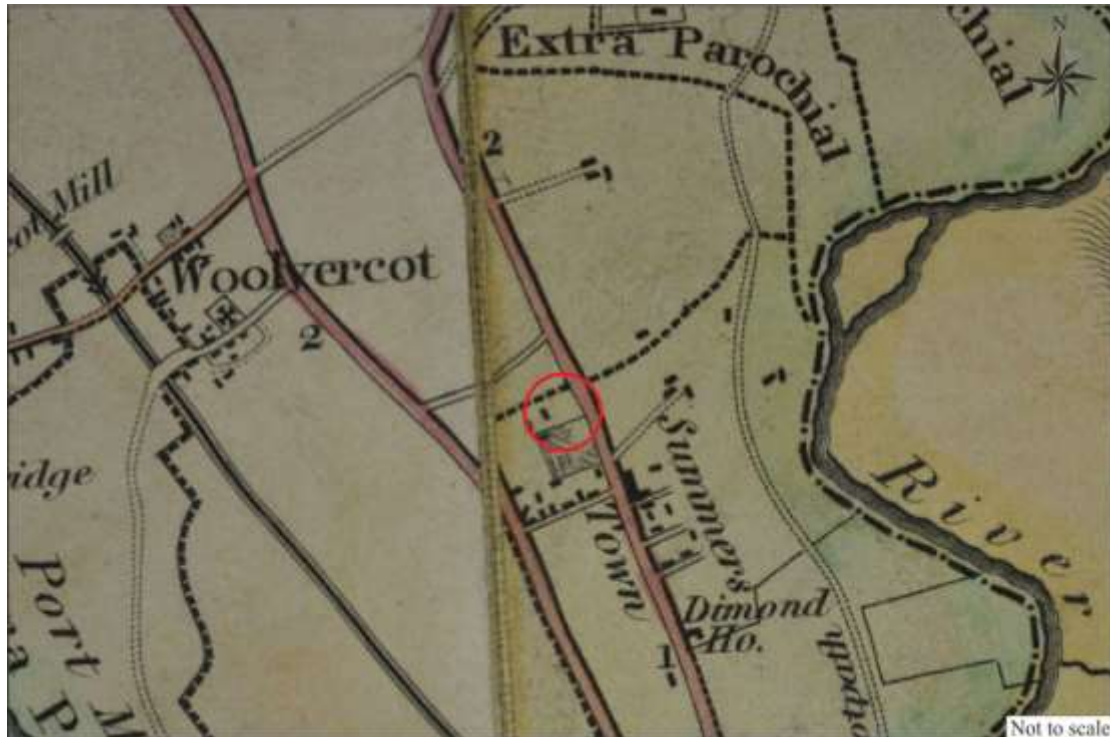
Figure 9 Bryant's Map of 1824

Bryant's Map of 1824 that was plotted in 1823 (P345/M/1), the year Summer Hill Villa was initially constructed, shows buildings in the Summertown area. It is difficult to categorically relate one of the marked structures with 333 Banbury Road. Diamond House at the south end of Summertown is marked.

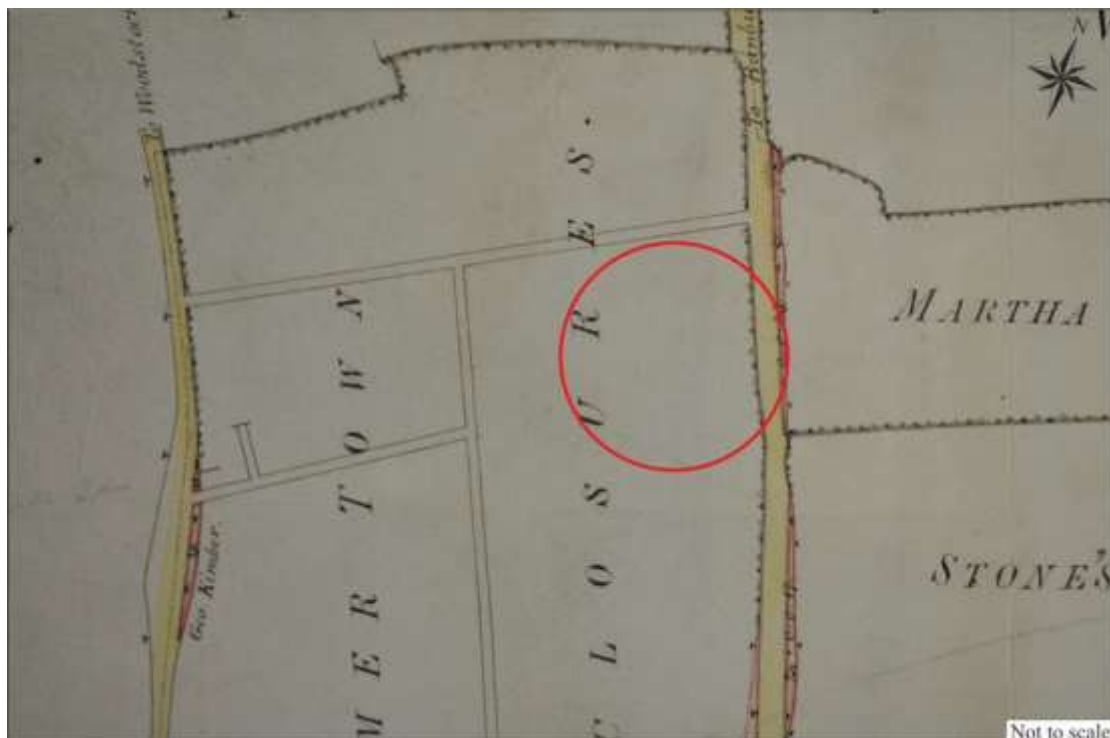
Figure 10 Inclosure Map of Saint Giles' 1832

The Inclosure Map contains three separate plans and is dated c 1832 (QS/D/A/vol E).

The Summertown Enclosures have roads marked on them only on Plan A, though development is known to have started across the area. Plan C shows a building of Crews Dudley by Prospect Road and the possible outline of a building on the east side of the Banbury Road to the south of Prospect Road. Prospect Road had its name changed later to South Parade.

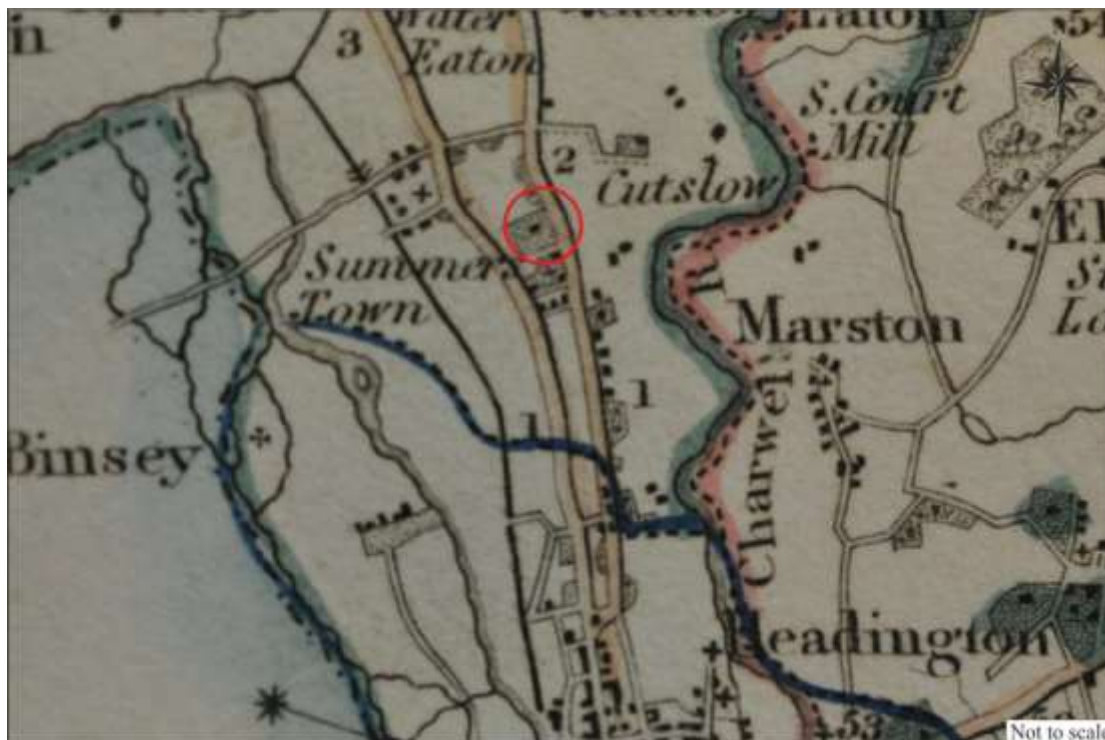
Figure 11 Ordnance Survey Map of 1834

An Ordnance Survey map of 1834 (CH.XLVII/1) shows houses marked in the vicinity of the Summertown Enclosures and it is likely that as the house was built in 1823 that this structure is one of those buildings represented. The Ordnance Survey map of *c.* 1850 (CH.XXIV/4) also shows that development has continued in the Summertown Enclosures west of the Banbury Road (Fig. 11).

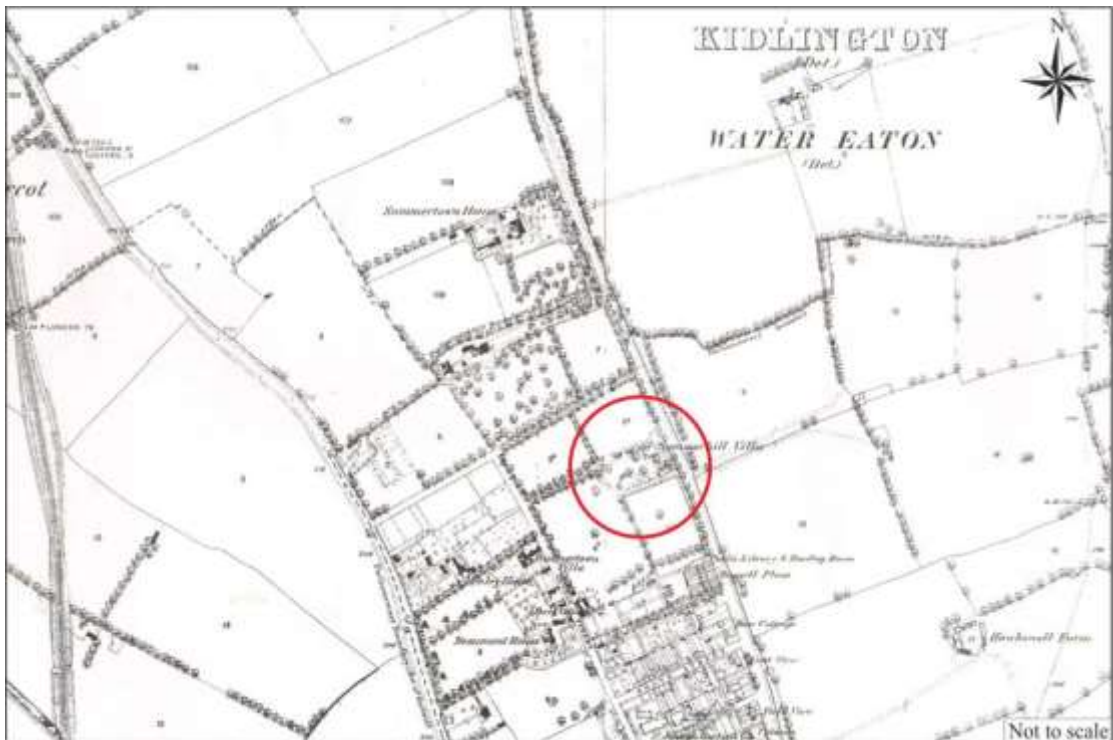
Figure 13 Ordnance Survey Map of 1876

By 1899 (OS map 1:2,500) Summerhill Villa has expanded and Hermes Road opposite has been constructed with associated building plots for detached houses (Fig. 13). By the third series of 1913-1921 the area to the south of Hermes Road has a distinctly urban character, although on the opposite side of Banbury Road development ceases at Albert Road. However by 1937 there is considerable development to the north of the site along both Woodstock Road and Banbury Road as well as to the north of Hermes Road. The outbuilding or rear extension behind 333 Banbury Road seen on earlier maps is not present on the 1937 1:2,500 OS map or that of 1957.

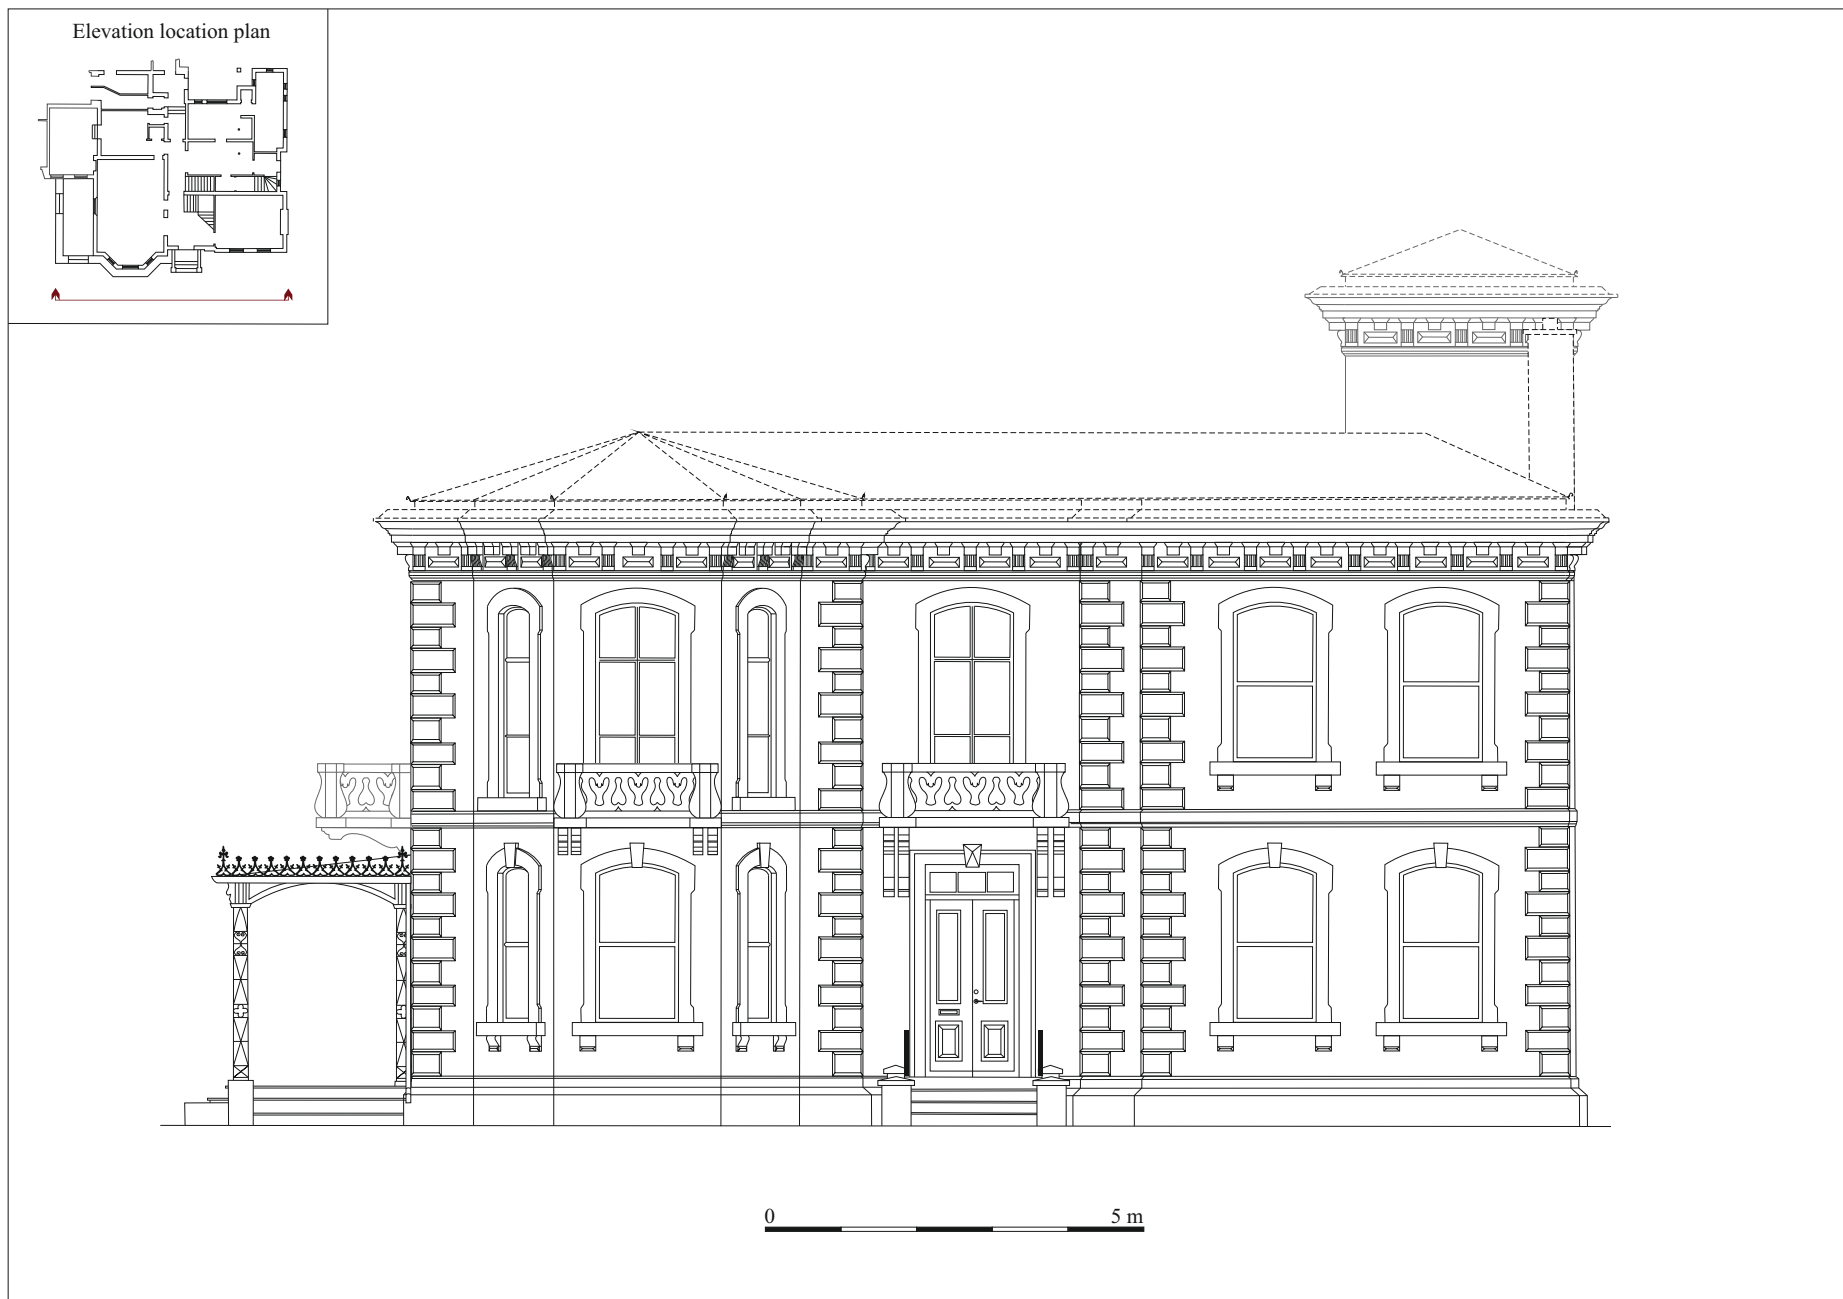
Figure 17. South elevation

The south façade consists of three vertical components in two storeys (Fig. 17, Plate 1). These are broken at the base by a plinth, and centrally by a raised band and above by an elaborate cornice in a Greek or Roman Doric tradition. Slightly off centre and to the west are steps leading up to a large door with panel and glass design, painted black. The arch is square headed with a keystone and moulded surround. Above the door is an ornate balcony with S shaped scroll designs and console supports (the balconies are so designed on the west façade). On the first floor entering the balcony is a segmental arched door with patio window of six large glass panels. The door, porch/balcony, is set back between two protruding but slight wings (if they can be so called).

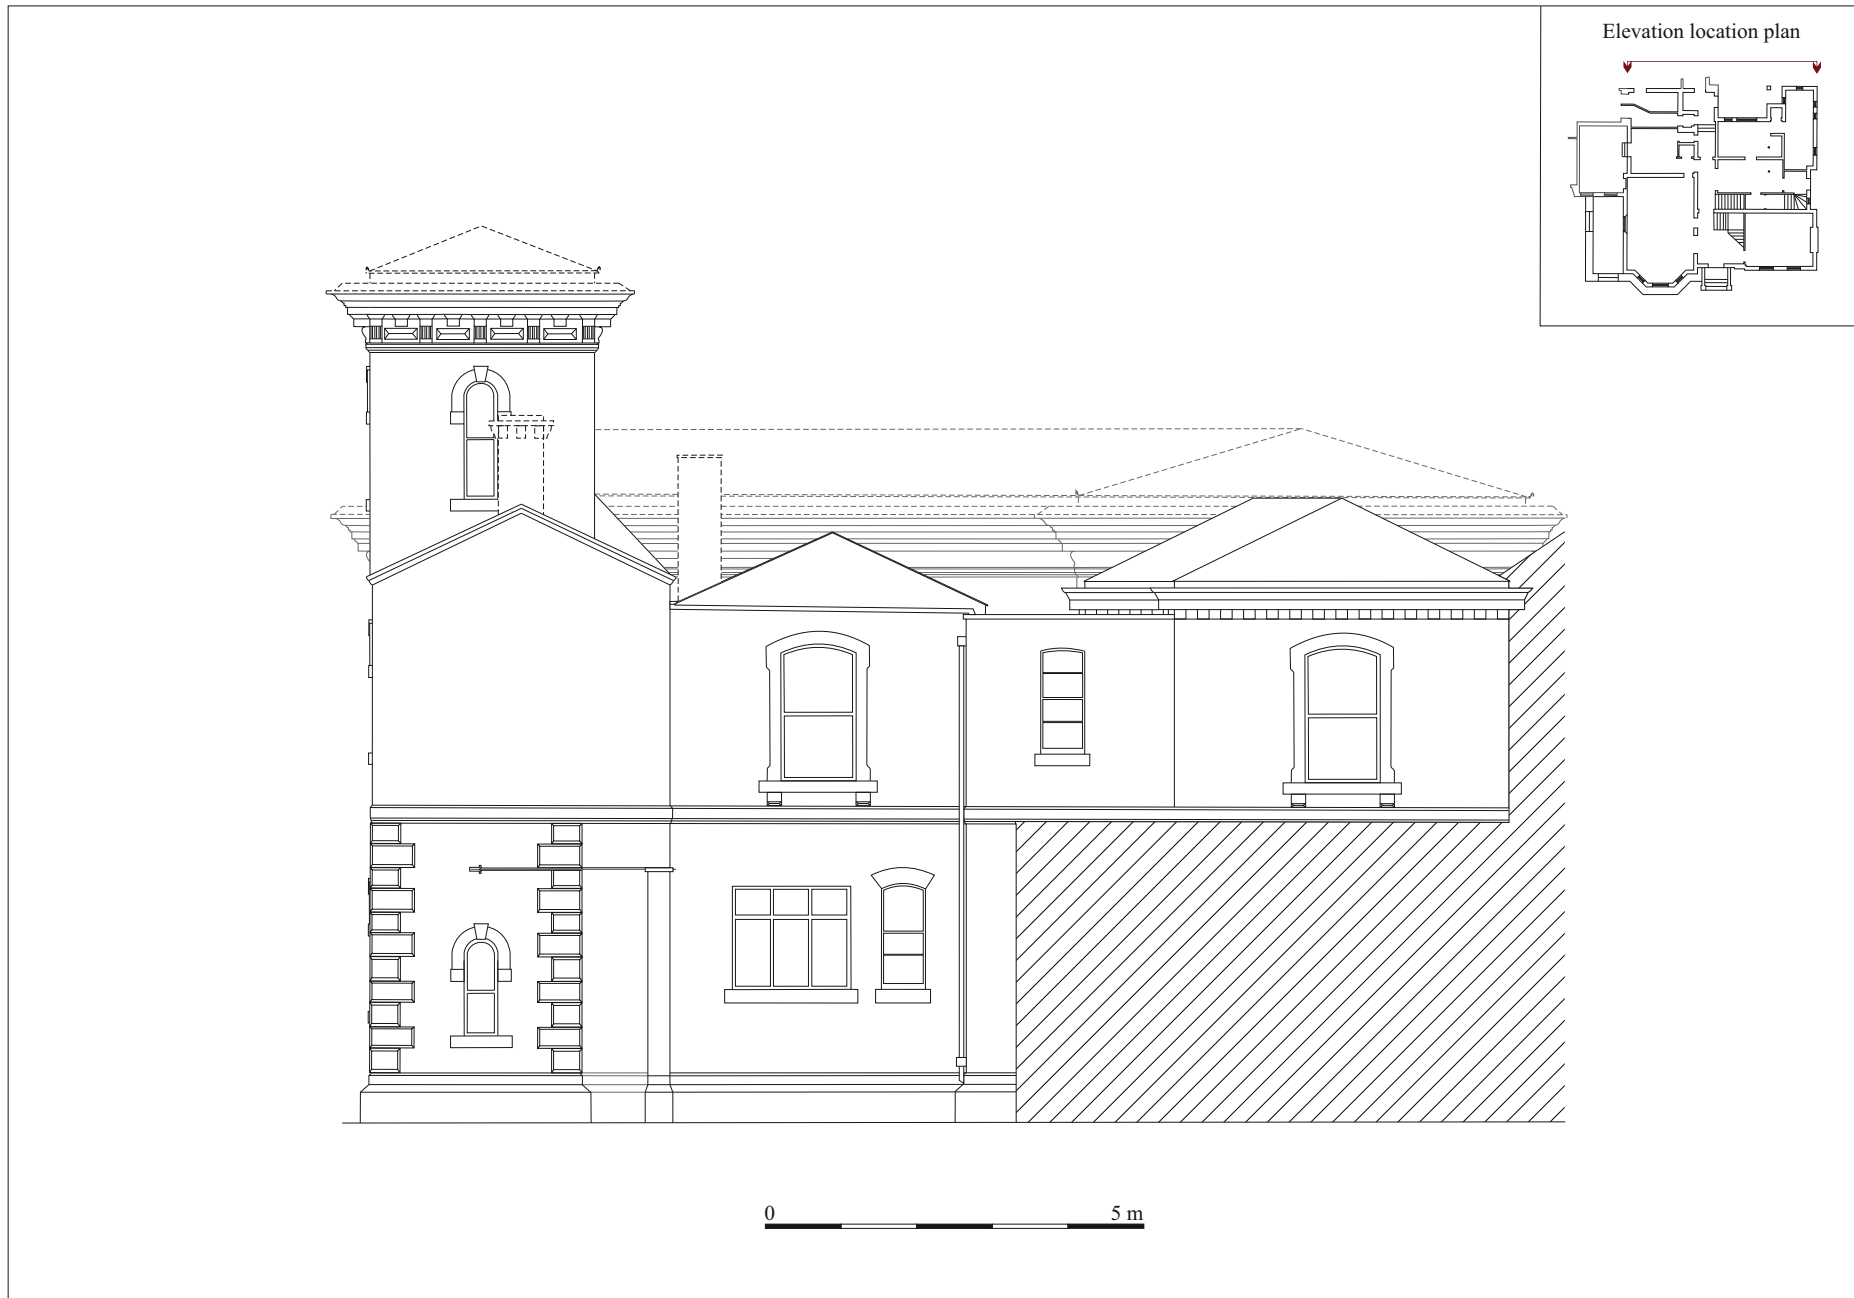
Figure 19. North elevation

The North façade is obscured on the east side by the new build; only the upper storey is visible (Fig. 19). The façade has two wings around a central recess. The western wing consists of two parts, the west part in limestone and the east part in render. The limestone west wall has the remains of an elaborate cornice that continues from the west wall. In the centre of this original limestone wall first floor there is a segmental-arched window with moulding (Plate 4). Alongside this is the east part of the west extension which is a later addition and rendered (Plate 4). Here there is a small segmental-headed window with no moulding and the cornice here is a plain lip (Plate 4).

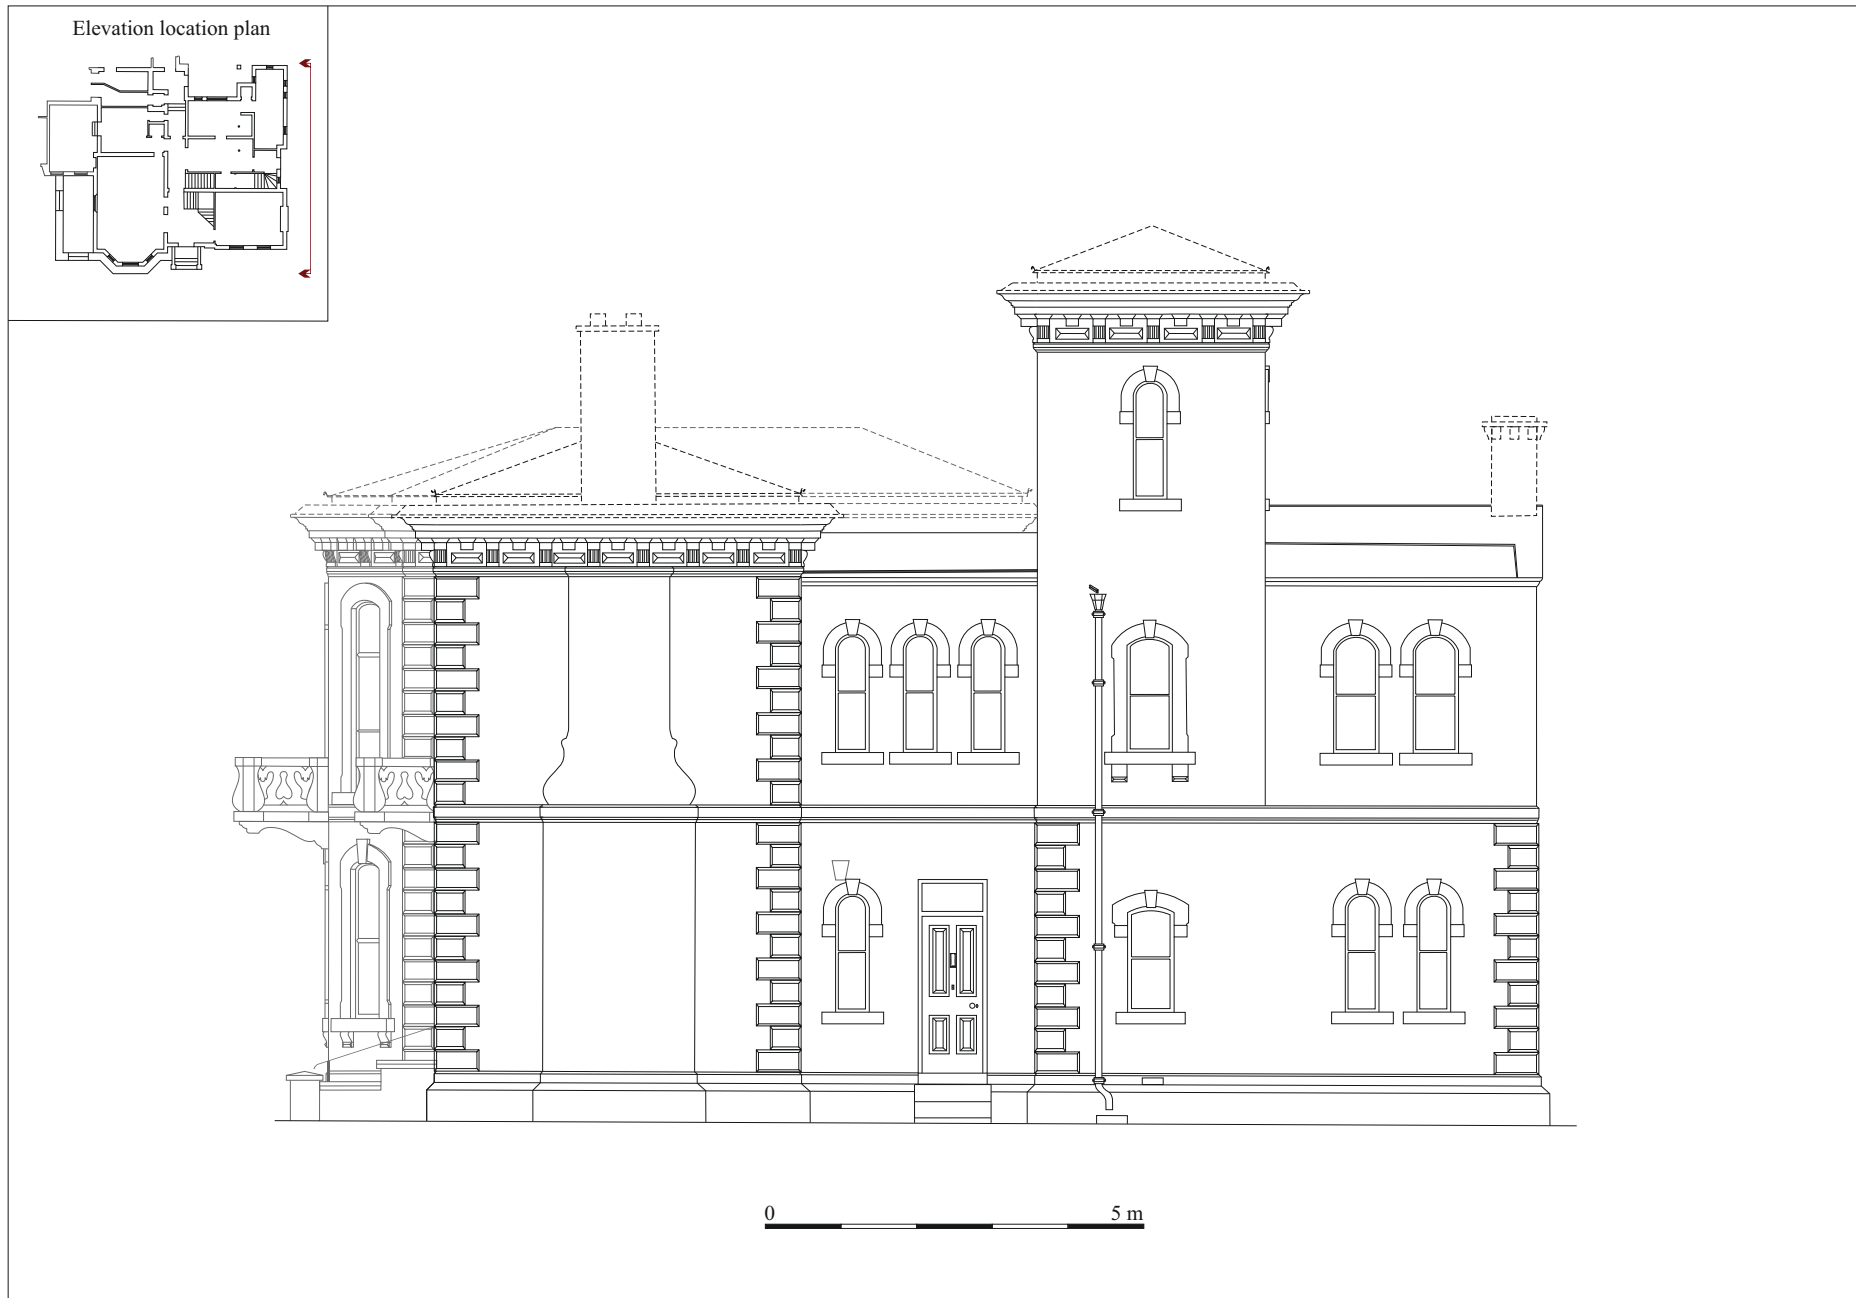
Figure 20. East elevation

The east façade contains four vertical components, with some common horizontal components including a ground floor plinth and central band between the ground and first floor (Fig. 20, Plates 8 & 9). On the south side there is a hipped gable end, extending, with limestone quoins, a central chimneybreast, an elaborate cornice to match the south façade and west facades. The cornice continues slightly around the north corner, but only for visual effect, and then ceases. This would mean that the second storey adjacent must have existed when the cornice was made (either for the original building or less likely even the reworking in the 1840s). There is a brick chimney above the roof line of a later date and added after 1954 as the plans have an elaborate chimney taller and with tabatures at the top and base.

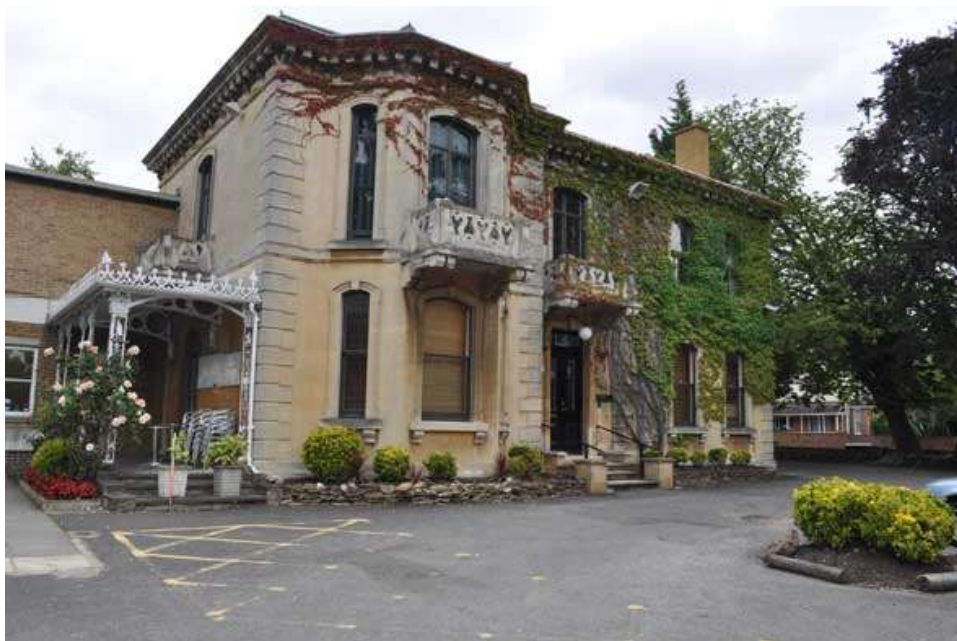
Plate 1: South façade

The main façade of the villa is architecturally pleasing and proportionate, plans and sections of 1954 indicate that this remains unchanged from before that date (apart from chimneys, see below).

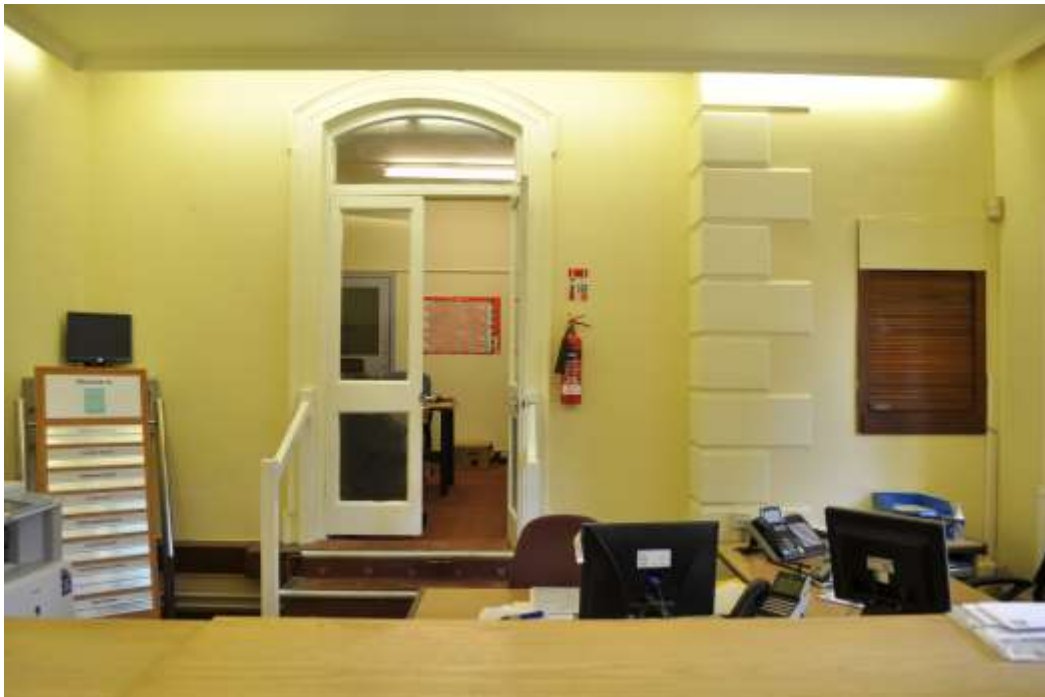
Plate 3: Internal part of original west facade

Part of the detail of the west elevation can be discerned above the outline of the modern additions and also internally in part of the extension (Plate 3). Above the new roof line it is possible to discern the Doric style cornice continuing. Internally it is possible to see the remains of quoin work as the west wall steps inward as it extends to the rear. There is a similar doorway to that already seen on the ground floor west wall under the surviving veranda, with a segmental headed-arch and moulded surround. Internally the remains of a matching window can still be seen in part, although it may have been blocked. The original exterior wall must have continued to where the wall between the gentleman's cloakroom and gentleman's toilets is, though

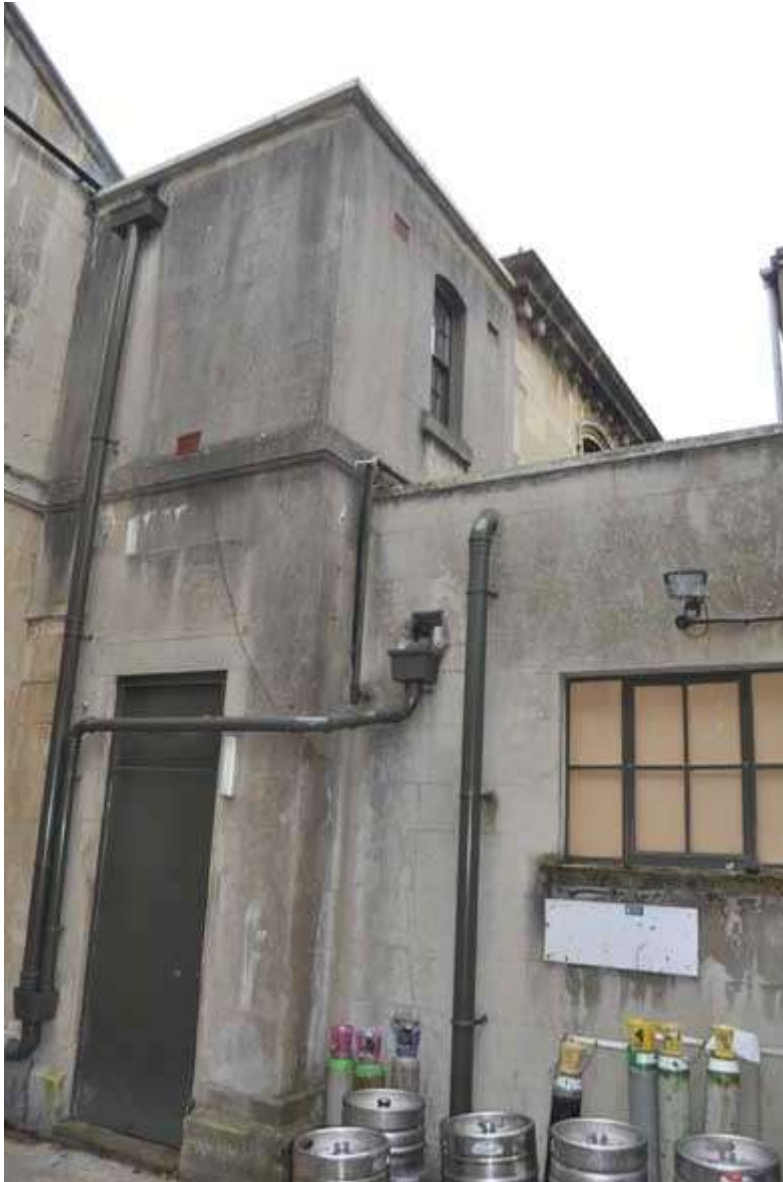
Plate 4: New construction on the north façade

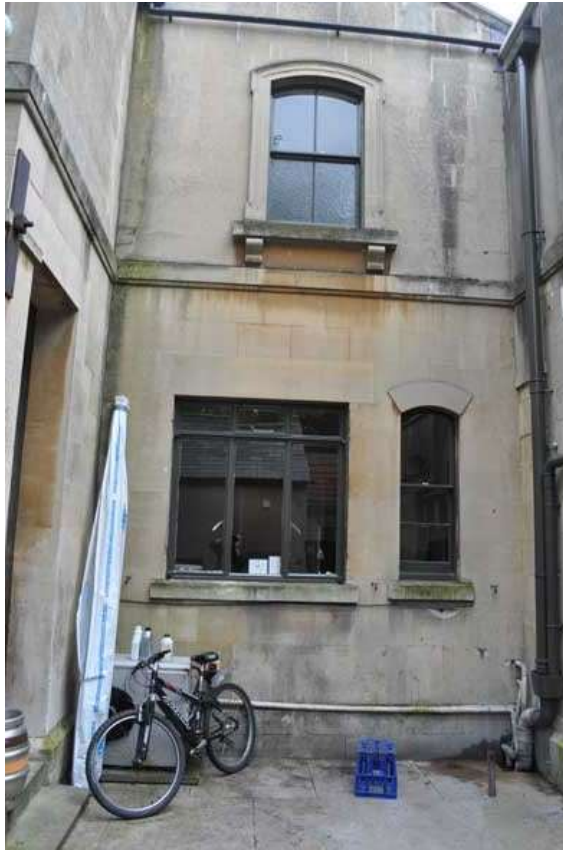
Plate 5: Central recess of north façade

There is a central recess between the northwest and northeast wings (Plate 5). On the short east wall of the northwest wing, there is a mixture of limestone walling and rendered exterior. The limestone walling contains a fragment of banding or corbelling (Plate 7) that would indicate that much of the limestone walling in this area has either been refaced or is a later addition. There is a doorway on the ground floor, which has been inserted into a filled-in larger opening. There is a plinth or stylobate exposed that would have been part of a free standing column that has subsequently been incorporated into the wall generally. The main north facing wall of the recess has a ground floor and first floor set under a gable end with a raised moulded outline. There is a plinth and a raised central band (Plate 5). On the ground floor on the east side there is a segmental-headed arch with sill and sash, alongside this there is a wide square-headed window with a 1950s or 1960s metal framed casement. On the first floor there is a segmental-headed window with moulding and sill. The west facing wall of the northeast wing has evidence of a plinth and central band and a corbel band under the eaves. There is an opening on the ground floor and a column with quoins. In the recess opening there are the remains of a round headed sash window. The window is small and low, probably original, but has no decorative detail.

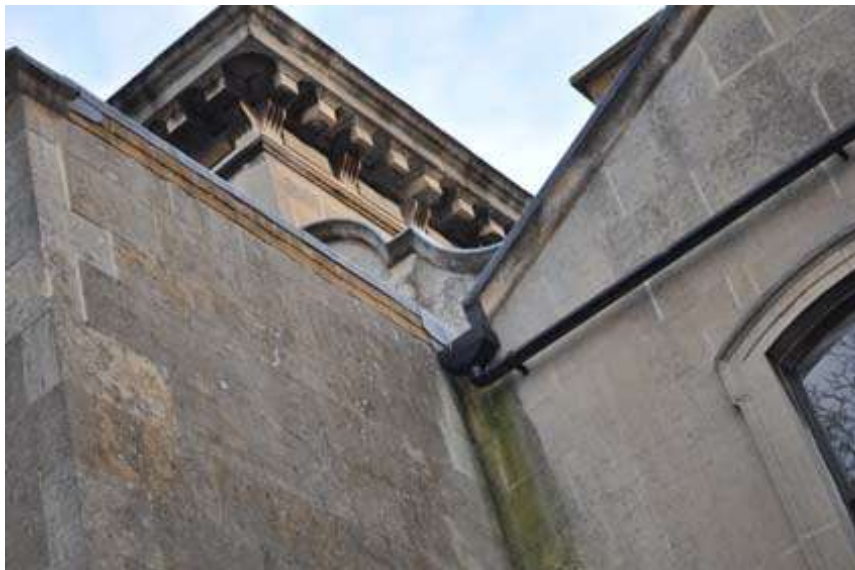
Plate 6: Partial gable end associated with stair access to second floor of tower

The north side of the tower has a single arched window and corbelling. There is a partial gable to incorporate the stairwell to the tower (Plate 6).

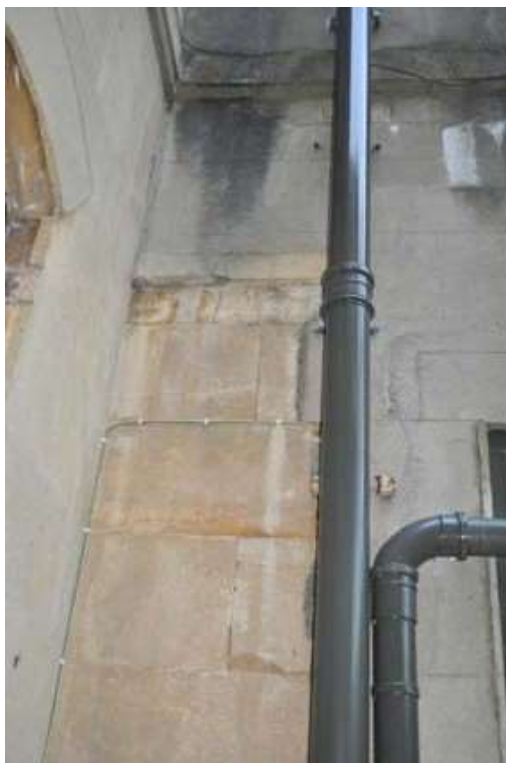
Plate 7: Remains of earlier corbelling

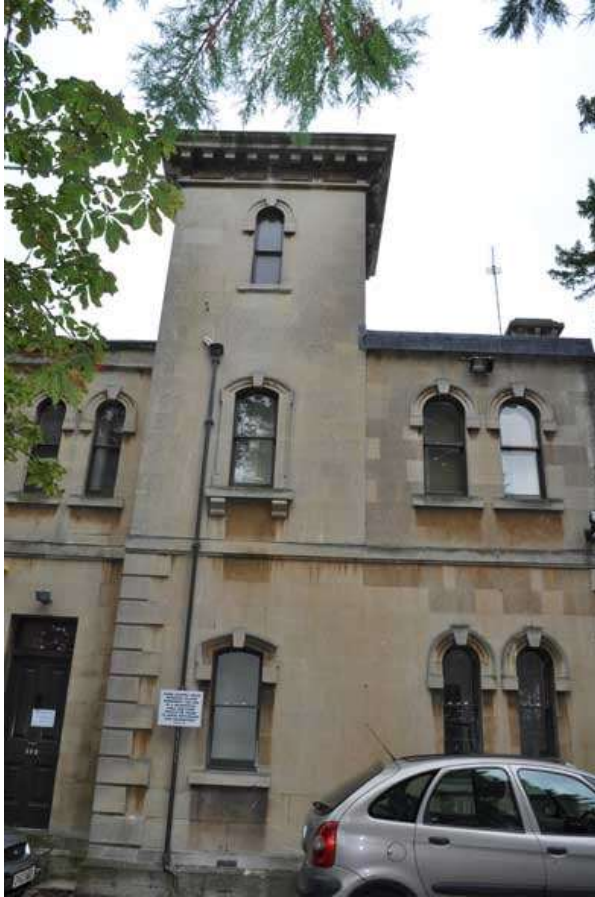
Plate 8: Tower, east façade

The next component is the tower, which extends out as far as the fourth component (plate 8), but is divided by a distinct butt joint in the limestone façade that extends over both storeys (first and ground). On the ground floor on the south side of the tower and on the north side of the fourth component there are quoins extending up to

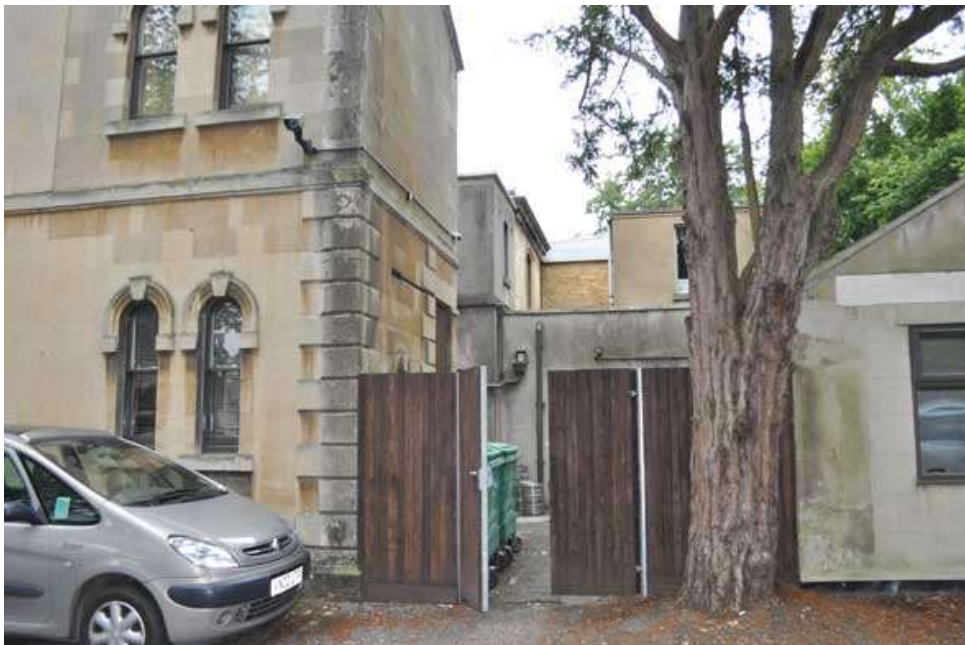
Plate 9: Northeast corner of building

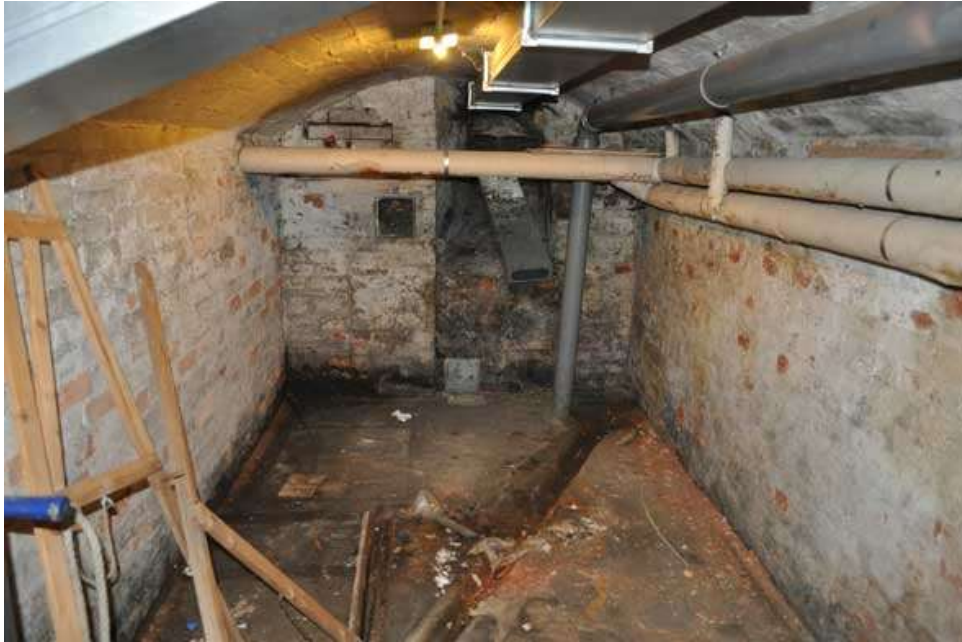
Plate 10: Cellar

The stairs to the cellar are now of concrete, this leads down to an open area composed of five brick vaults that extend under the southeast room and hall of the ground floor, and the stair passage that extends to the north of the southeast room. Three vaults are located on the east side (Plate 10) and two on the west. The northeast vault is narrow, keeping to the size of the passage above. The southeast vault and central vault on the east side contain the brick support for the chimneybreast in the southeast room, while flanking either side of the chimneybreast are two coal shoots. The coal shoots are indicated as being additions of 1954 on plans of that year. There are two vaults

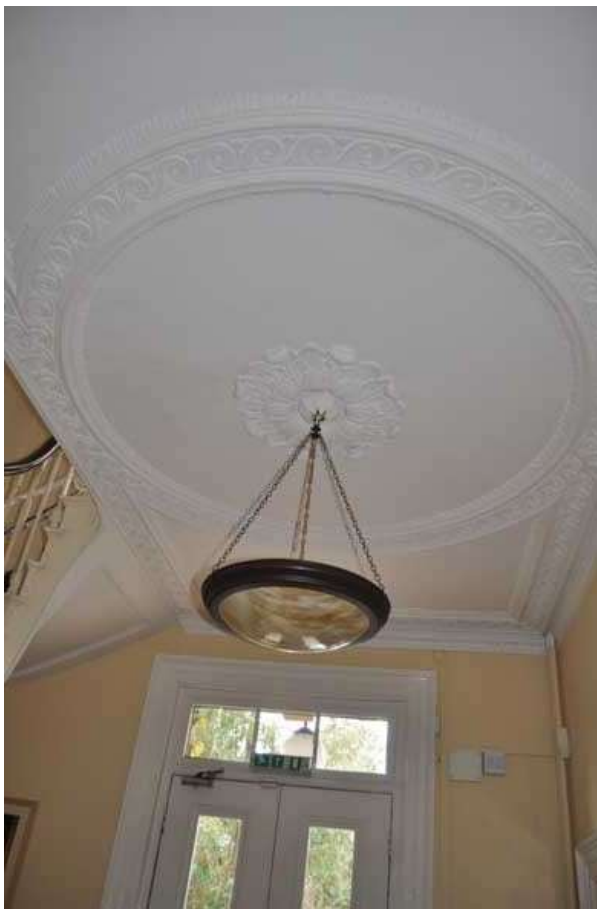
Plate 11: Hall ceiling

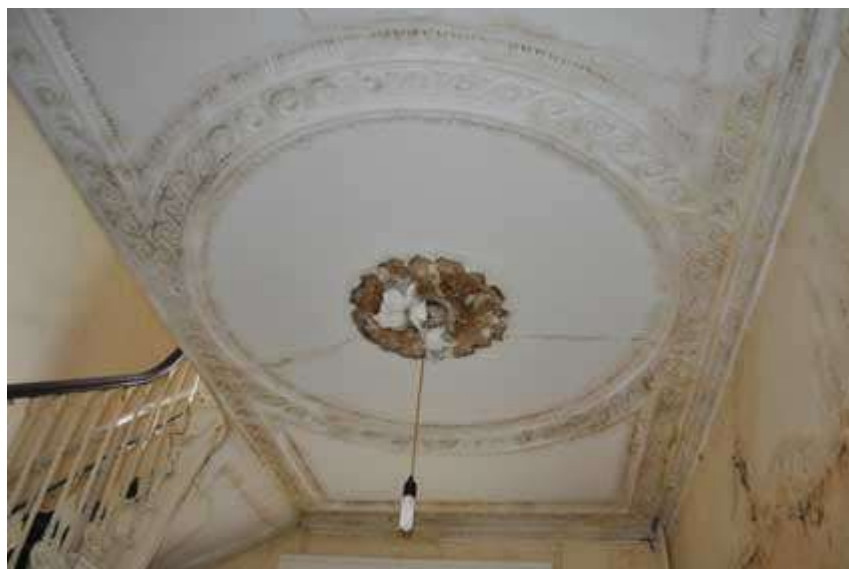
Plate 11a Damaged hall ceiling

Since the original report was written in 2012 the building has been affected by damp in the hall. Water leaking from the roof has caused the plaster to deteriorate and the elaborate roundel to partially collapse (plate 11a).

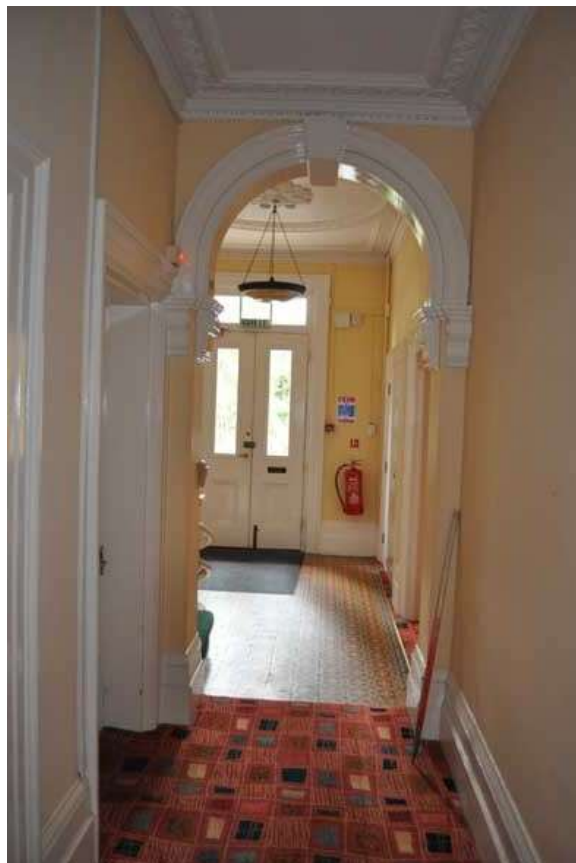
Plate 13: Decorative details, back hall

The main entrance to the ground floor would have been through the hall (G1). This on the surface is a rather elaborate showy affair, but which has seen some alterations in the past. The main front door still retains moulded features (Plate 13). There is a large wrought iron staircase on the right hand side as one enters the hall through the front door (this uses standard iron fixtures and Baltic wood). The underside of the stairs contains moulded plaster. This sweeps round to a main ceiling, which is decoratively moulded, with a border butting to the wall and a large oval panel around a suspended light fitting (Plate 11). The decoration contains scroll motifs. Straight ahead there is a round headed opening with mouldings of grandeur emulating a keystone and jambs (Plates 12-13). In the east wall below the staircase is a door with original moulded surround, but new fire-door. On the west wall there are two large openings, both of which are either new or widened, but have in effect been carried out in a sympathetic Regency manner. There is an ornate tiled floor, the skirting is probably original. The use of floor tiles in the Victorian hall is standard in the mid to latter part of the 19th century (Ferry 2010, 20).

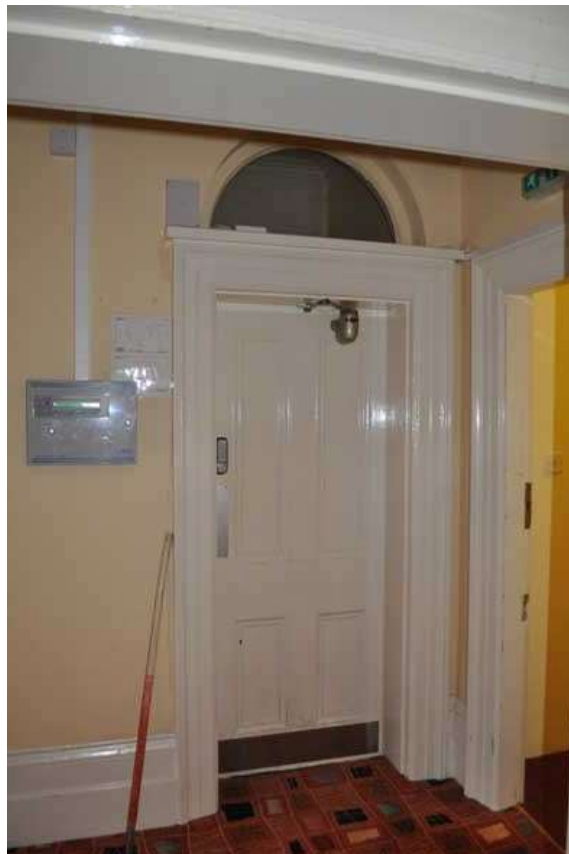
Plate 14: Round-headed arch and door

The archway on the north-side of the hall leads to a passageway or rear hall (G4), with a ceiling containing moulded borders. There is a door on the east side immediately with an original moulded surround, now a panelled fire-door (leading to cellar). The wall has been opened up to the north of this. In the west wall there is a panelled door with a moulded surround set in a round-headed arch. In the north wall there is also a panelled door with a moulded surround (Plate 14).

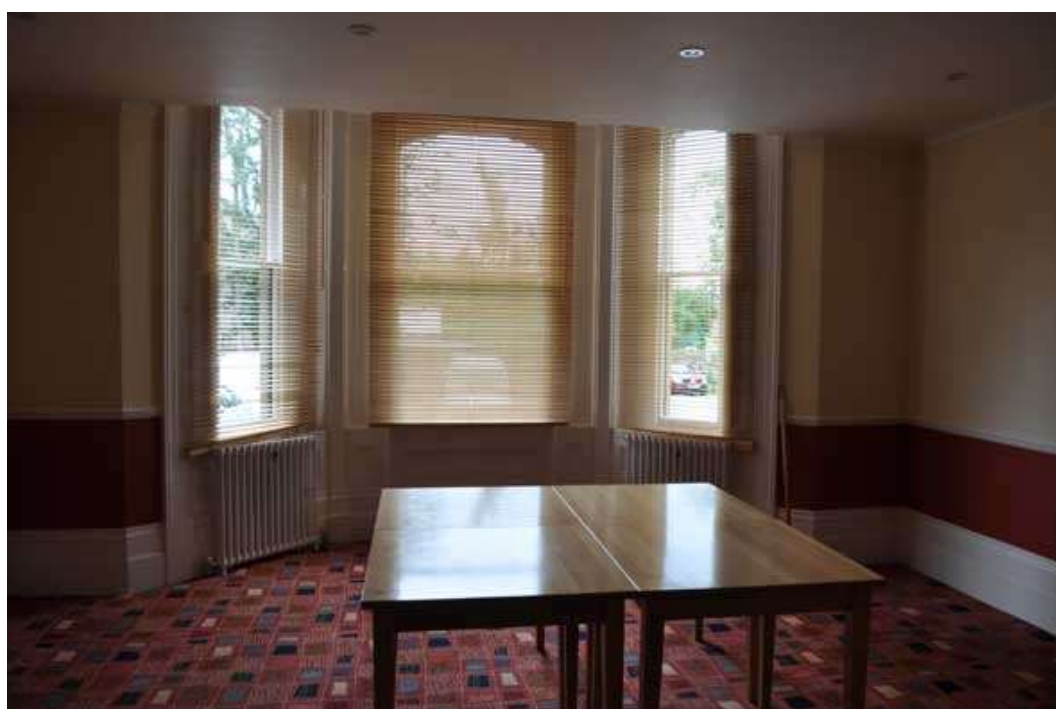
Plate 15: Bay window

surrounds. There is a door in the west wall which also has a moulded surround. A further moulded door of the period is found in the right-hand corner of the north wall. The ceiling here has been lowered, this is apparent as the moulding in the tall bay windows and west door continue up above the ceiling (Plate 15).

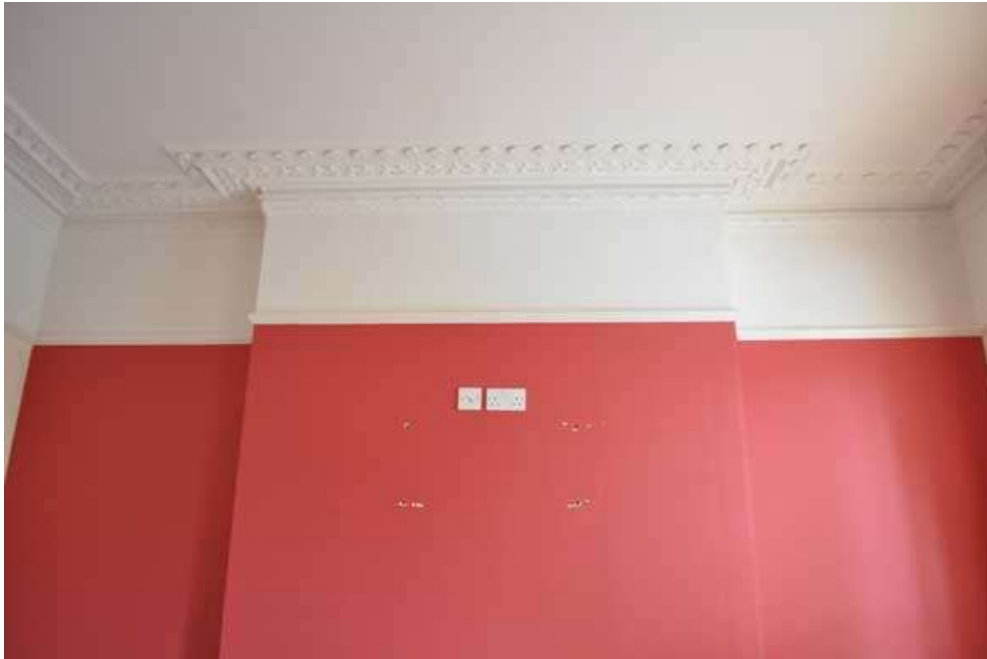
Plate 16: Chimney breast, plaster moulding, dining room

The southeast room (G2) is a large rectangular room with moulded ceiling, and a dado rail (Plate 16). The fireplace has been removed, but not the chimneybreast. There are two sash-windows on the south side with panelled and moulded surrounds, original (Plate 17). The skirting is probably original although sympathetically treated where the fire has been removed. There was probably a door in the north wall that has probably been blocked up that would enter a small passage into what is labelled the Kitchen on the plans of 1954. It is plausible that this room is, therefore, the Dining Room.
