**AN ARCHAEOLOGICAL DESK-BASED ASSESSMENT
(INCLUDING BUILDING ASSESSMENT)**

SUMMERHILL VILLA, 333 BANBURY ROAD,

OXFORD

OCTOBER 2014

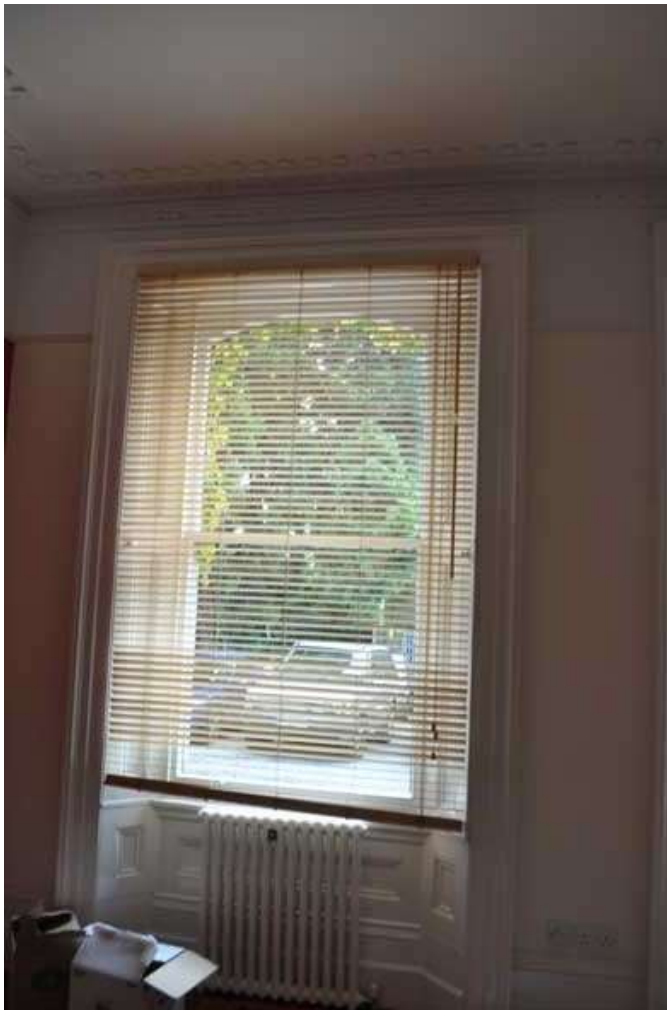
Plate 17: Sash windows, dining room

The southeast room (G2) is a large rectangular room with moulded ceiling, and a dado rail (Plate 16). The fireplace has been removed, but not the chimneybreast. There are two sash-windows on the south side with panelled and moulded surrounds, original (Plate 17). The skirting is probably original although sympathetically treated where the fire has been removed. There was probably a door in the north wall that has probably been blocked up that would enter a small passage into what is labelled the Kitchen on the plans of 1954. It is plausible that this room is, therefore, the Dining Room.

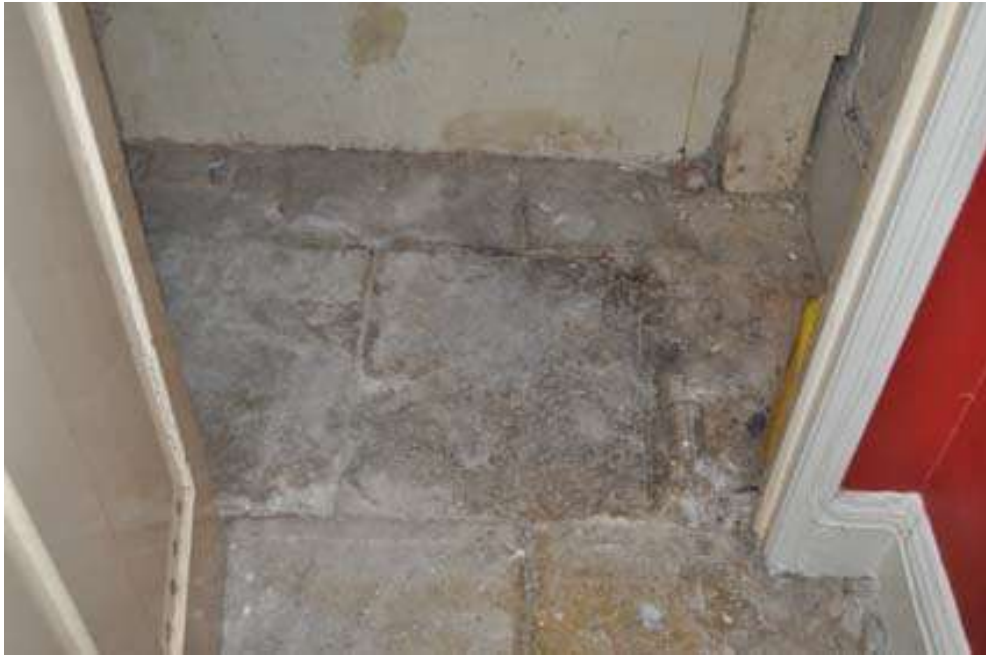
Plate 18: Flagstone flooring, scullery

In the area to the east of the removed original wall the carpets were lifted to uncover the remains of large limestone flagstones (Plate 18). It should be noted that in later Victorian traditions that flagstones or quarry tiles were employed in the scullery (Ferry 2010, 53), where all the wet duties (later associated with the kitchen) would be carried out. Water was often just piped into this area and there was also a central or corner drain. The door in the east wall of the south part of the old kitchen leads to a hall (G9) at the base of the back stairs (see below). The stairs is a dog-leg arrangement but with no old features. The east wall of the hall contains a panelled door and also a rounded headed sash window. The north wall is blank, but the 1954 plan indicates that there is a blocked double door in that wall. The floor here is also flagstones and is indicative of the present backstairs being located in the original scullery, which has been reduced in size.

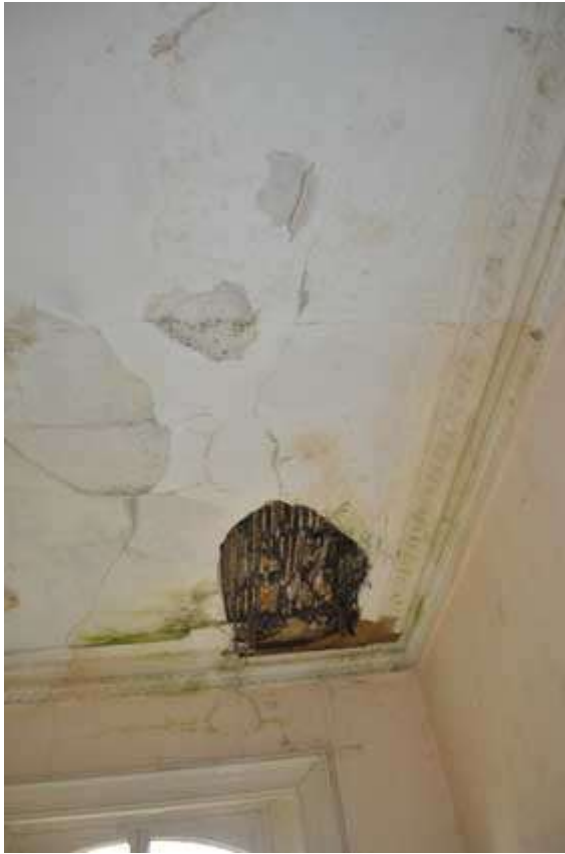
Plate 21a Landing showing damaged plaster

Since 2012 water has been leaking through the roof over the hall and landing. This has caused damage to the ceiling in the landing area (plate 21a).

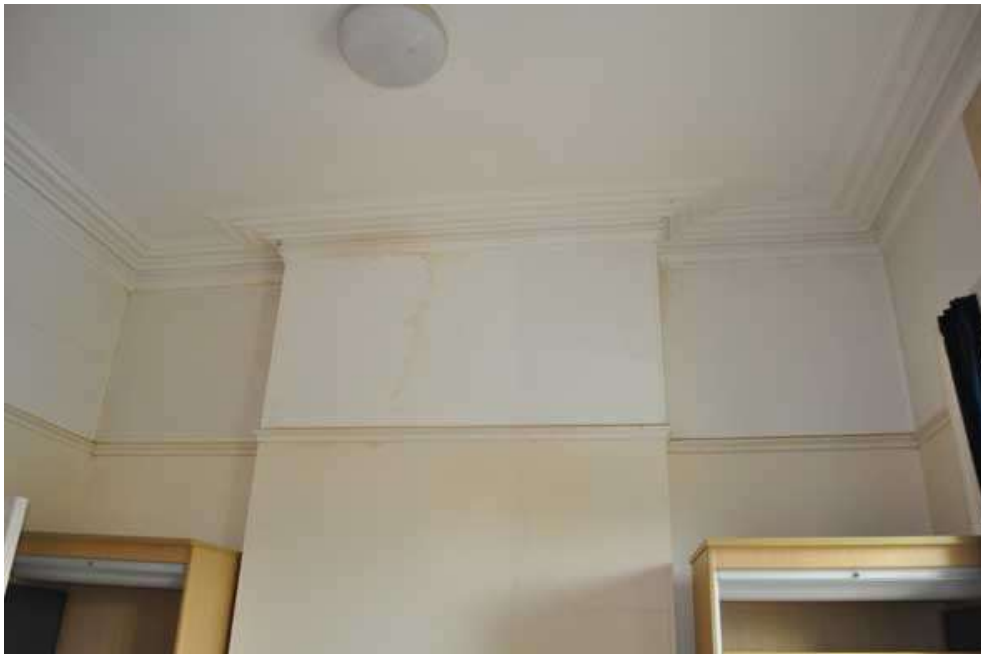
Plate 24: Chimneybreast and moulding, bedroom

The room (F3) entered on the south side of the east arm of the L-shaped passage is perhaps the chief bedroom (although not the largest room on this floor). The door is panelled and has a moulded surround, it is probably original. The ceiling contains a moulded border (Plate 24). On the south wall there are two segmental-headed arches with moulded surrounds, and a mirror fitting between, with apparent moulded surround. The fireplace in the east wall has been removed or blocked, but the dado rail survives. There is a further panelled door in the north wall leading into a small room (F4) above what is now the back stairwell. In the adjoining room it is apparent that the moulded border that does not surround all of the walls once incorporated the adjacent room to the north. There are two round-headed sash windows in the east wall (Plate 25). The room is now used as a toilet and wash room. In the original house an *en suite* is not likely although it could have been a dressing room.

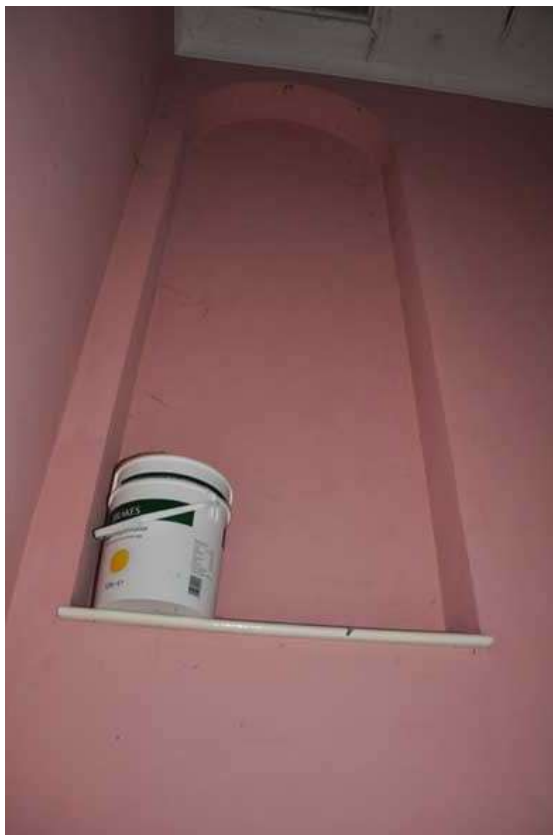
Plate 26: Round headed recess over present back stairs

The double door seems to have possibly been designed to separate servants' quarters (F6) from the main part of the house; however, this would seem to be problematic. The door opens up into a long passage (F6) running north from the head of the backstairs. Above the backstairs in the west wall is a round-headed recess (Plate 26). Midway along the passage is a round-headed arch. At the north end of the passage, the ceiling is raised to provide access to the tower, through a panelled door. There are two doors in the east wall on the first floor; these enter a toilet room, which have a continuation of the heavily moulded ceiling, and round headed window seen in the

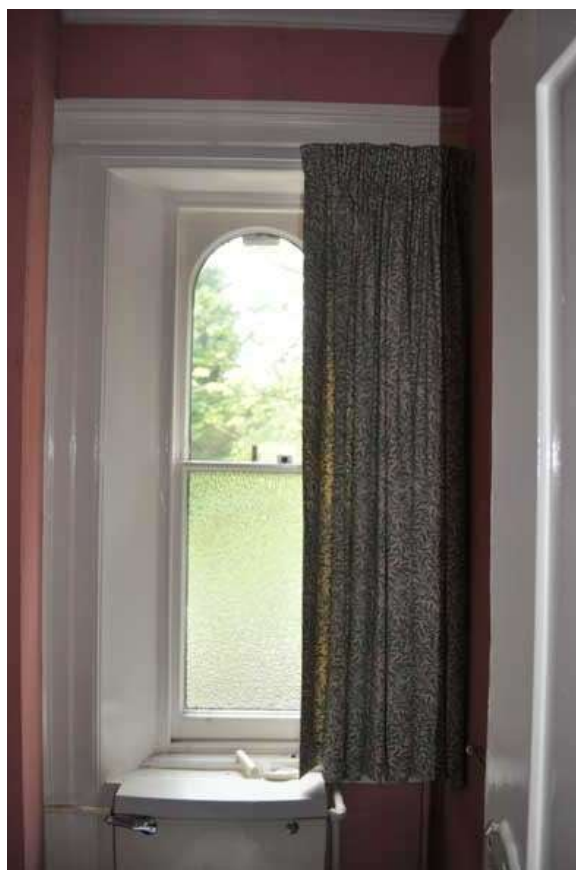
Plate 27: Window once in dressing room

dressing room, later wash room adjacent (Plate 27). The northern door enters a small passageway, with angled wall at end. The plan of 1954 indicates that the wall in line with west side of the tower is a modern wall inserted, which is a plasterboard wall. The door in the south wall enters a shower-room, with a round-headed sash-window in the east wall. The partition here is modern. The door on the north enters a room (F7) through a panelled door with moulded surround; this door is in a pre 1954 location. In the east wall there are two round-headed sash-windows. In the north wall there is a fireplace and chimney breast. The fire surround is of limestone.

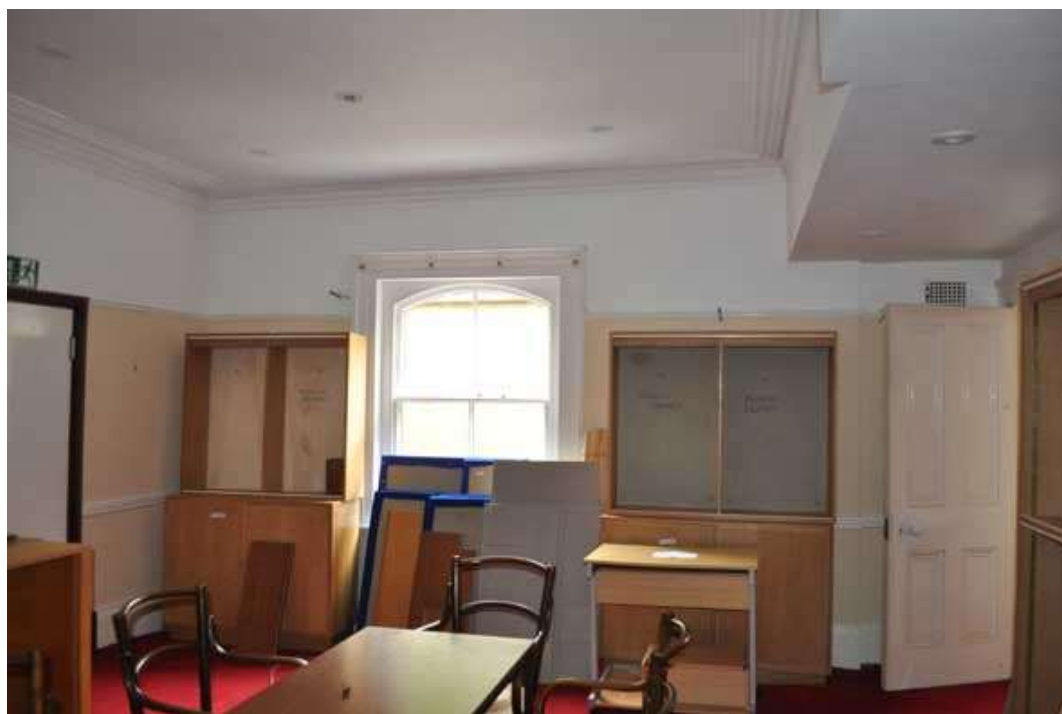
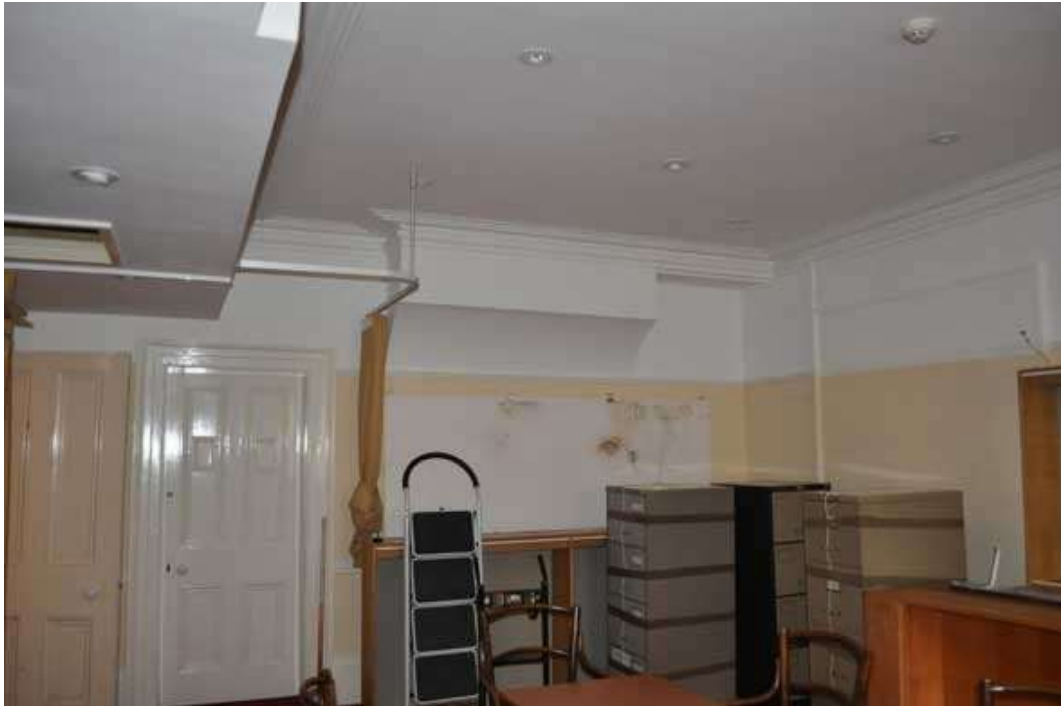
Plate 28: Northwest room, first floor

Plate 29: Northwest room, first floor

The west door of the L-shaped passage enters the northwest room (F8) of the historic standing structure. The ceiling does contain a border of moulding with rolled lines (Plates 28-30). The moulded ceiling does not extend to the east side of the room and it is evident that walls have been removed from this area that would have matched those on the ground floor. In the north wall there is a window with a segmental-headed arch with a square-headed moulded surround. There is a new doorway in the west wall and a blocked opening of a window in the west wall. The wall has two dado rails. A fireplace has been removed in the south wall, and there is a door here that has been moved, but may contain original features (see below). A second door is located in the east wall with moulded surround, which enters a small side room with a round-headed sash window in the north wall. It is possible to discern an area in the central part of the west wall and ceiling that may be the scar of a wall line, thus indicating that the large Museum Room as it was later called may originally have been divided into two smaller rooms.

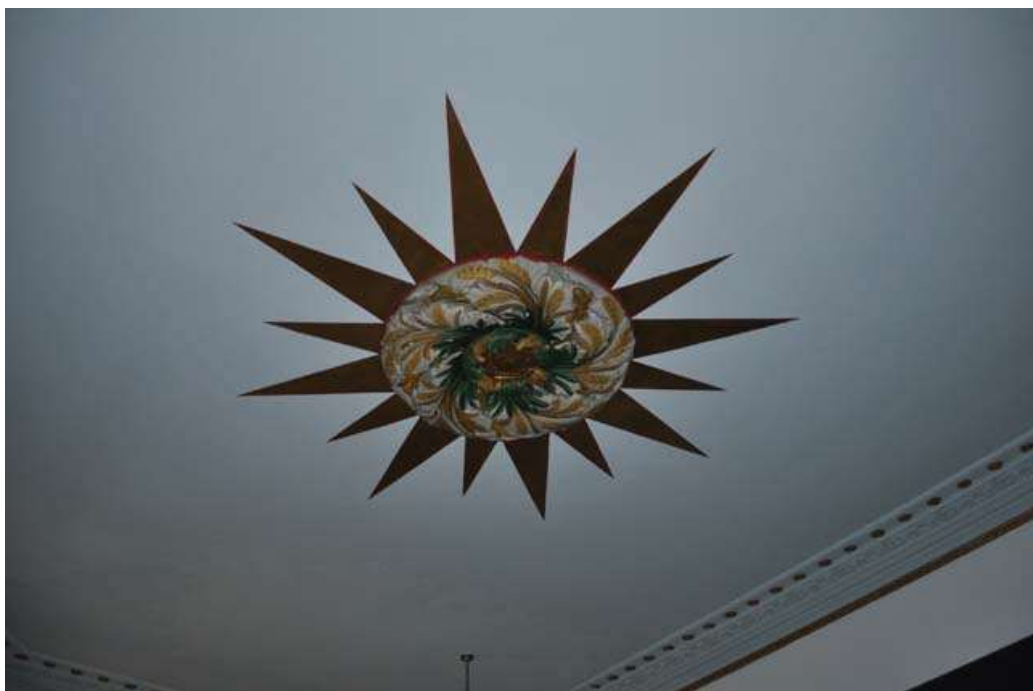
Plate 35: Temple Room, moulded ceiling details

has a large bay window in the south wall, matching that in design on the ground floor. There is a further segmental headed window in the west wall. The ceiling is elaborately moulded with a border containing flower motifs and a large central roundel for the light fitting. In this room the plaster is not whitewashed but painted in light blue with other vivid colours. In the north wall the fireplace has been removed and corbelled thus allowing for the insertion of a new door (no door is shown on the 1954 plan). There is a dado rail around parts of the room. The new door contains features associated with the temple, a wooden door knocker and a lockable peep panel. The floor has also been dropped so as to be on the same level as the rooms at the back of the house. The original floor line and skirting are evident in certain locations. The remains of a blocked door are evident in the east wall, which would have been the only door into the room initially. This would have provided access from the main landing and the original floor levels of both would have been the same.
