JOHN MOORE HERITAGE SERVICES

HISTORIC BUILDING ASSESSMENT

STARBANK HOUSE, HIGH STREET,

THAME, OXFORDSHIRE

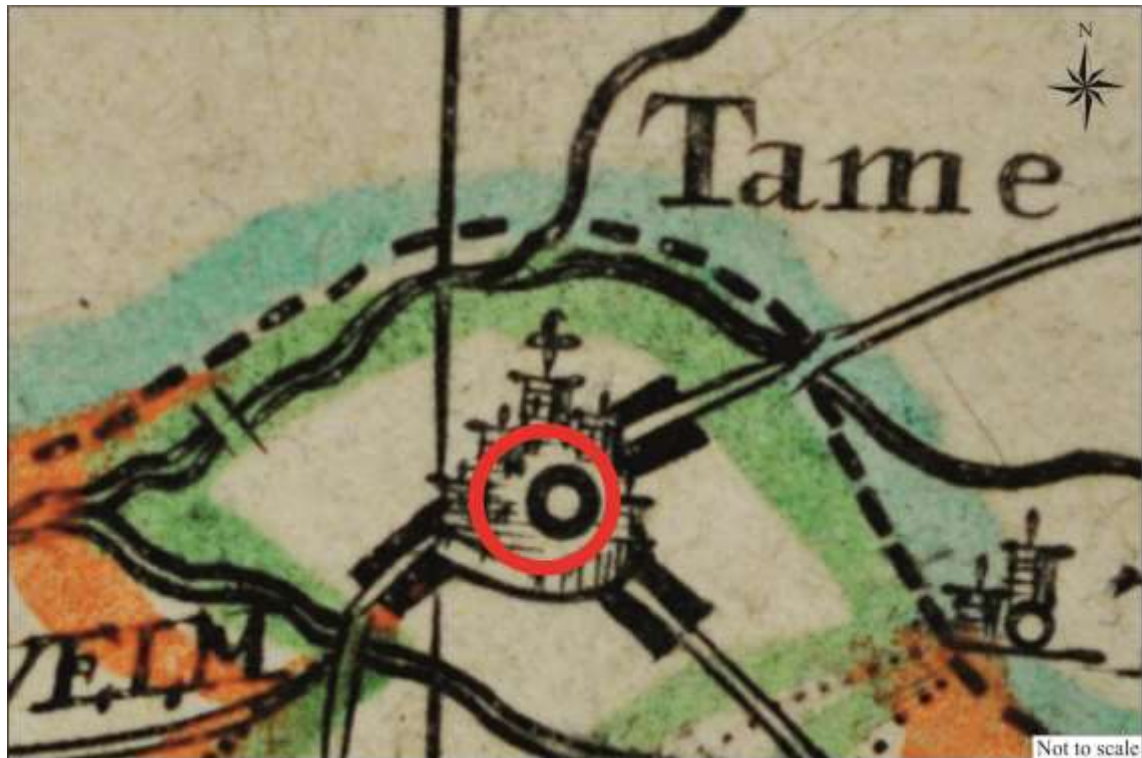
Figure 3: An 18th century map (CH.XXIII/8)

An 18th century map (CH.XXIII/8) of Oxfordshire shows Thame with a picture of a developed town, but with extended urban development along the Oxford Road, High Street and also along the road to Aylesbury (Fig. 3).

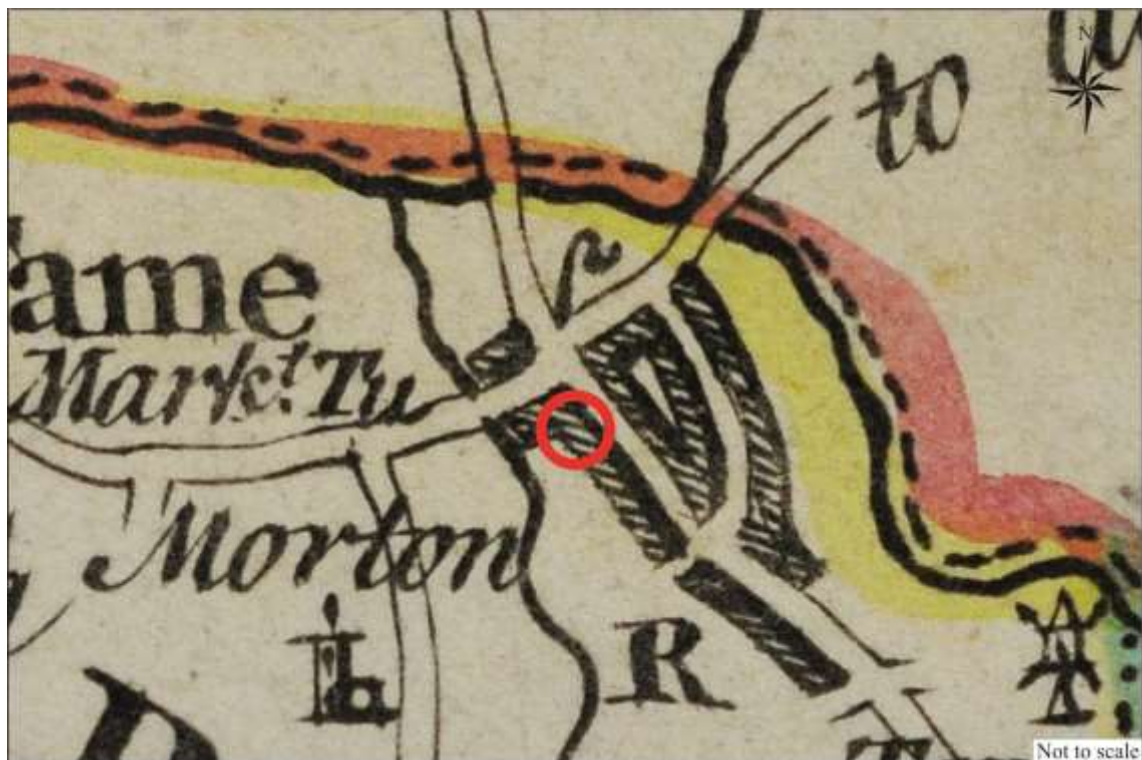
Figure 4: Kitchen's map of 1753 (CH.XXIII-11a)

Kitchen's map of c. 1753 (CH.XXIII/11a) shows a map of Thame that indicates the area of the west end of the High Street was fully developed (Fig. 4).

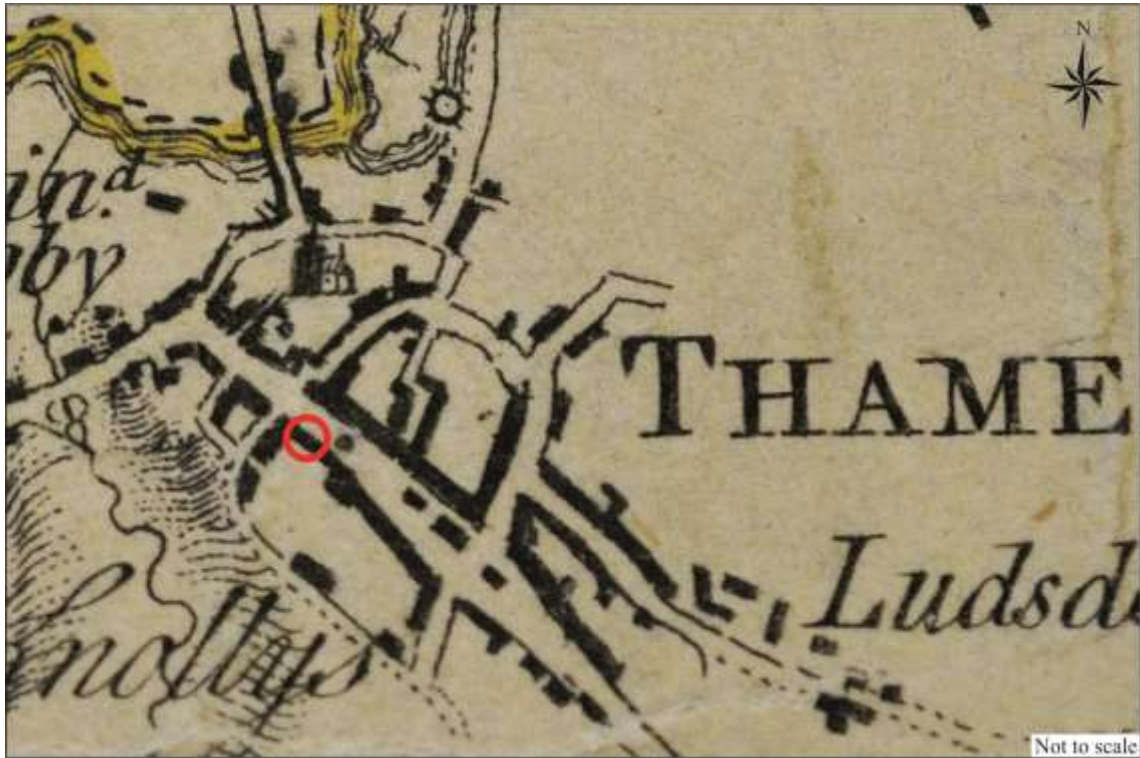
Figure 5: Jefferys' map 1767

Jefferys' map of 1767 (CP/103/M/1) shows the High Street and parts of the town to the north of the High Street as being developed (Fig. 5).

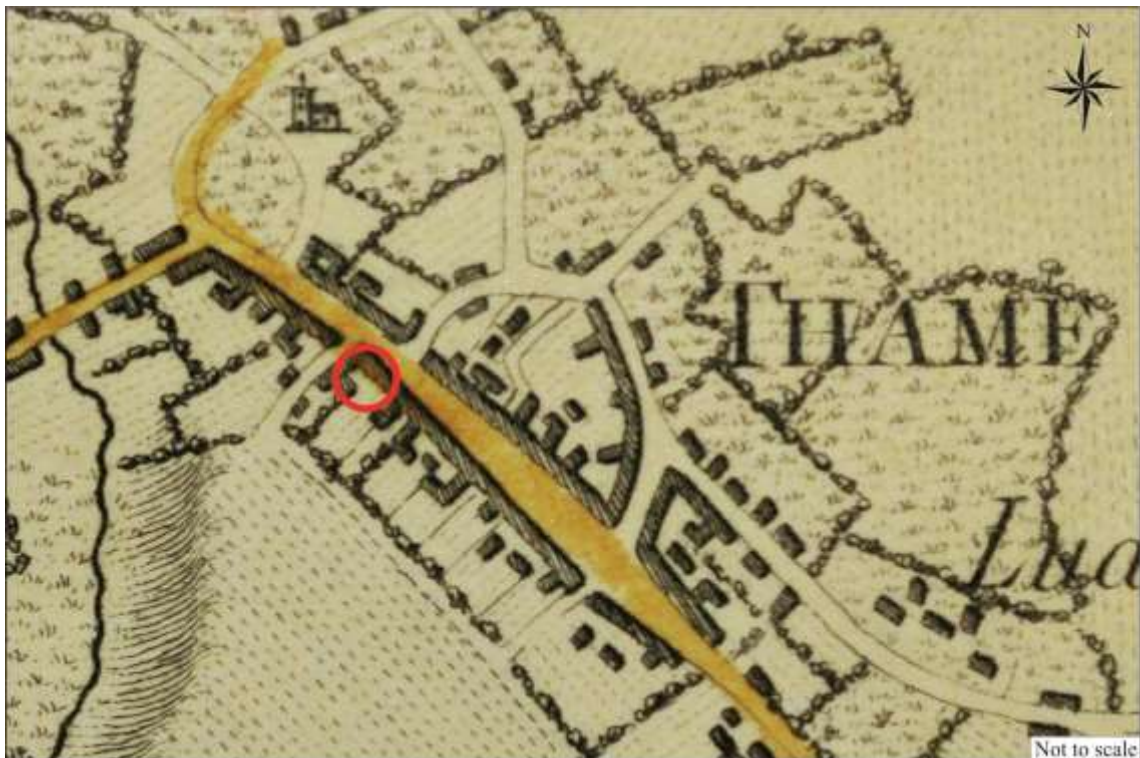
Figure 6: Davis of Lewknor's map of 1797

Davis of Lewknor's map dated 1797 (CH.XX.2) shows that the site of Starbank House

is occupied by a dwelling (Fig. 6).

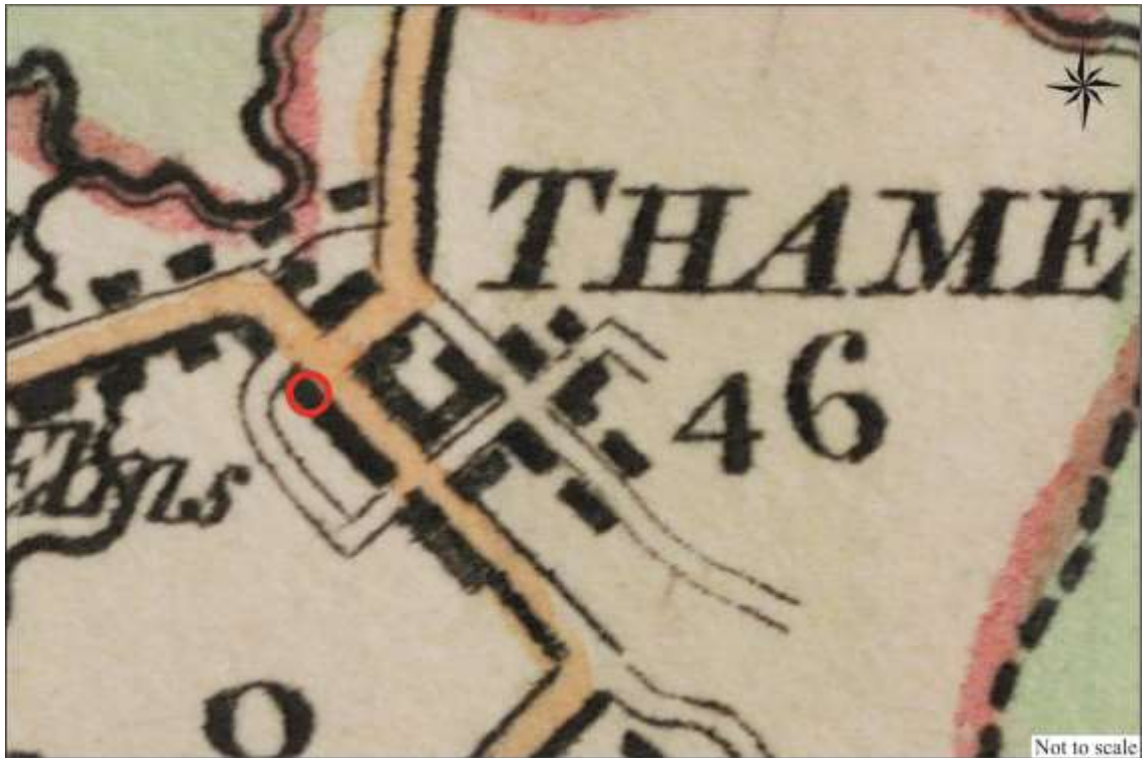
Figure 7: Smith's map of 1804

Smith's map of 1804 (P350/M/1) shows simply that the High Street is fully developed (Fig. 7).

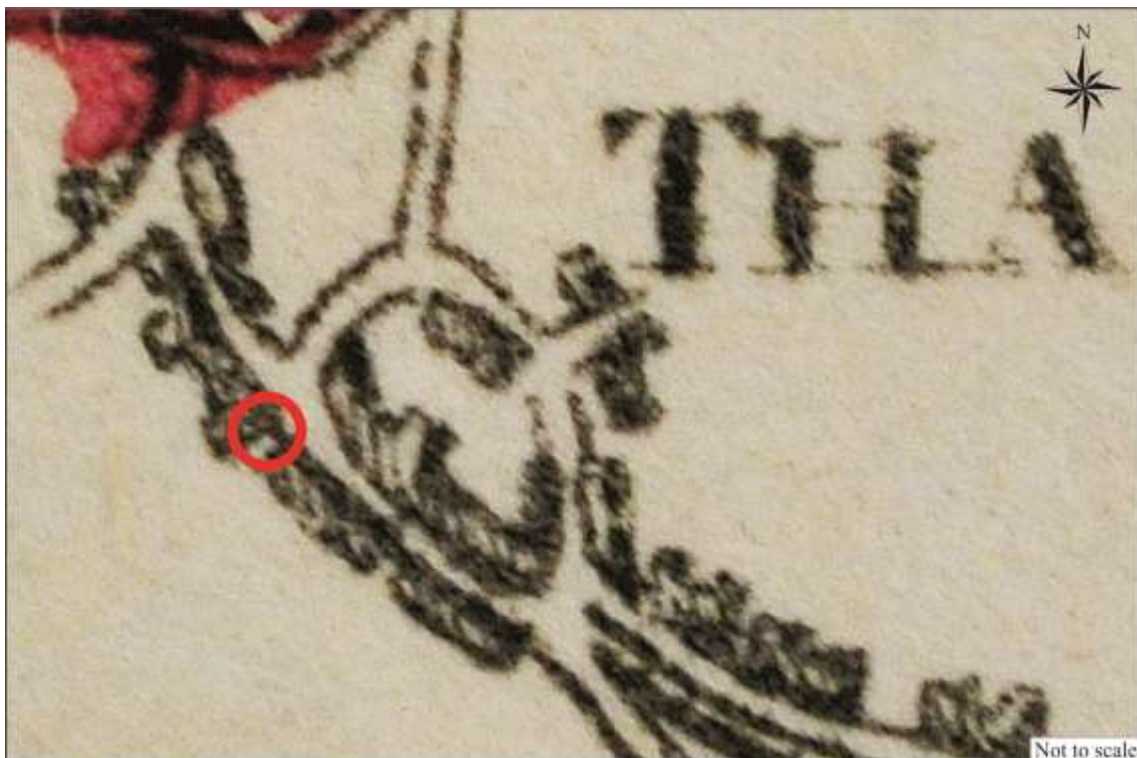
Figure 8: Carey's map of 1805

Carey's map of 1805 (CH.XXIII/12) shows that the west end of the High Street is fully developed (Fig. 8).

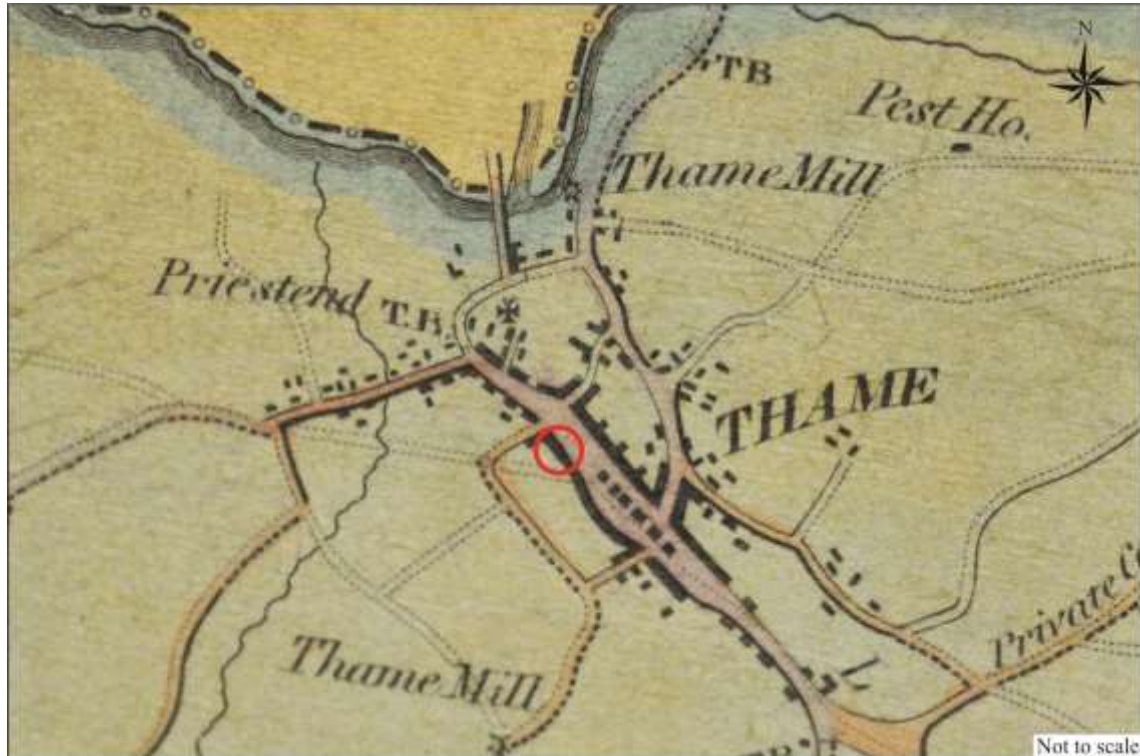
Figure 9: Bryant's map 1824

Bryant's county map of 1824 simply shows that the High Street is developed and that the site of Starbank is occupied (Fig. 9).

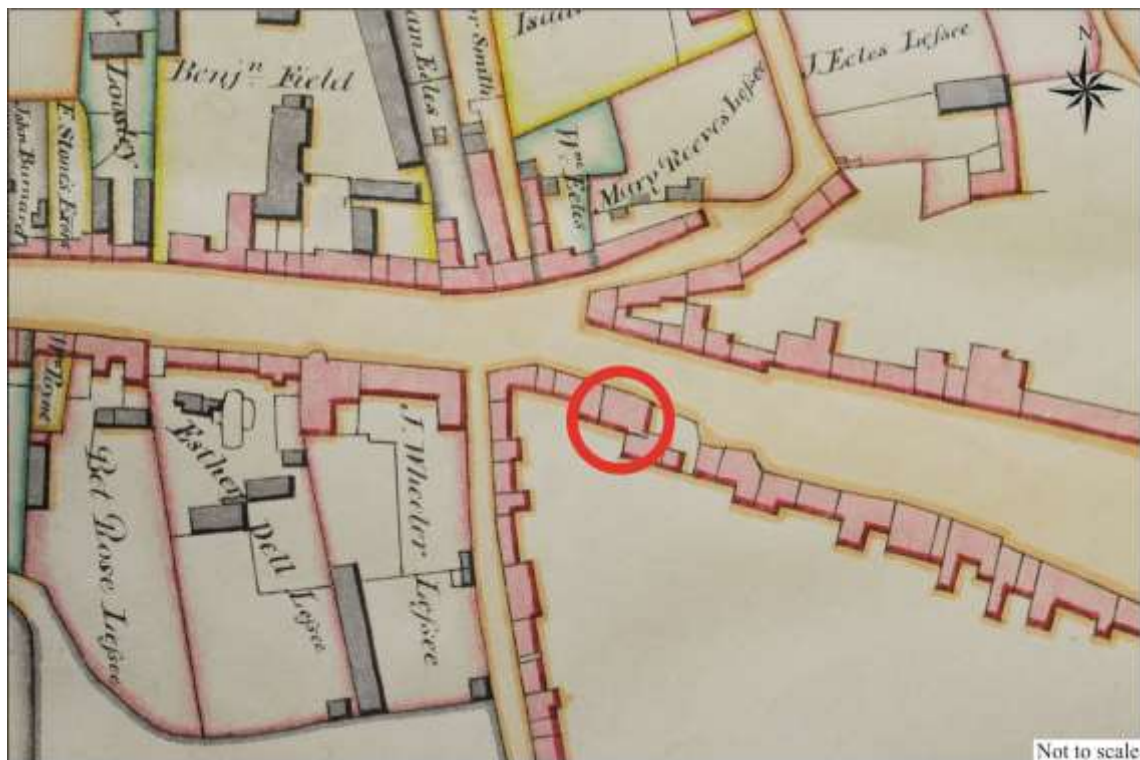
Figure 10: Inclosure Map of 1826

The Inclosure Map of 1826 (QSA/D/A/book 56) shows the first detailed plan of the town (Fig. 10). The property is shown as a rectangular structure that extends out in front of the neighbouring property to the east. This could be an inconsistency in the map. The map does show that the two single storey rear extensions do not exist.

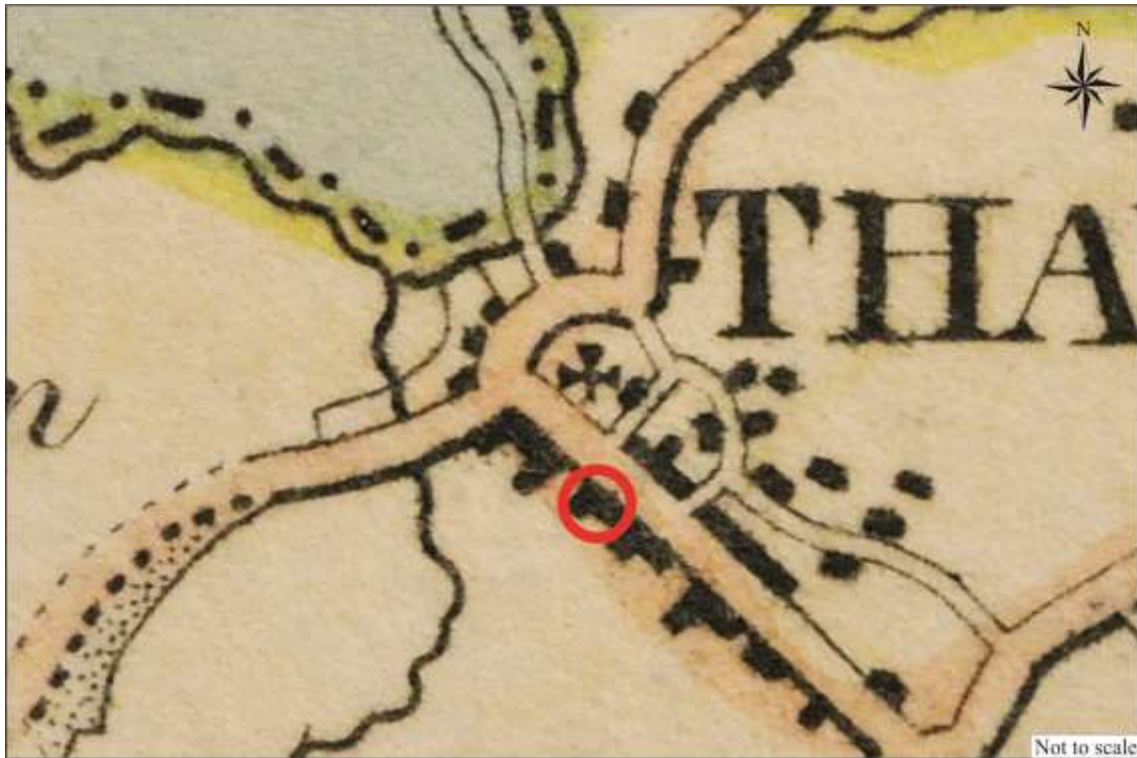
Figure 11: Ordnance Survey map of 1834

The Ordnance Survey map dated 1834 (CH.XLVII/1) shows the site of the house along the High Street developed.

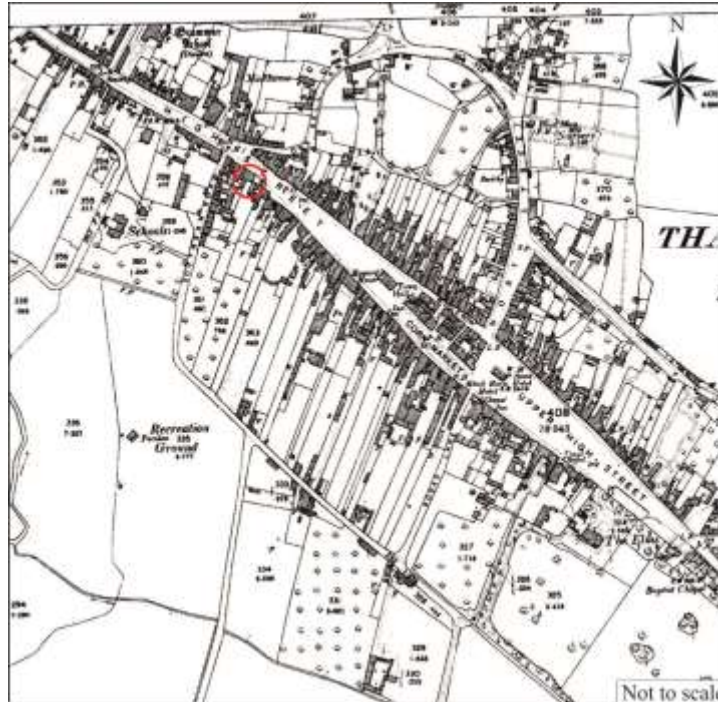
Figure 13: Ordnance Survey map of 1899

The Second Edition dated 1899 (Oxon 41.3) shows the same arrangement with the large irregular front of the property with the single storey extension to the rear (Fig. 13). The Third Edition Ordnance Survey map dated 1921 (Oxon 41.3), which shows the building in the same form (Fig. 14).

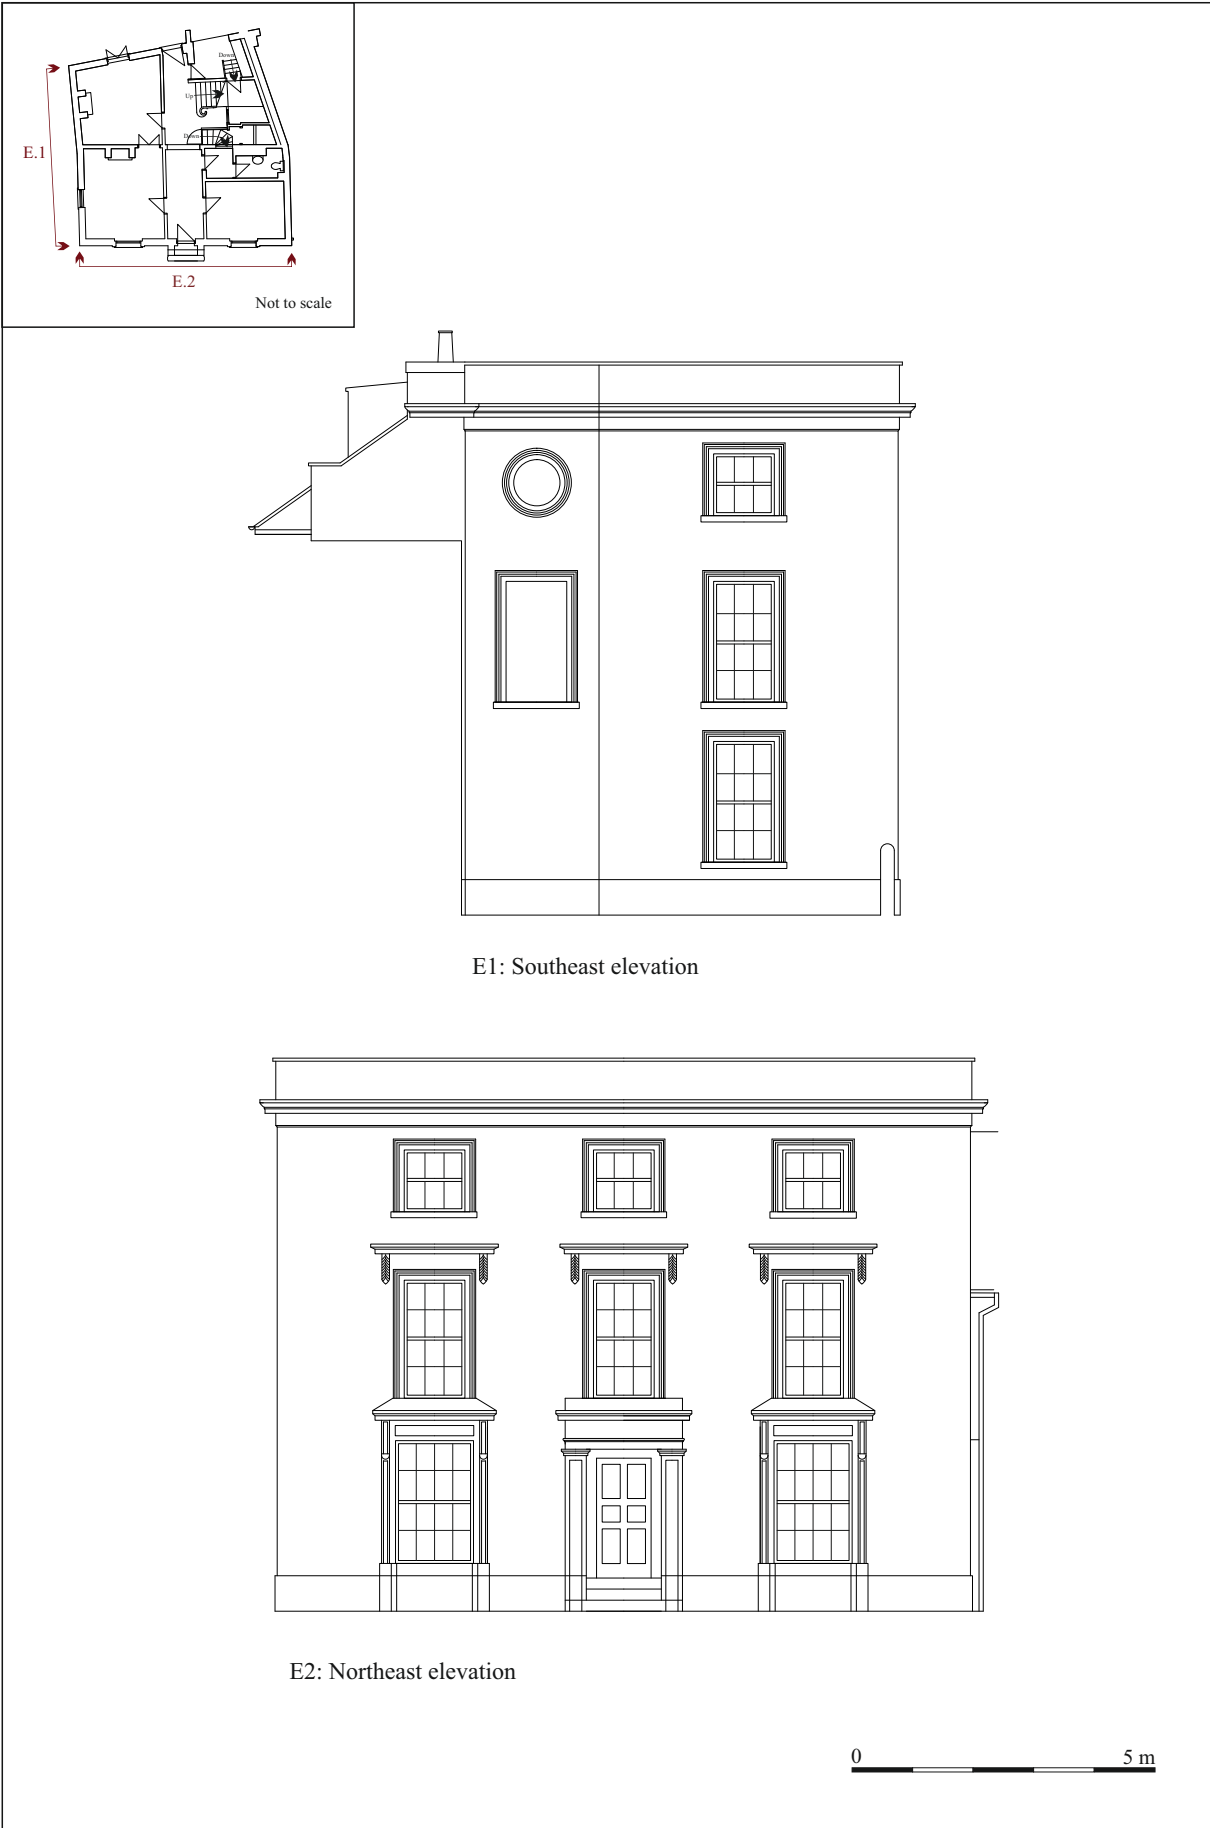
Figure 17: Northeast and southeast external elevations

The front façade (Fig. 17, E2) of the building contains three bays above a black painted podium in which there is located a light for the cellar. The ground floor contains a central door with a porch supported on square pilasters with square capitals. The columns support a cornice with a blank entablature. The two flanking windows contain sash windows under scroll supported hood mouldings. The first floor contains three windows all of which are sash and square-headed and contain a hood supported on scroll mouldings. The second floor or attic floor contains three sash windows with moulded surrounds. Above this there is a cornice and parapet. The roof is not visible from the front, but it is evident that this was part of a slate roof.

The southeast façade appears to be a mixed affair (Fig 17, E1, Plate 2). Part of the building can be associated with the rebuild of *c.* 1820, while the back part of the façade appears to contain earlier features. At the rear of the building there is a central chimney on the back gable. To the left of this there is a partial gable with copping. To the right of the chimney the wall imitates the front façade of the building, and the structure is designed with two bays. On the ground floor there is a sash window with moulded surround. On the first floor there is a similar square-headed sash window with a moulded surround, while centrally a similar moulding is produced that is a blind window. On the second or attic floor there is a smaller sash window with a moulded

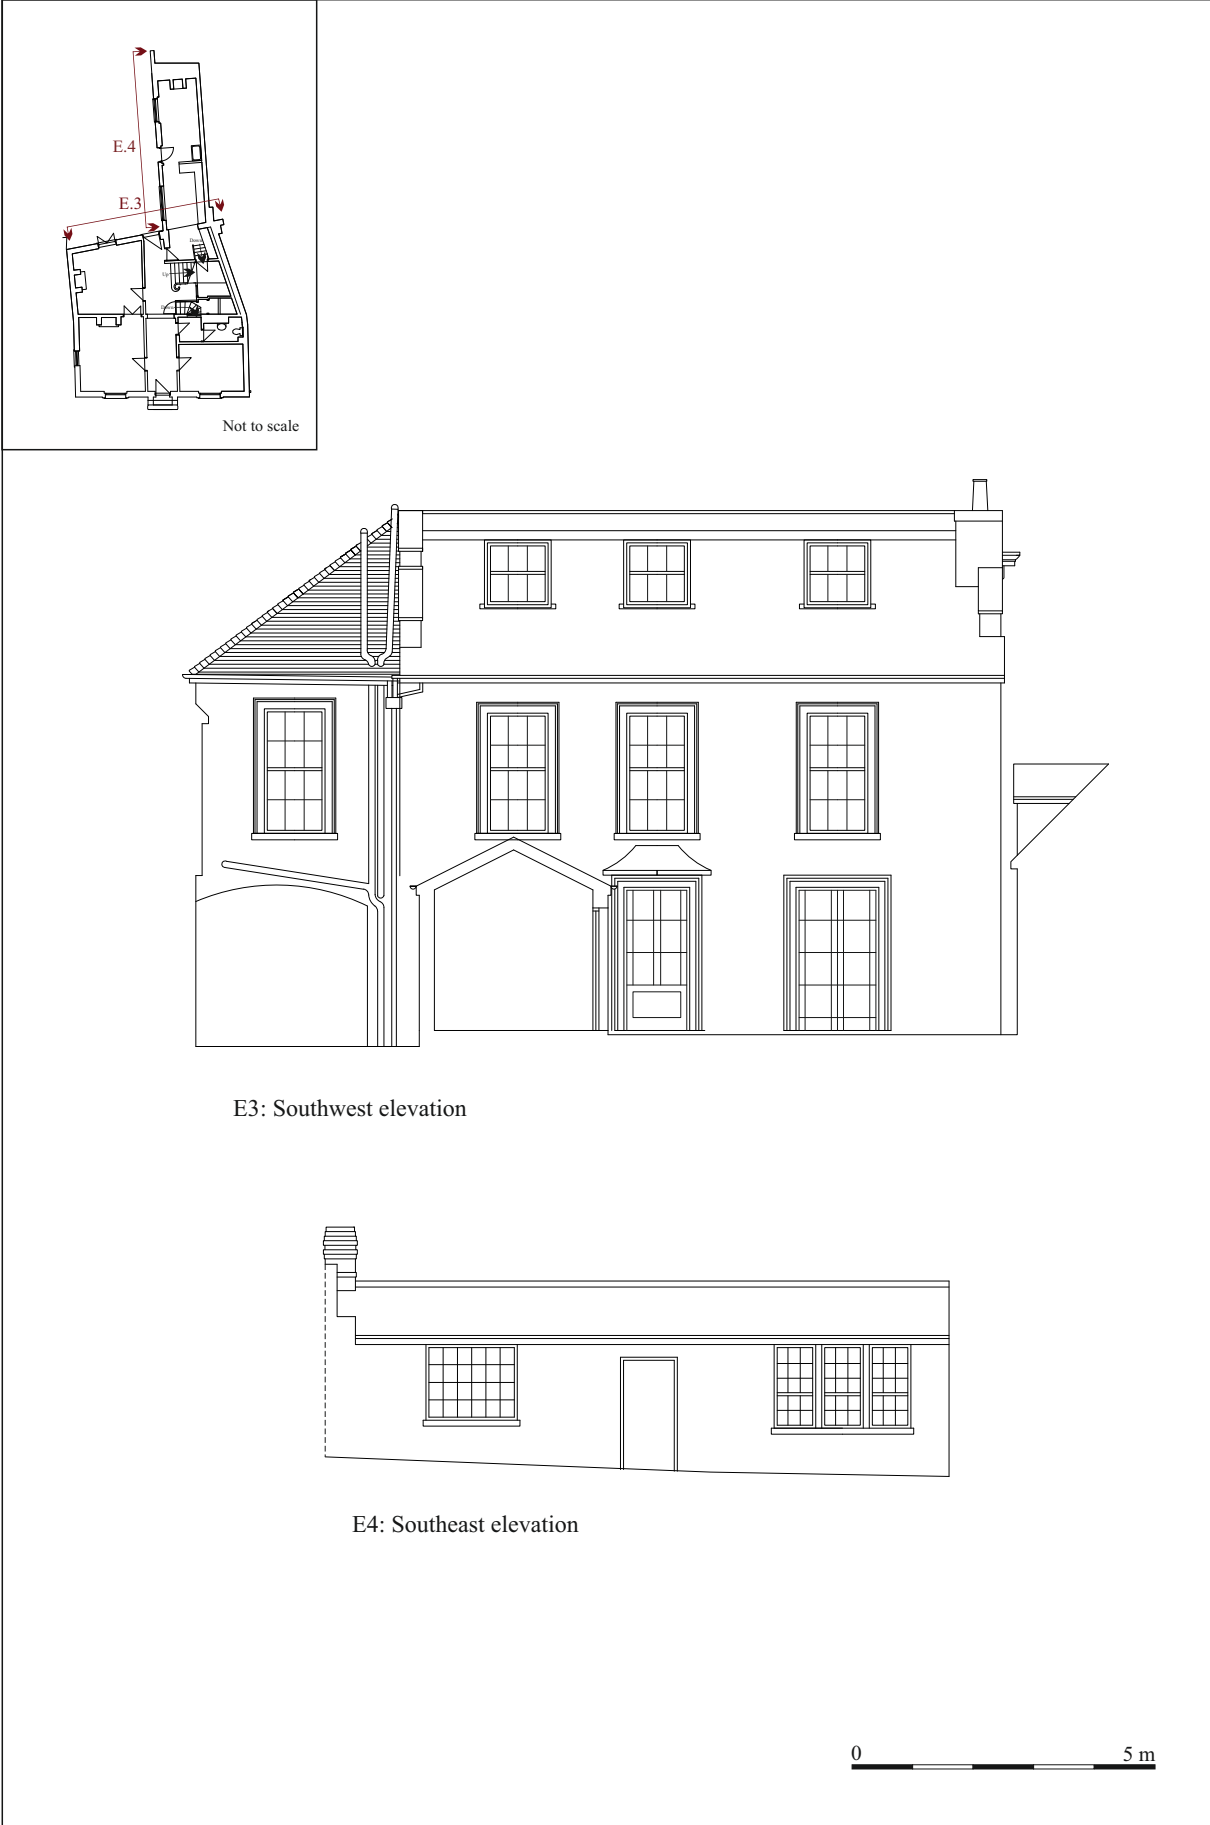
Figure 18: Southwest and southeast external elevations

There is a single storey rear extension with a series of large windows located in the southeast wall (Fig. 18, E4). At the north end there is a combination window containing three sash windows, with a further broad sash window at the south end. Centrally there is a door.

The rear façade (Fig. 18, E3) contains a ground floor level that has two doors on the ground floor, which have square heads and a moulded surround. The door on the east side of the building only has the moulded surround, while the door that is centrally located contains additional decoration (Plate 4). On the west or left hand side of the building there is a gable end of an extension. To the west of the extension there is a

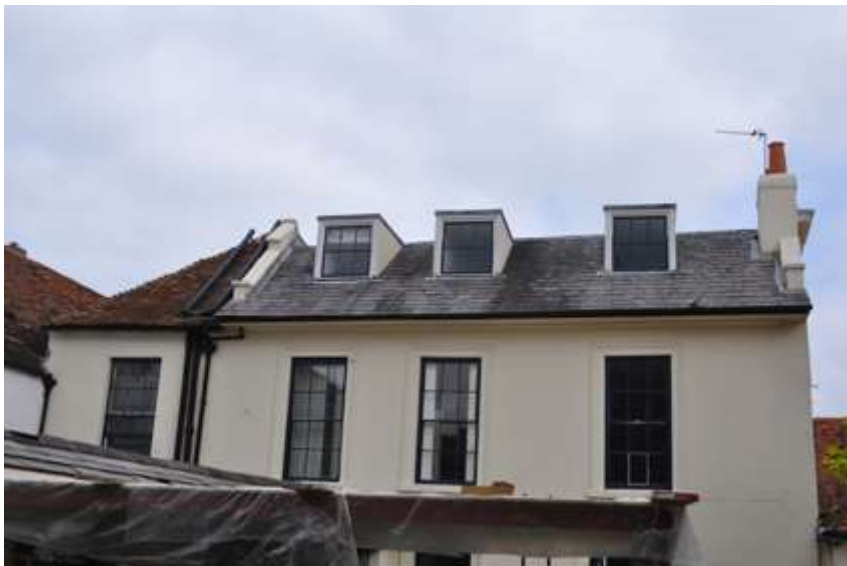
Plate 3: Rear elevation

carriageway. On the first floor there were four bays of square-headed sash windows. Three of these are surrounded by mouldings, while the western window has no moulding. The second floor is shown from the rear to be an attic storey. It is here that the real lines of the building become apparent. There are three flat roofed dormer windows covering the building. Here the roof is covered in grey slates. On the east gable end there is a parapet with copping and on the west side there is a further parapet, which would originally have been located at the west end of the building. The fourth window on the first floor sits below a hipped tile roof.

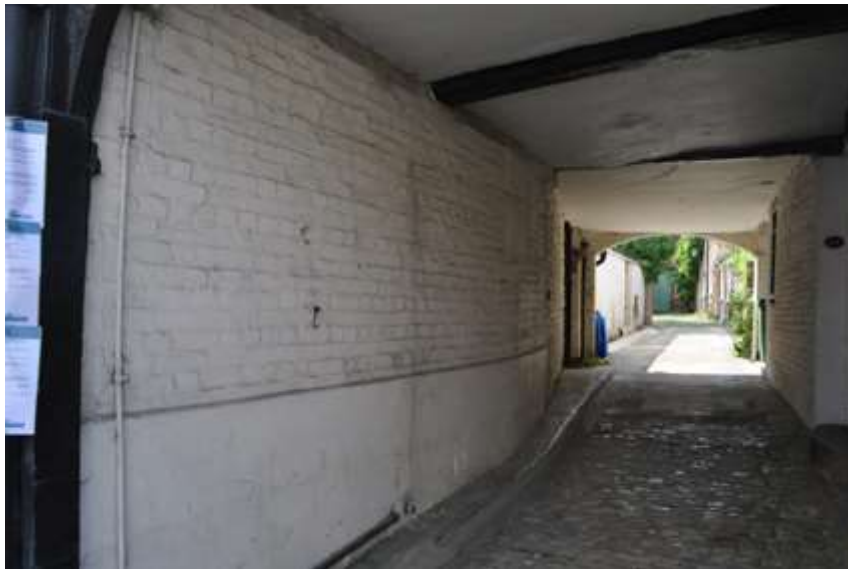
Plate 5: Cart way

The other area of walling on the façade is in the carriageway where the wall bows (Plate 5), with a stuccoed podium below and brick walling above. There is the remains of a timber framed structure in the rear and upper part of the brick wall (which ties in with internal evidence visible from stripping, Plate 6). The rear part of the house is a stone wall in the passage. There are a number of attached timbers; some concerned form part of the external frame for the original gateways at either end of the

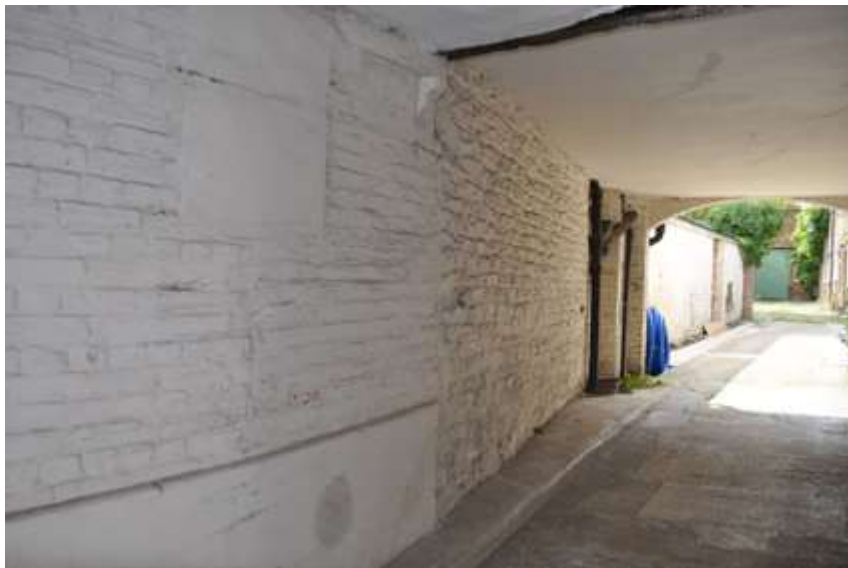
Plate 6: Cart way with remains of timber framing

The remains of timber framing were noted in the west wall of the front part of the house, internally and in the adjoining carriageway. The design of the timber suggested that this was part of a kerb principal truss from a box frame structure. Early dates associated with these structures can date back to the 14th century, but as a feature in smaller dwellings it is often dated to the 16th century. The mortise joints in the timber imply that horizontal timbers extended from the timber post into the space of the current structure.

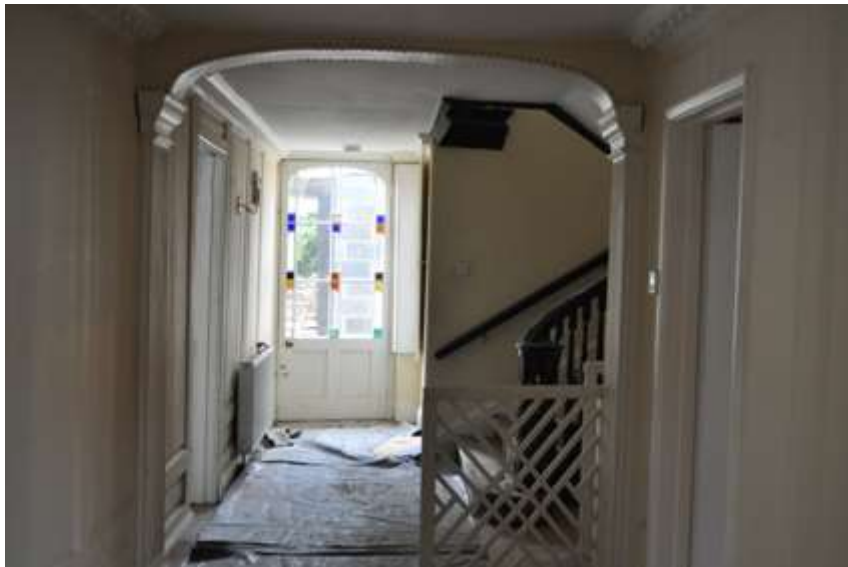
Plate 7: Room G1a

The front door is panelled and enters into a long central hall (G1 & G1a) that runs the length of the main part of the building to a rear glazed and panelled door. On the east side of the hall there are two panelled doors. On the right, west, side of the hall there are two doors, before one reaches a central decorative arch (Plate 7). Beyond the central arch on the right there is a large stairwell to the first floor and smaller side stairs that leads down to the cellar (Plate 9). Beyond the stairs there is a further door on the right hand side. The central decorative arch has square pilasters and capitals; the edge of the arch is decorated by beading. The walls of the hall both in the front of the hall and the back are decorated by panelling along with moulded skirting board and a cornice. The cornice contains a band of decoration based on egg and dart. There are also a series of features that are based on guttae of classical architecture (Plate 8).

The removal of the floor in the hall uncovered the remains of the top of a brick arch in the northern part of room G1a. This relates to a feature still extant in the cellar.

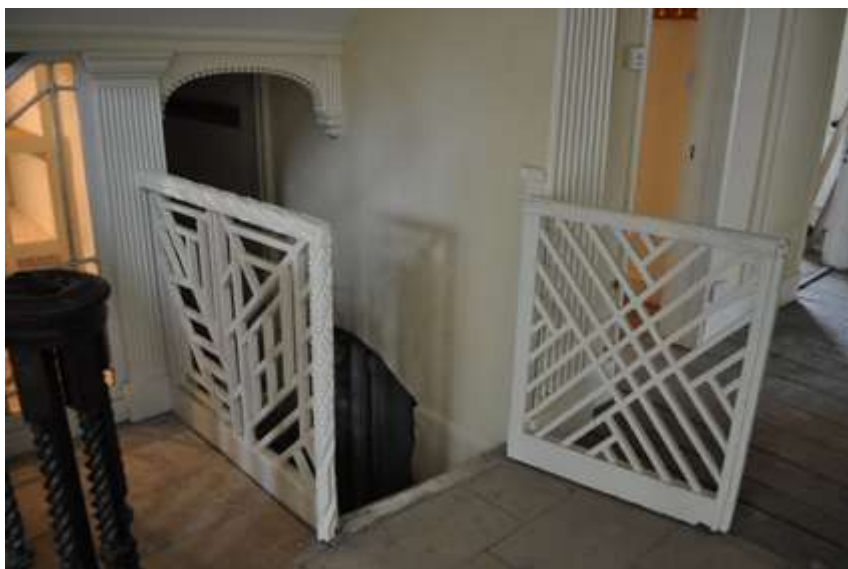
Plate 9: Cellar entrance G1

Back in the hall there are two stairwells. The smaller one on the north has a decorative rail and gate (Plate 9). It leads down to a small area under the stairs (G7) that is entered through an arch with bead decoration. There is a flap in the stairs that lifts up and allows access to the cellar. The cellar (Fig. 19) features included brick stairs, a series of

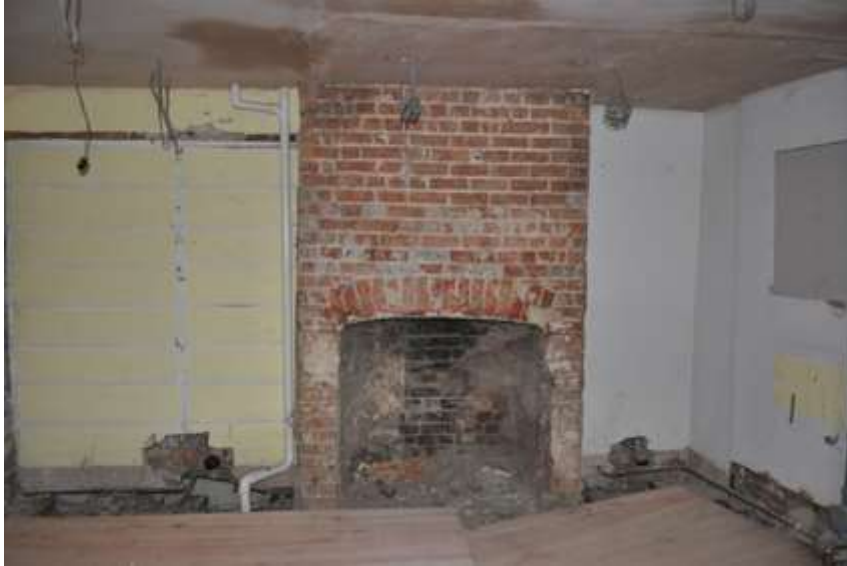
Plate 10: Stripped out room G4 with uncovered chimneybreast

There is a door on the west side of the hall that is new. This leads into small rooms that now incorporate a toilet and are called the Ante and Cloaks (G4a & G4b). The removal of the internal walls revealed that rooms G4, G4a and G4b had originally all been one room and that set in the south wall was the remains of a fireplace that had lost its fittings (Plate 10).

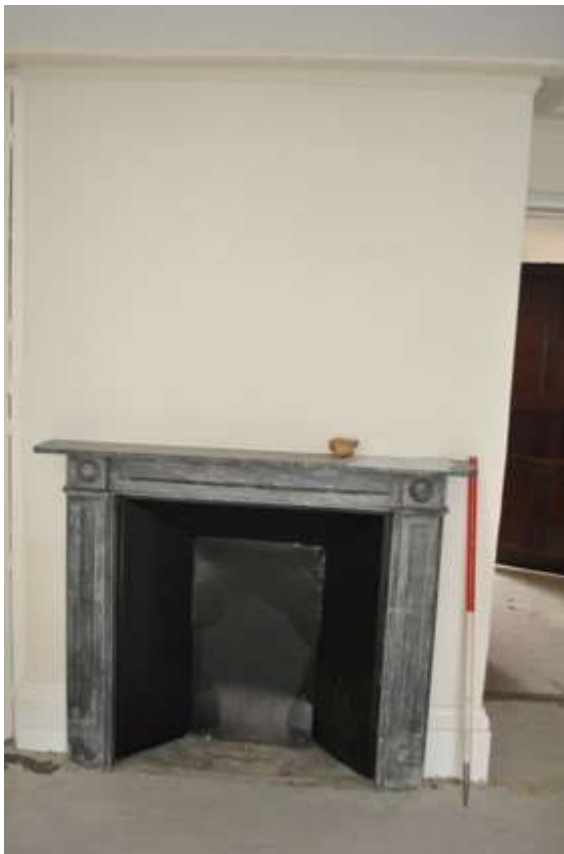
Plate 11: Chimneybreast in room G2

The door on the east enters a room (G2) that has a sash-window in the north wall, and a further one in the east wall. In the south wall there is an elaborate fireplace with roundels (Plate 11), which has a built-in cupboard to its left and also a double panelled door to the right. The doors are panelled but not elaborated in the same way as those entering onto the hall. Removing the floor revealed the cellar wall and brick channel (Plates 14-15).

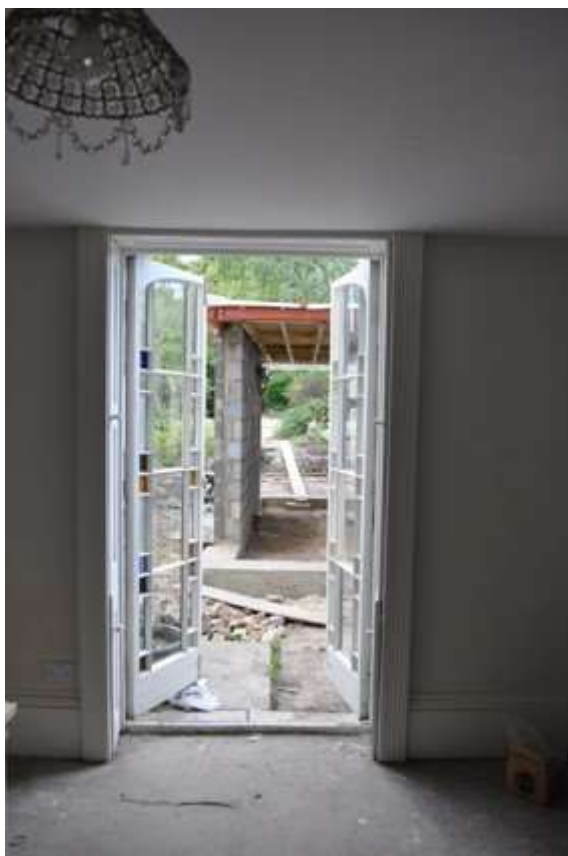
Plate 12: Patio door room G3

The double doors lead into a rear room on the east side (G3). There is a panelled door leading back into the hall in the west wall. There is a chimneybreast with fireplace in the east wall; the design of the fireplace is in-keeping but extends either side of the chimney perhaps indicating a replacement. In the south wall there is a double patio door with glass panelling (Plate 12). This door has a panelled surround and there is moulded skirting.

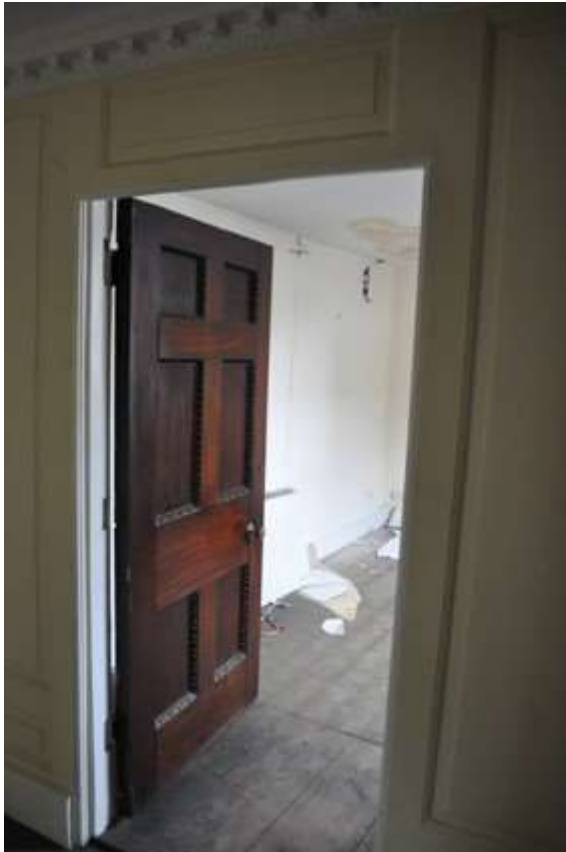
Plate 13: Door into room G4

The doors immediately to the right and left of the front door are both panelled doors with bead decoration. The door on the west side (Plate 13) leads into a room with a sash window in the north wall (G4).

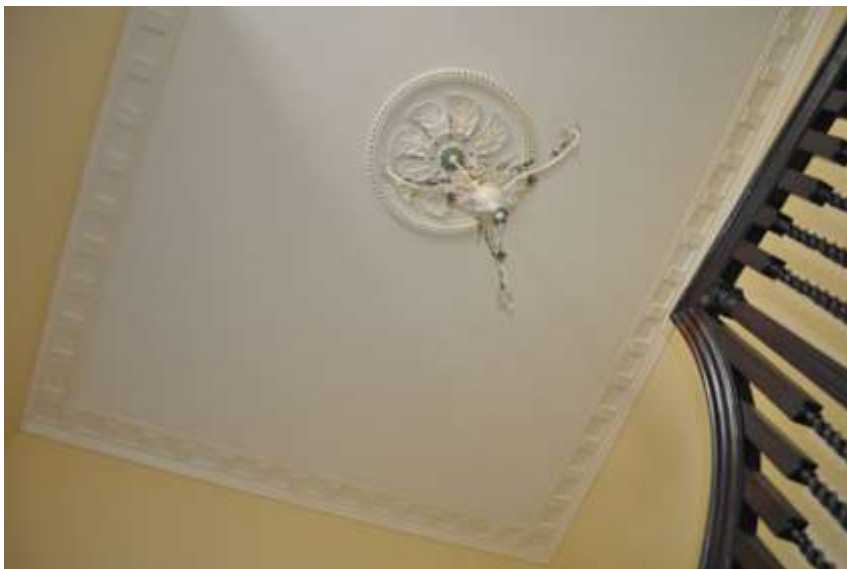
Plate 16: Ceiling above stairwell

The slightly C-shape stairs lead up onto the first floor landing (F1). The walls are panelled in a similar way to that of the hall below. The ceiling has a less elaborate cornice to the hall with guttae containing flower or leaf designs and there is a central roundel with bead decoration and leaf motifs (Plate 16). In the south wall there is a sash window (Plate 17). In the southwest there is a panelled door in a panelled wall leading into a small bathroom (F8) with a sash window in the south wall. The décor of the bathroom is modern. In the east wall of the landing (F1) is a door facing the stairs.

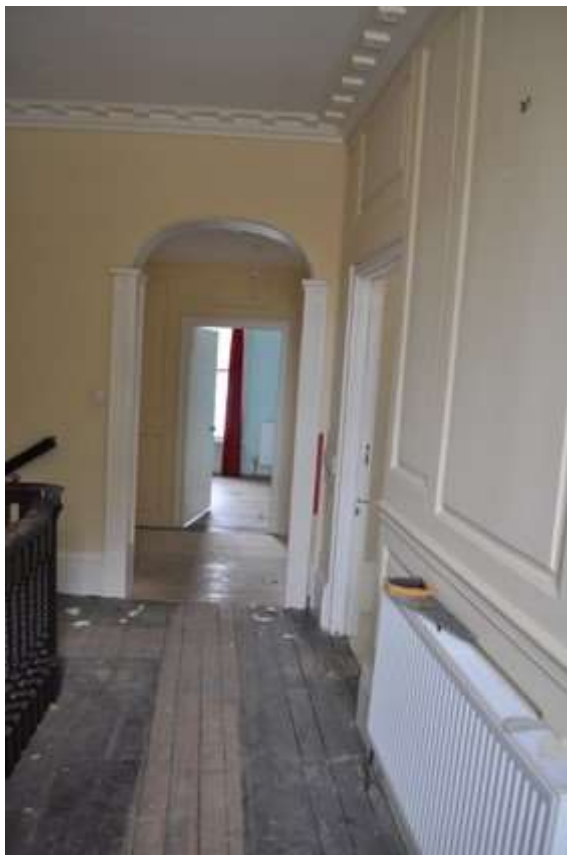
Plate 18: Landing F1 looking north

On the north side of the landing (F1) there is an arch with a moulded surround (Plate 18) that imitates the central arch of the hall (G1). This has fluted pilasters and a bead decorated arch. This arch leads into a further part of the landing (F2 & F2a) in the north part of the house. Here the north and south walls show indications of panelling, but there is no cornice or skirting. There is a stairs on the south wall of this part of the landing that leads up to the second floor. There is an opening adjacent to the stairwell that has a square-head that leads into the western part of the landing. In the east wall there is a panel door with moulded surround, in the north wall there are also two doors, that in F2 a panel door with a moulded surround, while the one in F2a is a glass panelled door. In the southwest corner of landing part F2a there is a panelled door into a further room and also a panelled door into a section of wall behind the large stairwell. The wall at the back of the cupboard is made by plank panelling.

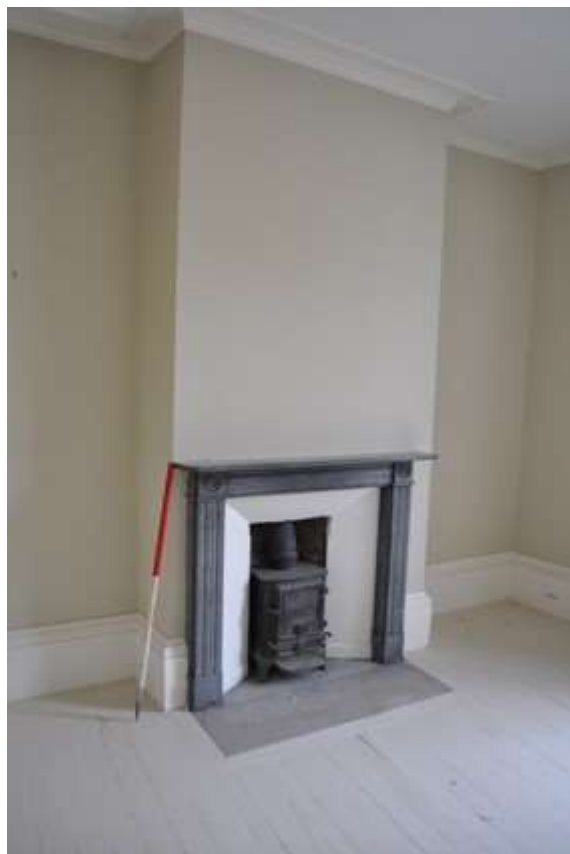
Plate 19: Fireplace room F3

The east door leads into a bedroom (F3), which has a fireplace in the east wall (Plate 19). This has its original features with fluted and roundel designs. There is a moulded cornice with roundel designs (Plate 21). In the south wall there is a sash window with moulded surround (Plate 20). The skirting board is high and with a moulded top.

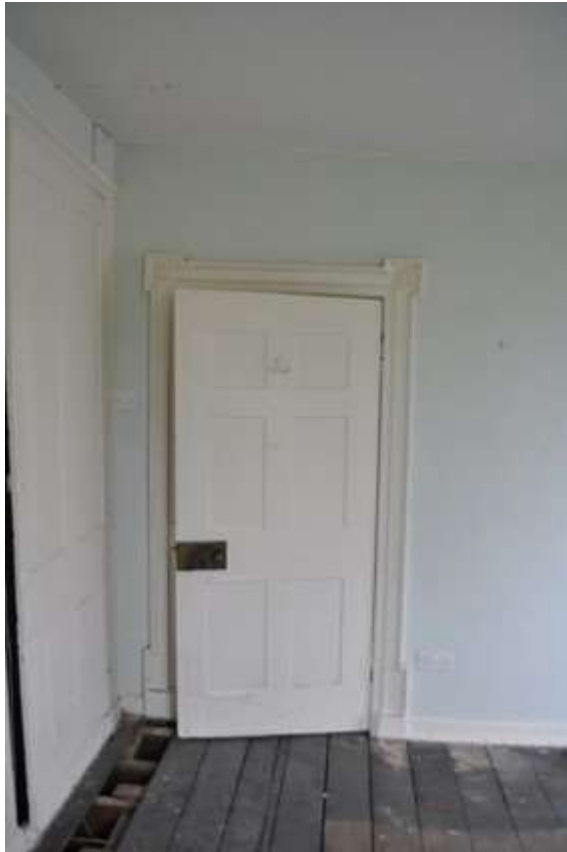
Plate 24: Door room F4

The east panelled door leads into room F4 (Plate 24), which has a chimneybreast in the south wall with a probable original fireplace and cast iron grate (Plate 23) and built in

cupboard to its right. In the east and north walls there are sash windows. The door in the west wall, from the landing, has a moulded surround.
