JOHN MOORE HERITAGE SERVICES

HISTORIC BUILDING ASSESSMENT

STARBANK HOUSE, HIGH STREET,

THAME, OXFORDSHIRE

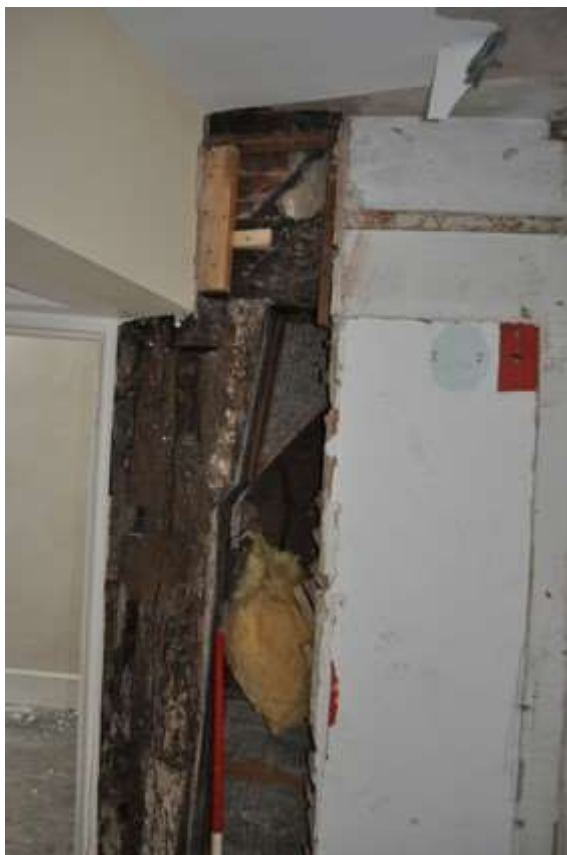
Plate 25: Kerb principal truss in F2a

Stripping back of the west wall of the landing in part of F2a there was evidence of an earlier timber framed structure (Plate 25). The timber form can either be part of a jewelled head or gunstock head; the form lying between the two forms. This would indicate, in conjunction with the tie-beam above and the possible kerb principal, that this was part of a kerb principal truss from a box framed timber building. This apparent feature, a kerb principal truss, can be dated from the 14th to the 16th century (RCHME 1981, 58-98).

The remains of timber framing were noted in the west wall of the front part of the house, internally and in the adjoining carriageway. The design of the timber suggested that this was part of a kerb principal truss from a box frame structure. Early dates associated with these structures can date back to the 14th century, but as a feature in smaller dwellings it is often dated to the 16th century. The mortise joints in the timber imply that horizontal timbers extended from the timber post into the space of the current structure.

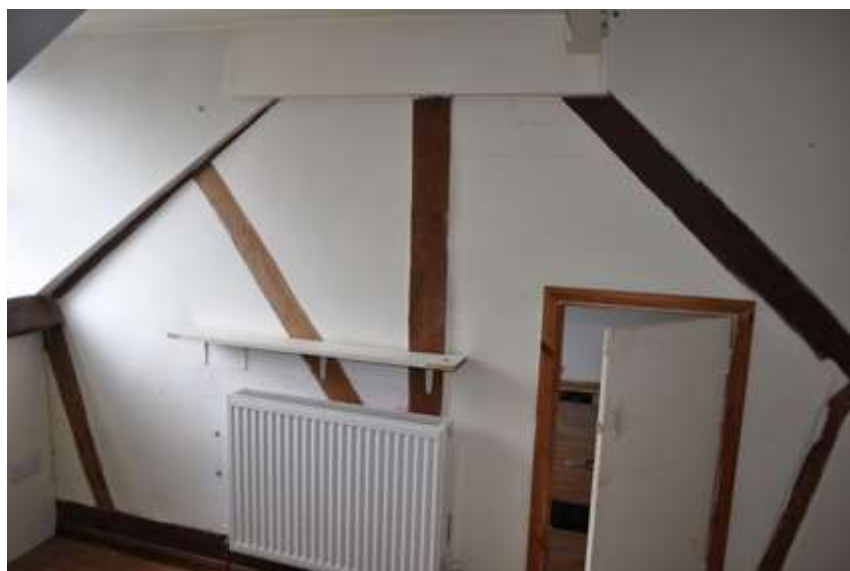
Plate 26: Truss in rear of second floor

shape. Room A3 is in the east part of the range. There is a chimneybreast and possibly blocked fireplace in the east wall. In the southwest wall there is a sash window set in a dormer. In the west wall there is part of the roof truss containing a king post with struts (Plate 26).

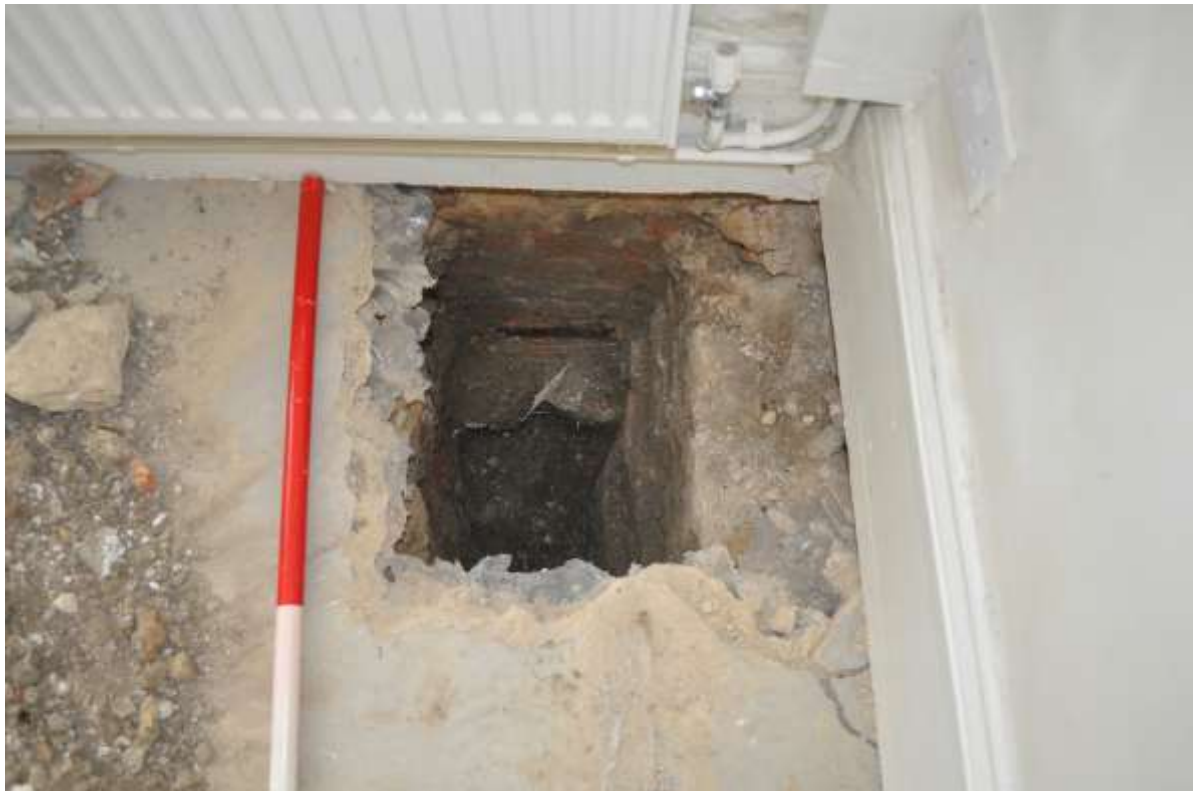
Plate 27: Sondage 1 in G2

The sondage in room G2 (Plate 27), outside the area of the cellar, had a lowest recognisable level with context (07) a compact mid to dark grey silt clay (Fig. 19, Section 1). It was not apparent from the small insertion if this layer was truncated by cut 23 or if layer (07) represented a layer that had been spread internally within the structure. Cut 23 is used here to represent the probable five linear cuts that would have formed the foundation cut of the earliest structure. The cut was filled by masonry wall 05 a limestone rubble structure constructed with narrow bands of stone. The wall was probably at least 0.5m wide and could have been as much as 0.6m wide. Two of the wall lines were visible in the room G2 sondage, while two of these stone walls continued into the cellar (east and north side). There was possibly a further stone wall running to the rear of the segmental arched alcove on the south side. The depth of the wall implied from the cellar is that it is likely to extend at least 1.7m below the current internal floor level. Butting up to that wall and most certainly laid internally is the remains of context (06) a compact white mortar-sand layer some 0.04m thick. This represents an earlier floor layer internally. It is possible that a door or earlier window was identified in the sondage as the wall on the north side contained brick infill extending to a lower level, practically to the level of the mortar floor. These features are undoubtedly part of the earliest recognisable phase of the building. Though there is no dating evidence a broad range of dates from the later 11th to the 16th centuries is feasible.

Though not requested by the planning procedure, observations were made of the internal alterations at the request of the clients. In a sondage in the front of the building (room G2) it was noted that the stone walls at the front of the property were extremely deep set and that there was at least one earlier mortar floor surface evident.

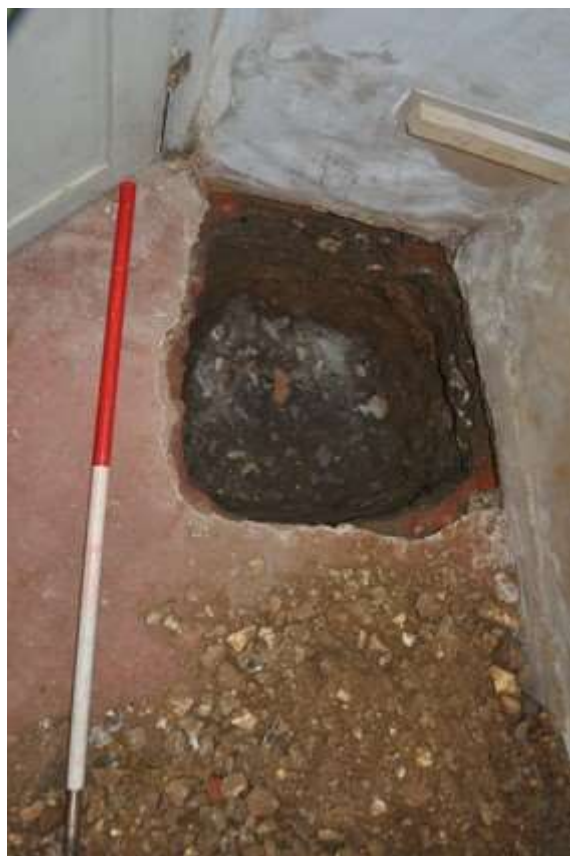
Plate 28: Sondage 2 in G6

Cut into deposit (09) was foundation cut 24, which was for the rear range that butted up to the original front structure 05. This was filled by the three walls of masonry structure 08, which was made of limestone rubble and bonded with mortar. In this location it was apparent that the foundation cut extended below the floor level to a depth of 0.2m; however, the floor in room G6 was some 0.5m below the floor levels in the rest of the rear of the house (G1a, G3, G5) thus implying that the foundation for the rest of the structure was probably 0.6-0.7m below the current floor level. Internally there a floor was laid above this; a brick floor with a mortar skim above.
