JOHN MOORE HERITAGE SERVICES

BUILDING RECORDING AND EXCAVATION

WARREN FARM, FOREST ROAD,

WOKINGHAM, BERKSHIRE

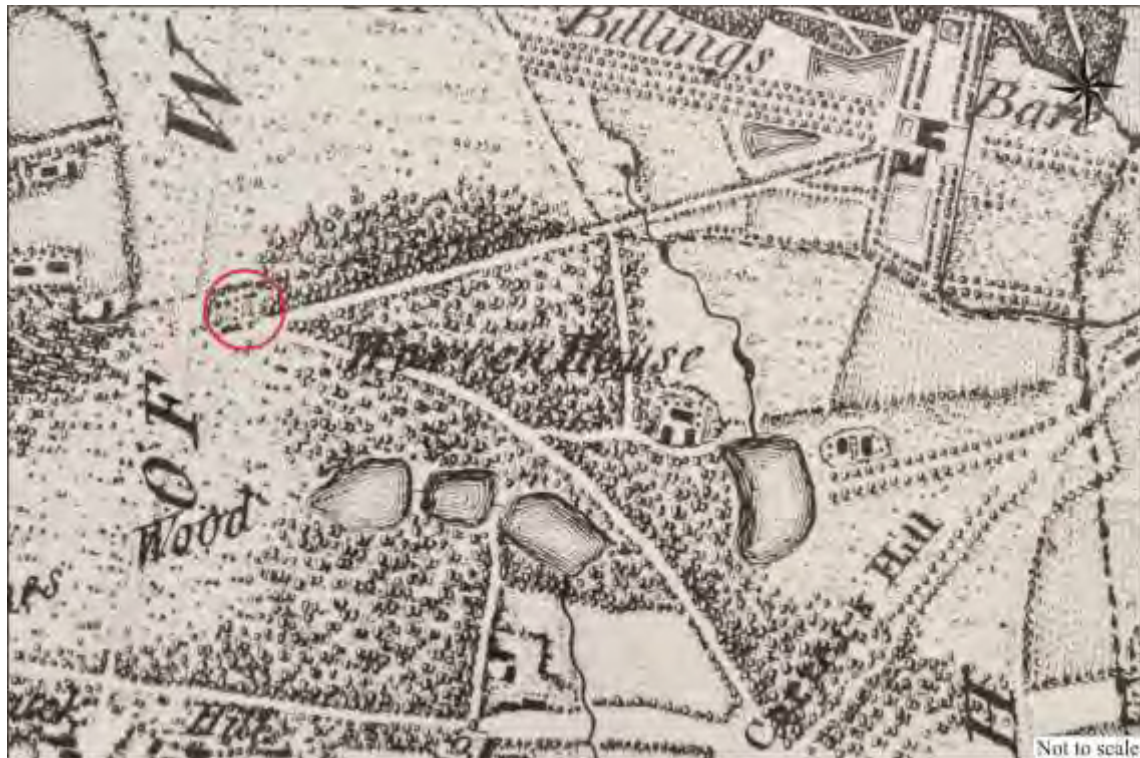
Fig. 2: Rocque's Map of 1761

Cartographic information associated with Warren Farm commence like most Berkshire places with the maps of the latter part of the 18th century. The map of Rocque dated 1761 (T/M128) shows a building in the location of Warren Farm roughly orientated east to west in line with the road that leads towards Billingsbear (Fig. 2). There appear to be no buildings associated with the site that could be indicated as a farmyard with surrounding

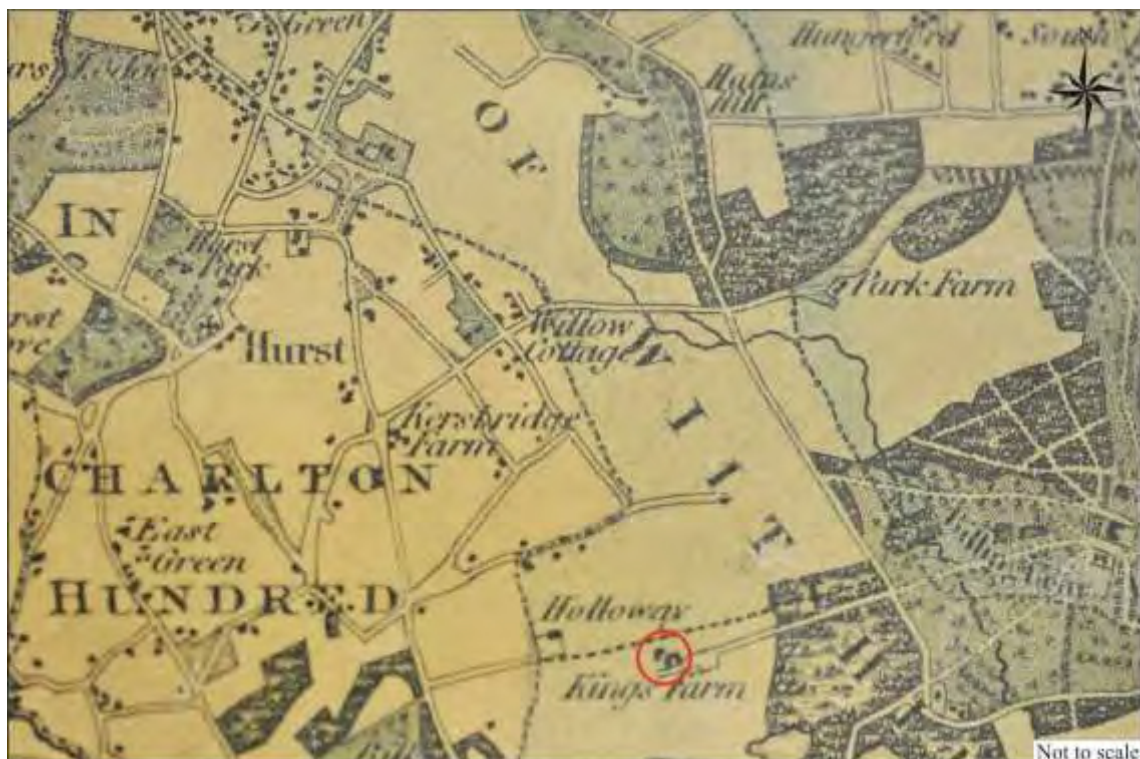
Fig. 3: Greenwood's Map of 1824

The second map that shows the building is that of Greenwood dated 1824 (D/ERu P5). The buildings shown appear to be part of a yard which is open on the south side (Fig. 3). This map records the name for the farm as Kings Farm. The road is shown running to Billing Bear Park. To the west there is a farm called the Holloway, which could either refer to an east west orientated trackway or one running north to south that is marked on Roque's map running up over the common. Such place-names are common and refer to a well established route way, many of which are at least medieval in date. The name indicates that even though Warren Farm may appear to be somewhat isolated now that in the past it was on a recognised route.

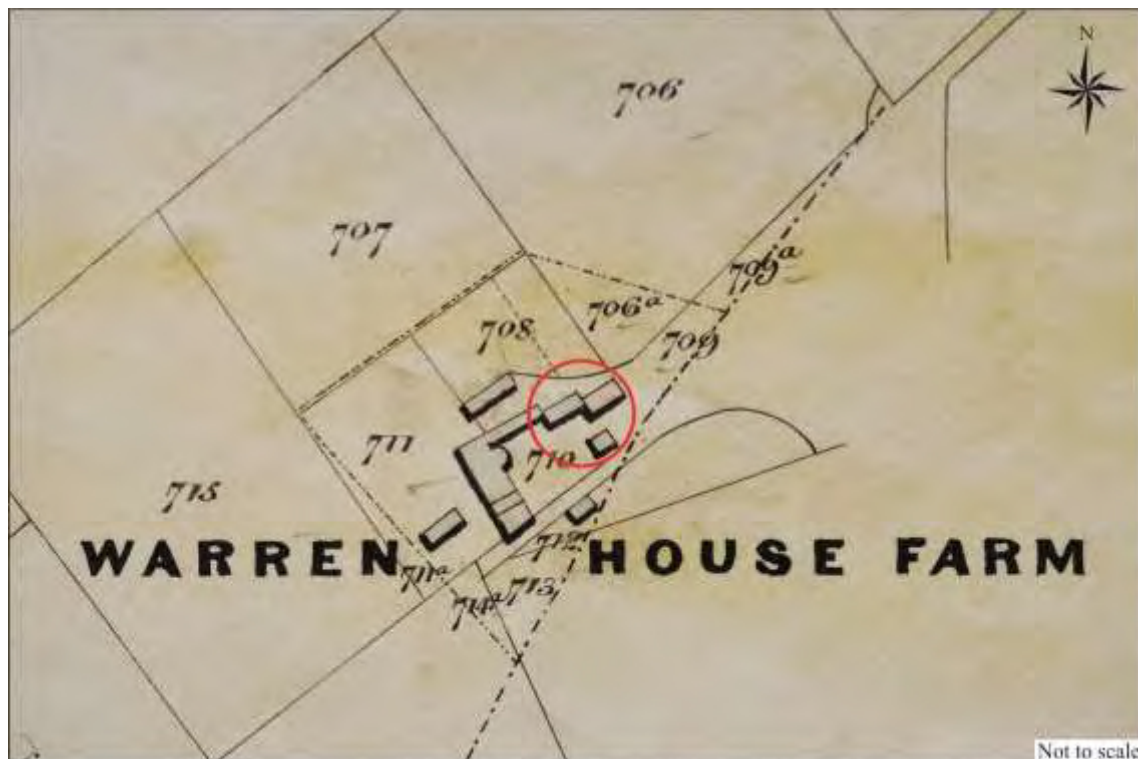
Fig. 4: Hurst Tithe Map of 1842

The next cartographic representation of the building is on the Hurst Tithe Map of 1842 (D/D1 73/1). This shows the house as a pink rectangular structure roughly orientated east to west (Fig. 4). There are outbuildings marked to the rear of the structure, an east to west barn and then an L-shaped structure that forms part of the yard. There are four other isolated buildings located around the wider area of the farmyard. In the parish of Hurst Saint Nicholas there is a reference to *Warren House Farm* that was recorded as *Warren* or *Little Warren* in 1841 (Gelling 1973, 101). Perhaps more significantly it is on this map that

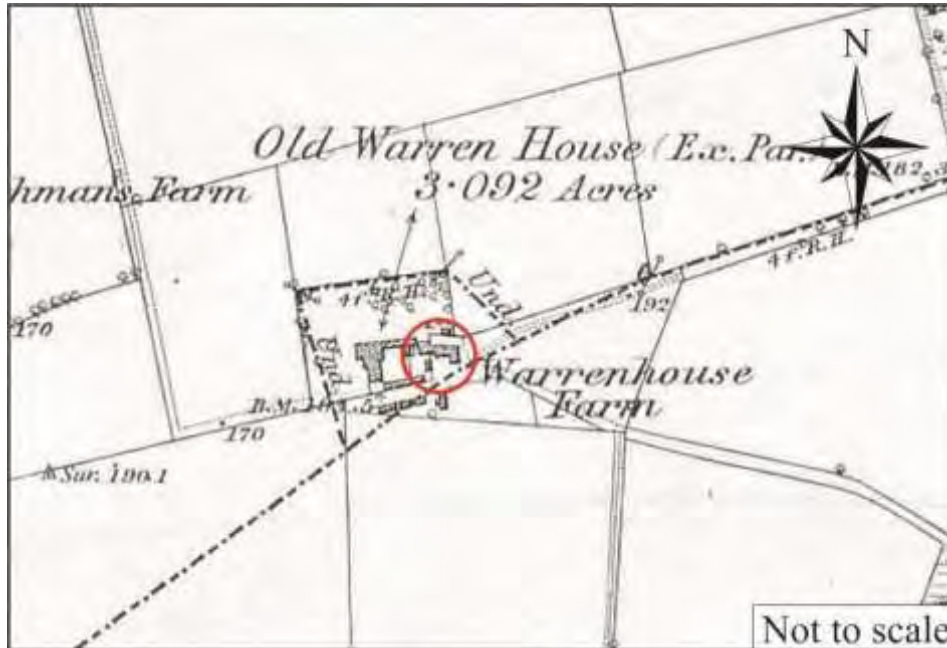
Fig. 5: First Edition Ordnance Survey Map of 1877

The First Edition Ordnance Survey Map of 1877 (Berks 38.7) shows an L-shaped building orientated predominantly east to west (Fig. 5). The barn to the west appears to be shown as being attached to the house. The farmyard has an L-shaped building to the north and west

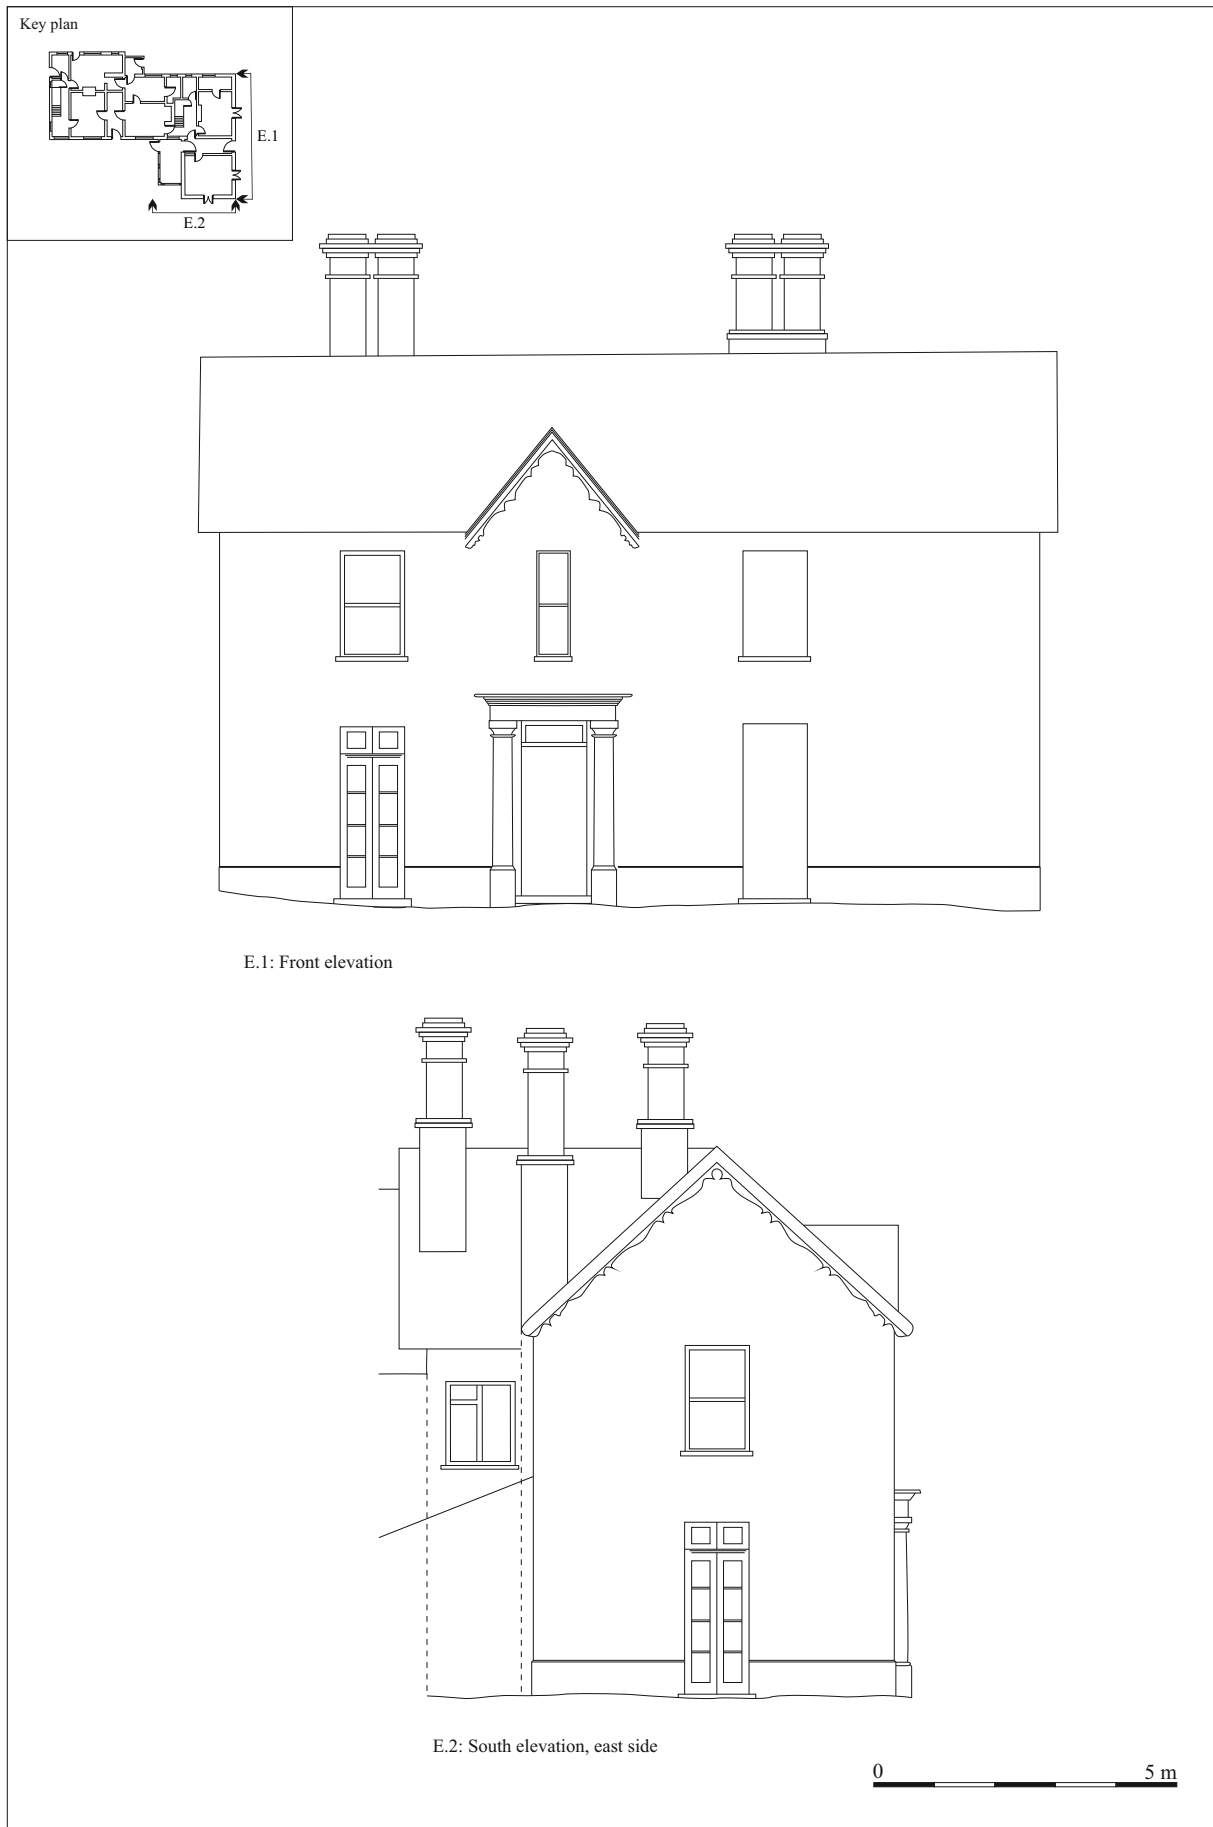
Figure 10: Front and south external elevations

The front façade of the building faces roughly towards the east (Fig.10, E1, plate 1). It is of brick with a red clay tile roof. The façade contains three bays. Centrally the ground floor has a square headed door with window light and porch, and is panelled. The porch contains two square pilasters with Doric type features, above which is a cornice. The first floor window above is a square headed sash window that contains two window panes and sill. Above the first floor window there is a small gable. The two flanking bays contain double glass panelled doors with window light above. The first floor window above in both cases is a square-headed sash window with four panes. Above the roof line it is possible to see the remains of three double chimney stacks with brick water tabature.

The south facing façade is dominated by the gable end of the front range (Fig. 10, E2, plates 2-3). This has a single bay with a double door, glass panel door with roof light on the ground floor. There is a square-headed sash window on the first floor with four panes and a sill. To the west of this façade there is a rear extension with five bays. The four west bays have modern casements and the central one from the east contains a ground floor door. Between the two central groups is evidence of a butt joint. In the corner between the rear extension and the front range, there is the end of a brick conservatory, a single square-headed window in its south range. This conservatory conceals a square headed window, and there is a further square headed window above. This bay closest to the front range is located in the timber framed structure with brick infill.

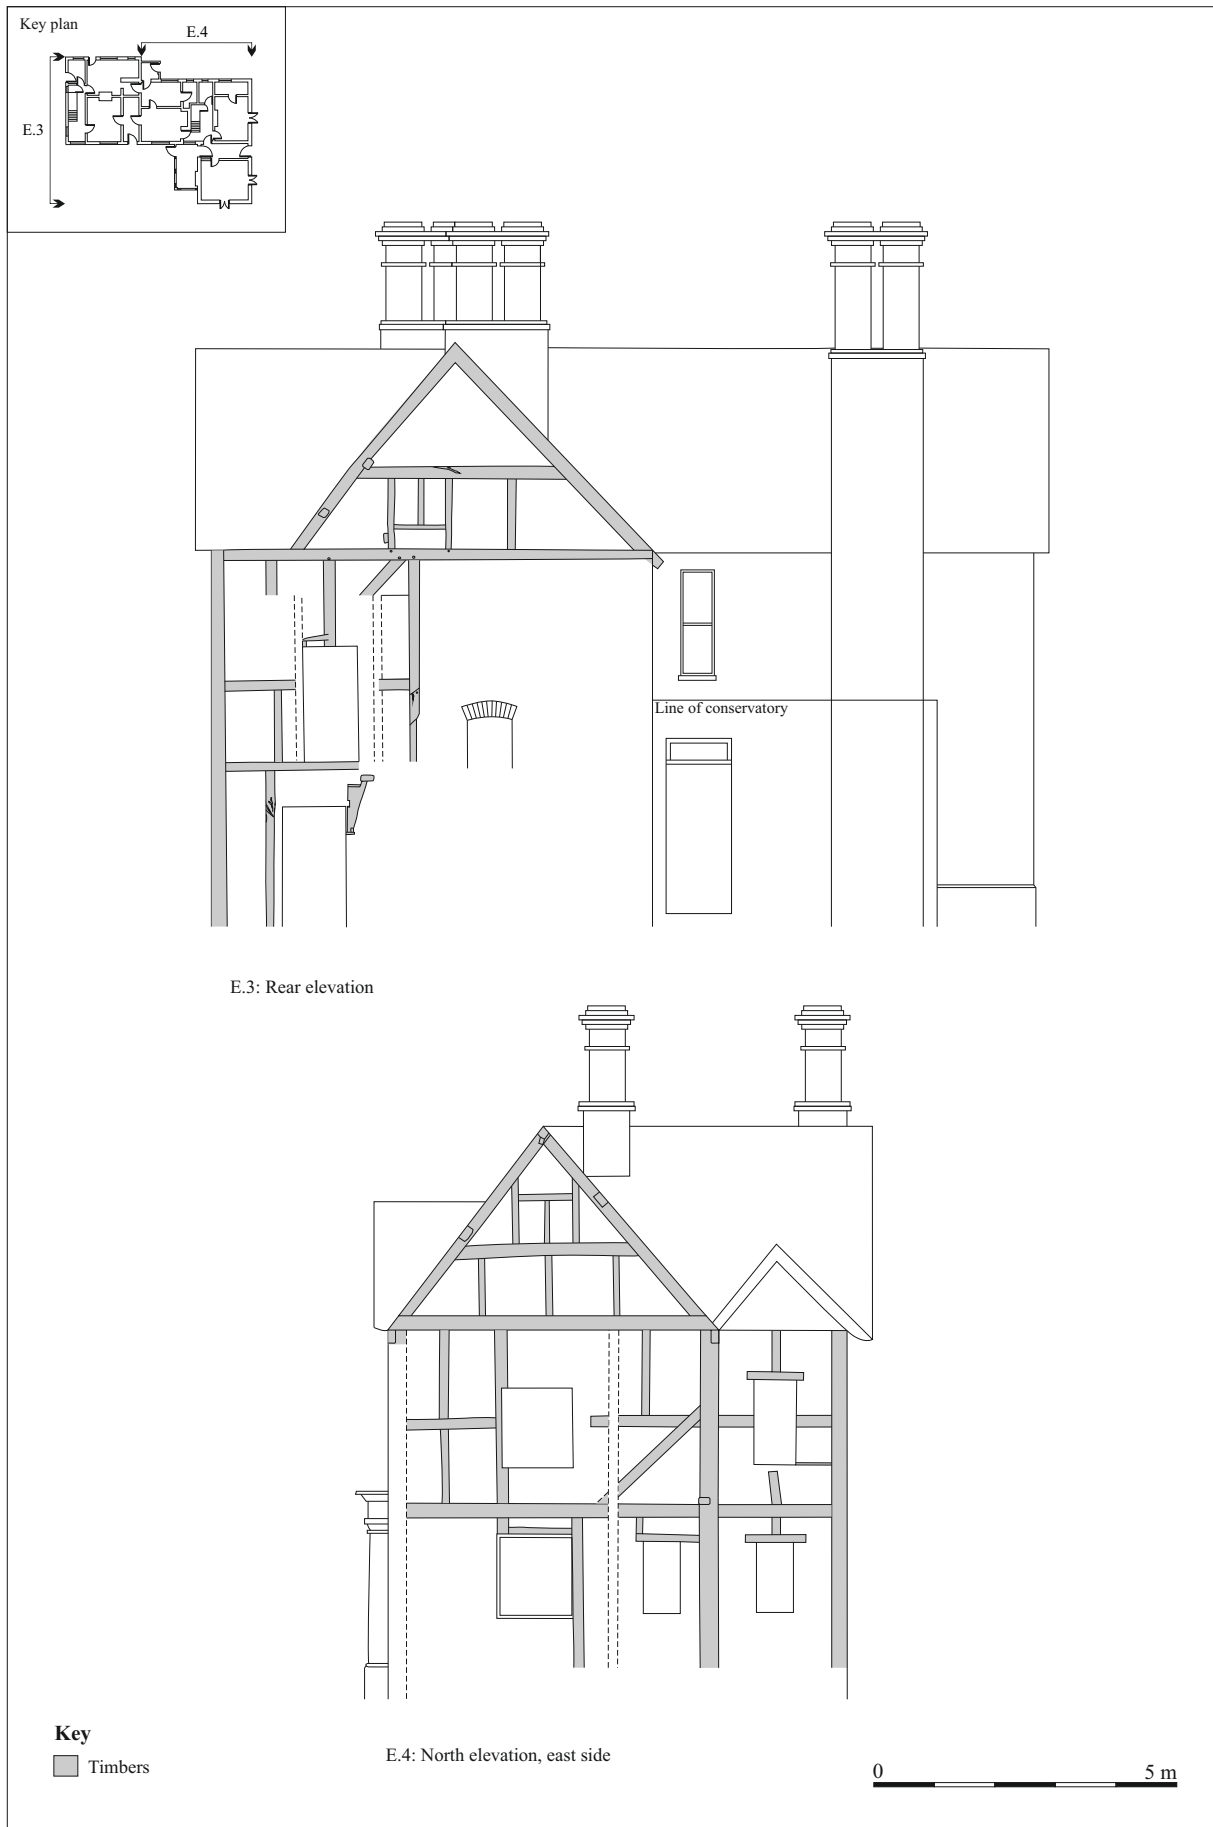
Figure 11: Rear and north external elevations

The north façade contains a gable at the end of the front range (Fig. 11, E4, plates 7-8), and a small side gable, which is often interpreted as the stair turret. Both of these gables and walls below contain evidence of box framed timber structures with brick infill and underlying plinth (plate 9). The remains of a brace is evident on the first floor. This part of the building contains three bays on the ground floor, with modern casements. On the first floor it is only the two outer bays that contain windows. To the west of this there is a rear extension of two parts. The first part contains a wall in line with the front range of the building, which has a window and door on the ground floor, both of modern casements, and on the first floor there is a single window. To the west of this there is a flat roof extension out from the gable that contains four bays. Three of the bays contain modern casements on the ground and first floor, with the second bay from the west having a door on the ground floor.

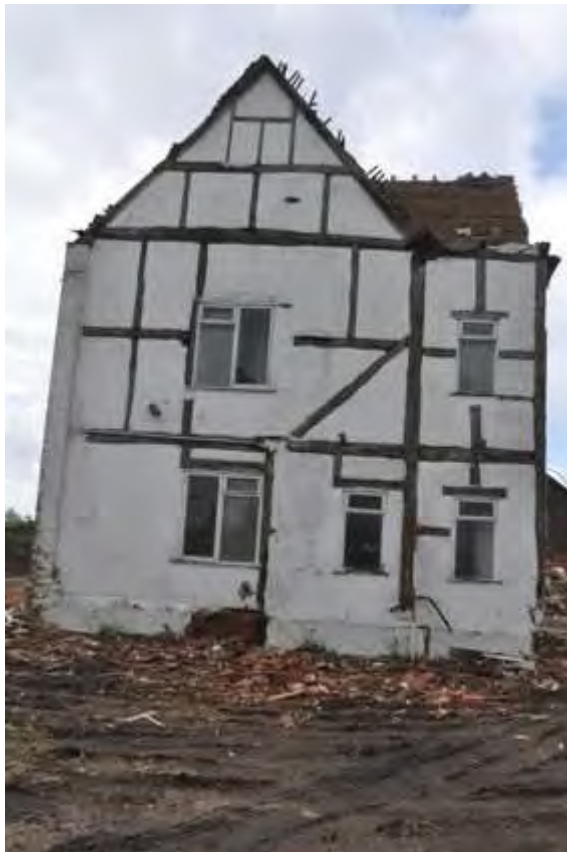
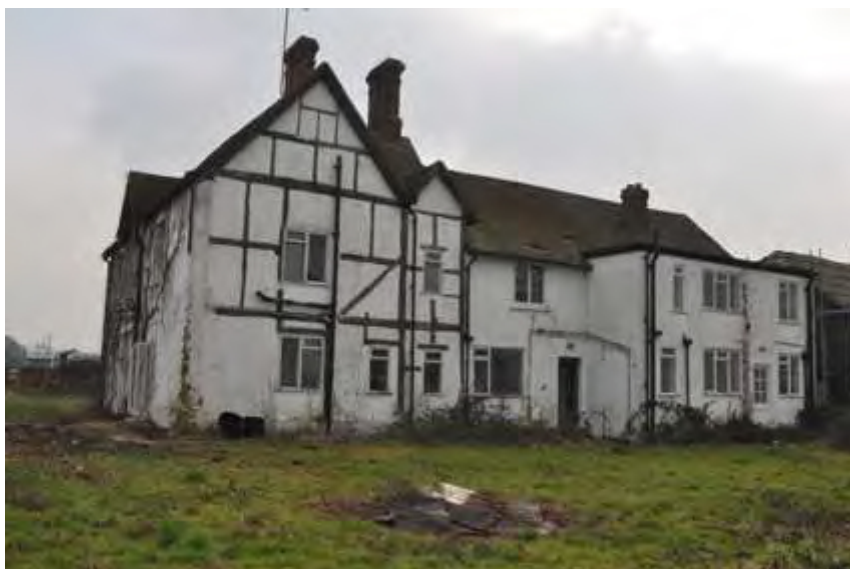
Plate 7: North façade

Plate 8: North façade

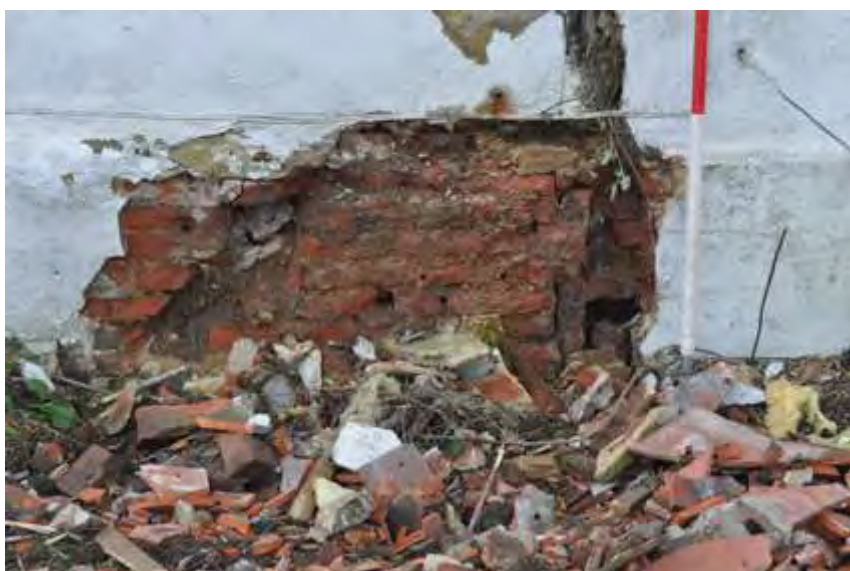
Plate 9: Plinth on north façade (wall 2/12)

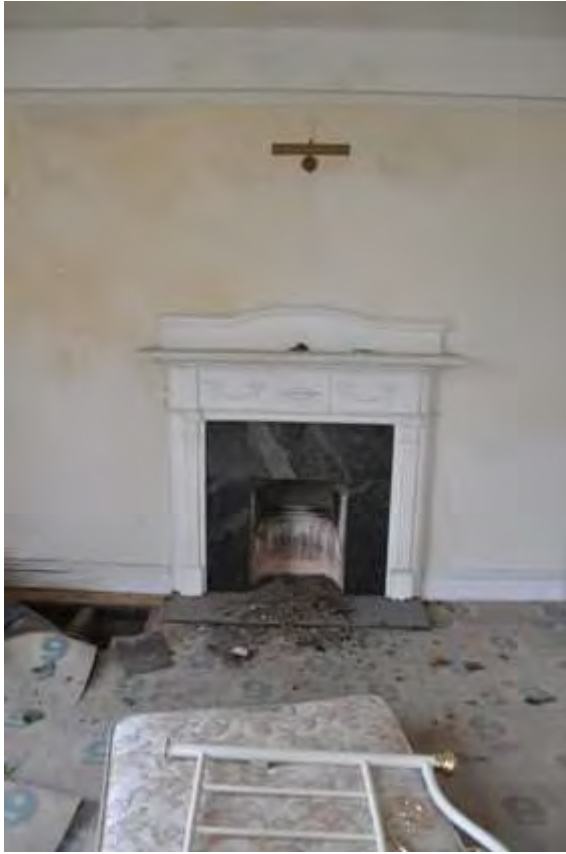
Plate 10: Fireplace G2

The door on the south side enters room G2. This has a Georgian fireplace in the west wall (plate 10) and double glass doors in the south and west wall. The panelled door is in the north wall. There is a moulded skirting and a cornice rail and central roundel (plate 11).

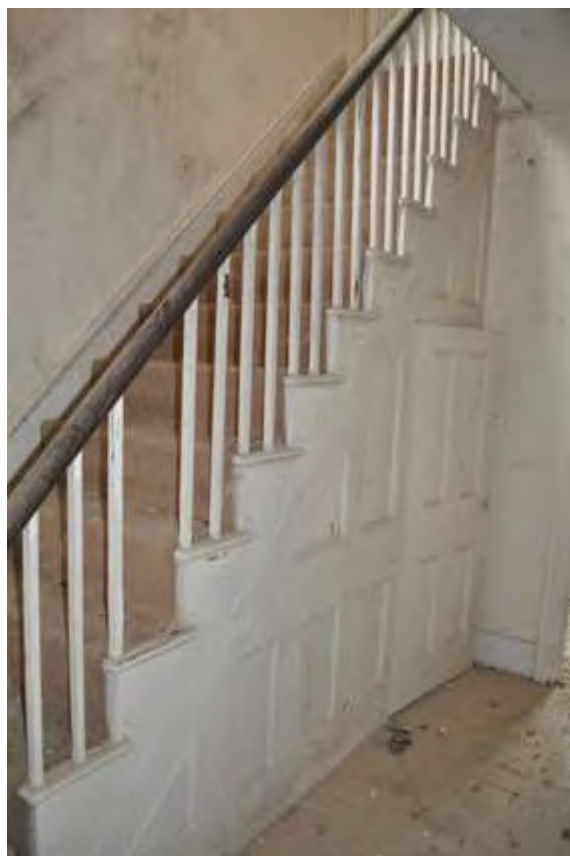
Plate 12: Early 19th century staircase G4

The door on the north side of the hall (G1) leads into a further hall (G4), which is of an L-shape. This is dominated by a ladder stairs with panelling enclosing the area underneath the stairs (plate 12), with a panelled door to a cupboard. The stairs have a simple balustrade arrangement. This is one of the features that were used to provide dating evidence for the rebuilding of certain elements of part A and part B dated *c.* 1800. In the south wall is the window that looks into the conservatory (Fig. 12, E6). In the east wall there is a panelled door, and further ones in the north and west walls at the end of each arms. Some timbers were uncovered in the south wall by stripping.

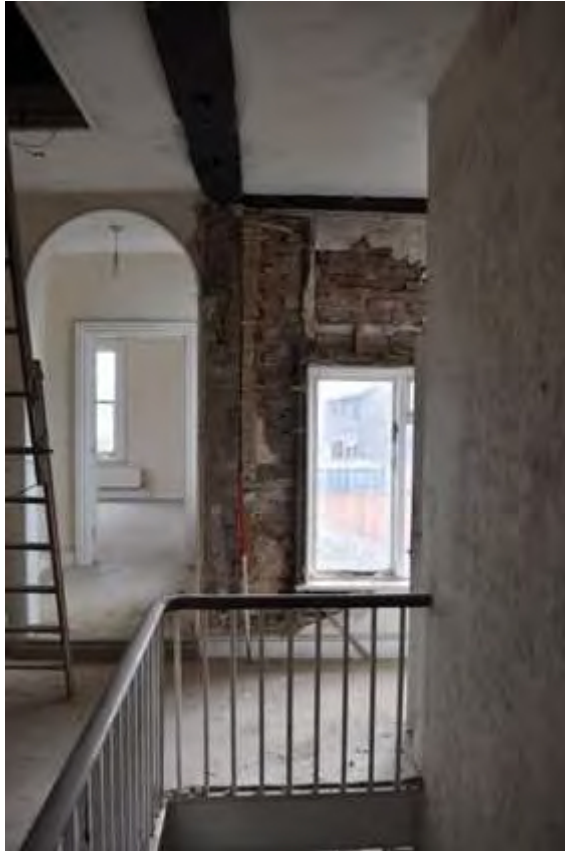
Plate 16: South wall F1

side of which there are two panel doors. There is a cupboard set to the north of the chimneybreast. The west wall contains timber framing, which was exposed (Fig. 13, E9, plate 14). There is a panel door in the staggered north wall line, and an alcove, which contains timber framing (Fig. E10, plate 15). More timber framing was uncovered in the north wall (Fig. 13, E11, plate 15). In the east wall there is a single panelled door. In the south wall there is a round headed arch on the left hand side and a modern casement window on the right. When this wall was uncovered there was evidence of timber framing surviving (Fig. 13, E12, plate 16). The ceiling contains a timber beam (plate 17)

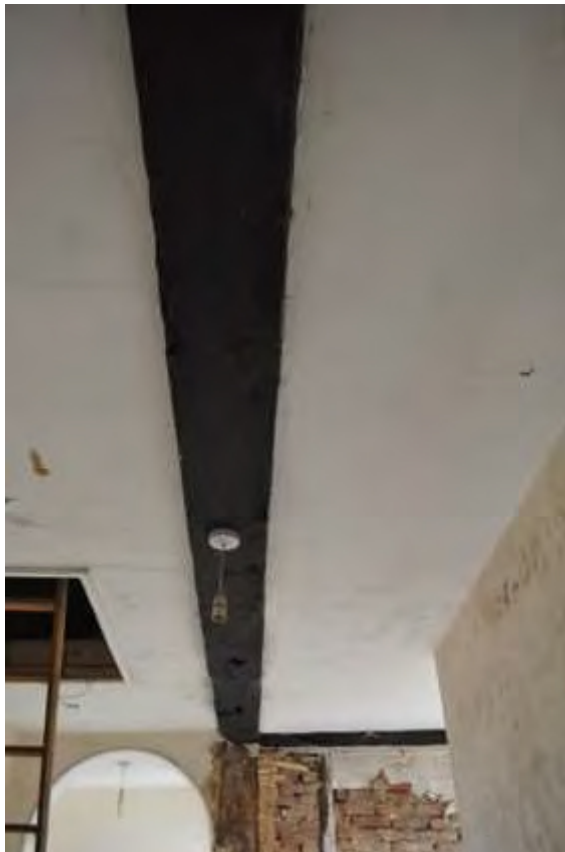
Plate 17: Ceiling timber F1

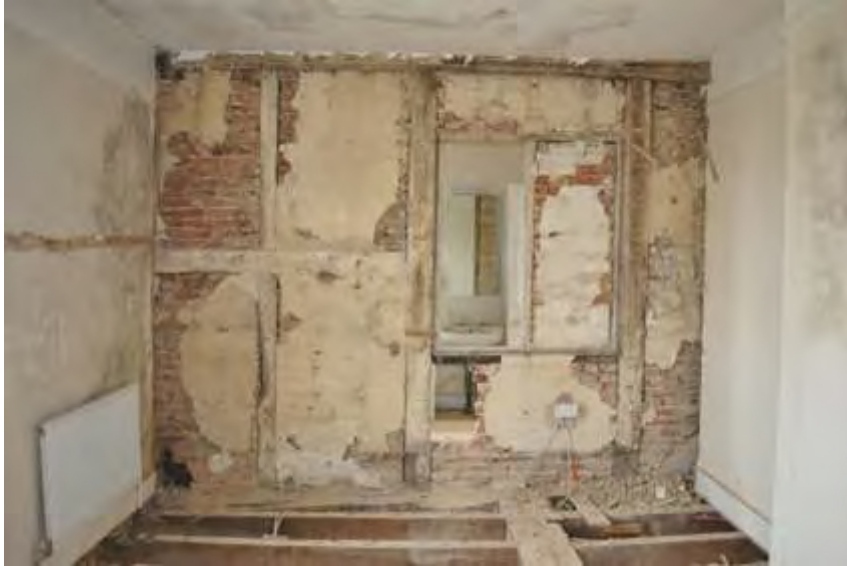
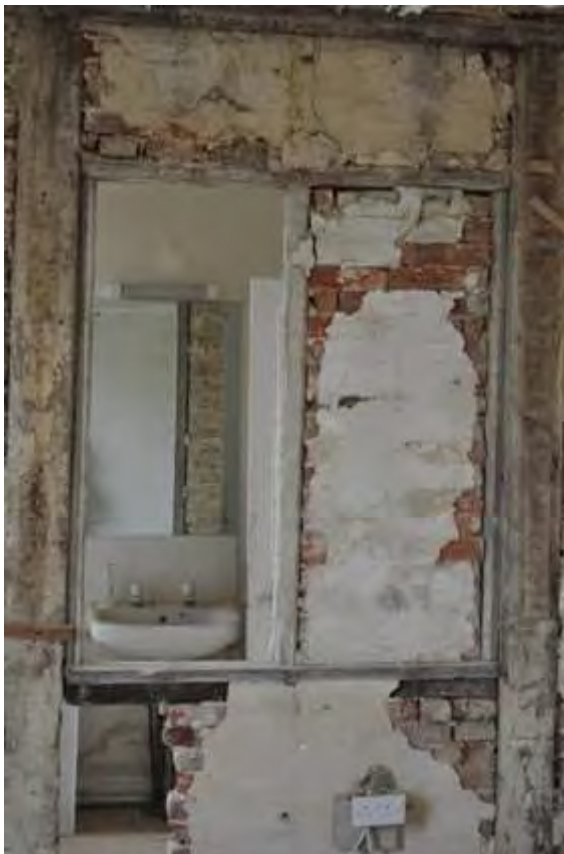
The panel door on the east side of the landing (F1) leads into room F3. This room has a sash window in the east wall and a chimneybreast in the west wall. In the south wall the stripping back of the plaster uncovered the remains of timber framing (plates 18-19). In the north wall there is a door that enters an *en-suite* (F4) with a window in the north wall. The north wall also contains indications of timber framing.

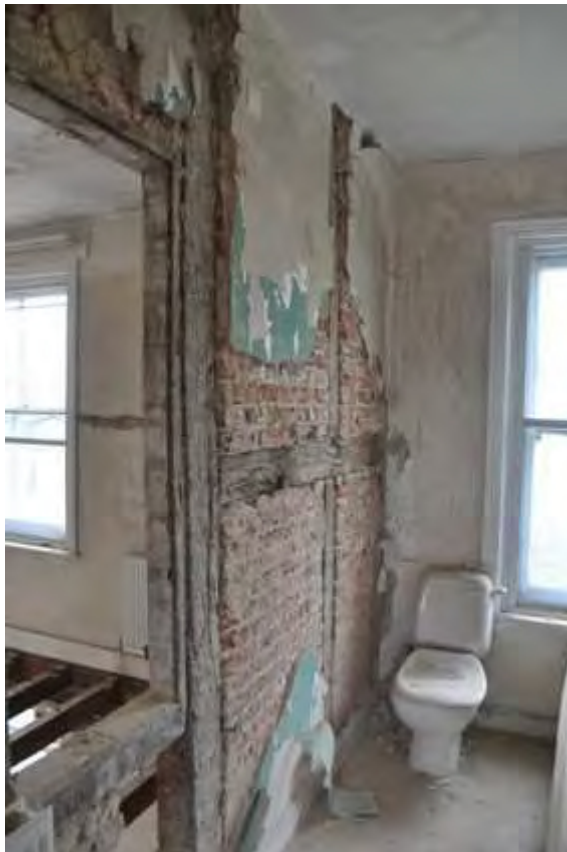
Plate 20: Timber framing F5

The east door from landing F1a enters a bathroom F5, which has a narrow sash window in the east wall. Stripping of plaster revealed that the north wall contained timber framing with brick infill (Fig. 13, E13, plates 20-21). The bricks have a depth of about 50mm and thus are likely to be 16th or 17th century in date.

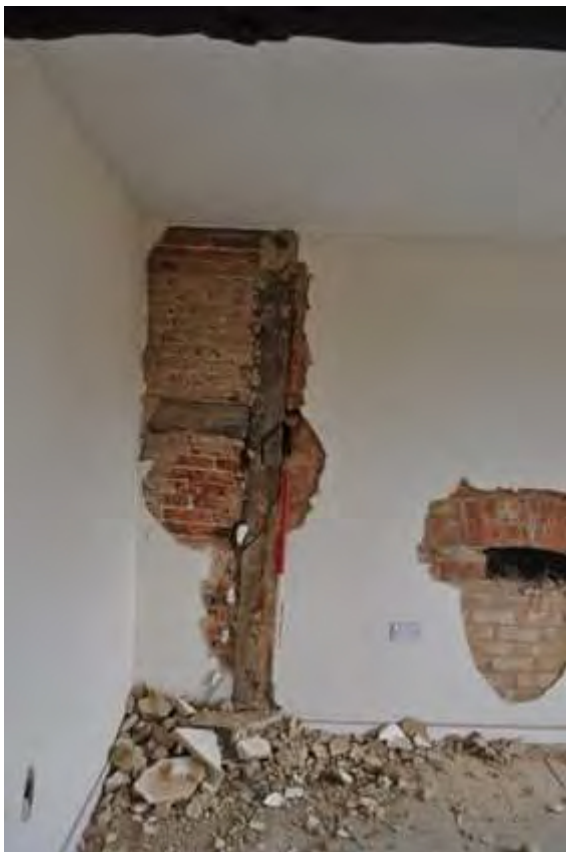
east wall. Stripping of this wall uncovered the remains of timber beams (Fig. 13, E14, plate 22). Timber transverse beams are evident in the ceiling.

Plate 22: Timber framing F7

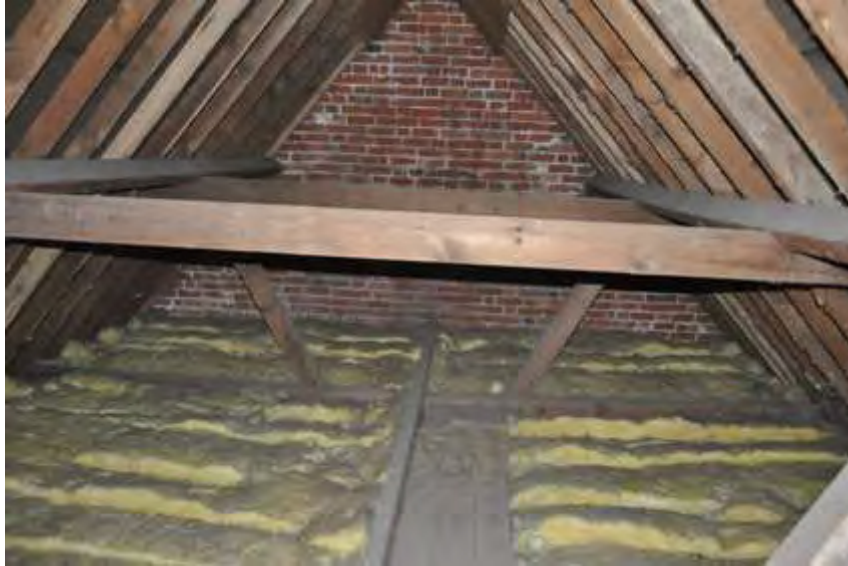
Plate 32: Attic B

The attic space over part B has nicely cut timbers. There are two trusses, both of which have two struts, and one of which has a narrow plank acting as a collar-beam between the two purlins (Fig. 15, E18, plate 32). There is a further plank acting as a collar beam between the purlins. The gable end wall on the south side is of brick with no timber framing, and the timber frame between the attic space over part A and B is roughcast on its south side.

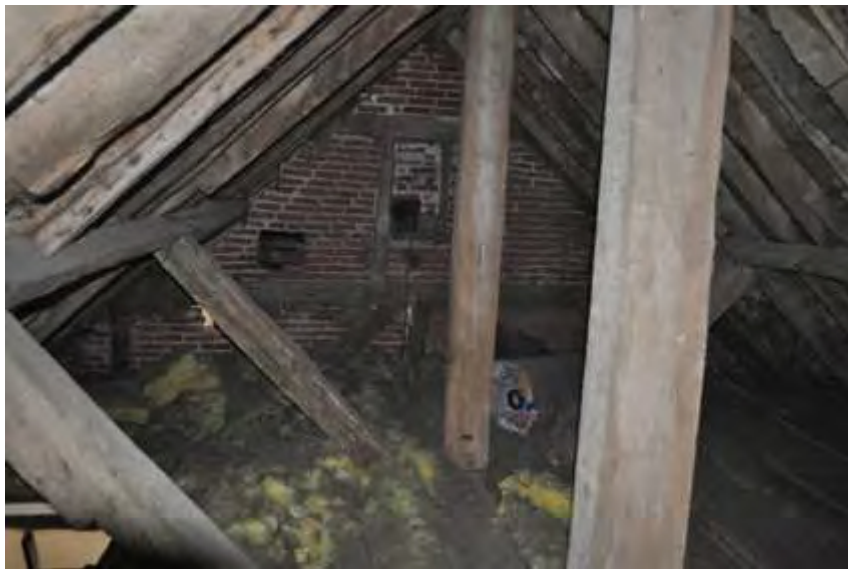
Plate 33: Attic C

The attic space over part C contains part of the timber frame gable on the west side of part A (Fig. 15, E19, plate 33), which has already been described. Below the wall plate there are posts surviving of timber framing, part of a box frame. There is also a brace surviving in this area. There are two trusses in this roof space that each contain a king post with two accompanying struts, set over a tie-beam (Fig. 15, E20, E21, plates 32-33). The timbers in these trusses contain the remains of mortise joints, thus implying that they have been reused from elsewhere.

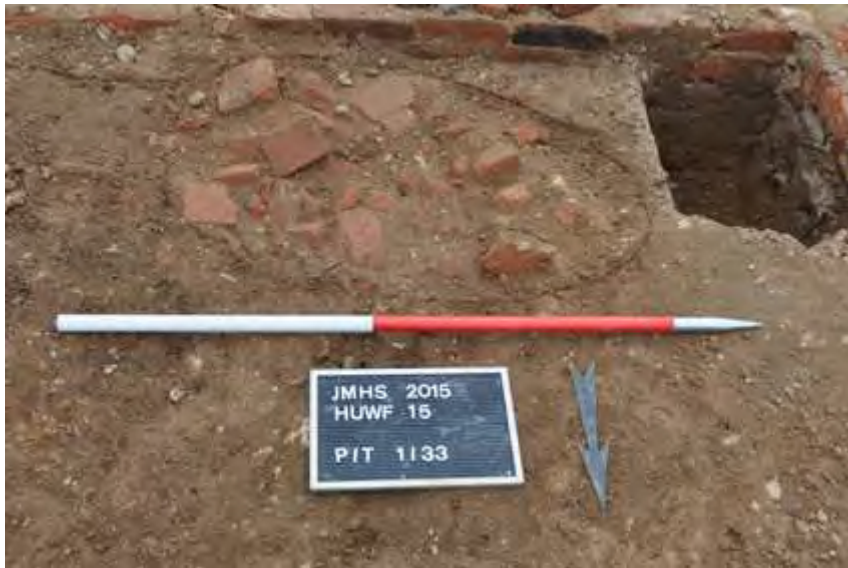
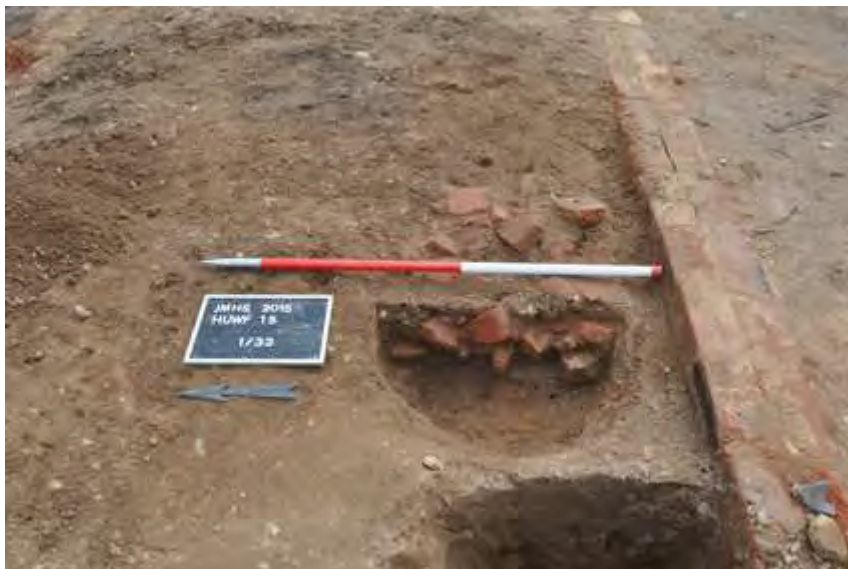
Oval pit 1/33 had gradually sloping sides and a flat base and measured 0.91m by 0.61m and was 0.21m deep (Fig. 20, S6, plates 37-38). The fill (1/34) was a compact mid-brown sand with frequent inclusions of brick, which had an approximate depth of 50mm or less.

Plate 37: Cut 1/33

Plate 38: Cut 1/33

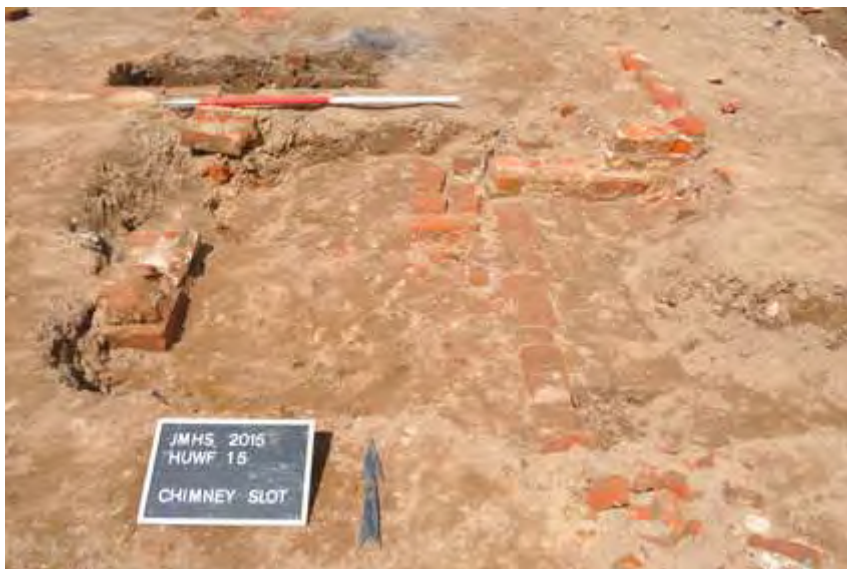
Rectangular cut 1/71 represents a rectangular feature in which the original west chimney breast was constructed (Fig. 20, S7, Plate 39). This cut was 0.64m to 0.7m wide and was at least 1.5m long. The sides of the cut were relatively steep. Masonry wall 1/42 was of red bricks that measured 210mm by 110mm and 45-50mm. This was bonded by a grey brown mortar and was orientated north to south. This stretch of the wall had a single brick width and represented the back of the fireplace. Butting up to the brick wall 1/42 (but not apparent on S7) was fill (1/44) a compact brown sand with frequent charcoal inclusions, which was 0.08m deep. A sherd of pottery with a mid-16th century profile was recovered from this context, and also a flint blade of a Late Mesolithic to an Early Neolithic date. Overlying this was layer or lens (1/49) which was a moderately compact dark brown sand with frequent ash inclusions measuring 0.07m deep and 0.5m across. This last lens represents an area of burning in the base of the chimney breast.

Plate 39: Wall 1/42

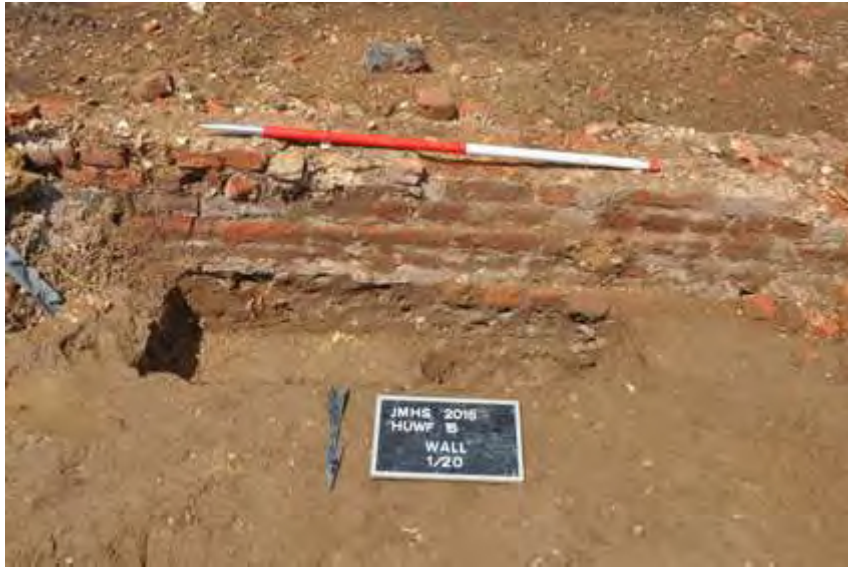
Foundation cut 2/17 was a linear feature measuring some 7.6m long and 0.36m across, which had vertical sides and a flat base. This was associated with masonry structure 2/12 that was constructed of red brick measuring 220mm by 110mm and by approximately 45-50mm (plates 40, 9). The wall was 7.6m long with a width of 0.36m and a height of 0.29m, having six visible rows. The next wall was a continuation; wall 1/20, although there was a slight deviation in the orientation of the line of the wall. The deviation in the wall line may not be due to a different date for construction, but that two timber-framed constructions were being replaced and that they had probably been slightly misaligned originally. Foundation cut 1/73 is a linear feature that is about 0.5m across and 0.08m deep, with shallow sloping sides and a rounded base. Masonry 1/20 was a brick wall and foundation with a yellow sand mortar bonding, which is orientated east to west. This formed part of the plinth that underlay the northern part of the building (plate 41). The bricks measure 110mm across and 45-50mm deep. The wall survived to at least three courses after the concrete flooring had been removed. Backfill 1/66 is a moderately compact mid-grey brown silt sand with stone inclusions. This deposit produced a sherd of pottery that has a profile of a 17th century pot and two fragments of clay tobacco pipe, one

Plate 40: Wall 2/12

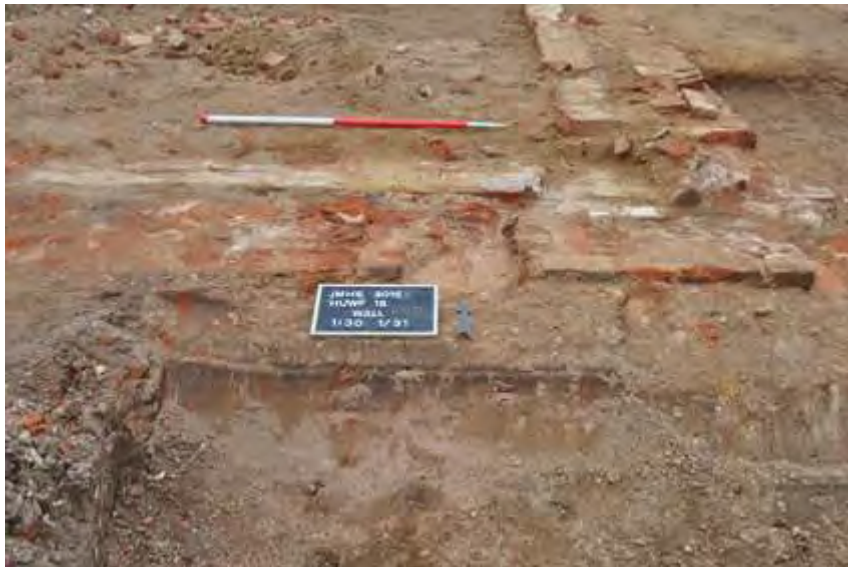
Foundation cut 1/78, for wall 1/31, was recognised over a 6m length and 0.5m across, where the wall survived, but had presumably originally extended up to 8m in length. The sides were vertical and the base flat. The associated masonry wall 1/31 was constructed of bricks with an approximate height 45-50mm, and which was bonded by a white yellow mortar (plate 42).

Plate 42: Wall 1/31

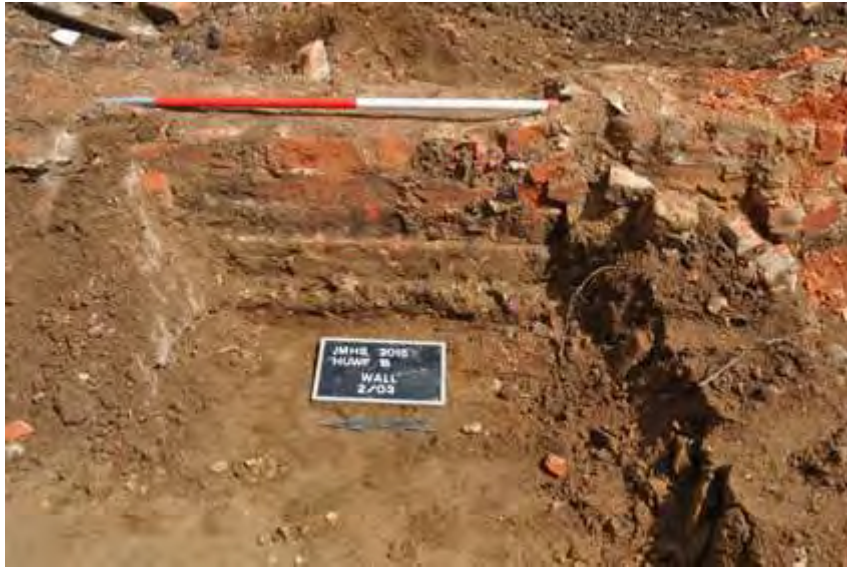
Foundation cut 2/18 (for 2/10, 2/11, 2/03) was a linear feature 13.6m long and 0.4m wide with vertical sides and a flat. Ballast foundation 2/10 was a cemented mix of gravel pebbles with also brick and burnt inclusions (Fig. 20, S11, not on plan). The bricks were reused and measured 220mm by 110mm by approximately 50mm. The foundation was 0.11m deep. The ballast foundation was capped with masonry wall 2/11 is constructed of red bricks 40-45m deep (not on plan). Masonry structure 2/03 was constructed of bricks 230mm long by 70mm deep and was bonded by a grey white mortar (plate 45). The wall survived to a height of 0.26m and 0.4m wide and was 13.6m long.

Plate 45: Wall 2/03

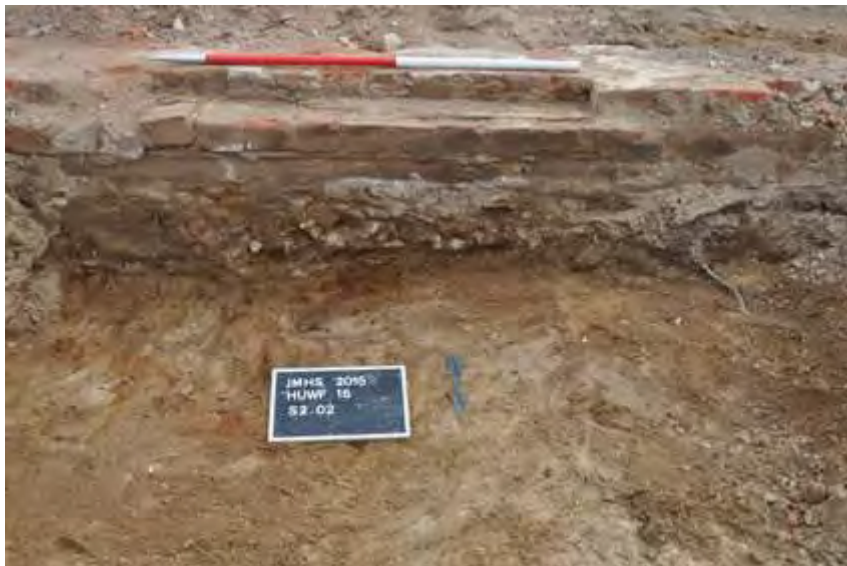
Plate 46: Wall 2/04

Foundation cut 2/19 (for 2/13 and 2/04) was 5.8m long and 0.45m across with vertical sides and a flat base. Ballast foundation 2/13 was a cement mix with gravel, brick and burnt inclusions with a height 0.21m. The ballast foundation was capped by masonry structure 2/04 was made of bricks measuring 240mm by 110mm by 70mm (plate 46). This wall had a height of 0.35m and was 0.45m wide and some 5.8m long (Fig. 20, S12).

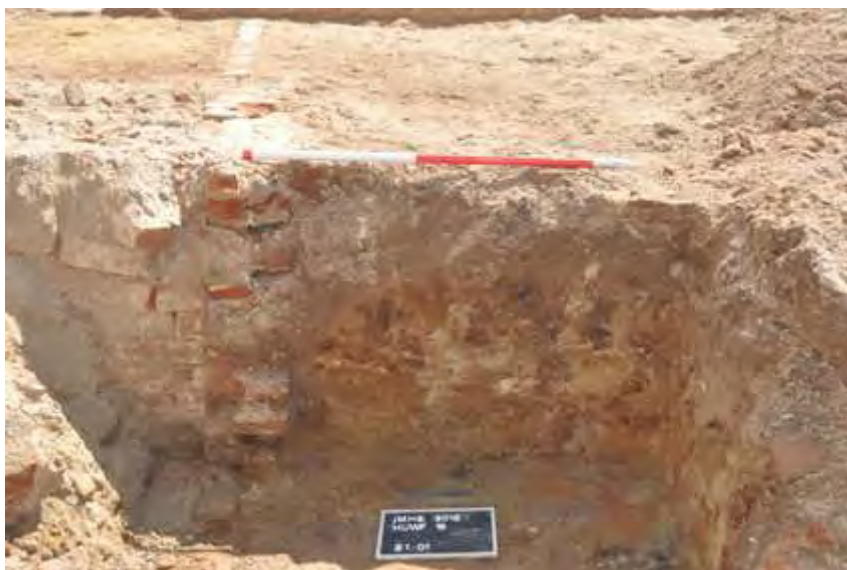
Plate 47: Wall 1/09

A significant cut had occurred in the northwest area of part D of the building. This was for a half cellar probably used as a 'Warren House'. It was also the case that a couple of the walls looked as though they were not bonded in properly to the other walls. Linear foundation cut 1/86 that was at least 2m long and 0.22m across, with a steep to vertical side with a flat base. The masonry structure 1/09 was constructed of a brick with a depth from 65-70mm (Fig. 20, S15). Foundation cut 1/07 was a linear feature. The masonry wall 1/06 was a brick wall orientated east to west and 0.24m wide. The wall was bonded by a grey white mortar. Backfill (1/08) was a loose mid-grey sand with inclusions of brick, mortar, and stone and measured 0.24m wide and 0.87m deep. Brick floor 1/10 was 0.08m thick and butted up to walls 1/09 and 1/06.

Walls in the area of part D not related to the post 1911 build included 1/13, 1/09, 1/06, and 1/45. Foundation cut 1/87 was for a wall about 3.7m long and some 0.4m across. The masonry structure 1/45 was a brick construction with the bricks measuring 270mm by 110mm by approximately 60mm. The wall is orientated north to south and has a stretcher bond. The backfill (1/55) was a loose red sand. This deposit produced a residual sherd of the mid-16th century and a clay tobacco pipe fragment of an early 18th century date. This wall is interesting in that it was located in line with the end of wall 1/31, and as such must represent part of a wall line that was located at the west end of the building. The bricks in this part of the wall appear to be 19th century in date, while part of the wall line appears to be missing. It is possible that the surviving wall may have existed as timber framing, and thus have been extremely ephemeral in nature. Foundation cut 1/62 which was for wall 1/13, had vertical sides and a flat base. The masonry structure 1/13 was made of bricks 210mm by 110mm by 60mm and bonded by a grey white mortar. The wall was orientated east to west and was 1.3m long. This joined up to wall 1/45.
