JOHN MOORE HERITAGE SERVICES

BUILDING RECORDING AND EXCAVATION

WARREN FARM, FOREST ROAD,

WOKINGHAM, BERKSHIRE

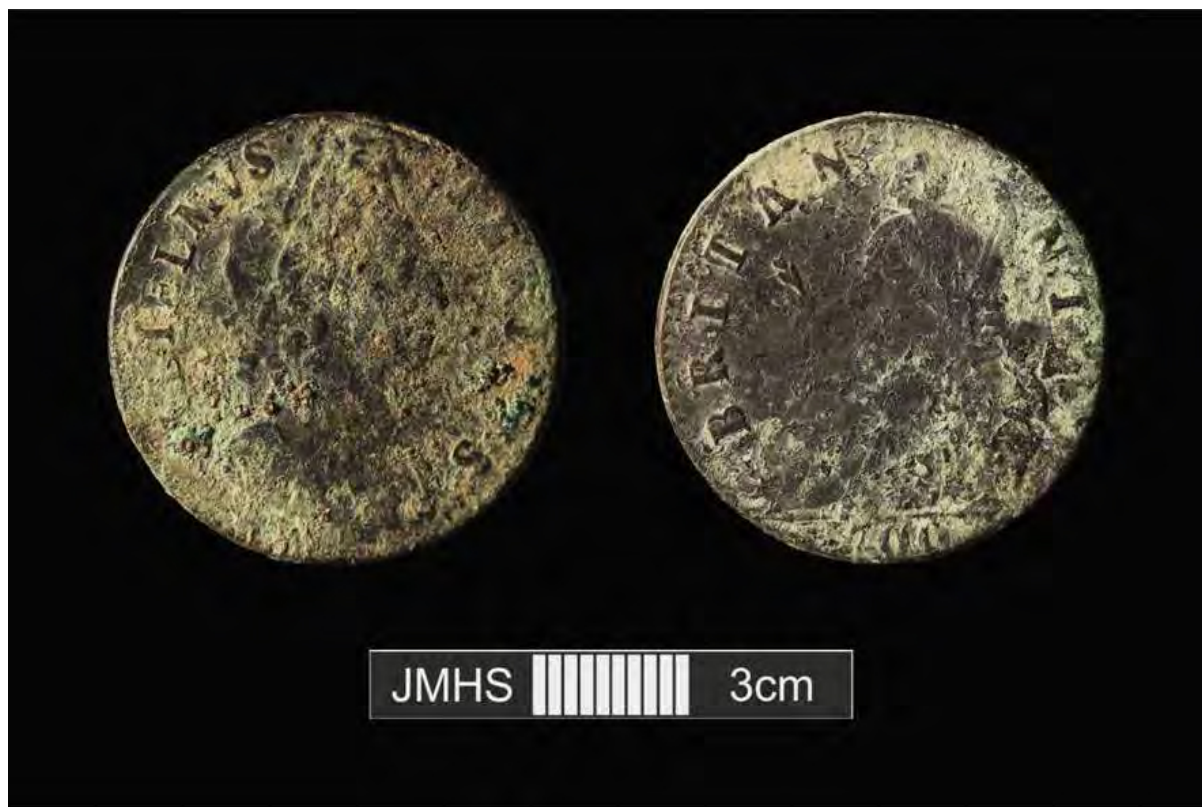
Plate 48: Halfpenny of William III (1694-1702)

Archaeological information: SF 1, context (1/60).
