JOHN MOORE HERITAGE SERVICES

BUILDING ASSESSMENT
ON
THE GARDEN COTTAGE,
LAWN UPTON HOUSE, LITTLEMORE,
OXFORD
NGR SU 53793 02699

On behalf of
Vanderbilt Homes

Building Assessment

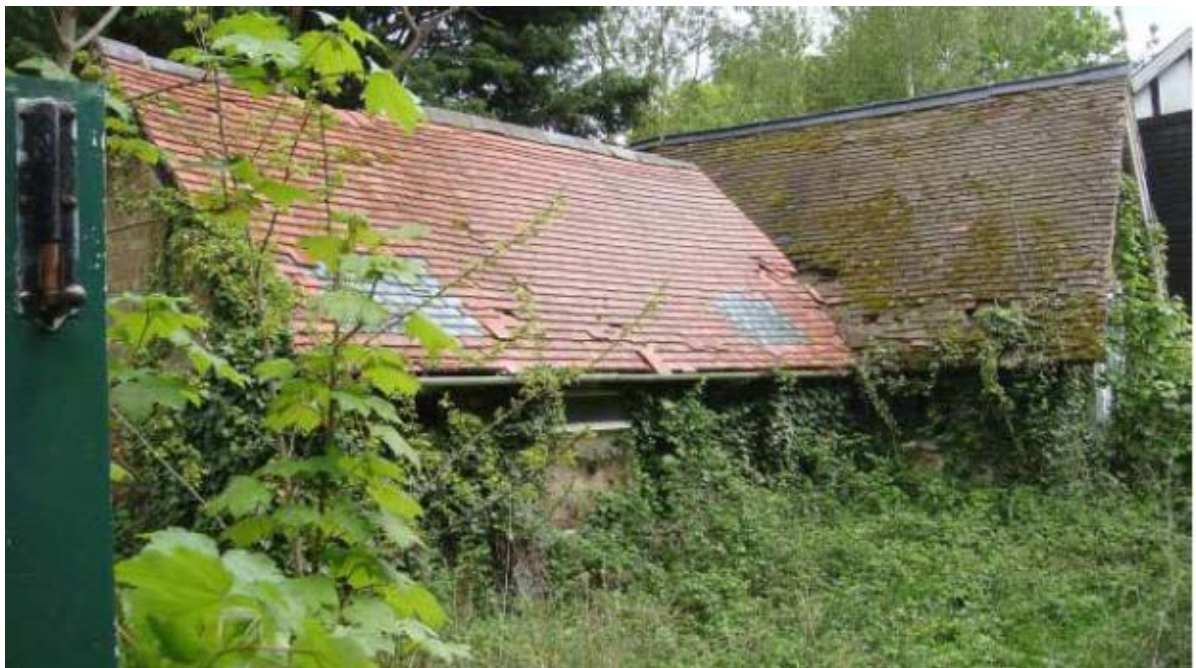
Plate 1 South elevation west end

The front elevation has three component parts. On the left hand side the elevation contains three different windows (plate 1). The windows are all of different sizes, with the two outer windows being of similar window pane size, while the central window is a modern insertion. The central component is a gable end with fascia boards and containing three large joined windows (plate 2). It is set at a non right-angle to the other axis of the building. The small right-hand part of the elevation contains a porch area with a window set in the porch (plate 3). There is a door on the left-hand side of the entrance.

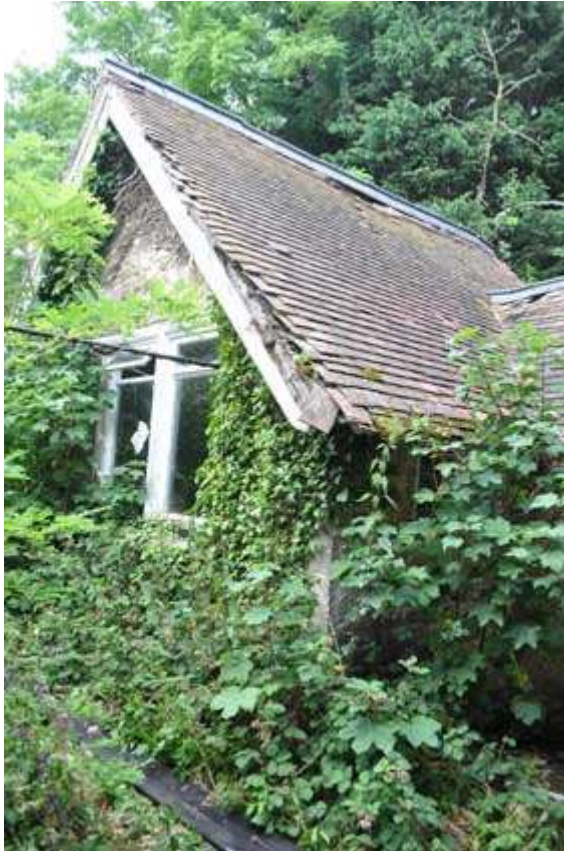
Plate 2 South elevation gable end

The west end contains a blank gable end. The gable can be seen projecting to the south, and has a small window inserted.

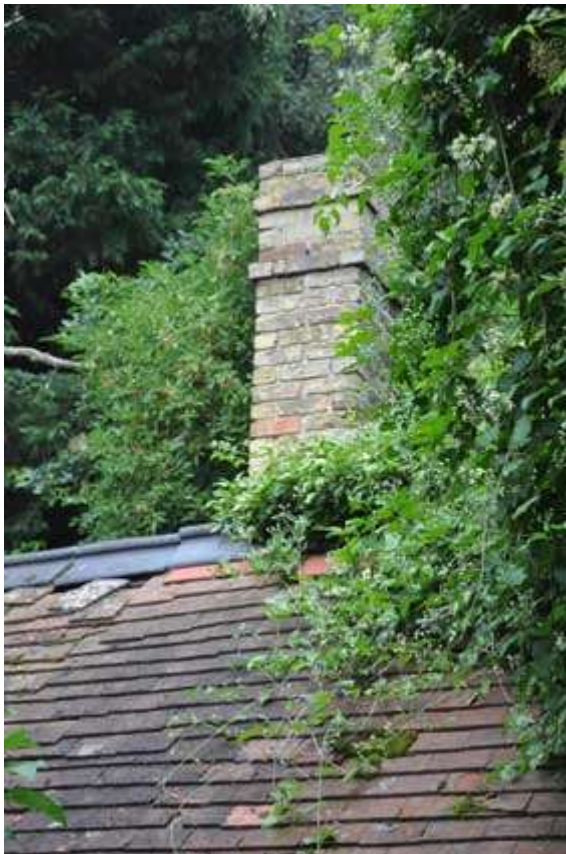
Plate 4 Chimney

The rear façade is formed along the line of the boundary wall, which had a thick width and was made of stone rubble. On the right-hand end there was a door, above which was a roof. At the east end of that roof there is a short chimney set at the junction. There is a central gable end with fascia. This central gable and the gable on the right-hand side are not joined. On the left-hand side there is a roof that is joined to the central part of the roof. From the left-hand roof there is a slender yellow brick chimney (plate 4) that rises above all roof lines.

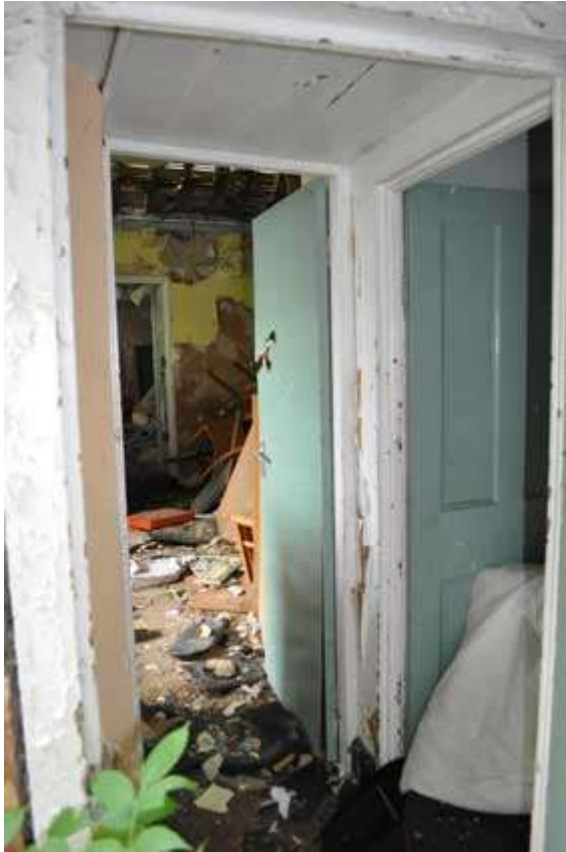
Plate 5 Entrance hall

The main entrance to the structure is through a porch on the southeast end of the building. On the left-hand side of the porch is a door that leads into a small square area with a door to the right and one straight ahead (plate 5). The door to the right leads into a small roughly square room with a sink in the southeast corner and a further door in the east wall leading into a toilet cubicle, which had a frosted window in the east wall.

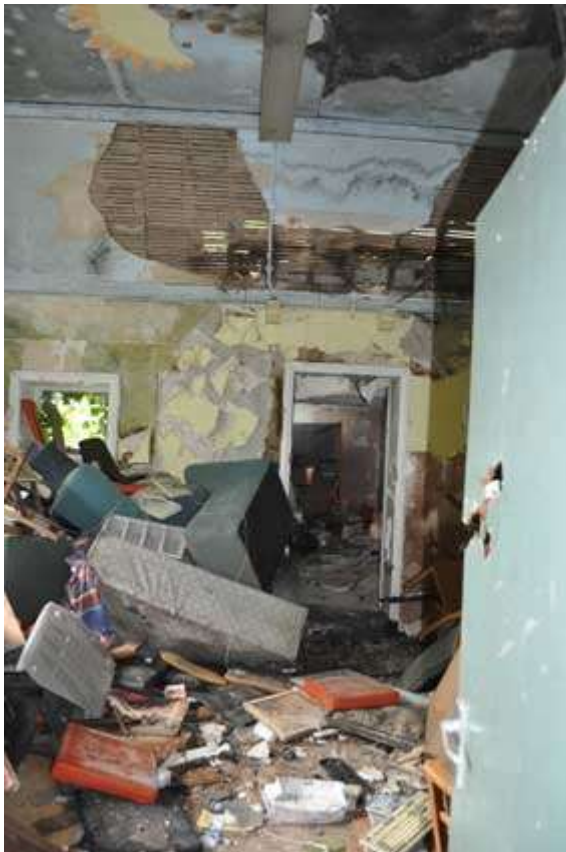
Plate 6 Central room

The door straight ahead leads into an irregular rectangular room and is a door roughly central to a staggered east wall. In the south side of the east wall there is a window. In the south wall there are three large windows. In the south end of the west wall there is a window. There is a door off-set from centre in the west wall (plate 6). A washing basin is located in the southwest corner of the room.
