JOHN MOORE HERITAGE SERVICES

ARCHAEOLOGICAL WATCHING BRIEF

MILLEN COTTAGE, CHURCH ROAD

ARDLEY, OXFORDSHIRE

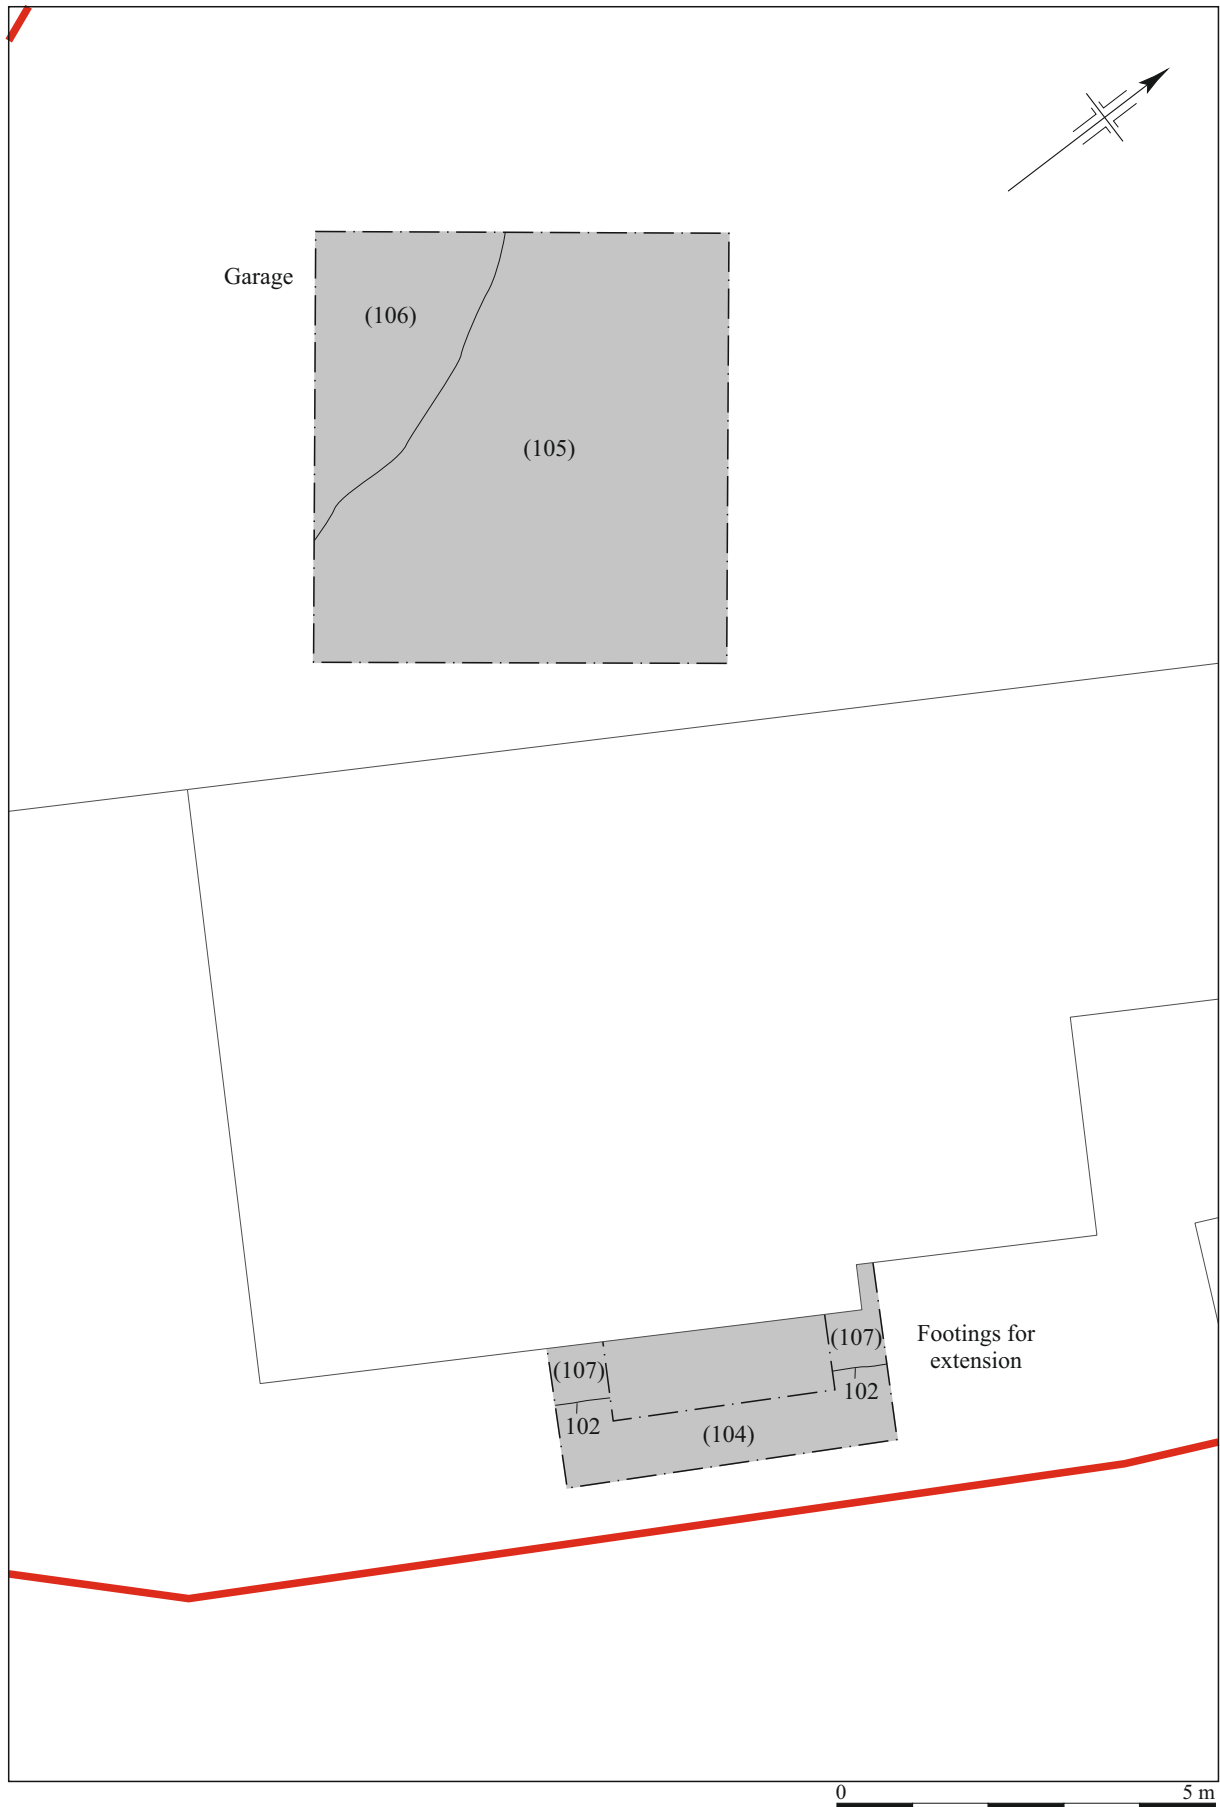
Figure 2: Plan areas

The lowest deposit encountered in the footings trench was natural (104), a firm light yellowish brown silty clay with frequent sub angular stone (weathered top of White Limestone Formation). This deposit had a thickness of 0.1m, and extended below the limit of excavation. (104) was overlain by soil layer (103), a soft mid brownish grey silty clay with a thickness of 0.7m. (103) was truncated by 102, the footings trench for Millen Cottage; 102 had a depth of 0.8m in the trench, and extended below the limit of excavation. It was filled by (107), a concrete slab with a thickness of 0.2m, and (101) a soft dark greyish black silty clay loam containing moderate fragmented brick

and slate inclusions. This deposit was overlain by (100), a hardcore drive surface 0.2m thick that was present across the whole trench.

An area of 5.5m by 5.7m was reduced to a depth of 0.3m. The lowest deposit encountered in this area was natural (106), a firm mid yellowish brown silty clay, 4m in length by 2.3m in width, and with a thickness of 0.1m. This layer extended below the limit of excavation, and appeared to be the same as natural (104) in the footings trench. (106) was overlain by (105), a soft dark brownish black clayey silt loam, with a thickness of 0.3m. This layer also extended below the limit of excavation.
