**BUILDING ASSESSMENT**

**54 NEW STREET,**

**HENLEY-ON-THAMES, OXFORDSHIRE**

**SEPTEMBER 2014**

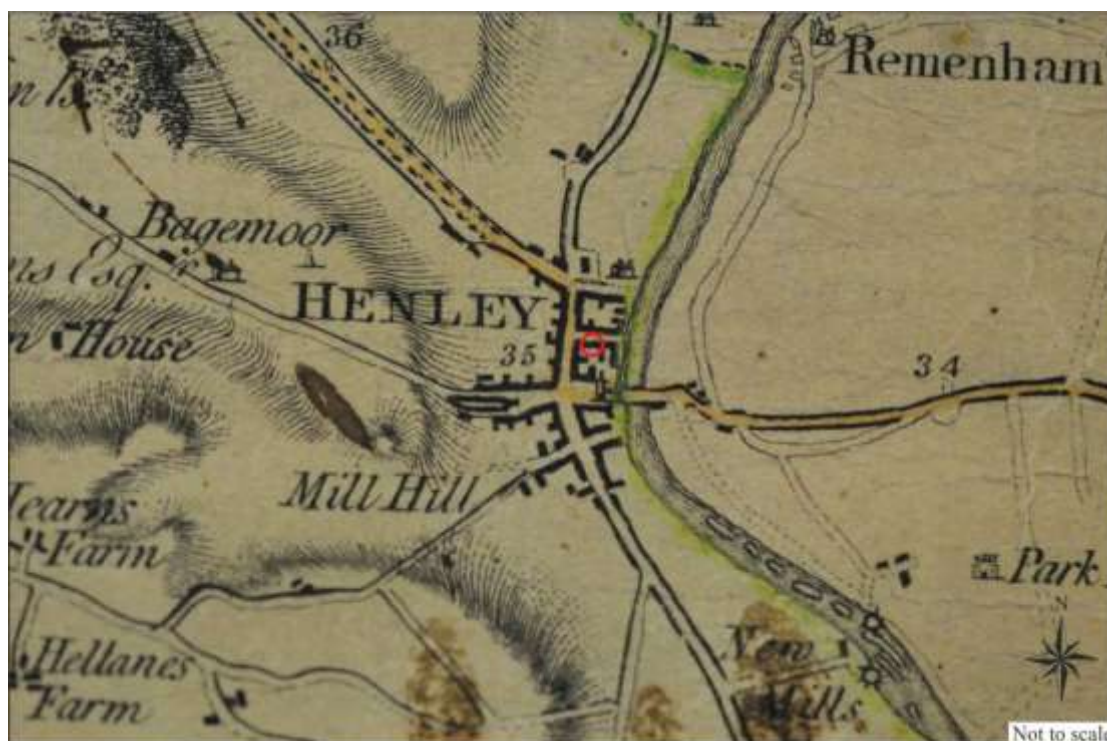
Figure 2 Jefferys' Map of 1767

The earliest map evidence of the 18<sup>th</sup> century includes Jefferys' Map of 1767 (Fig. 2) and Davis of Lewknor's Map of 1797 (Fig. 3). They show Henley as a series of roads forming a series of squares, with properties lining the street. Thus it can be assumed on both maps that there is a property in the present location. The map of Bryant dated 1824 (Fig. 4) shows a similar arrangement.

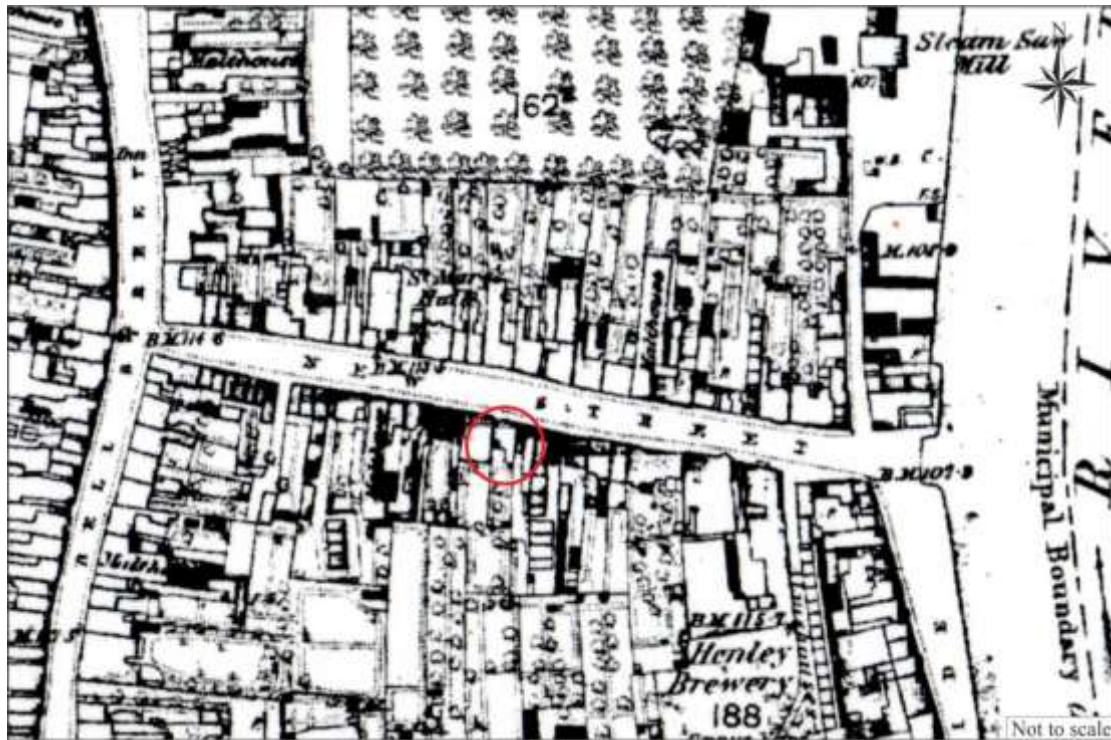
Figure 6 Ordnance Survey Map of 1879

The First Edition Ordnance Survey Map of 1879 (Fig. 6) shows the building in its current form with the rear wing or extension added. The second phase of the building can thus be placed prior to that date. The Second Edition Map of 1899 (Fig. 7) shows the building as it

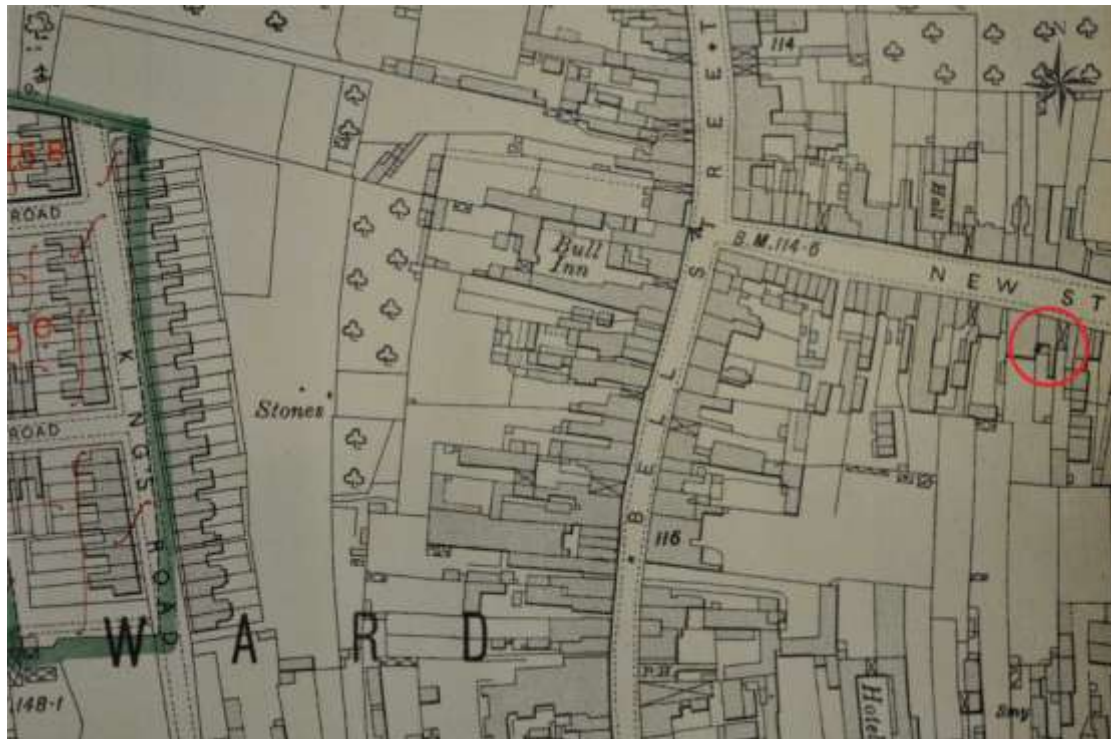
Figure 7 Map derived from Ordnance Survey Second Edition 1899

is but with a small addition, perhaps a conservatory between the two back doors. This external feature is still there in 1913 (Fig. 8), but has gone on the map of 1962. All of these maps were at a scale of 1: 2,500.

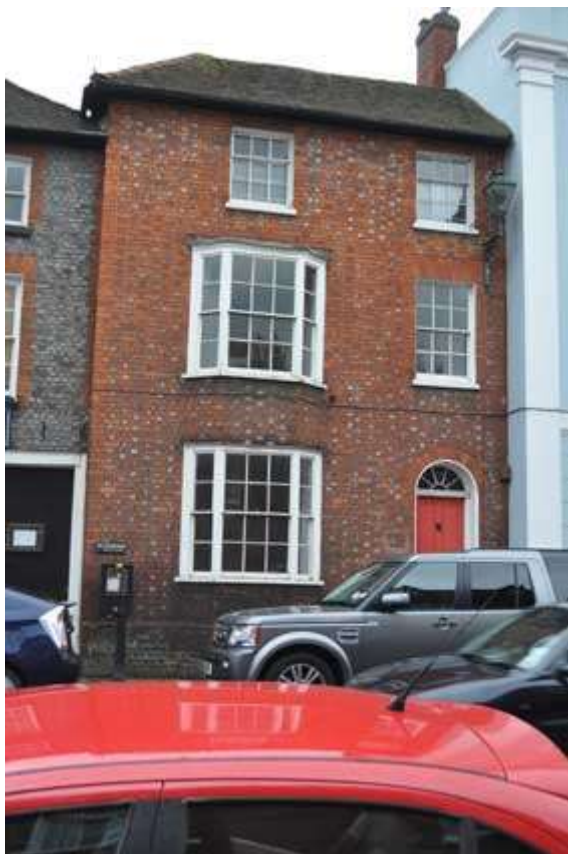
Plate 1 Front Facade

The front or north façade of the building is of chequered brick with two bays (plate 1). There is a plinth at the base up against which stone steps are placed along with railings running up to a front door on the right hand side. The ground floor front door is a panelled door in a round headed arch with a radial fanlight above. Onto the upright glass panel the number is inserted. The door contains a letter box and a lion knocker painted black. On the left hand side is a two storey canted bay window, of which the part on the ground floor contains a composite window with a sash forming the main and central part. The shape of the bay window is carried down into the plinth of the building and in the lower part of this there is an opening with a segmental window. The first floor also contains a bay window of composite parts that replicates the form of the window below. The upper bay window is capped with a flat lead roof. On the right hand side of the first floor is a sash window with a soldier lintel. The second floor contains two smaller sash windows that contain smaller soldier lintels that reach up under the over-hanging eaves. The roof is a red clay tile and is hipped on the east side. On the right hand side the roof is butted up to a neighbouring Georgian/Regency style building.

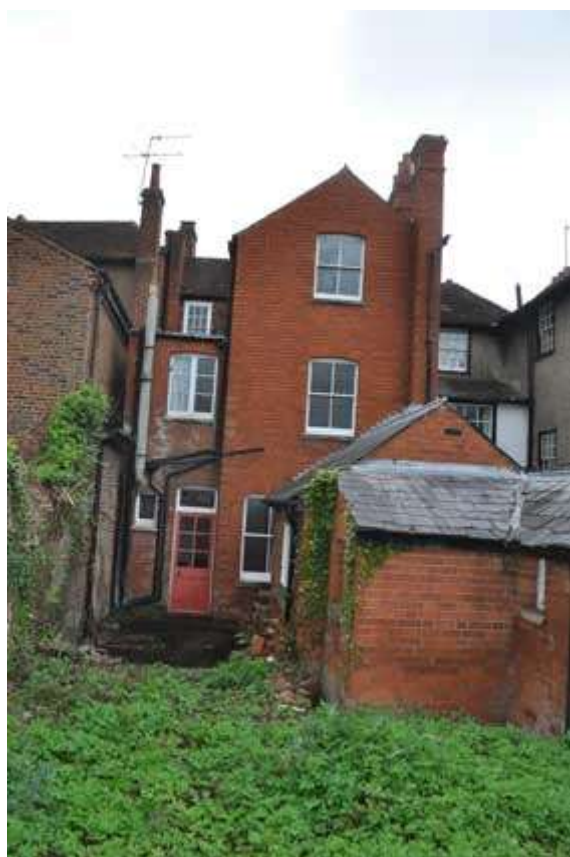
Plate 2 Rear Façade

The rear façade is dominated by a gable on the right-hand or east side (plate 2). On the right hand corner of this gable there is a chimney with water tablet at the top that extends above the line of the gable ridge. The first floor and second floor have sash windows centrally placed with segmental arched lintels. The ground floor has a further extension placed against it, but which has a narrow sash window in the remaining external wall of the large gable. This also has a segmental arch. The extension also has a gable end with lean-to and further extension at the south end. There are two small segmental windows located in these southern lean-to structures. On the east side this rear extension uses an earlier brick wall, which formed a boundary between plots. On the west side the inserted window is later with a concrete lintel; there is also a door, panelled, with a light above under a segmental arch.

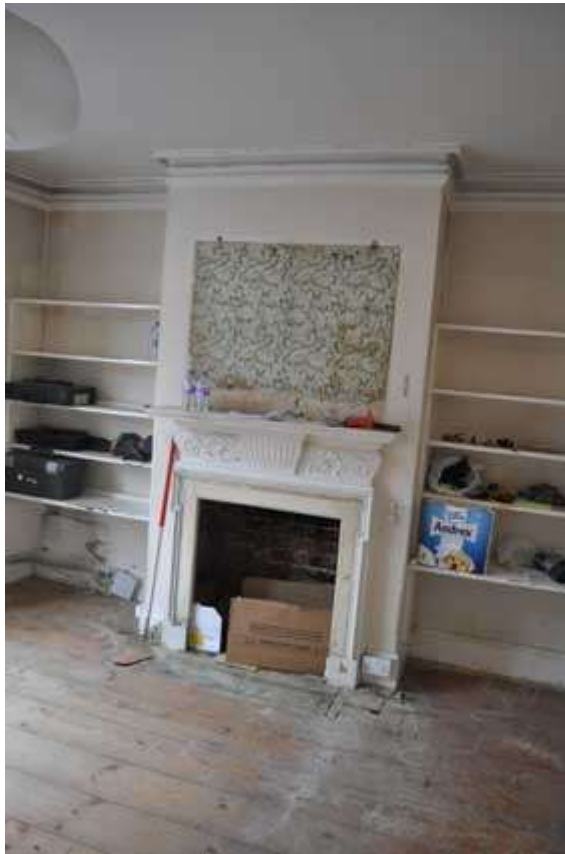
Plate 3 Fireplace G2

The panel door in the inner angle of the L-shape leads into room (G2) a rectangular room with a fireplace and chimneybreast in the east wall. The fireplace surround is probably original (plate 3), but the shelving either side are not original fireside cupboards. A bay window in the north wall has a timber surround (plate 4). The room has moulding around the ceiling, and also skirting board possibly not original.

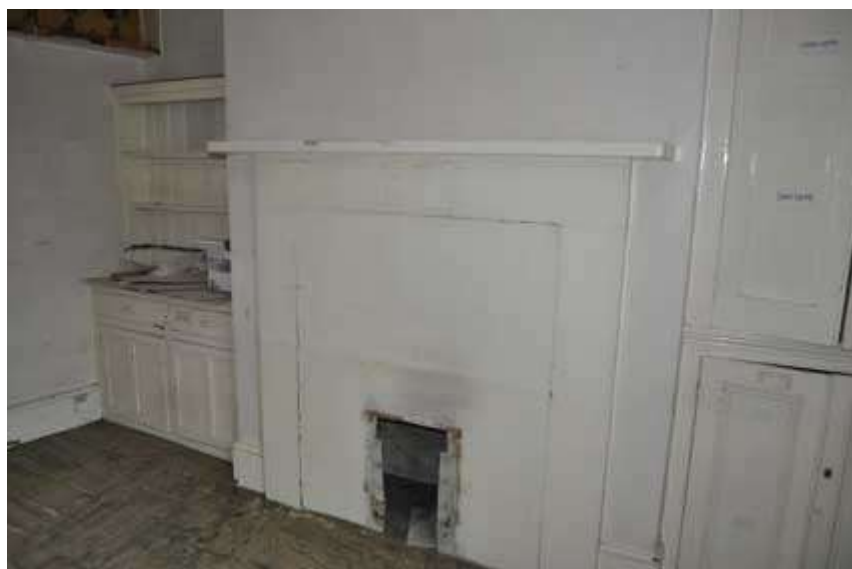
Plate 5 Fireplace G4

The panel door, with obscured glass, in the south wall of room G1 leads into room G4 a rectangular space with a large chimneybreast in the east wall with two original built in cupboards either side (plate 5). The fireplace contains a simple surround, but is large and of a simple style seen elsewhere in Regency or Victorian kitchens. The south wall contains a doorway with panel door and a sash window with a timber surround. The west wall contains a large recess with central dado. On the north wall there is a ring of servants' bells (plate 6), some of which still work.

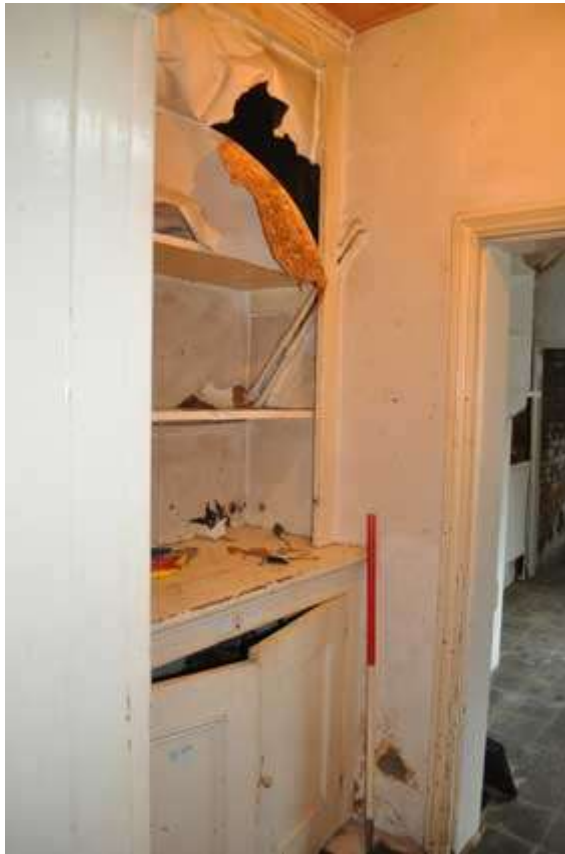
The south door leads into room G5 a small lobby area which has an external door on the west wall with window light above. On the east wall there is a built in cupboard (plate 7), which backs onto a wall riddled with damp, causing the cupboard to show signs of rot. An opening in the south wall leads into room G6. The west wall has a modern window inserted. The west wall has a built-in cupboard, which also backs onto a wet wall. The damp wall is an old garden wall onto which the rear extension was constructed. In the southeast corner there is a small passageway with a small square room G8 at its end entered through a doorway with a panel door and a window in its south wall. There is a further door in the

Plate 7 Cupboard G5

On the Ground Floor it is proposed that alterations will include modifications to room G3, where a partition wall around the toilet space will be rebuilt. It is proposed that the rear single storey extension, which has damp and structural problems, rooms G5-G8, is removed and that a new extension is inserted.

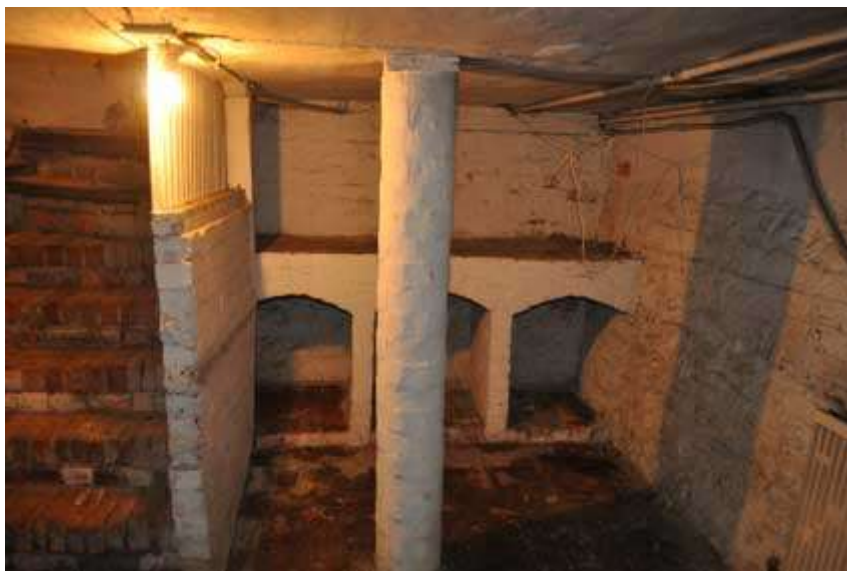
Plate 8 Cellar

The panel door under the dogleg stairs leads from room G1 to a brick staircase, curving at the top and straight at the base, which descends into the cellar. There is a small rectangular space off the side of the stairs. The cellar has a round brick post adjacent to the stairs that stands in front of a brick bench in the south wall (plate 8), under which are a series of alcoves with segmental arched openings. In the north wall there is an extension out under the road with a segmental arch over the entrance. The whitewashed walls in the cellar are a mixture of brick and flint.

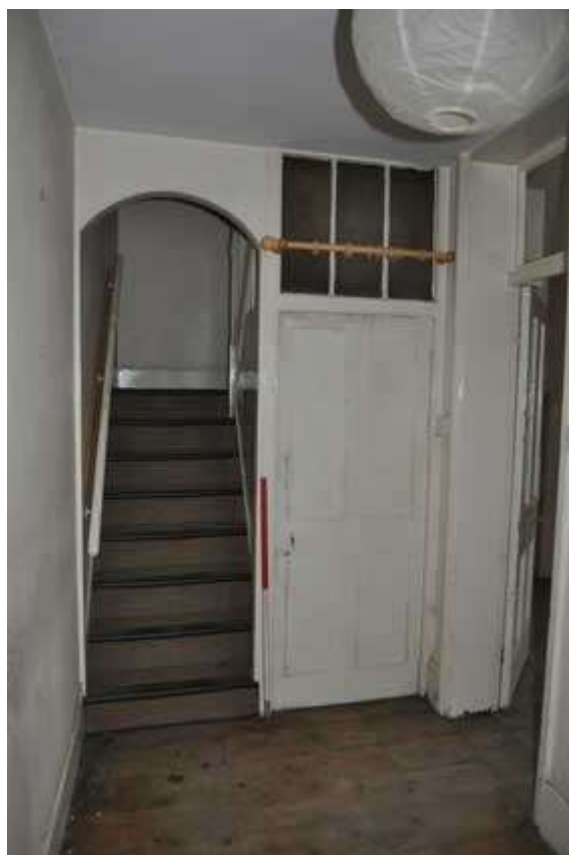
Plate 9 Stairs G1

The lower staircase (G1) is interconnected with the wooden panelling and door leading into the cellar, these pieces are probably original and would only be replaced if the material had deteriorated. A window light is located above the cellar door and there is a segmental arch above the lower flight of stairs on the dogleg staircase.

The dogleg stairs have a moulded banister main post at each end, but the intervening balustrade rails are simple and square cut. These stairs lead up to a landing F1 of an irregular shape (plate 9). Two doors lie on the north side, one at an angle, two on the south, with one on the west side; the majority are panel doors. On the east side there is a further dogleg stairs.

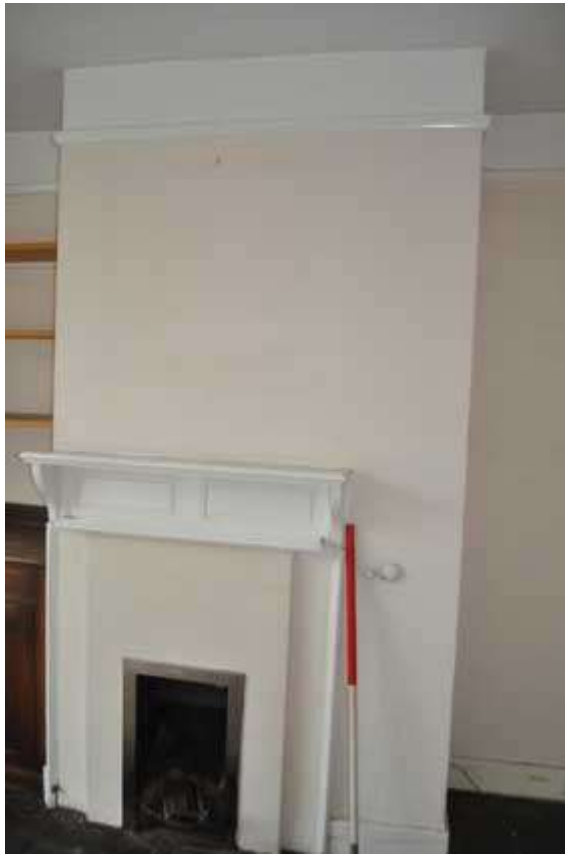
Plate 10 Fireplace F2

An original panel door leads into room F2. This has a fireplace and chimneybreast in the east wall (plate 10). The alcove to the left has a built-in cupboard, but the design is not suggestive of it being original. The timber mantle could be original but the fireplace and grate are modern. In the north wall there is a bay window. In the west wall are the remains of a blocked opening (plate 11), which means that rooms F2 and F3 were previously joined, but as there is a slight moulding around this opening. This may have been to provide bearing for the wall above on the second floor. The skirting is not original, and no crown moulding exists as such, but there is a rail running around the wall a foot or so from the ceiling.

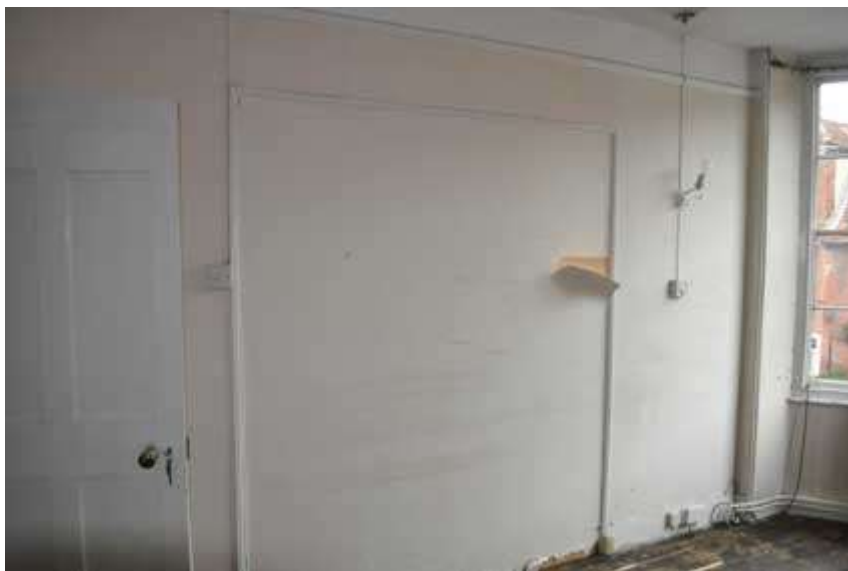
Room F3 is entered through a doorway with an original panel door. In the east wall there is a blocked-in opening. The north wall contains a sash window with timber surround. In the west wall is a chimneybreast with no fireplace or mantel; as the rooms were joined it is difficult to know if there was one originally. The skirting is not original, there is no crown

Plate 11 Blocked opening between rooms F2 and F3

On the first floor it is proposed that the opening between the two rooms F2-F3 is reinstated, but that it is widened. In room F5, the bathroom, it is proposed that the existing cupboard be removed and that a new roof light be inserted. The flat lead roof to this part of the building will be replaced, the previous roof was leaking.

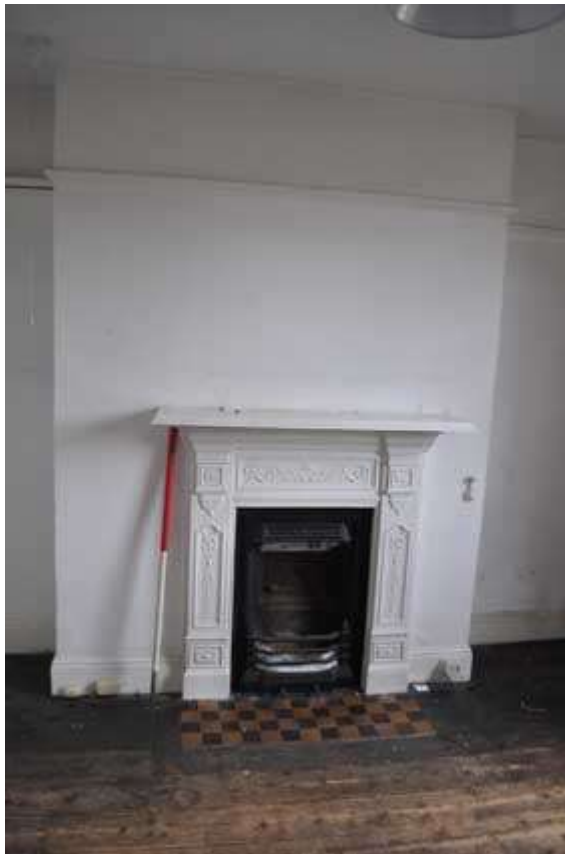
Plate 12 Fireplace F6

The left-hand door in the south wall of the landing leads to room F6. There is a fireplace and chimneybreast in the east wall (plate 12). The fireplace is decorative and original. In the south wall is a sash window with moulded timber surround. The skirting board is relatively undecorated, while there is a beading for the crown rail, with a rail set below this.

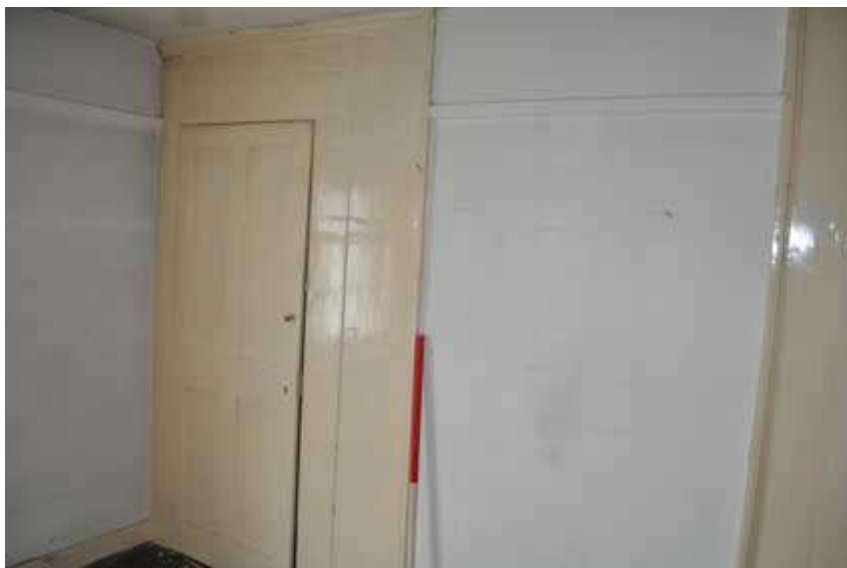
Plate 13 Cupboards and fireplace S2

A panel door on the north side of the landing leads to room S2. This has a chimneybreast in the east wall, there are two built-in cupboards either side which match and probably are original (plate 13). In the north wall there is a sash window. The skirting board is plain and there is a rail down from the ceiling. Offset in the west wall is a doorway with a panel door that leads to room S3. There is a sash window in the north wall of room S3, and a chimneybreast in the west wall. The south door has a doorway with a step at its base. The doorway is unconventional and may indicate that it is a later insertion. Room S4 into which this doorway leads has a sash window in the south wall and an opening with a moulded surround in the east wall.

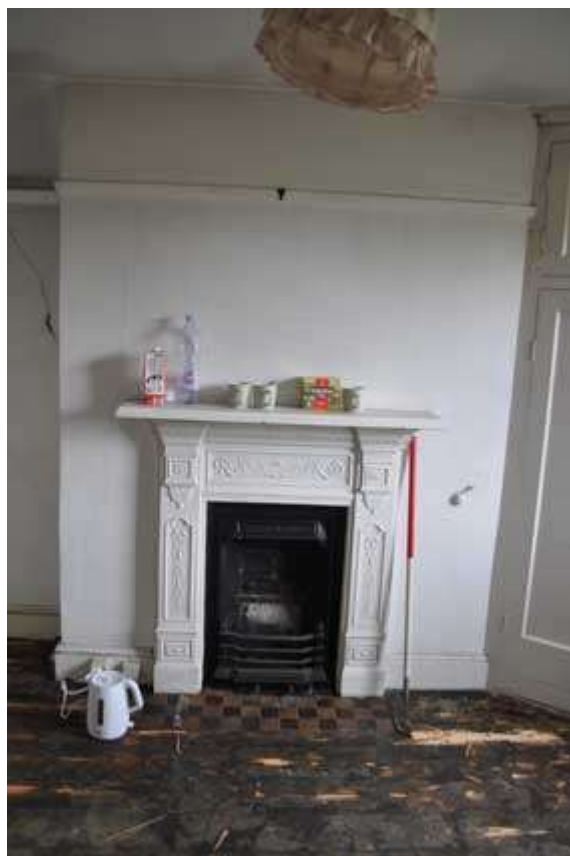
Plate 14 Fireplace S5

The south door from the landing S1 enters a large room S5 with a fireplace in the west wall. The fireplace is original and matches that in F6 (plate 14). There is a sash window in the south wall with a built in cupboard between the window and fireplace. The skirting board is not elaborate and there is a bead used for a crown rail with a rail placed down from the ceiling.

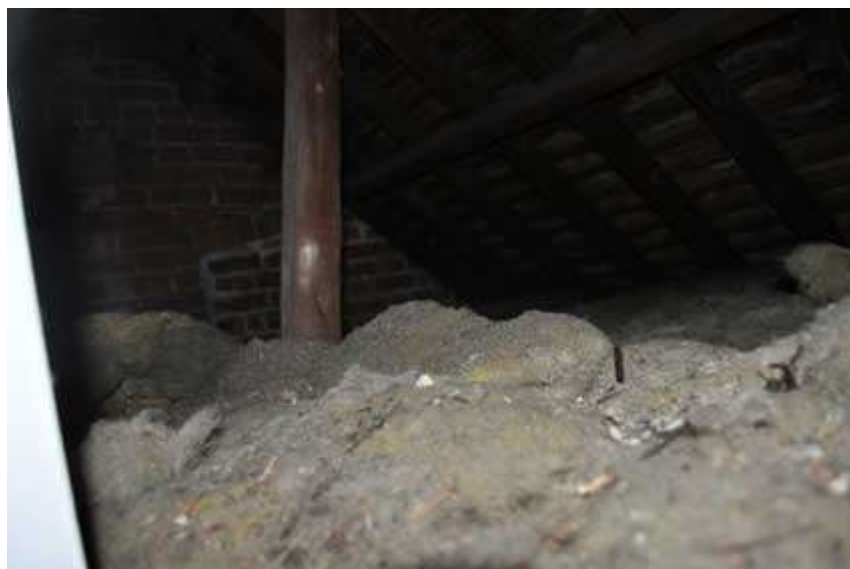
The front attic contains trusses with a single king post. It is possible to see a blocked segmental arch in the brick wall of the building to the west (plate 15).

Plate 15 Blocked segmental arch, attic

The building is essentially a structure of three builds. The front part of the building was apparently butted up to the neighbouring property as there is evidence of a blocked segmental arched opening in the attic space. It is easy to understand how this structure was catalogued as a later 18<sup>th</sup> century building as it has that style. However, there is a problem in dating No 54 as this is butted up to the No 52, and the latter structure is dated to later than c 1820. This indicates that the neighbouring property either has a façade that masks an older building or that No 54 was constructed later than that date and is purely 19<sup>th</sup> century. At present I am inclined to believe that the façade of No 52 masks an older building. Thus we shall keep the first phase as later 18<sup>th</sup> century, if not mid-18<sup>th</sup> century as that space is shown as filled on the two 18<sup>th</sup> century maps.
