**HISTORIC BUILDING RECORDING
AND ARCHAEOLOGICAL WATCHING BRIEF**

23-25 BROAD STREET, OXFORD

SEPTEMBER 2014

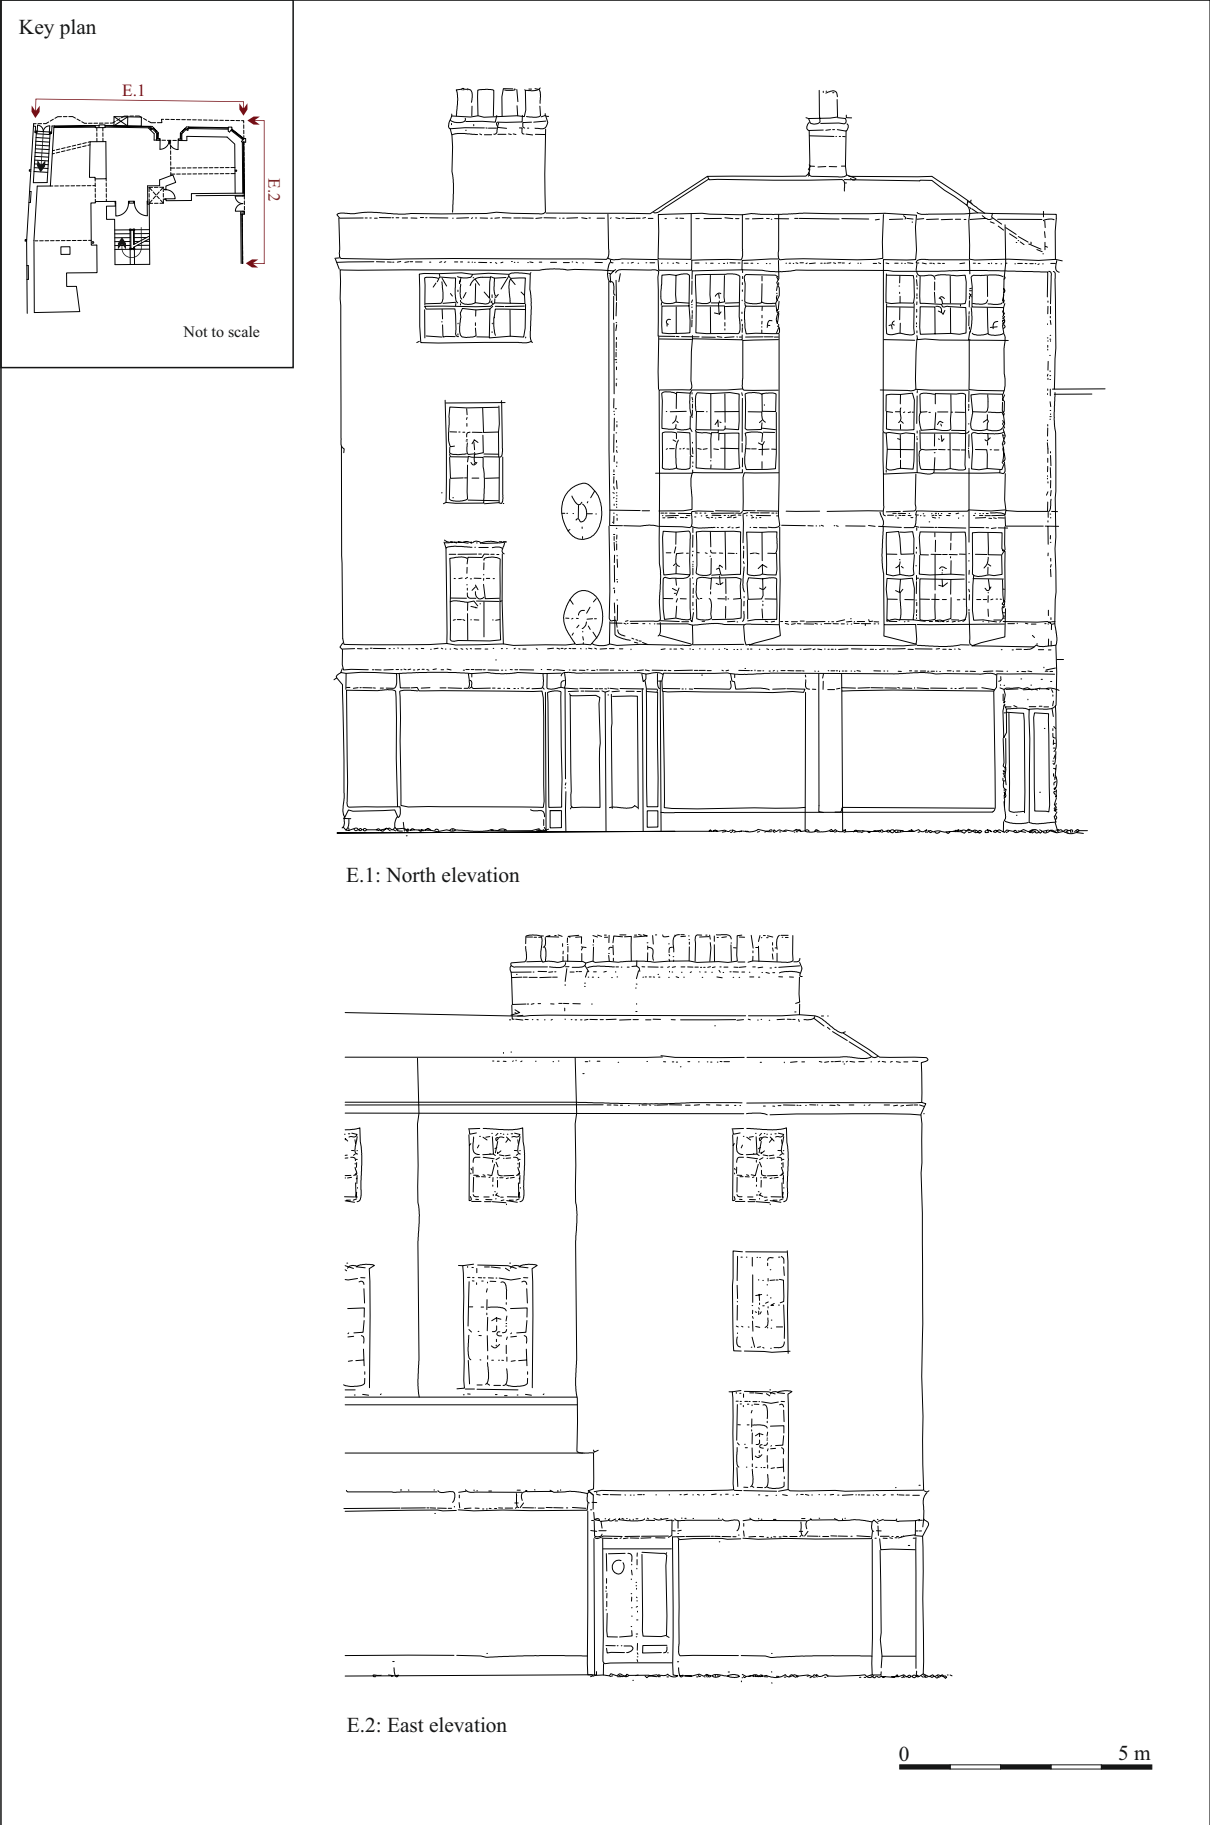
Figure 4: Front and side external elevations

The principle façade is that which faces onto Broad Street (Fig. 4, Plate 1). The ground floor contains glass windows of a shop frontage. There is an angle on the corner between Turl and Broad Street. Off centre and to the left there is a further door. This ground floor is a modern shop frontage insertion. Above the window line there are probable false beam ends as if indicating an earlier jettied arrangement.

On the east façade on the ground floor there is a large shop window between the corner angle door, and a door which presumably was an earlier access to the area above (Fig. 4, Plate 2). The same jettied arrangement is above. To the left the shop window is higher, and belongs to a different shop. Above this the frontage is of two parts. On the right hand side there are three windows in three storeys, with the lower two sash windows and the upper a smaller mullioned and transomed frame. The lower sash window has a cornice. On the left hand side the building extends over another shop frontage and here there are two storeys, both sash windows of 12-pane and 9-pane, with the lower having a cornice. The remains of a cornice and pediment continue along this side.

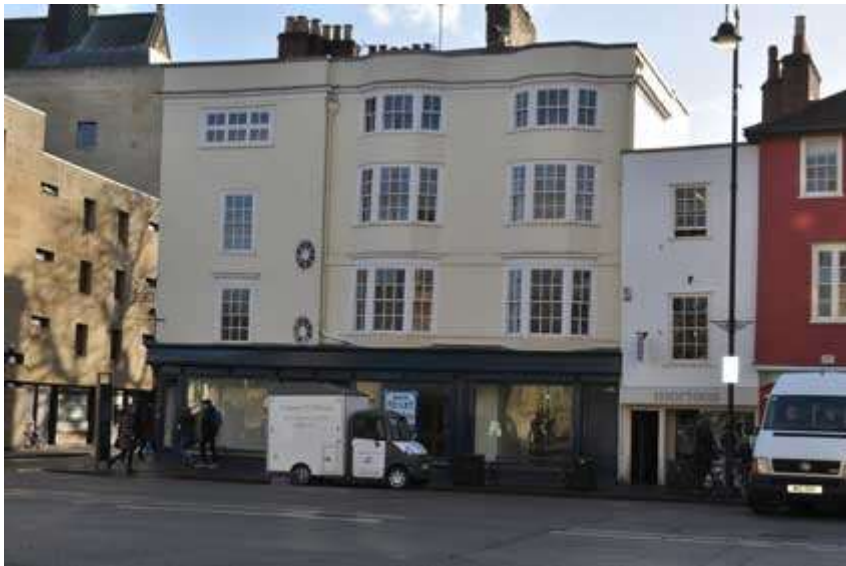
Plate 1 Broad Street façade

On the first, second and third floors the structure has three window bays of which the right hand two are bay windows of a composite design. On the first and second floor the windows are 4-panes high, while on the third floor the composite windows are 2-panes high. The first floor bays have cornices. There is a moulded cornice above this above which is a pediment with copping. To the left the building frontage projects slightly and centrally located on the first and second floor are 12-pane sash windows.

The first floor window has an architrave above. To the right and slightly below each of these windows there is a small oval window, perhaps indicating earlier staggered floor layers. On the third floor there is a mullioned and transomed window with three compartments. The cornice continues to run above this and above is the pediment with coping.

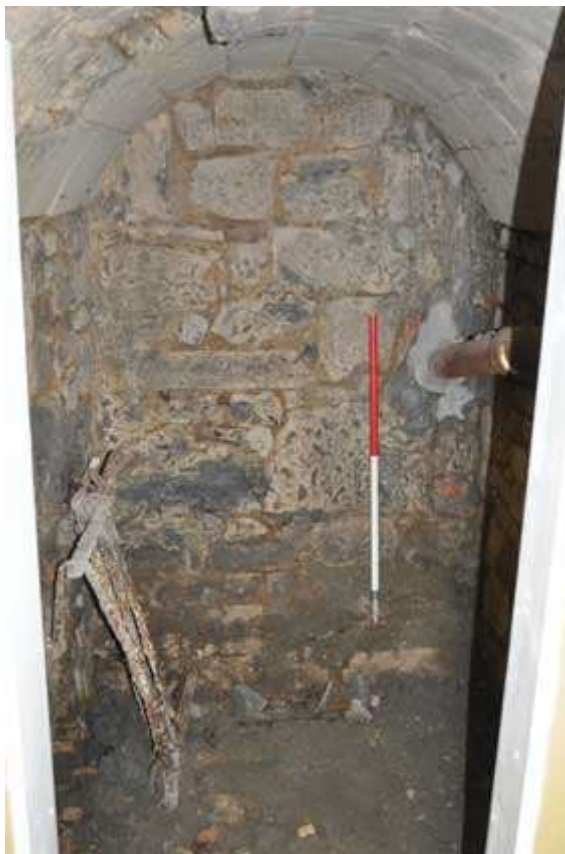
Plate 3 Stone wall and vault under the pavement

The stairwell has access up and down. The cellar contains four main rooms two of irregular shapes (C1 and C2). Of the southeast room, east wall south side, there is access to a small rectangular stone built vault (C1a). The back wall of the vault was drawn stone by stone as damage would have been caused to the stone vault (Fig. 5, Plate 3). The stones are of a rough limestone rubble bonded with a sand mortar of a yellow to pink hue. In the northeast room (C2) there is a side door in the east wall into a further side chamber under the road. The two smaller western rooms contain the remains of timber beams. In the northern room (C3) the timber is rough and chamfered, part of the ceiling was opened up during the refurbishment (Plate 4). In the southern room (C4) there is evidence of a wider earlier wall, a timber beam in the ceiling, and newer supporting beam.

Cut 09 is an irregular cut for the cellar, which is believed to have been inserted into layer (06), but this was not categorically proved. Masonry 08 is a limestone rubble wall with ashlar blocks forming the top of the vault. This is a cellar wall bonded with a

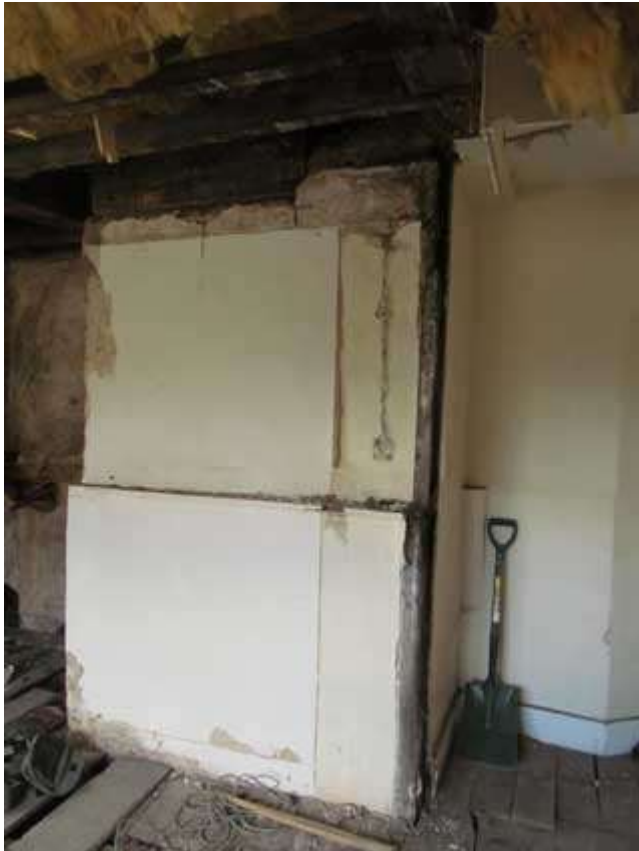
Plate 9 Chimneybreast in south wall of T3

transomed windows in the east and north wall. In the south wall the remains of a chimneybreast were revealed (Plate 9).

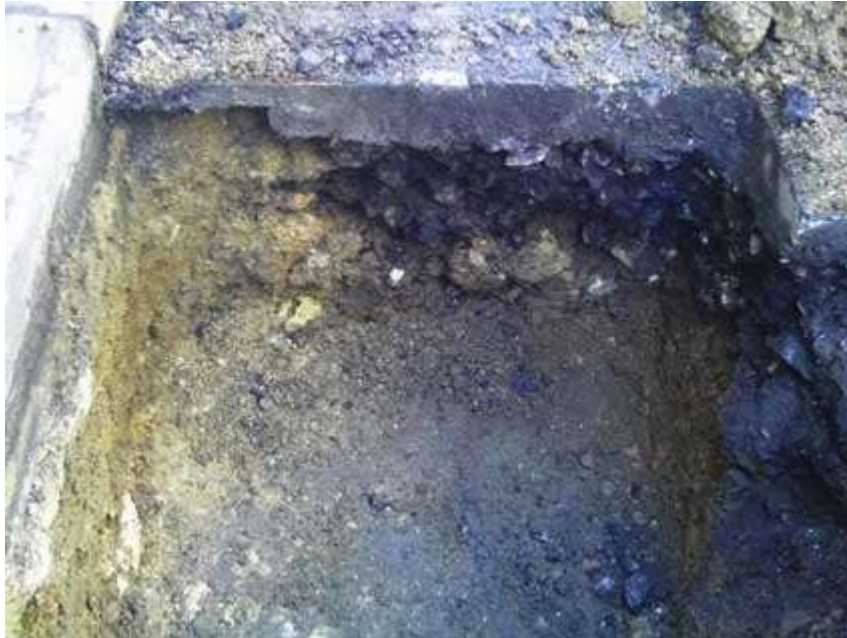
Plate 10 Deposits in watching brief

The lowest deposit seen was a layer (06) that was a very firm mid grey yellow coarse sand clay that was over 0.2m thick. The deposit lies in the vicinity of the city ditch and it is possible that if this is the natural that it could be located on the shoulder of the ditch cut or that this may simply be a layer running in the top of the ditch cut or above it. Agas map of 1578 shows the remains of an undeveloped site outside the city wall (Billam 2013). It is thus proposed that the earliest layers on the site must relate to this 16th century date.

Above layer (06) was layer (05), a cemented red white grey with chalk, stone, brick and mortar fragments some 0.26m deep. This may be an early road surface of Turl Street of the 17th or 18th century. Layer (04) was a firm grey black stone silt deposit that was an early tarmac. John Loudon McAdam c 1800 and John Henry Cassell in 1834 developed early forms of MacAdam Road surfaces in the 19th century.

The remains of a service cut could be noted as being cut into the top of layer (06) at least, but probably truncated layer (05) and (04). The fill (07) was a highly compact light brown stone hardcore some 0.38m wide and 0.8m deep. Service trenches originate in the later part of the 19th century and continue into the 20th century.

Cut 10 was a linear feature measuring 0.15m deep cut through the earlier road surface (04) to embed the kerb stones. The fill (03) was a friable mid to light yellow coarse sand. The embedded kerbing 02 was of stone c 150mm x 110mm x 90mm that were roughly squared. Butting the kerb is tarmac (01) a black layer some 0.1m thick.
