**BUILDING ASSESSMENT**

**HIGHMOOR FARM (GC Ed)**

**HIGHMOOR, OXFORDSHIRE**

**JUNE 2013**

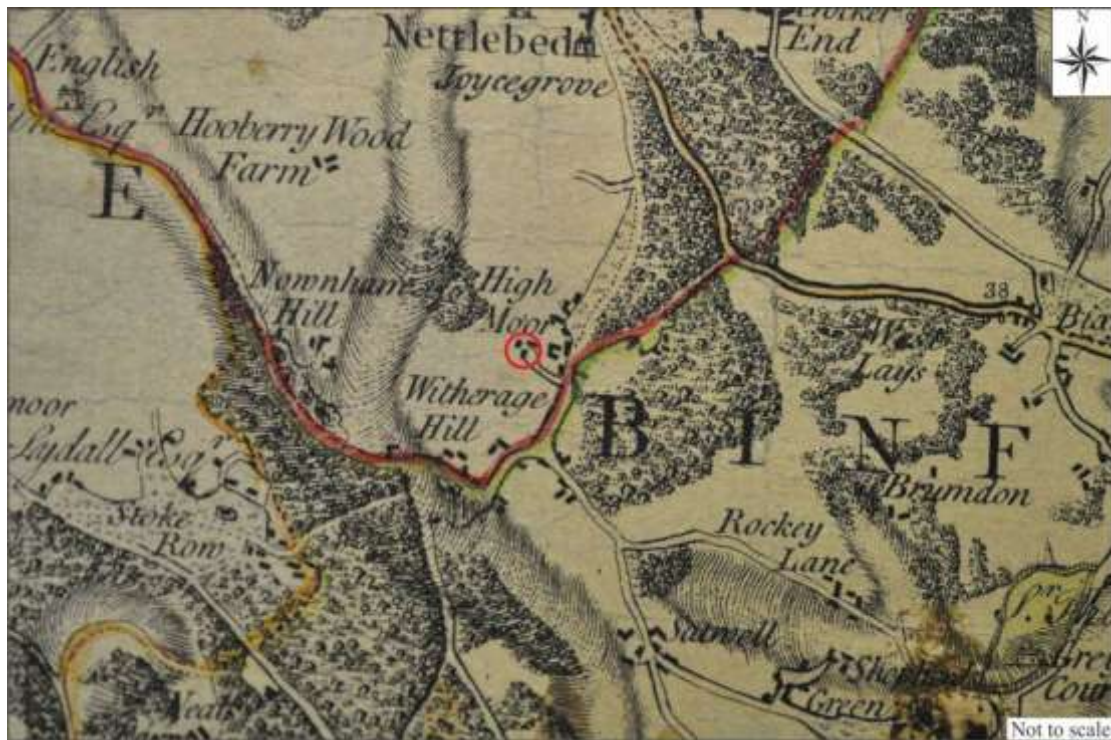
Figure 2 Thomas Jefferys' map 1767

The cartographic evidence for Highmoor Farm commences in the late 18<sup>th</sup> century. Thomas Jefferys' map of 1766-7 (ORO No Misc Bucks vii/i) shows three buildings at Highmoor Farm (Fig. 2), which must represent the house, the large listed barn and a building running north to south to the west at the west end of the farm complex. Richard Davis map of 1793-4 shows

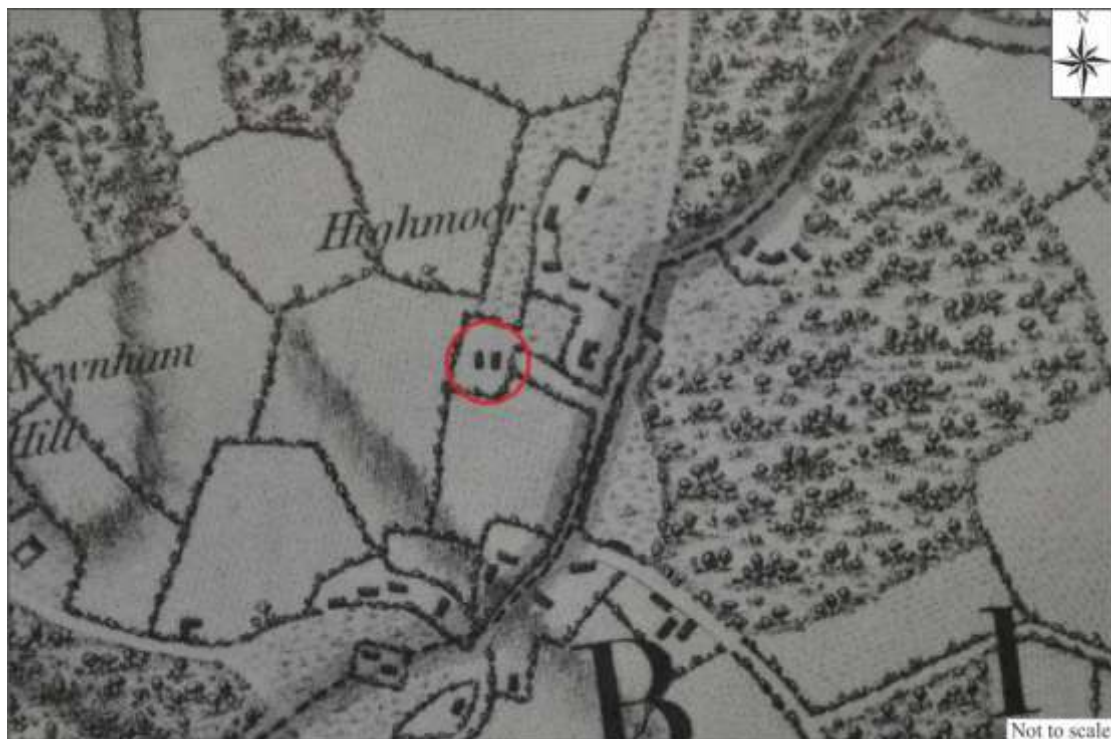
Figure 3 Richard Davis map 1793

two structures located at Highmoor Farm (Fig. 3).

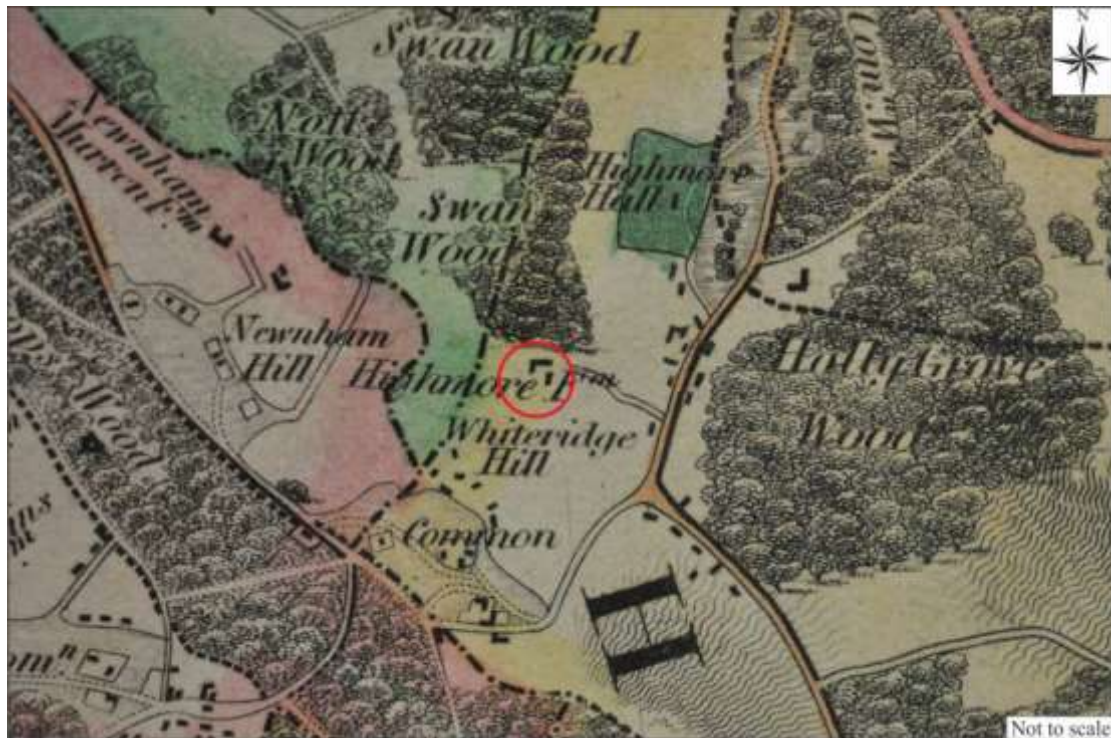
Figure 4 Bryant's map 1824

Bryant's map of 1824 (ORO P345/M/1) shows the house as a north to south rectangle with an L-shaped building to the north representing the barn (Fig. 4).

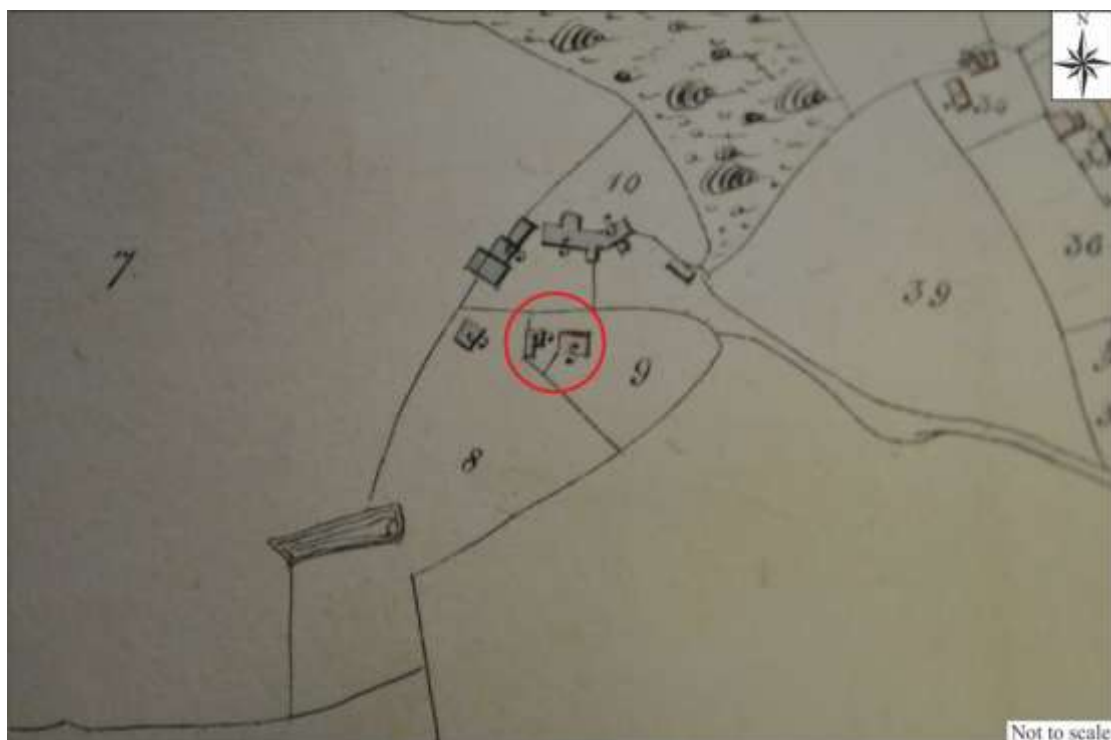
Figure 5 Tithe Map 1844

The Tithe Map of 1844 (ORO 325/M) shows a good representation of the building (Fig. 5). The house is shown as a rectangular building running southeast to northwest. The southwest

wing and the rear projection of the house are not shown. This could be because they are later additions to the structure or that they were omitted for stylistic grounds. To the rear of the building is a small L-shaped structure, which helps with the phasing of the agricultural structure to the rear of the old farmhouse. A further building is shown located near the west end of the cart shed. This may be part of the cart shed, however, it is not drawn in line, but this may be an error in the map.

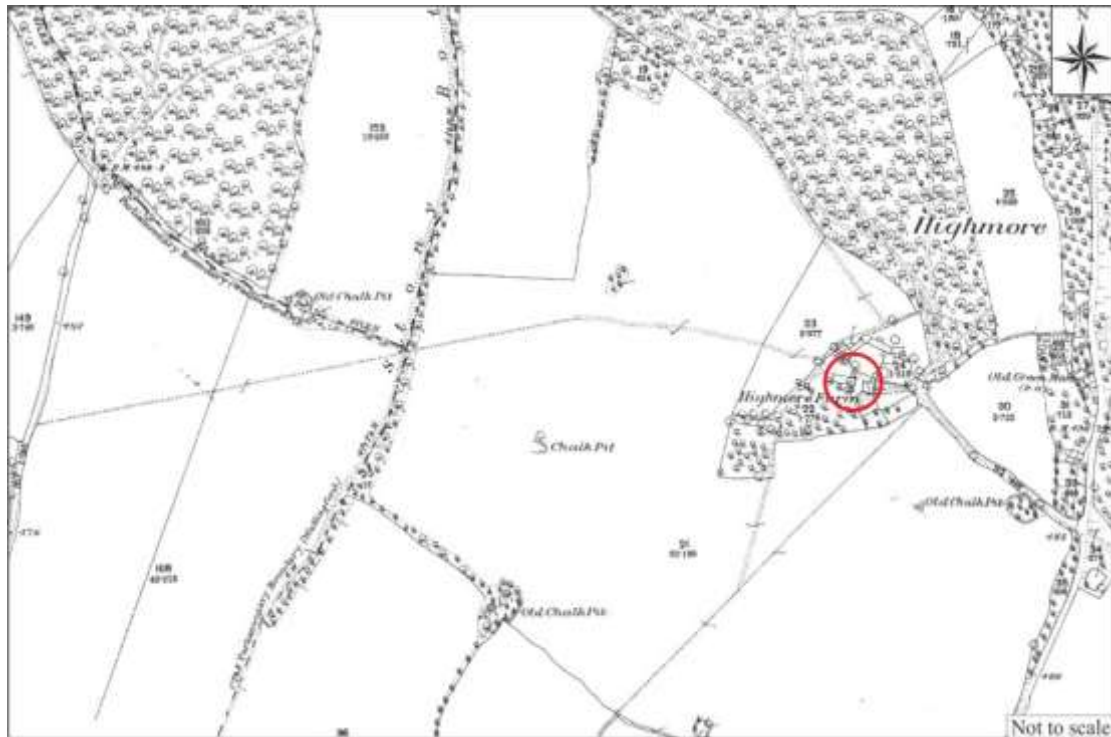
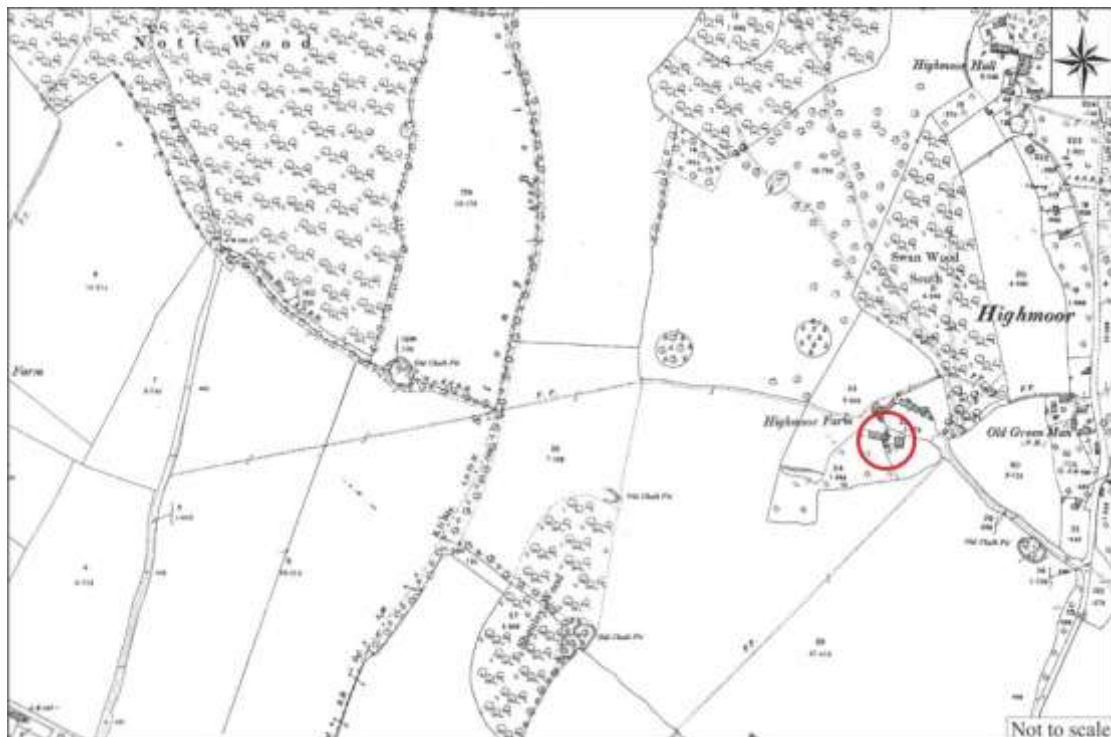
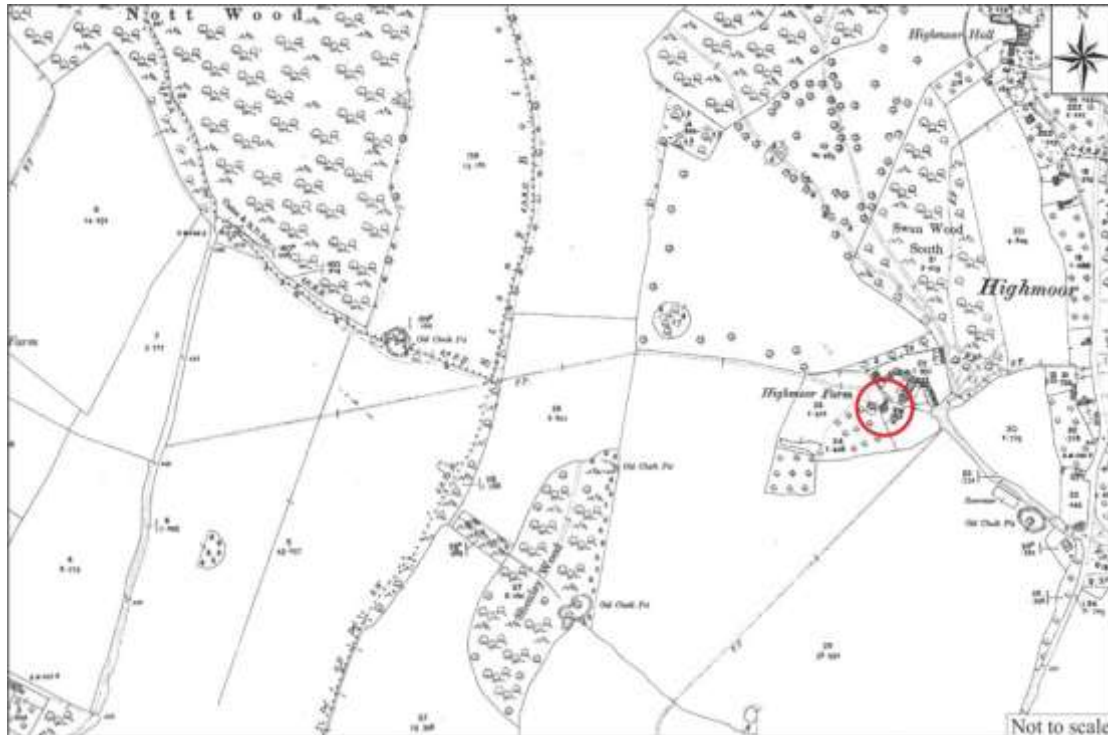
The first edition Ordnance Survey at 1:25,000 of 1879 shows the farmhouse with rear extension, but no apparent wing, and the agricultural building to the rear (Fig. 6). The agricultural building included the L-shaped structure at the east end and the cart shed at the west end. The representation is the same on the second series of 1898 (Fig. 7) and third series of 1913 (Fig. 8).

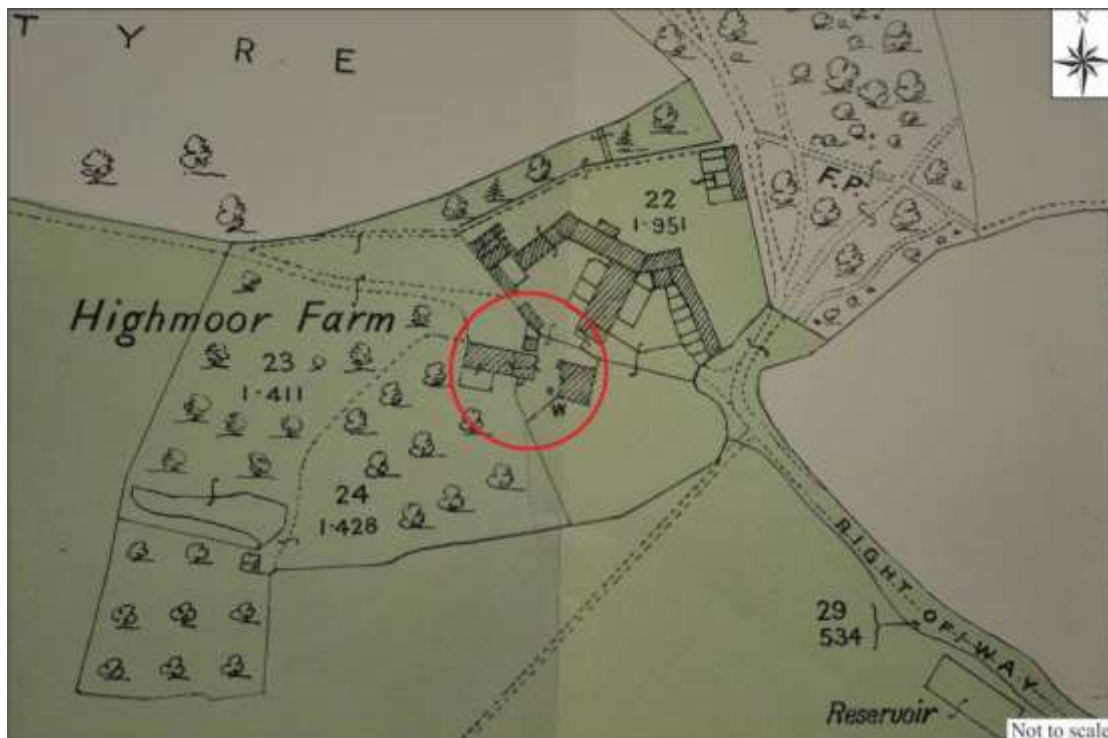
Figure 9 Sale catalogue map 1828

A sale catalogue map of 1828 (ORO E307/D/3) shows the two buildings with no joining structure (Fig. 9).

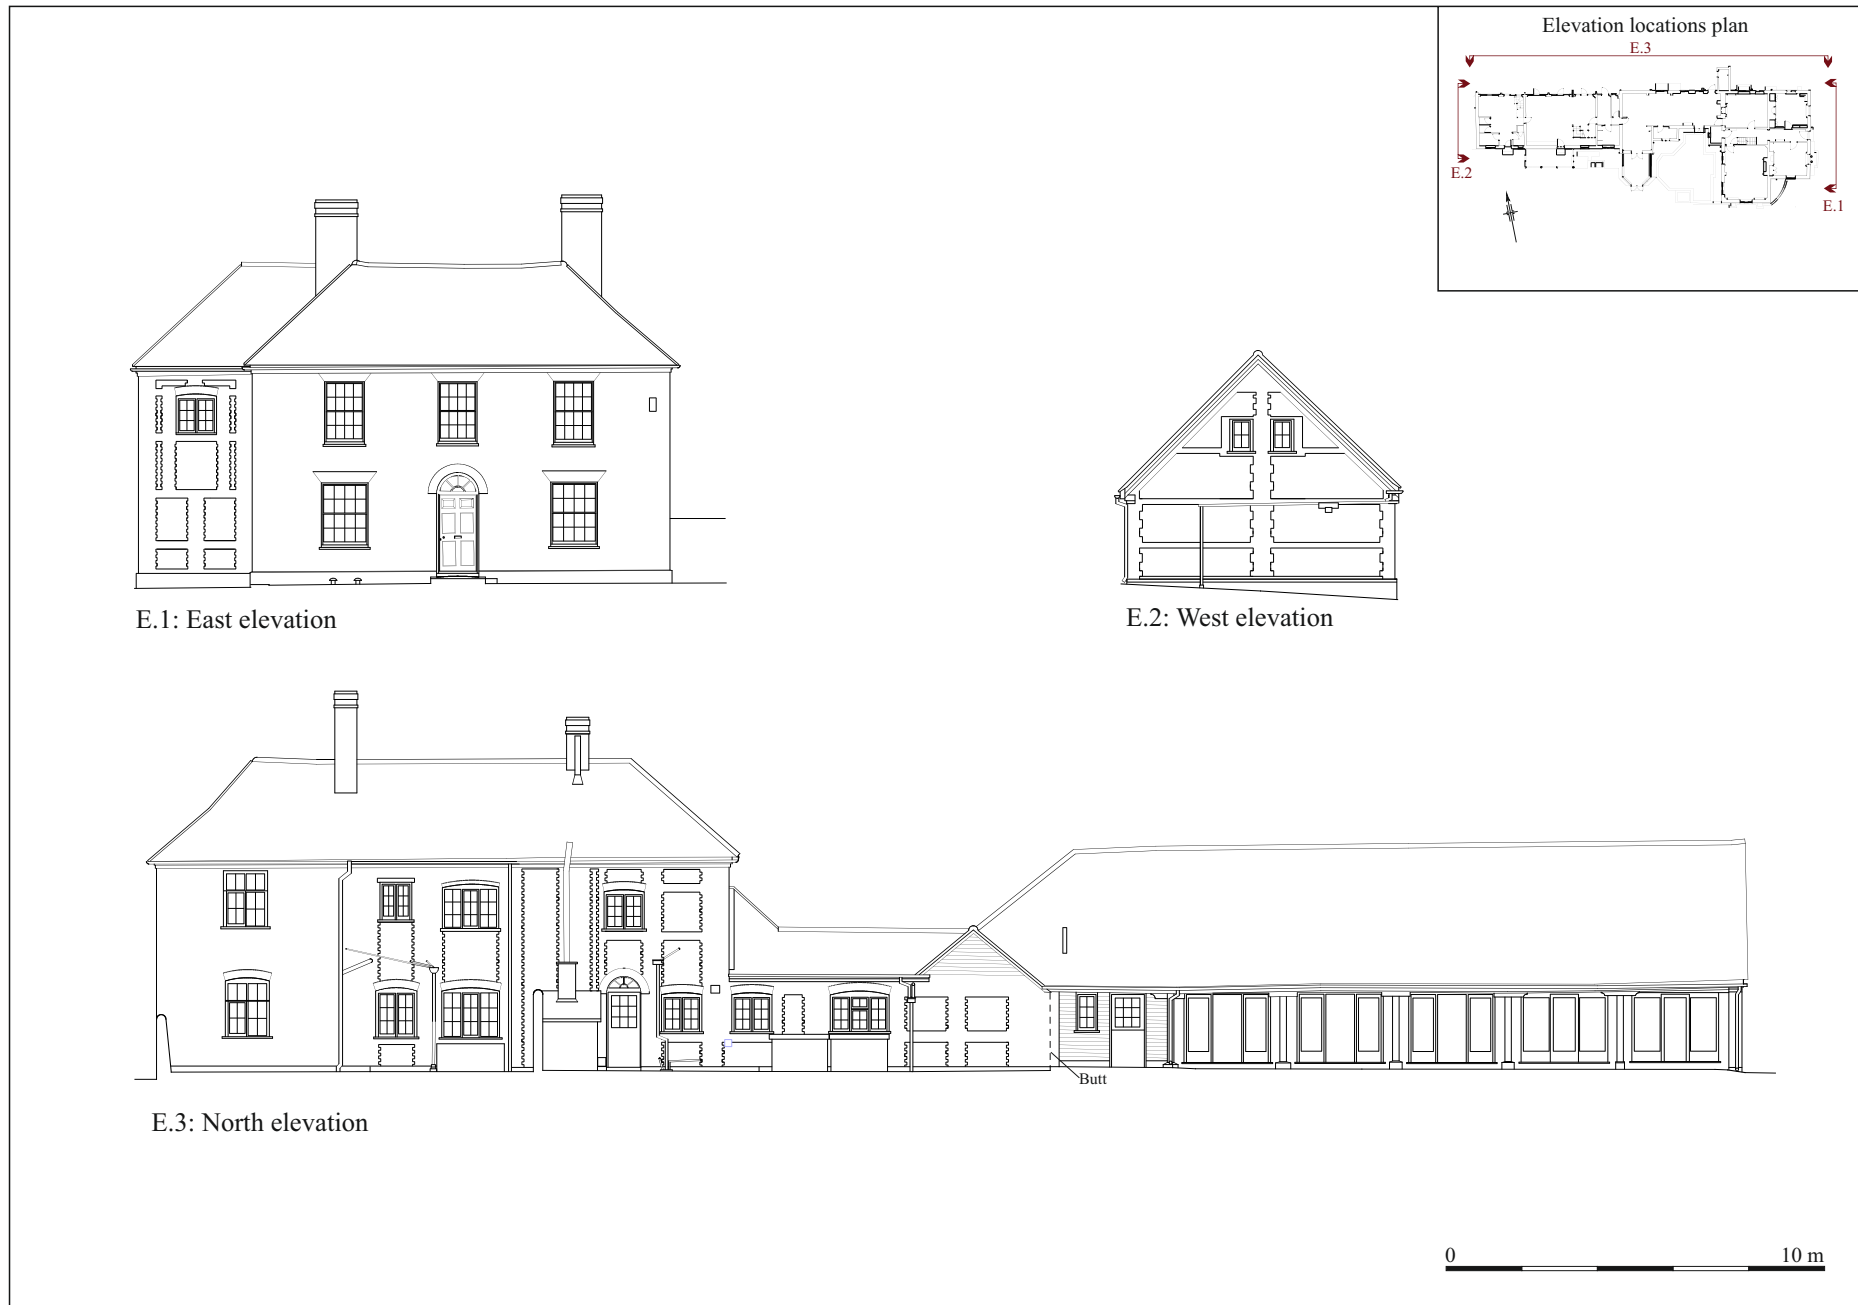
Figure 12. Elevations

The main façade of the two storey building is constructed in a red and blue brick chequer pattern of Flemish bond (Fig. 12). It stands on a low patio area accessible by a flight of four steps. The façade is symmetrical with three bays: the central bay contains a panelled door in a rounded arch and flanked by two sash windows set in square headed arches surmounted by brick lintel. The upper floor displays three sash windows with square headed settings and brick lintels. The roof is hipped, covered by red clay tiles, with two chimneys containing upper water tablets.

The structure joining the two components is made of red brick, there are a number of butts in the wall where this has been inserted (Figs. 12 and 13).

The northwest end of the old agricultural building is also of flint with red brick lacing (Fig. 12). There is a gable with window.

The north façade is divided into three components, part of which is obscured by the construction of granary that is only 1m away from the main building (Fig. 12). The western component is the agricultural building. The east component is the old farmhouse and finally the part that joins them together.

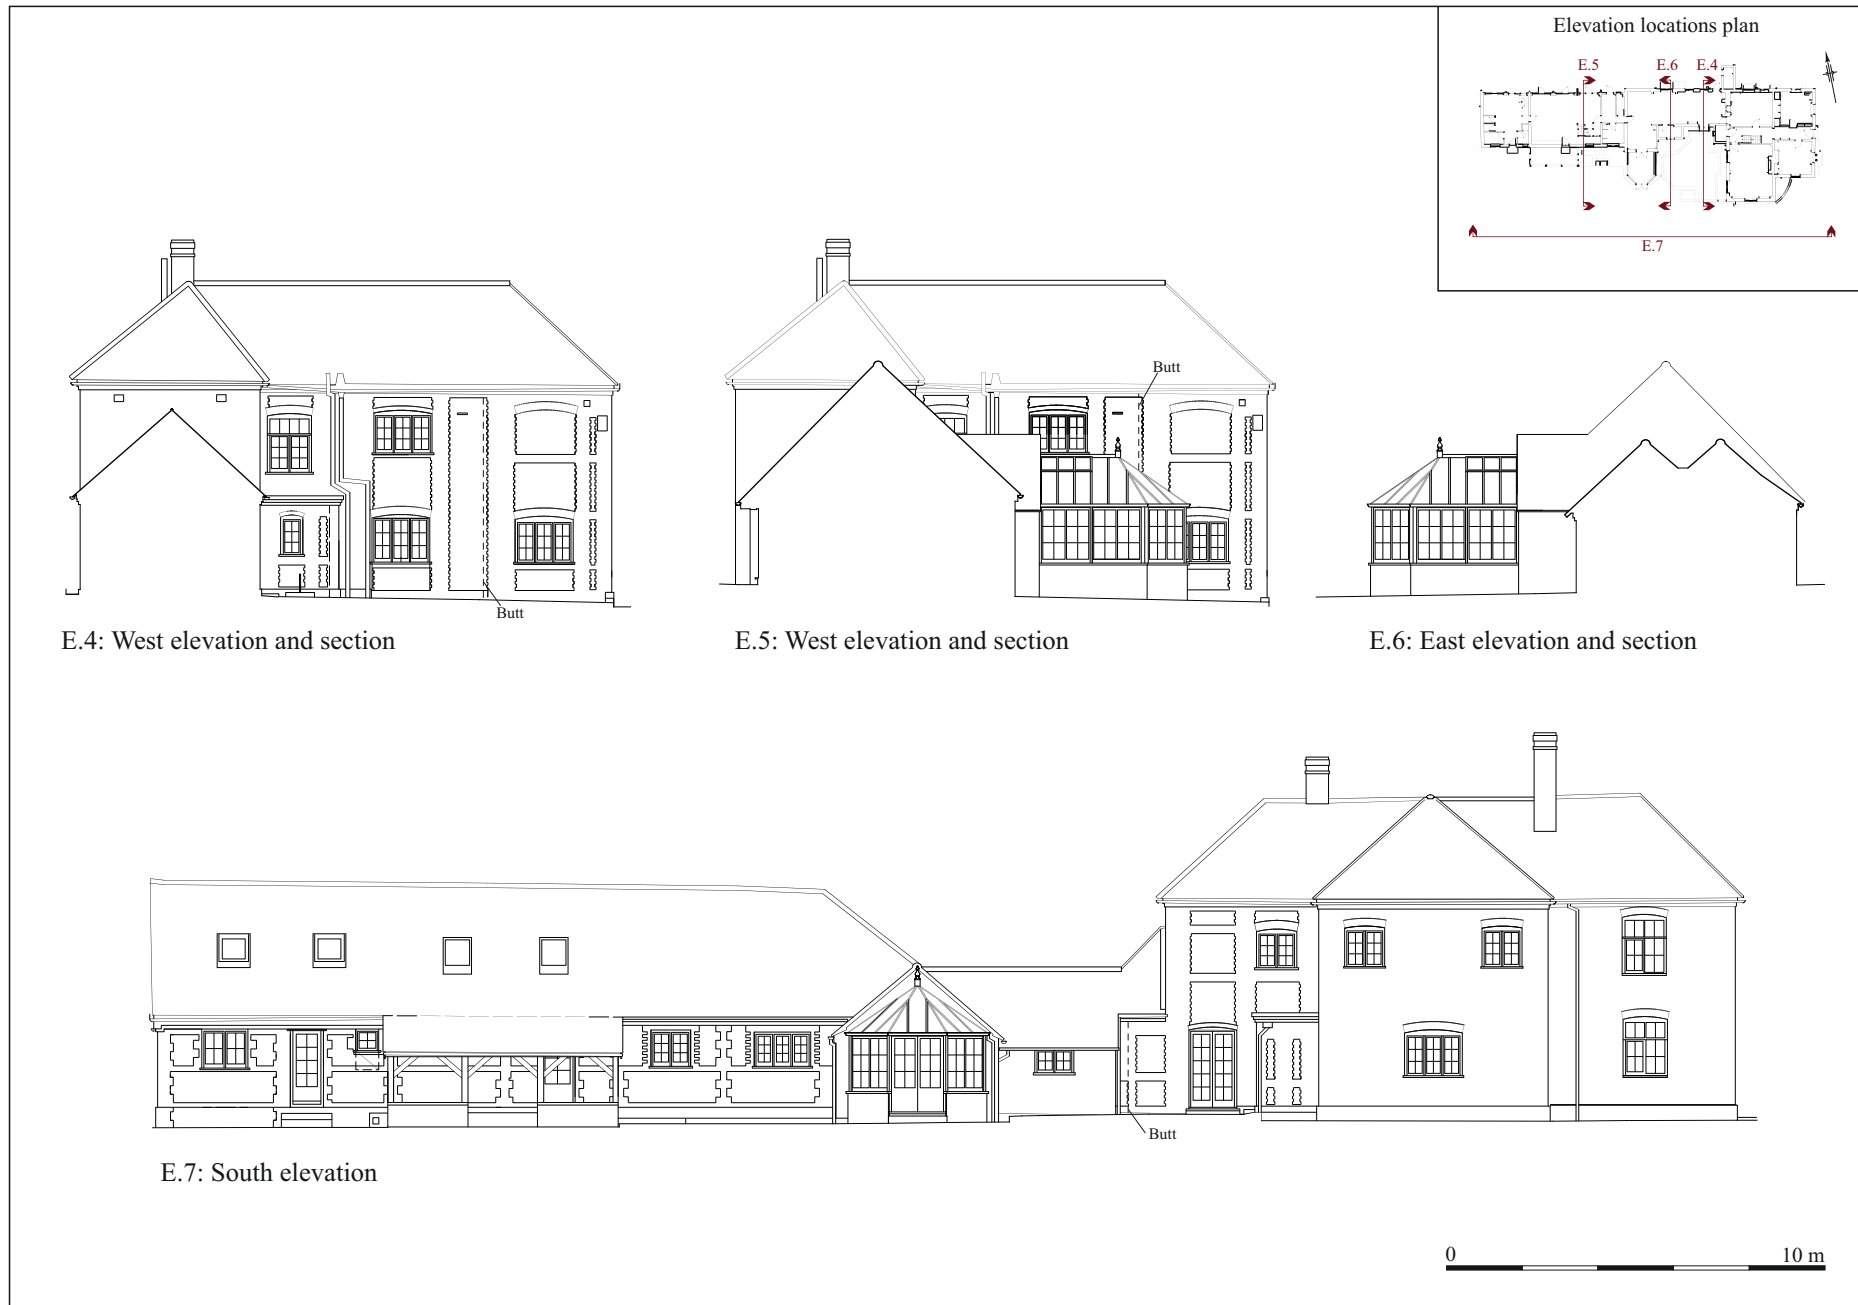
Figure 13. Elevations

The old farmhouse also has three components (Fig. 13). The east section of the farmhouse is as the main façade, constructed in a red and blue brick chequer pattern of Flemish bond. Both the lower and the upper floors of the single bay display contain mullioned windows under a segmental brick arch. The central section, the southwest end of the wing, is built of flint with horizontal and vertical lacing courses of brick, abutting from the main block. The façade is divided into three, with a single central window in a segmental arch on the lower floor. The first floor has two mullioned windows with segmental arches. A hipped roof of red clay tiles extending from the main block covers the wing. To the rear of the wing is a two story extension with a further single story extension below. There is a further smaller insertion in the angle of the main building with the wing. The walls here are of flint with brick lacing. A patio

The conservatory is modern, but probably attached to an older brick wall (Fig. 13).

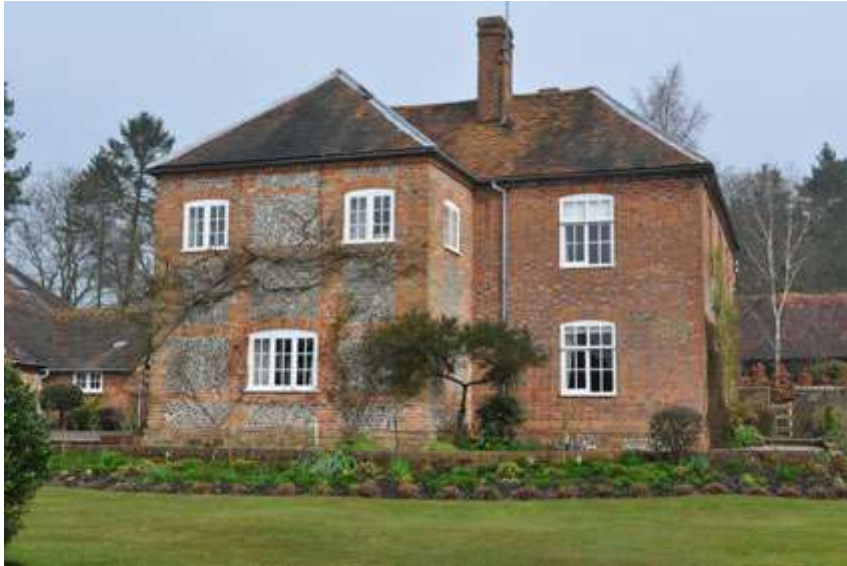
Plate 2 South façade details

The south façade is made of three components, the east belonging to the original farmhouse and the west to the original barn. The third component is the join in the middle (Plates 2-4).

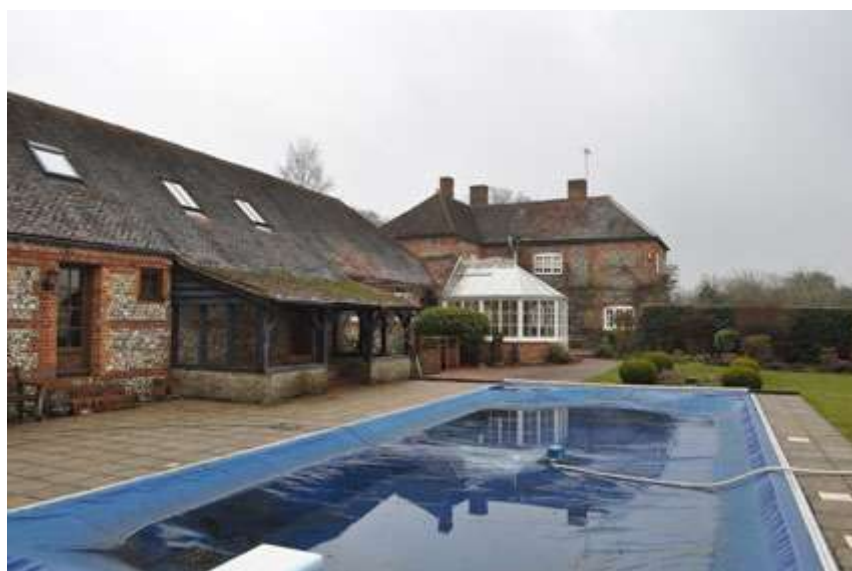
Plate 4 South façade

The southwest façade of the probable cart shed is also built of flint with red brick lacing; though the wall has been much altered. At the southeast end is a modern conservatory, which is possibly added to a short protrusion from the wall, which has indications of being old. There are two windows inserted into the lacing, with signs of alterations and with one of the windows having a timber lintel showing. The next component to the west is a timber framed lean-to on a dwarf wall, around a door. The western component of the barn has two later inserted windows flanking a door.

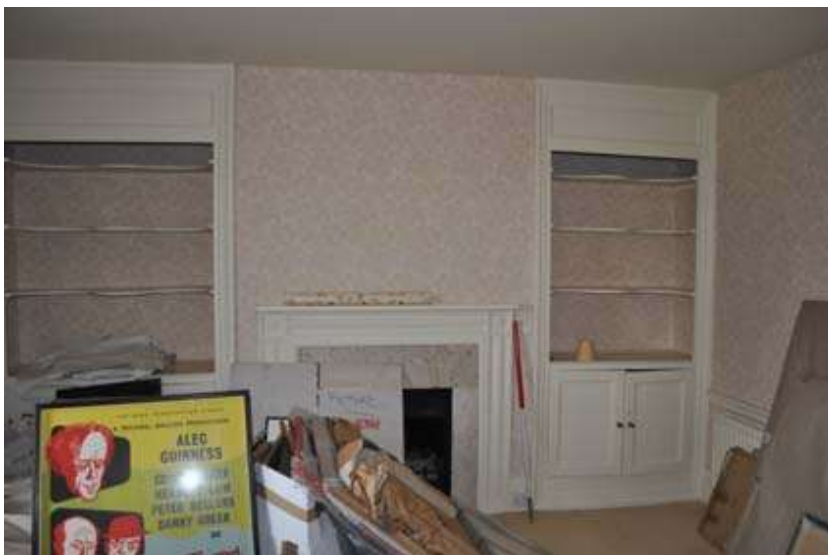
Plate 6 Room (R1)

Two rooms accessible through panelled doors flank the ground floor hall at the front of the house. The southern room (R1) has a sash window with wooden shutters on the southeastern wall and a mullioned window on the southwestern wall (Plate 6). The north-western wall has a central fireplace flanked by two symmetrical built-in bookcases. The eastern room (R2) has a sash window on the south-eastern wall and a mullioned window on the eastern wall, both with wooden shutters. The north-western wall is decorated by a framed partition and has a central fireplace flanked by two symmetrical built-in cupboards (Plate 7). A single roof beam running parallel to the north-western wall is visible on the ceiling, above the mullioned window and the door. It has slight mouldings on its edges.

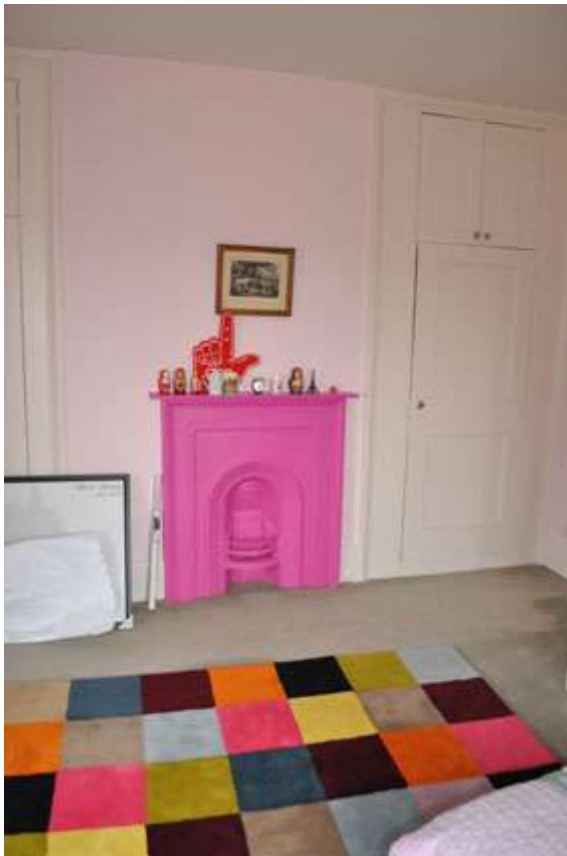
Plate 9 Bedroom (B1)

The southeast room (B1) is accessible through a panelled door on its north-eastern wall. A fireplace, flanked by two asymmetrical built-in cupboards (original), occupies the central section of the western wall (Plate 9). The south-eastern wall has a single, central sash window, while the south-western side has a mullioned window.

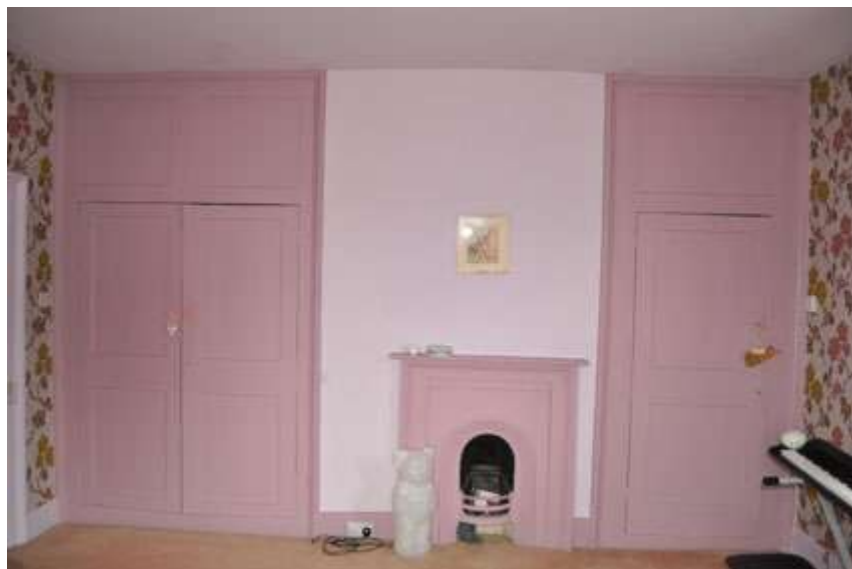
Plate 10 Bedroom (B2)

The eastern room (B2) is accessible by a panelled door on its western wall. The western wall is occupied by a central fireplace flanked by two asymmetrical built-in cupboards (Plate 10). The south-eastern wall has a single central sash window, while the north-eastern wall has a mullioned window.
