**HISTORIC BUILDING RECORDING**

**1 BEARGARDEN ROAD, BANBURY**

**JUNE 2013**

# 1 Beargarden Road, Banbury

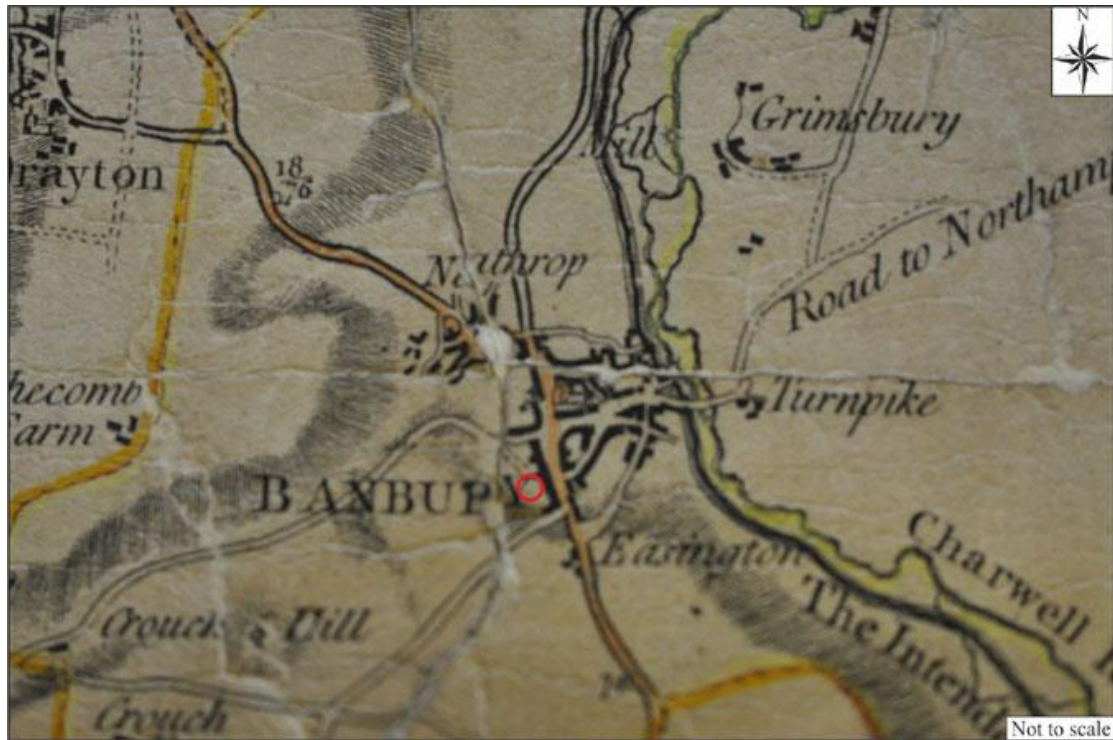
Figure 2. Jefferys Map, 1767 (ORO CP/103/M/1)

Surviving maps of Banbury commence in the later part of the 18<sup>th</sup> century. Jefferys map (Fig. 2) dated 1767 (ORO CP/103/M/1) shows a church in an island surrounded by roads around most of the sides of which has buildings facing out on to the roads. The map shows the location of Beargarden Road but it doesn't show any buildings along its course. The Davis map of 1793 (ORO 942/33 DAV) appears to show the line of the road as a field boundary, perhaps implying that the road is a field track at this point. There are no buildings

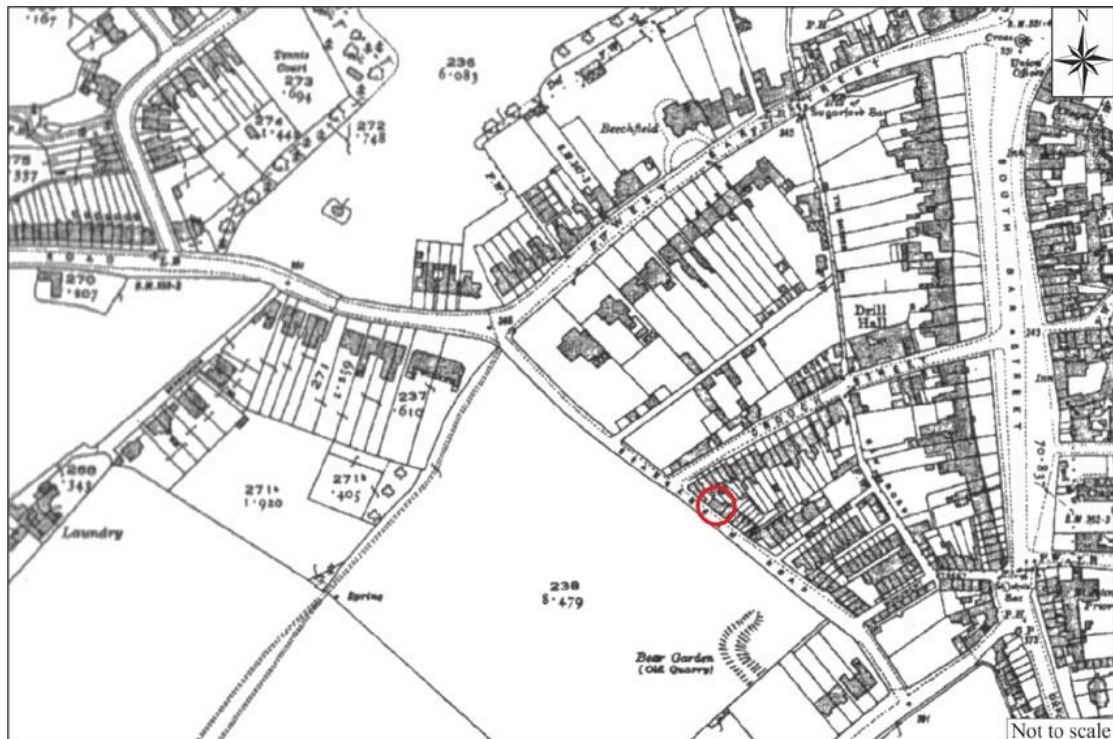
The building is also shown on the first series Ordnance Survey map of 1882 (Fig. 5), and the subsequent second and third series maps (Figs. 6-7).

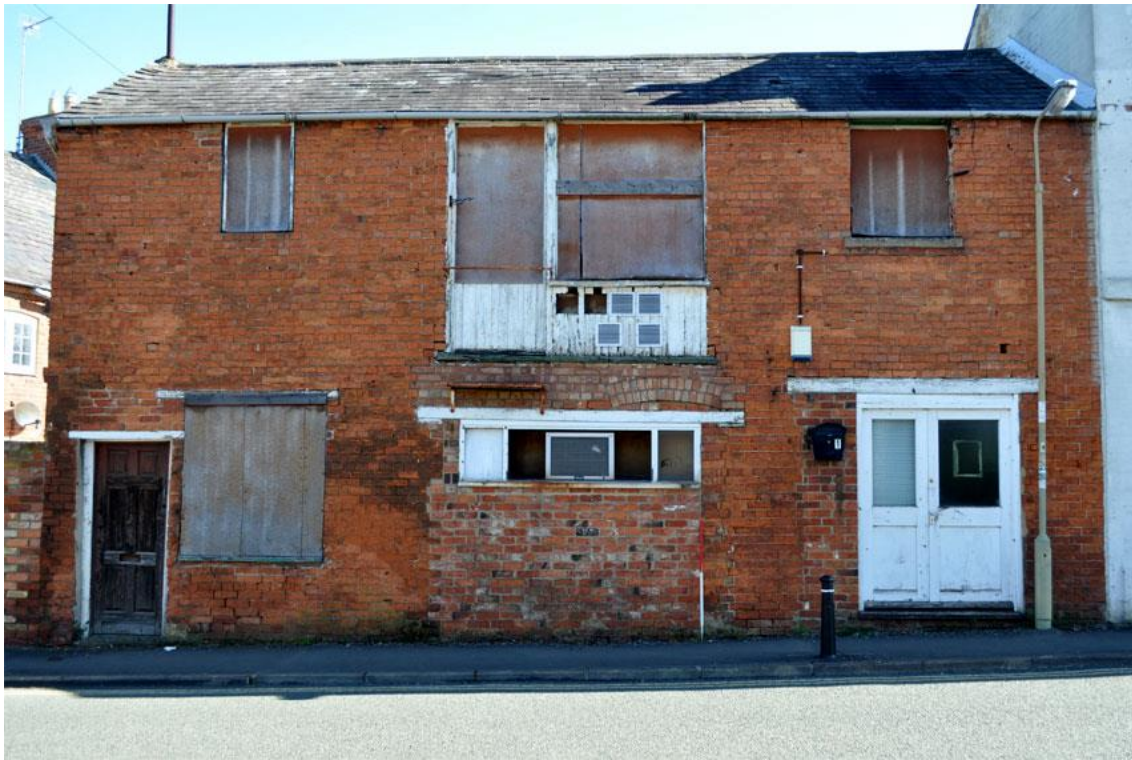
Plate 1. South-western Façade

The front, south-western façade consists of two stories, is asymmetric with three bays and shows a series of alterations built in different brick bonds (Fig. 9, Plate 1).

The original red brick wall is built in English Garden Wall bond with a row of headers every 5<sup>th</sup> course. It is preserved in the north-western bay in both the ground and the upper floors and in the upper floor of the south-eastern bay, but has completely disappeared in the central bay due to later alterations.

The ground floor has in the north-western bay a wooden panel door with a very flat wooden lintel; this door gives access to the upper floor. To its right there is a square window with a similar wooden lintel, later replaced by a wider one. The upper floor has a single window with no visible lintel.

The central bay has had major alteration; the original wall was entirely replaced, as was the original ground floor opening. This part of the façade was altered twice: the opening on the ground floor, now consists of a high wide window with a wooden lintel, replaces an older door opening. Above the south-eastern end of the window there is a segmental arch built of two rows of soldier bricks belonging to a door of the previous building phase. The opening was blocked with brickwork at a first stage and then altered again to fit the current high window. This later wall is built in English Garden Wall bond with a row of headers every 5<sup>th</sup> course as the older one, but the header courses are not in line with the older ones. The north-western end of the high window has a metal hood on console brackets. The upper floor has a single large opening, occupied by a balcony door and a window.

The ground floor of the south-eastern bay has a door, later in date than the original, with a wider opening. The door is surmounted by a wooden lintel spanning across the entire width of the older opening, the gap is in-filled by English Garden Wall bond bricks. The upper floor has a single square window, with a concrete windowsill.

The building is covered by a gable roof of black slate.

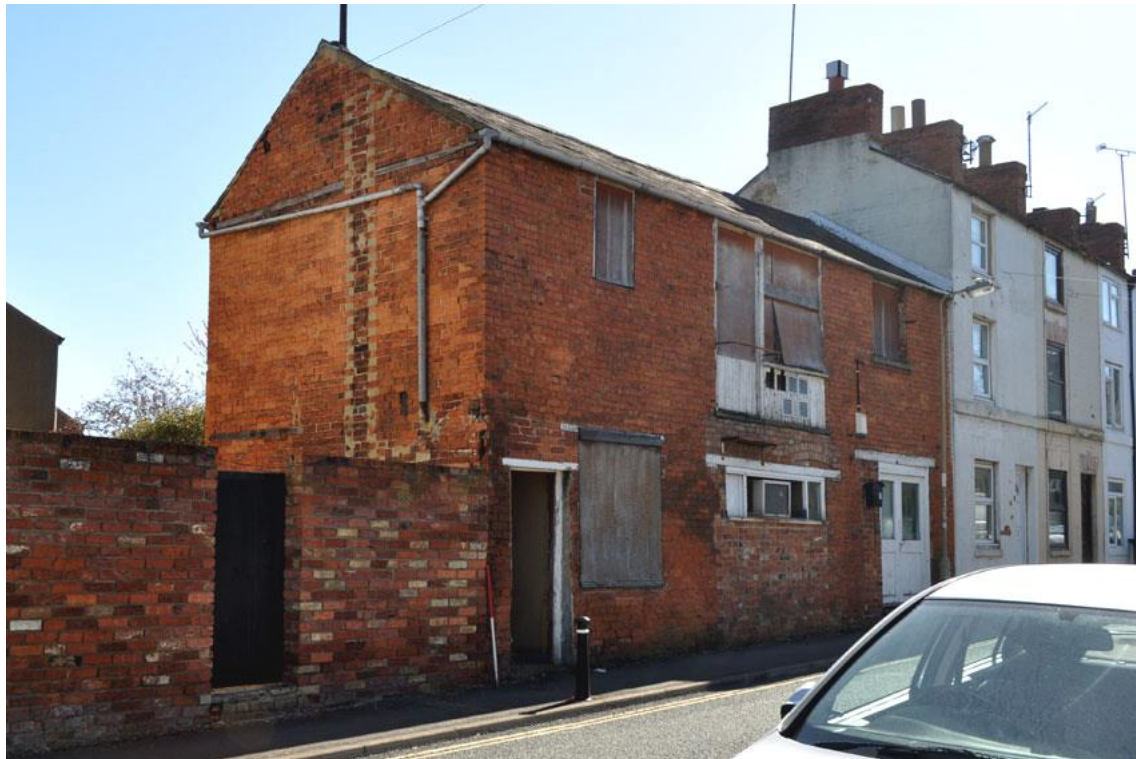
Plate 2. View from the west corner

The northern gable wall is built of bricks in a Stretcher bond pattern (Fig. 9, Plate 2). This side of the building does not have any openings. The western section of the façade shows traces of a removed chimney, and in the western corner a later replacement of the brickwork is visible.

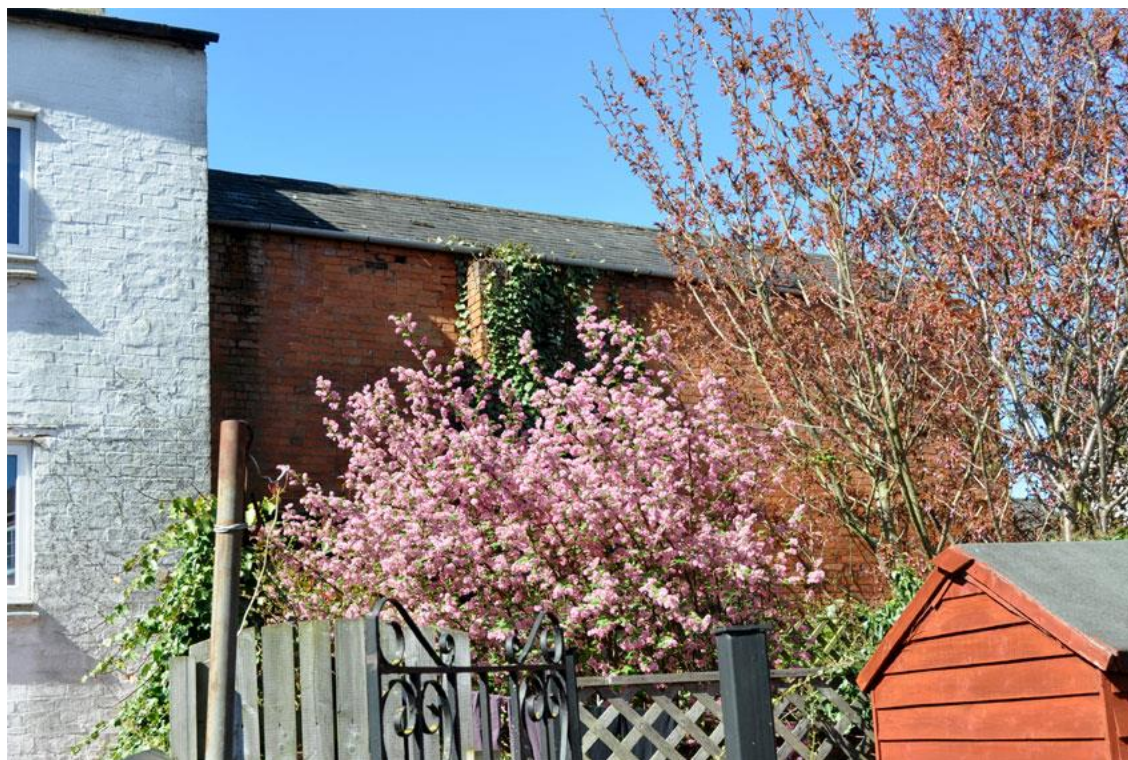
Plate 3. North-eastern Façade

This façade preserves the original brickwork, built in English Garden Wall bond with a row of headers every 5<sup>th</sup> course (Fig. 9, Plate 3). This side of the building does not have any openings. There are the remains of a lateral chimney.
