**SALVAGE BUILDING RECORDING**  
**ON**  
**THE COACH AND HORSES,**  
**62 ST CLEMENT'S STREET, OXFORD**  
**NGR SP 5258 0606**

*On behalf of*  
*Linfield Ltd.*

**DECEMBER 2012**

**JMHS Project No:** 2757

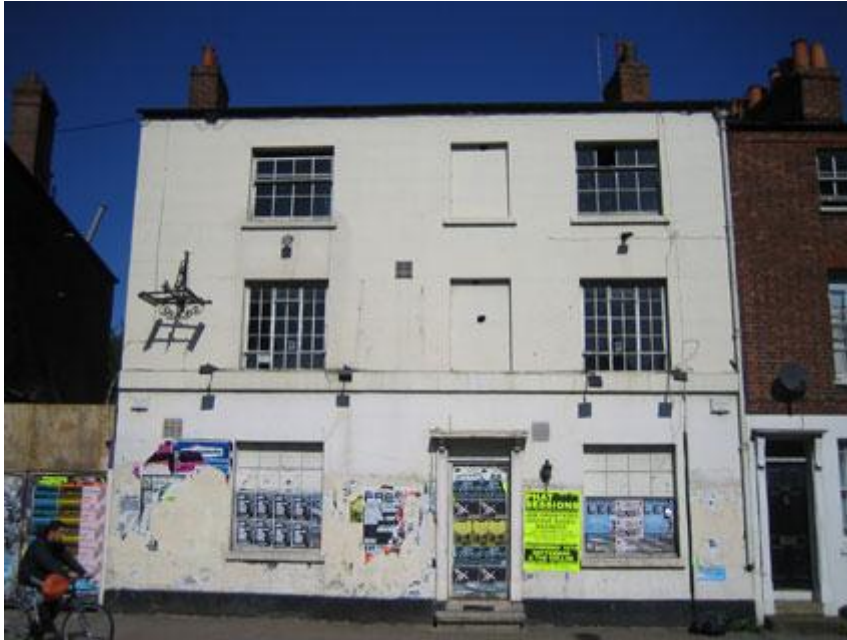
The southeast façade is asymmetric with three bays, plain except for a string at first floor level and is constructed of stuccoed brick, lined-out to simulate ashlar below a low-pitched Welsh slate roof (Fig. 3, plate 1). The central door has a surround of simple earlier 19<sup>th</sup> century type with a narrow sloped hood on console brackets (plate 2) and the ground and top floors have sash windows of the same date. Sixteen light on the ground and twelve light on the second, all with sills. The first floor windows have replacement aluminium casements and the central windows on both upper floors are blind. There is a modern wrought iron bracket for a public house sign and six lights.

Plate 1: Southeast facade

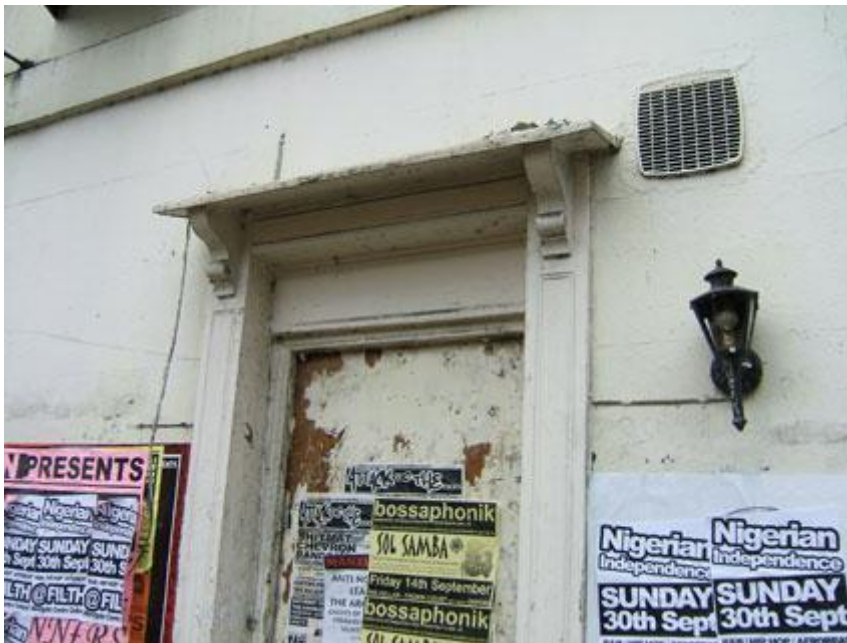
Plate 2: Front Door details

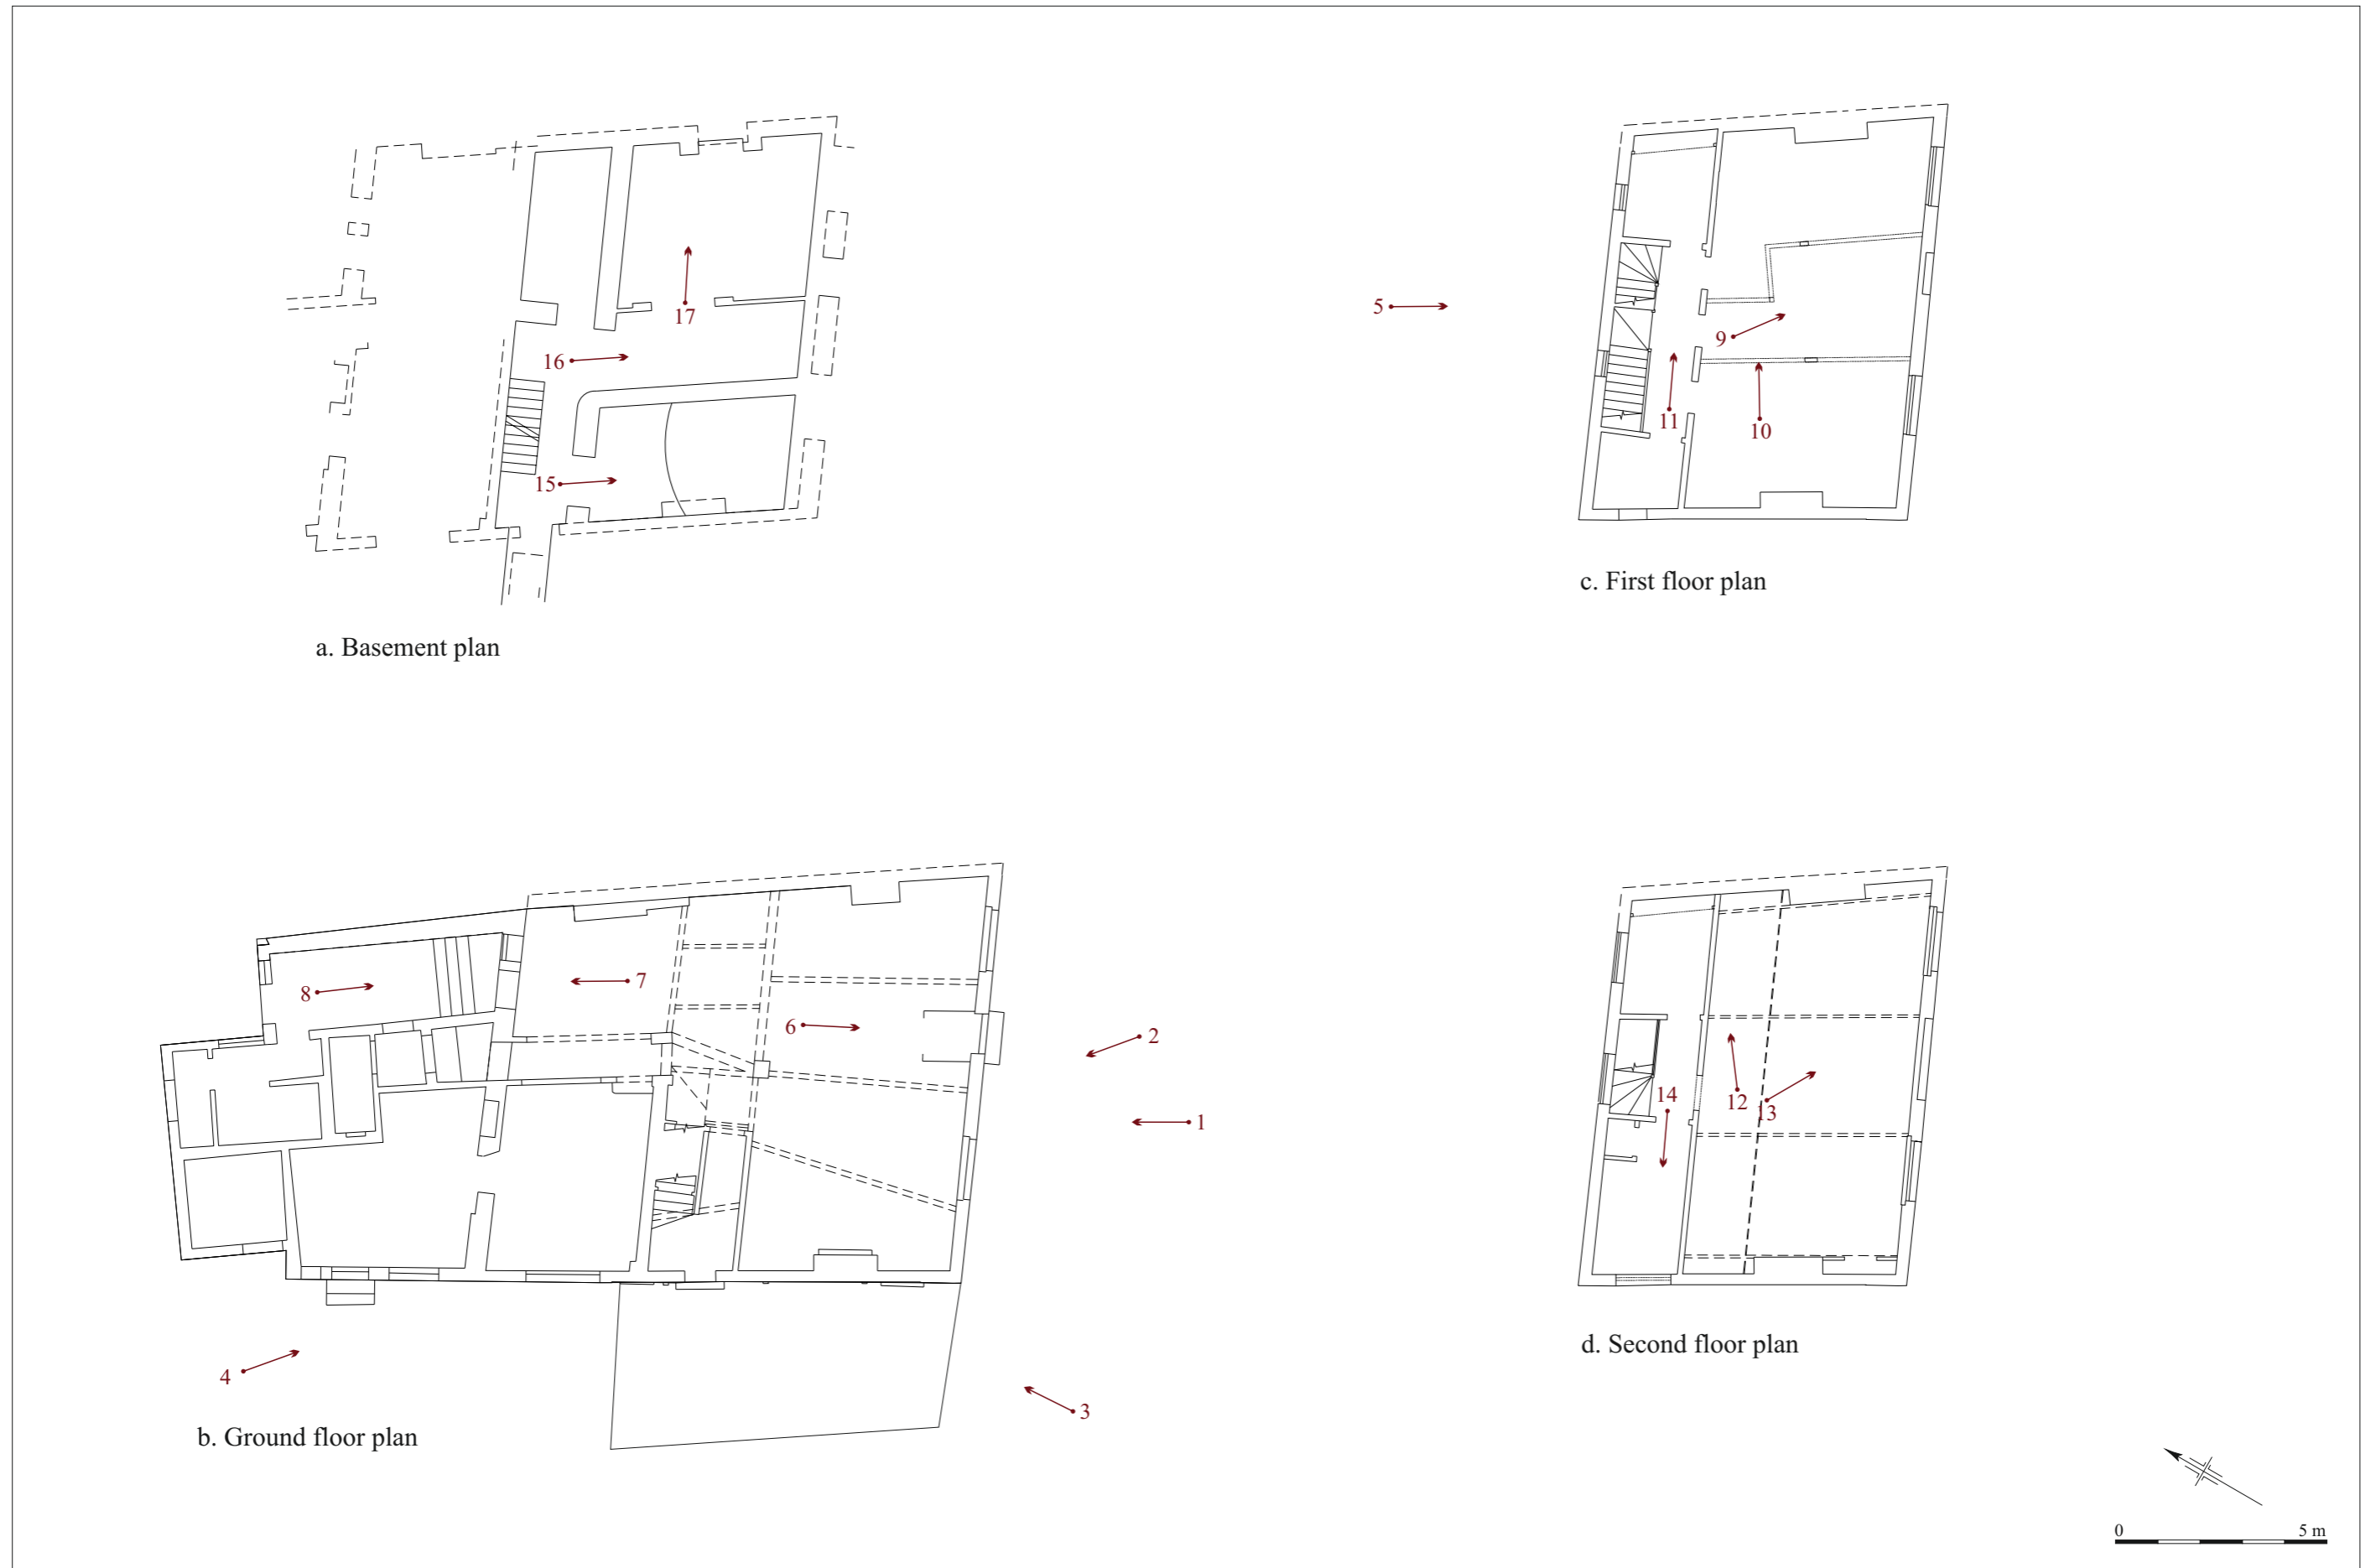
Figure 2. Floor plans of Coach and Horses

The building lies on the northwest side of the St Clement's Road, with its main façade facing towards the southeast. The main structure is of a sub-rectangular shape and located at the southeast end of the building (Fig. 2). There are four levels located in this part of the building plus the attic space. On the northwest side there is a single story extension, part of which is a lean-to structure.

The southwest façade is of brick below and rendered above with a gable end, showing a low pitched roof (Fig. 3, plates 3 and 4; direction of photographs for plates shown on Fig. 2). This faces onto the side drive or carriageway where there is a car port. On the ground floor of the gable there is a door on the ground floor (left hand side), above which are two windows, one on the first floor and the other on the second, with slightly segmental arches. To the rear of this is the remains of a single story extension, the part nearest the older part of the public house contains a lean-to, while that furthest away has a flat roof. In the lean-to part are the remains of a patio door, in the next part of the extension a window and a door, and in the end part a further door. The extensions to the rear all appear to be of a later date.

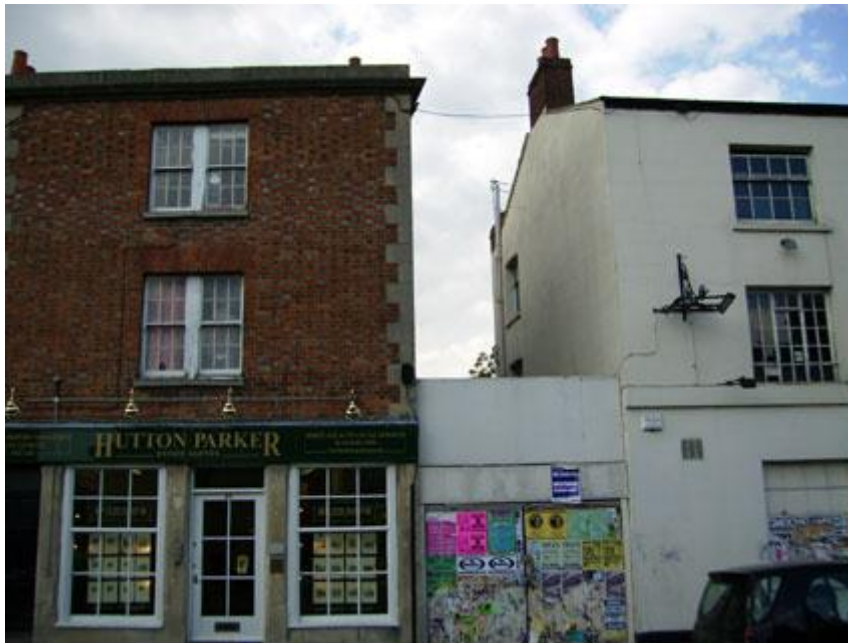
Plate 3: Southwest elevation from front

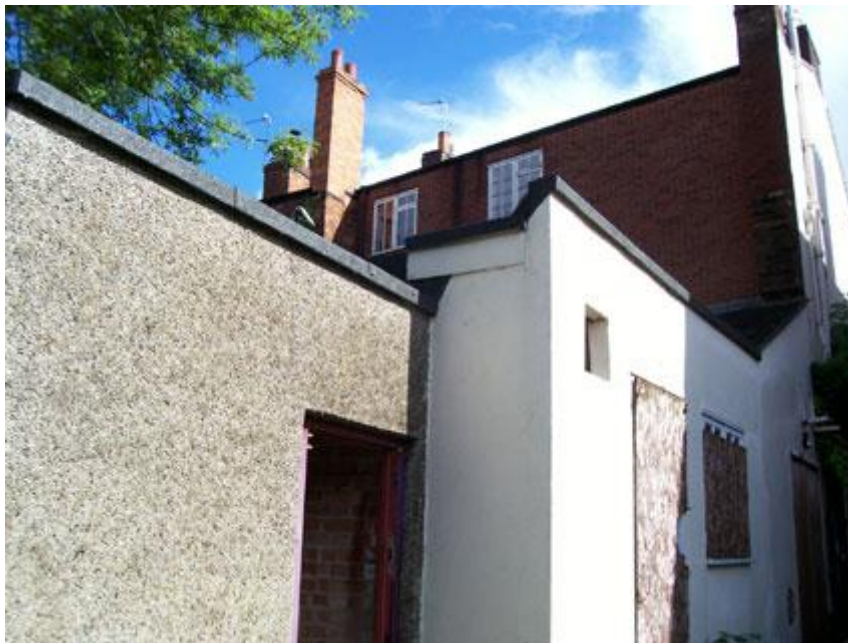
Plate 4: Southwest elevation from rear

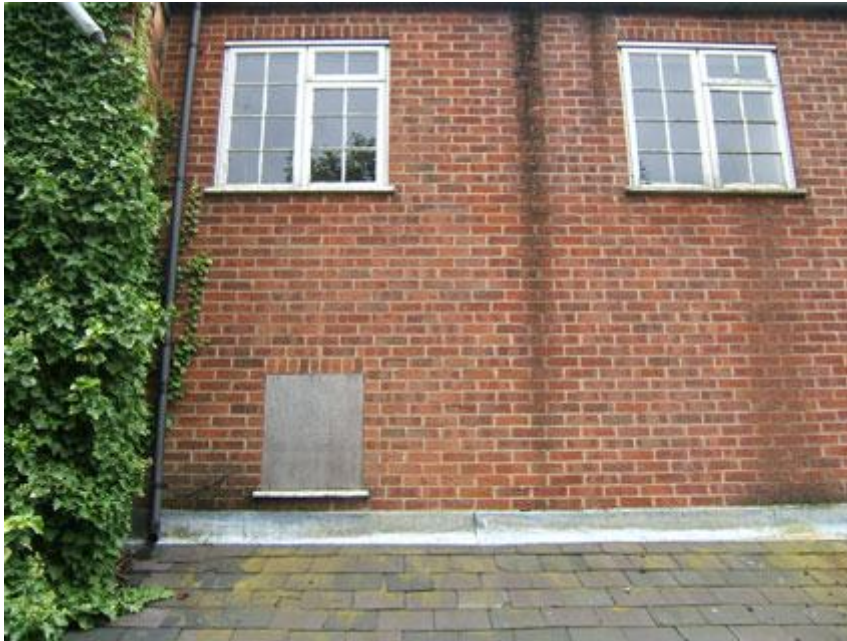
The yard at the rear is enclosed by a brick wall; 19<sup>th</sup> century on the west side, modern elsewhere. There is no trace of the former stable buildings and the yard is in-filled with a series of single-storey 20<sup>th</sup> century extensions of no architectural merit. On the ground floor a door with adjacent window lies on the left and to the right a six light window (Fig. 3). Above this level the back wall of the main building has been rebuilt in later 20<sup>th</sup> century brickwork with contemporary windows (plate 5).

Plate 5: Modern rear wall, northwest elevation

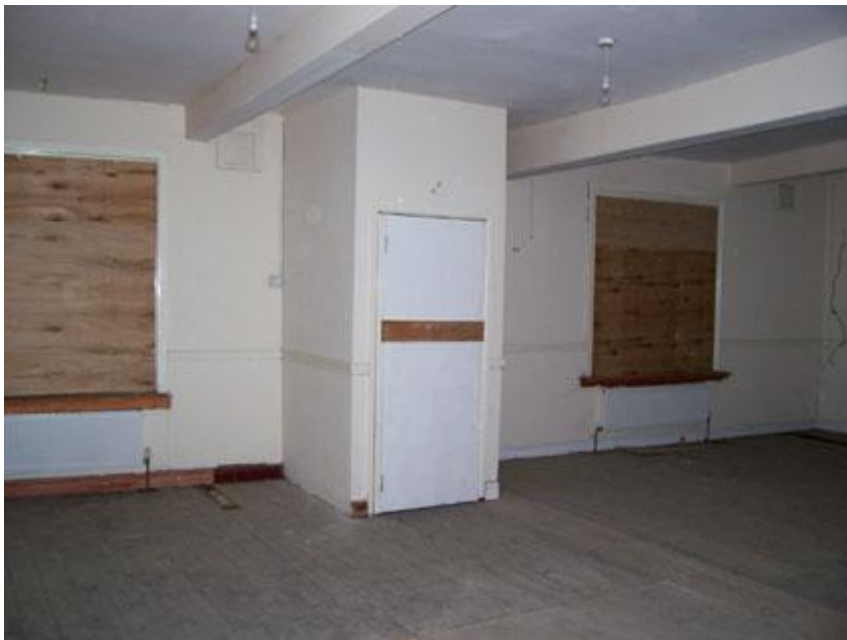
Plate 6: Bar area

Internally the ground floor has been opened up to form one large interconnecting C-shaped space with modern finishes; access is from the street and there would have been a central corridor originally. A modern entrance hall has been inserted (plate 6). The only surviving element from the earlier floor plan is the lateral passage to the side door which houses the staircase to the landlord's living quarters. This is of early 19<sup>th</sup> century type with stick balusters and a turned end post to the landing handrail (balusters replaced). A lower stair leads down to cellars.

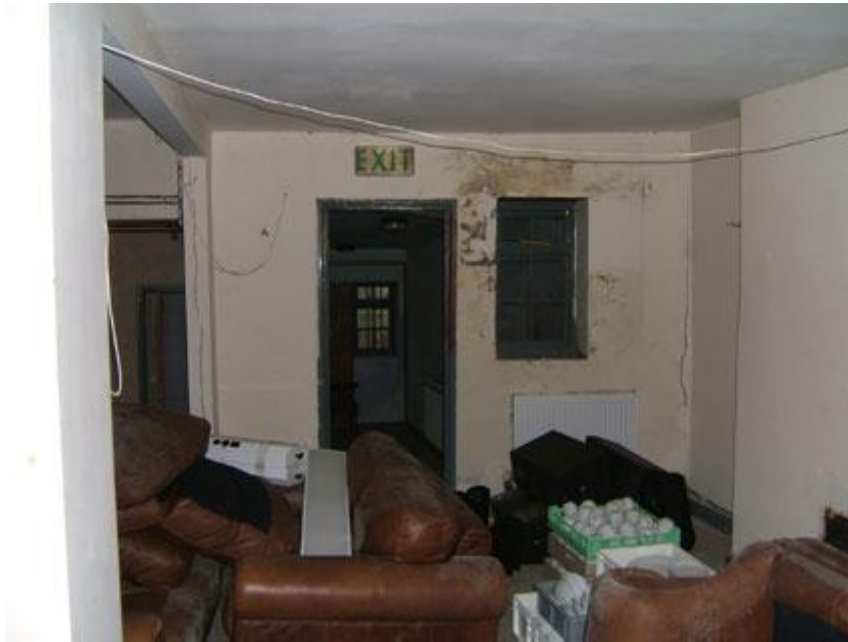
The wall between the lean-to structure and flat roofed extension is wider than would have been expected on the plans and pictures (plates 7 and 8), as is the wall along the partition on the northeast side. There is the possibility that these may once have contained earlier walling. A door and window at the north side of the lean-to leads into a passageway with steps. There are a series of smaller rooms to the southwest of this passage forming a toilet area.

Plate 7: Door and window rear of the bar

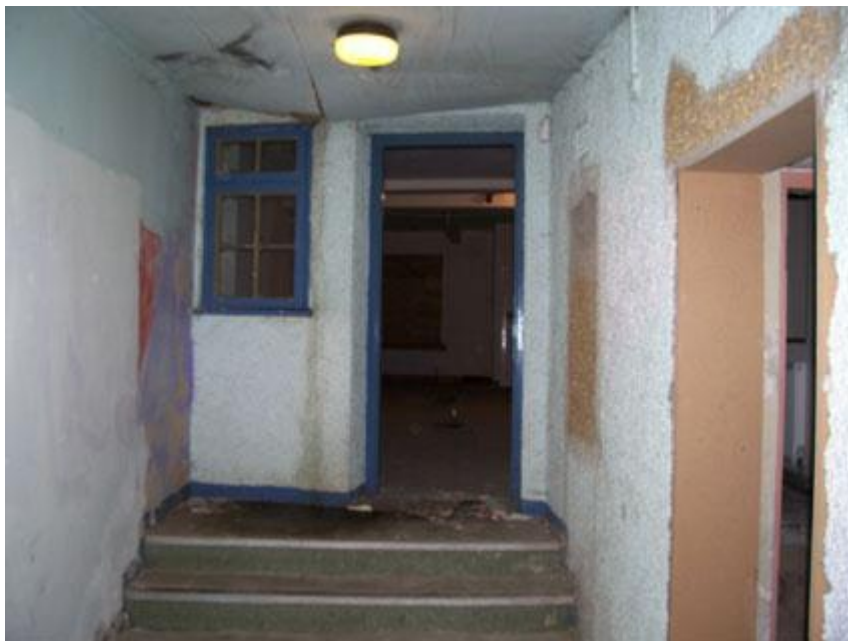
Plate 8: Door and window from inside the passage

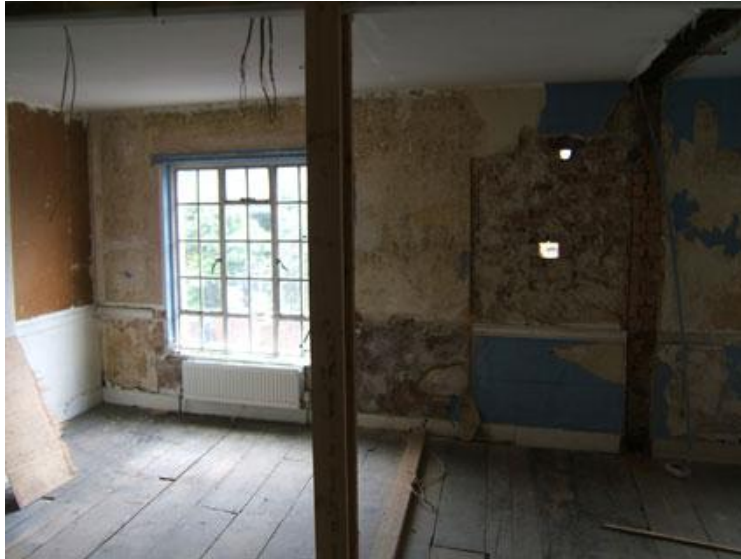
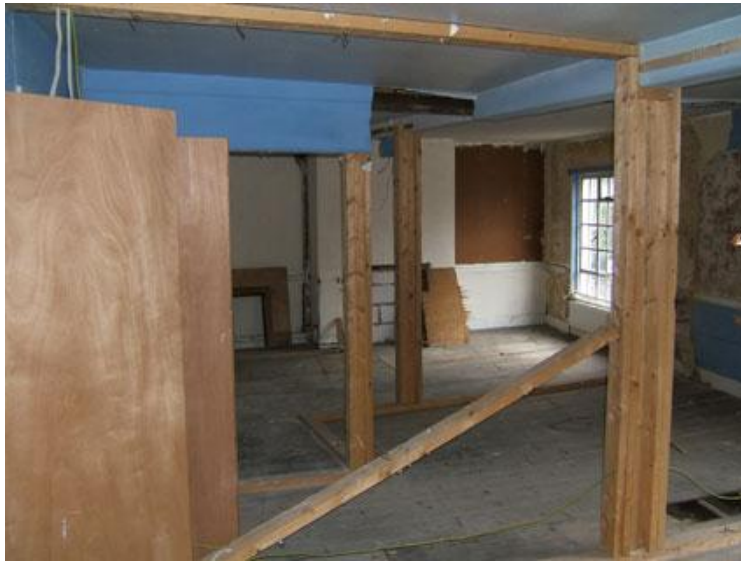
On the first floor there were formerly two main rooms at the front of the house (plates 9-10). These have no surviving historic features and the partition wall has been removed, leaving the ceiling beams unsupported. Chimneybreasts survive but with blocked fireplaces. On the northeast wall there is some panelling (presuming not original). The windows are replacements and there is an outline of the blocked window. There are two small back rooms at either end of the landing (plate 11). The southwest room has a sash window; the north eastern has a blocked modern window.

Plate 9: Views of the first floor

Plate 10: Views of the first floor

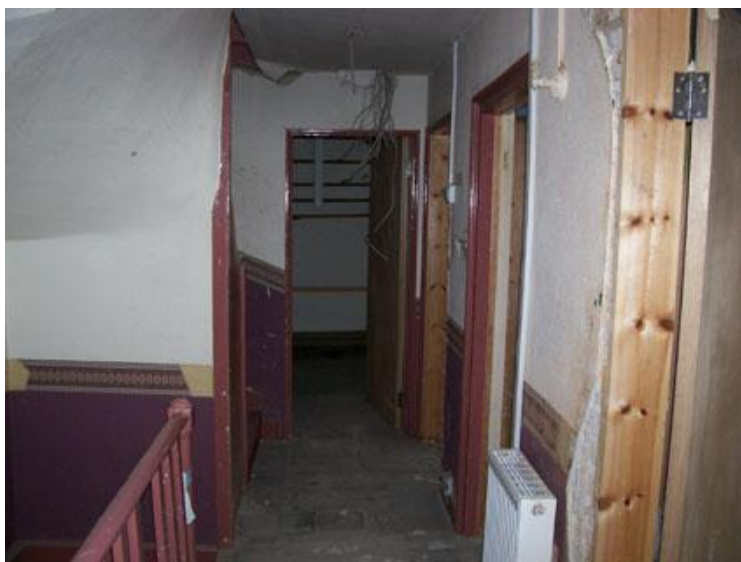
Plate 11: Landing

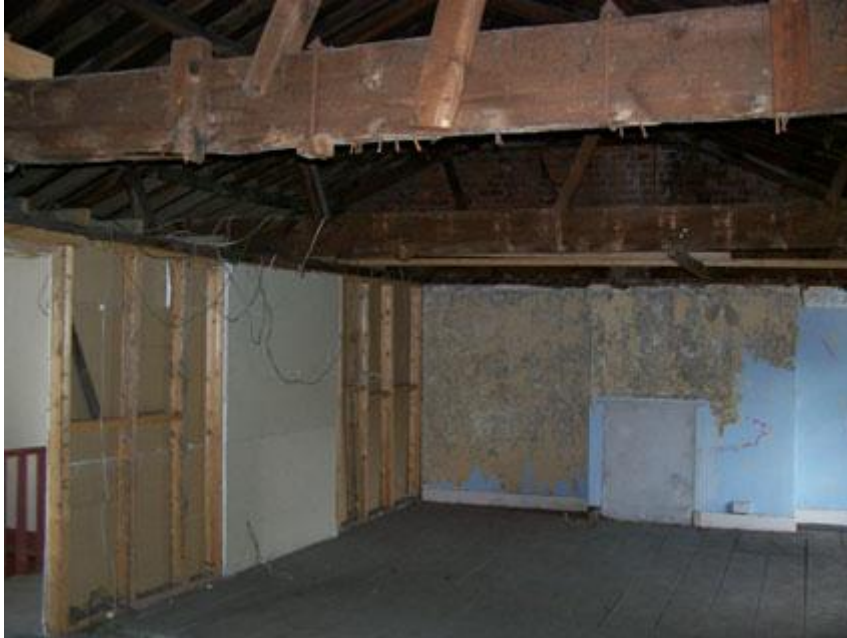
The front rooms have been amalgamated with the central partition removed and the roof structure exposed; the partition wall to the landing is modern. The fireplace at the northeast end has been blocked, but has the outline of a mantelpiece. The two windows contain sash windows.

Plate 12: Northeast end of second floor

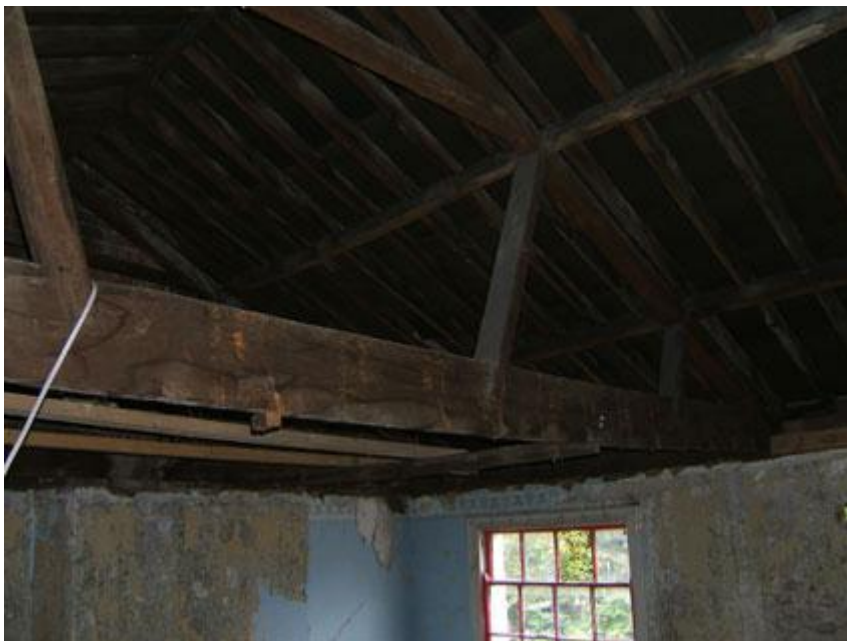
The exposed roof beams have queen struts and princess struts, but no interrupted tie beam.

Plate 13: Truss arrangements

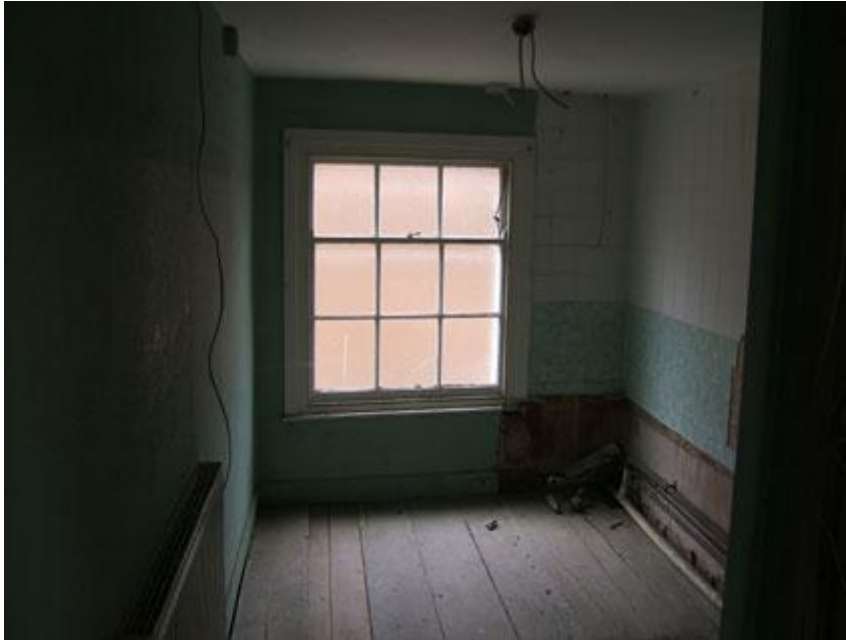
At either end of the landing there are rooms, the one at the southwest end contains an original sash window with nine lights and a moulded surround. The room at the northeast end of the building has a modern window located in the rear wall.

Plate 14: Southwest room, second floor

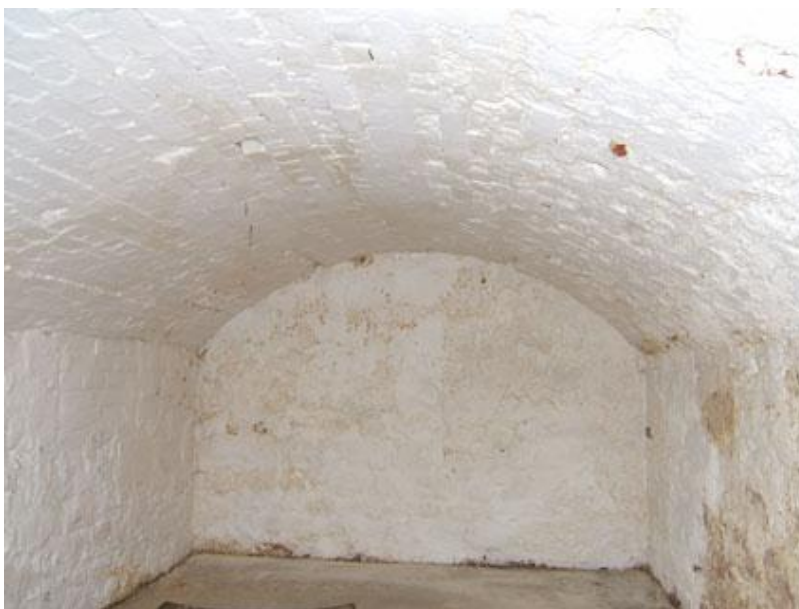
The basement covers the whole area of the old building. There is a long passage at the rear of the cellar divided into two. The stairs descend in the in the southwest part. The front of the cellar is divided into three unequal components, all of which are whitewashed. The southwest unit is entered from the northwest and contains a brick barrel vault (Fig 4, plate 15), and presumably has the base of the chimneybreast in the southwest wall. The central and northeast unit are separated by a narrower partition, and are entered on the northwest side of the central unit. In the southeast wall of the central unit are the remains of a blocked opening with a segmental arch (plate 16). The opening once extended to the floor of the cellar, but was at one time partially blocked up and then later completely blocked. The lower part of the infill is set in a slightly narrower opening. The arch is probably slightly out of line with the door and may provide the original reason for the asymmetrical appearance of the external front façade. It is likely that this opening represents a barrel run. In the northeast wall of the northeast unit is the base of the chimneybreast in which an arch is evident (plate 17).

Plate 15: Cellar vault

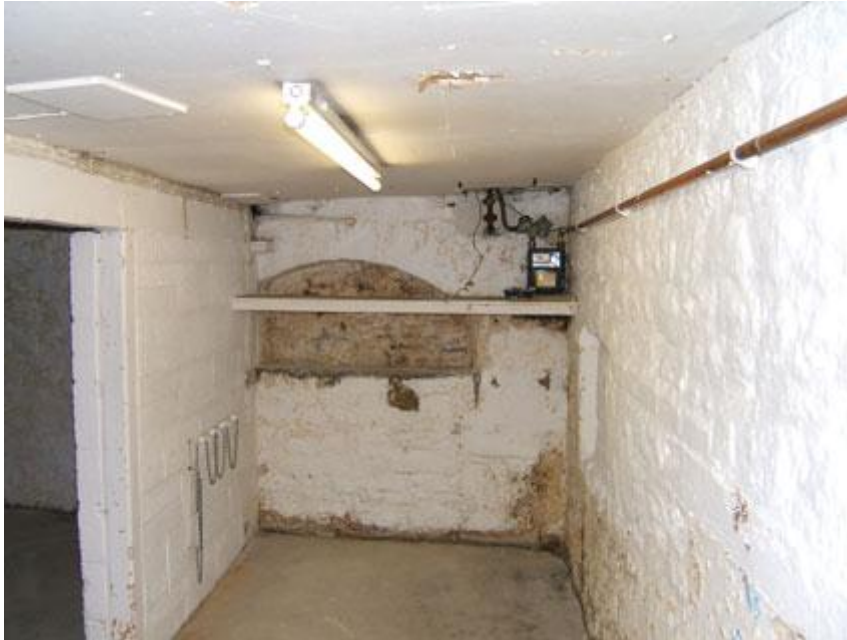
Plate 16: Central front part of cellar

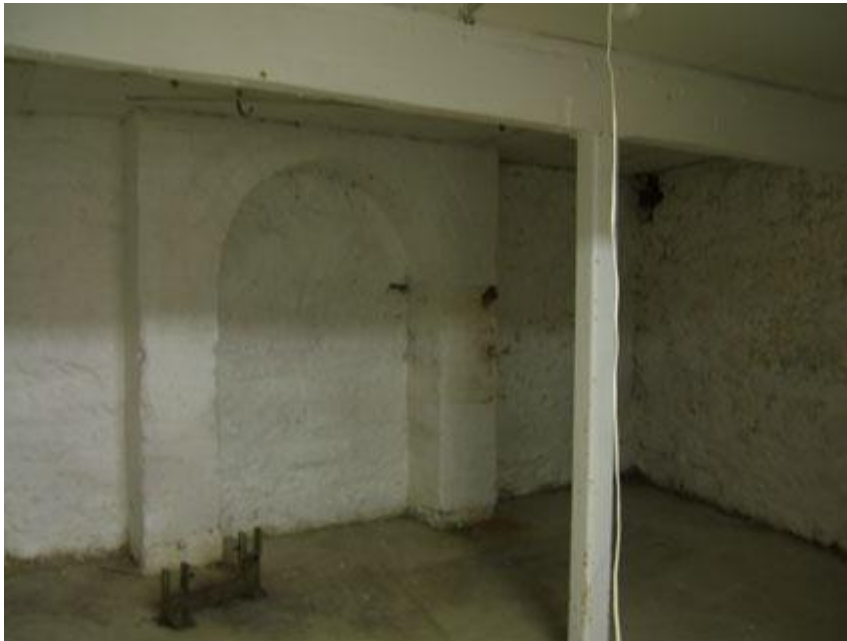
Plate 17: Base of northeast chimneybreast in cellar

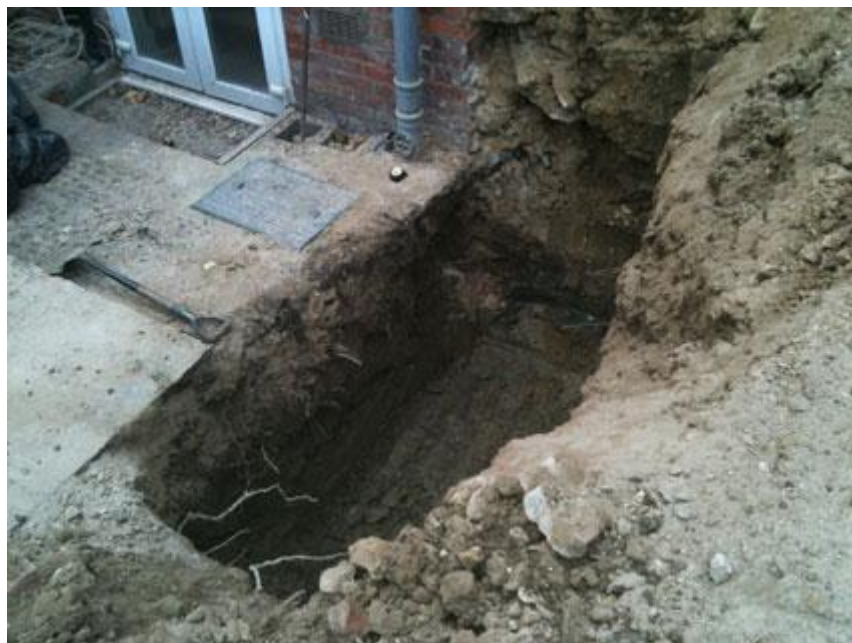
The 1960s and 1970s extensions and back walls were demolished, and a series of trenches cut to take the foundations. These were not witnessed and only three photographs have been provided of the cuts, two of which the foundations had already been constructed in. Only one foundation cut picture taken showed evidence of a section (plate 18), and this due to the lighting is not totally clear. It is possible to suggest that there were five contexts visible here. The first context (1) represents the dark natural clay. Above this is a garden soil (2), which has a rubble disturbance layer across the top. Cut into this were the foundation cuts of the 1960s or 1970s extensions (3) and the walls (4) and backfill that filled them (5). No proper descriptions of these contexts can be provided as they were not witnessed.

Plate 18: Foundation trench on boundary with no. 63 (possible stone boundary wall)
