BUILDING RECORDING

BREWERY GATE, 5 ST THOMAS STREET,

OXFORD

MARCH 2012

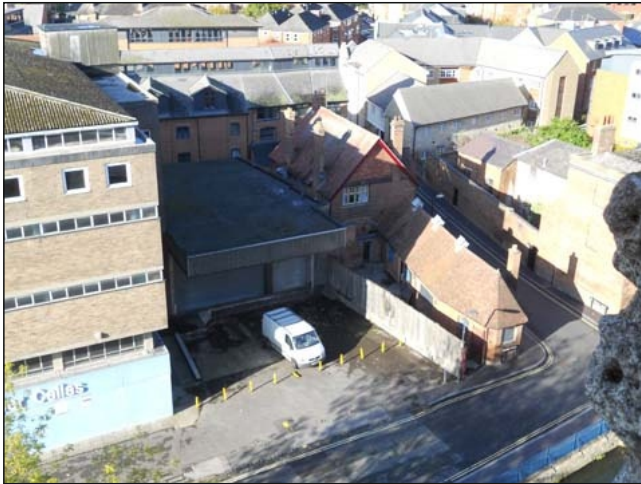
The buildings consist of two basic units, a two storey building on the west of the property (Building 1), and a single storey building on the east of the property (Building 2). The larger two-storey structure also has a lean-to structure between it and the main brewery site to the east and further buildings to the south. All façades are of red brick.

Plate 1. Brewery Gate from the east (castle)

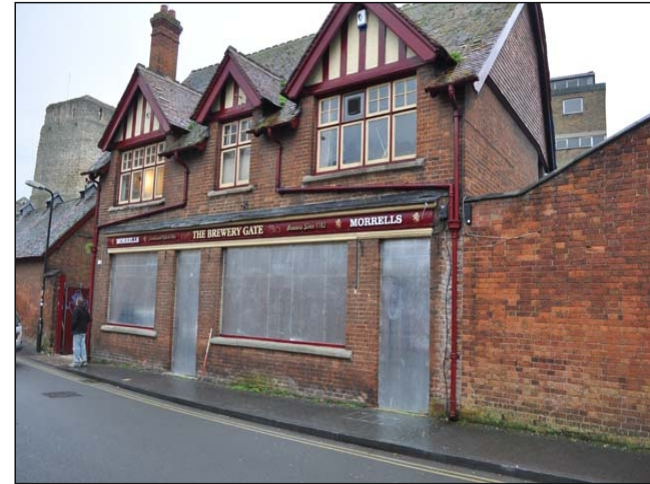
The front elevation is of two stories (Figure 3, E1, Plates 2-3). The ground floor contains a door on the right hand side and a further door located to the left of centre. Between the two doors there is a large window with six larger window lights below and smaller ones above. These lights are subdivided with smaller tracery. To the left of the central door there is a window of four lights with four smaller lights above. These are sub-divided by further tracery.

The upper storey or first floor is separated by a decorative pediment, which runs from door to window edge. The first floor contains three windows, the two outer ones divided into four window lights with four smaller ones above. The casement in the middle contains two larger lights at the base and two smaller at the top. These windows are again subdivided with tracery. Each of these windows is set in a dormer gable with mock wooden frame panelling.

Plate 2. Brewery Gate, north facade

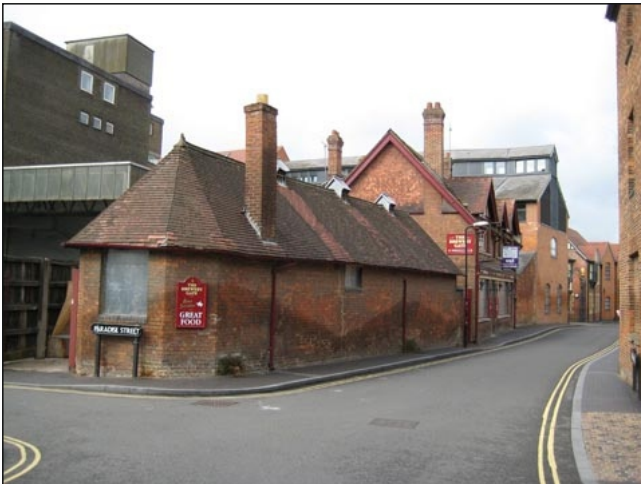
The end of the building is polygonal in shape to fit into the corner space of the street arrangement (Figure 3, E8, Plate 3). There is a window in the east end.

Plate 3. Brewery Gate, north and east facades

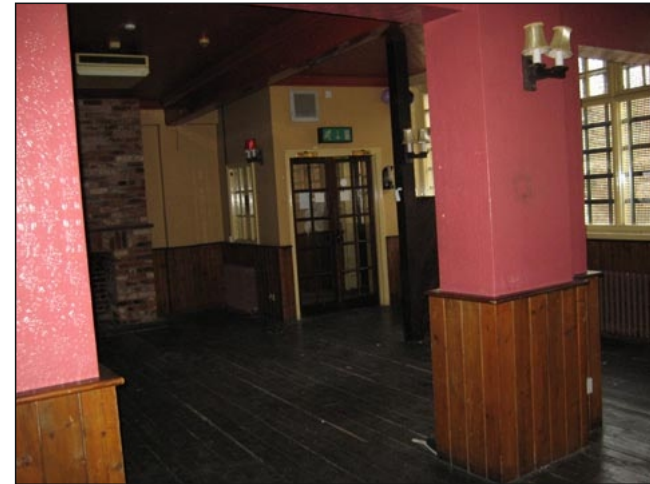
Plate 4. Brewery Gate, bar looking north west

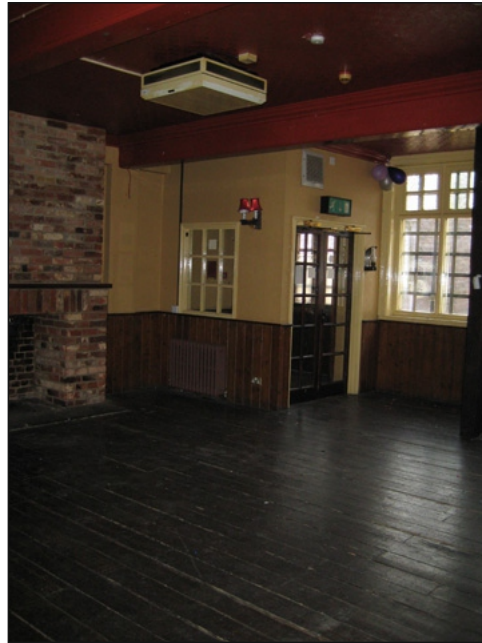
Plate 5. Brewery Gate, west entrance

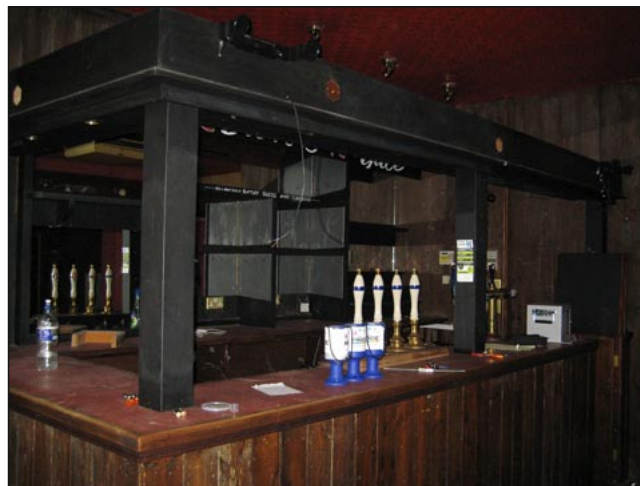
Plate 6. Brewery Gate, internal view of bar

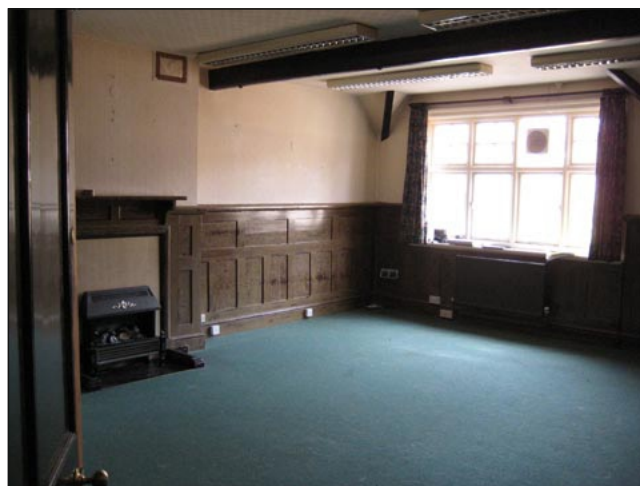
Plate 7. Brewery Gate, internal view 1st floor
