JOHN MOORE HERITAGE SERVICES

**BUILDING ASSESSMENT**

**61 BRIDGE STREET, CHESTER**

**JMHS Project No:** 2696

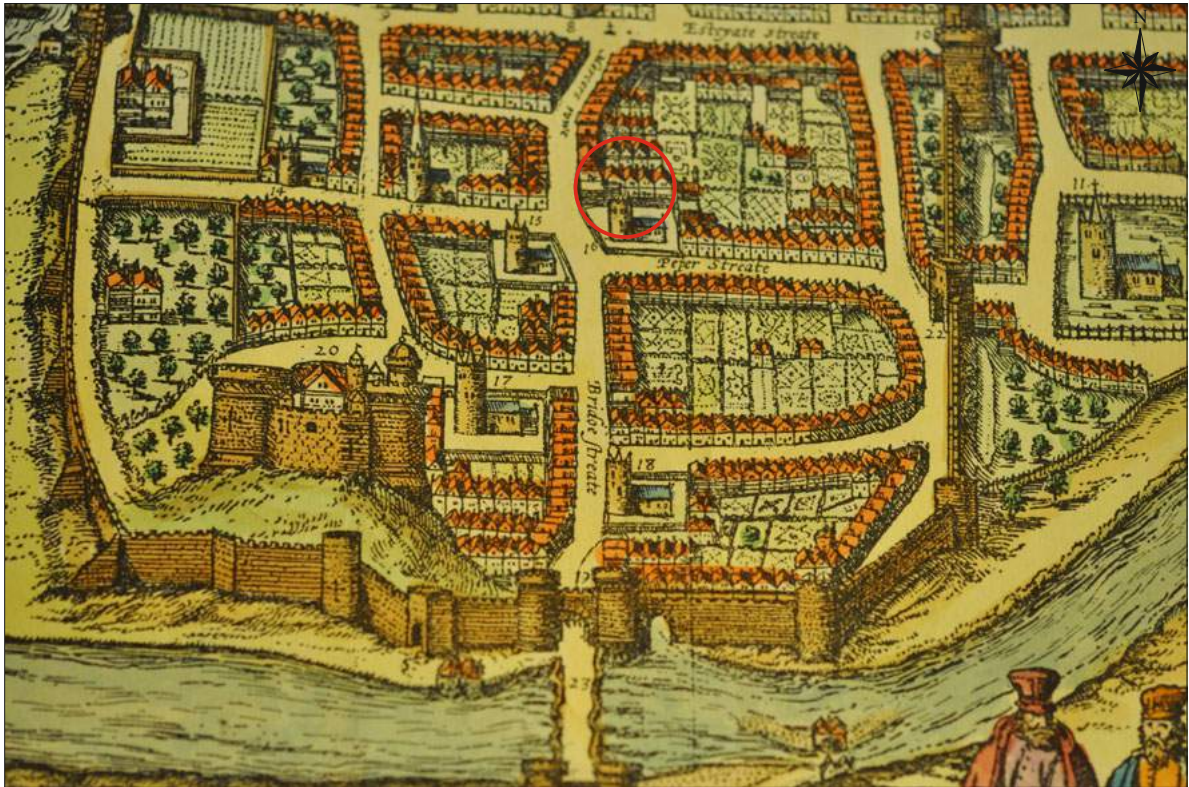
development of the site in question and the walls. The map of 1581 (CRO PM 14/1) is of interest as no.61 Bridge Street is located 2 doors away from the church of Saint Michael. The 1581 map shows the church sat in a churchyard extending to the north and potentially into the area where this property is located. There is a row of houses fronting on to the north side of the churchyard or a small lane on that side of the churchyard. It is feasible that the undercroft if of a medieval date formed part of this structure and that the superstructure above this previously carried a series of timber framed gables. The map of 1610 (CRO PM 14/7) also shows a cemetery around Saint Michael's church, which can be identified to the southwest and northeast of the church, while to the north the street frontage is drawn as if extending to the church. A similar situation is indicated on the map of 1729 (CRO PM 2/22). The map of 1745 (CRO PM 18/3) shows the block of land between Bridge Street and Fleshmongers Lane as being completely built over apart from an area running around the east and northeast side of the church,

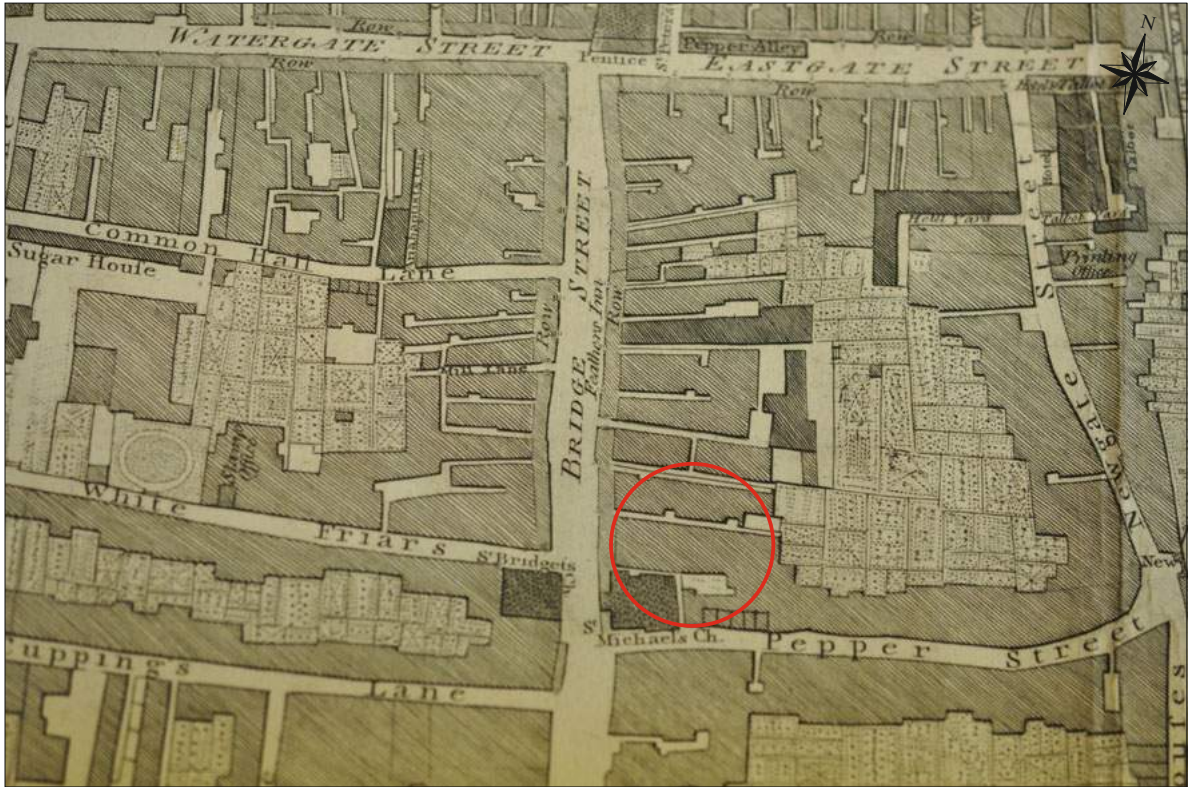
The maps from 1789, although they may not be completely accurate, do show a further level of competency. The first map of 1789 (CRO PM 18/4) shows the rows running from Saint Michael's church north past the front of the premises. There are paths drawn around the church and a courtyard to its east. A similar arrangement is on the map of 1796 (CRO PM 14/12). The 1805 map (CRO PM 15/1) shows the rows running down to the church for the first time along Bridge Street. Behind the rows there are a series of buildings extending back from the rows, but with passages between them. How, this arrangement worked is not known, but it may feasibly explain why there is no vaulted undercroft in the northern part of the premises. Access is still shown around the church from the east end. The map of 1817 (CRO PM 15/3) shows a similar arrangement. The map of 1833 (CRO PM 18/5) shows roads running back from the rows, but also appears to indicate that the rows were not present in the structures just to the north of Saint Michael's church. The first series Ordnance Survey of 1872 shows the individual building components for, but this map indicates more clearly how the long narrow alley ways or gardens only extend partially into the building range and not fully to the rows.
