JOHN MOORE HERITAGE SERVICES

A BUILDING ASSESSMENT
OF
GRANGE FARM
SHIPTON LEE, QUANTON
BUCKINGHAMSHIRE
NGR SP 735 208

JUNE 2012

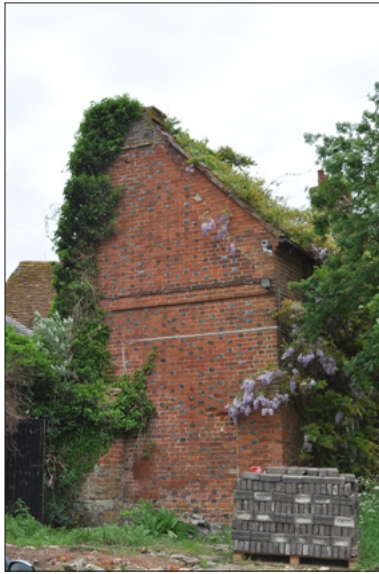
Rodwell indicated this chimney to be of the early 18th century in date (Plate 1), presumably from the pitch of the roof and the chequered brick pattern. The bricks in this wall measure 242mm x 108mm x 63mm. It is interesting to note that the floor level is lower than that which survives in the timber framework of the pre-18th century structure, and that the timber framed structure actually blocks the passage of the stairs, blocking its access to the upper story (Plate 4). This has serious implications for dating this part of the farmhouse and may indicate that parts of the structure are of a very early date.

Externally to the chimney there is a small rectangular structure butted up to the wall, which must contain part of an oven (Plate 1). The lower part of this structure contains bricks that measure 215mm x 100mm x 55mm. The depth of the bricks is indicative of the lower part of the structure at an early date, possibly as early as the 17th century. The bricks in the upper part of the feature are far larger, and are likely to be of a later date, probably 19th century.

Plate 1. Gable End, west.

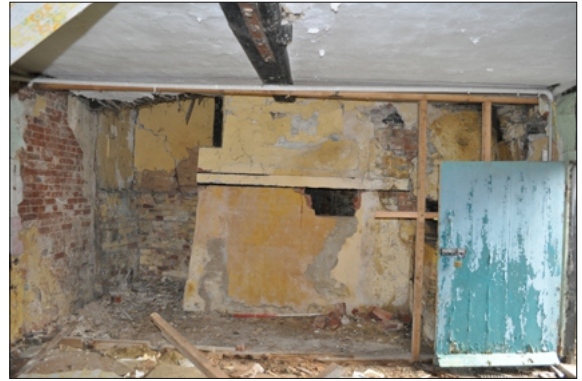
The removal of a late 20th century stud wall in the west room of the west end of unit A of the farmhouse has revealed the remains of a large inglenook fireplace (Fig. 4, Plate 2), which has lost its original lintel and has also been bricked up. The lintel has been replaced by RSJs, which have rusted. Above the lintel are the remains of a timber, indicative that the wall maintains component parts of an early date. Through a hole placed in the modern bricking up of the fireplace it is possible to see the remains of two brick arches with iron doors, which presumably lead into attached ovens (Plate 5).

Plate 2. Uncovered chimney breast.

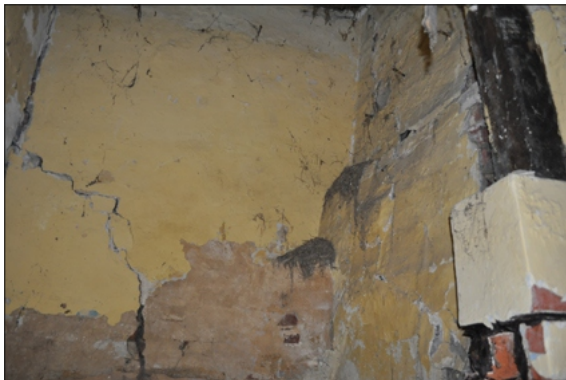
To the right of the fireplace is an iron washing tub, with a brick surround, which was presumably heated from the fireplace. Such a tub is probably of a later Victorian insertion. To the left of the fireplace is a recess, with a brick wall being built inside but only partially extending up the wall (Plate 3). On the chimneybreast side of this alcove it is possible to see the remains of two supports which would have held steps of a spiral staircase alongside the chimney and that there is also indication of an earlier floor level.

Plate 3. Remains of floor and step lines,
indication of earlier stairwell.

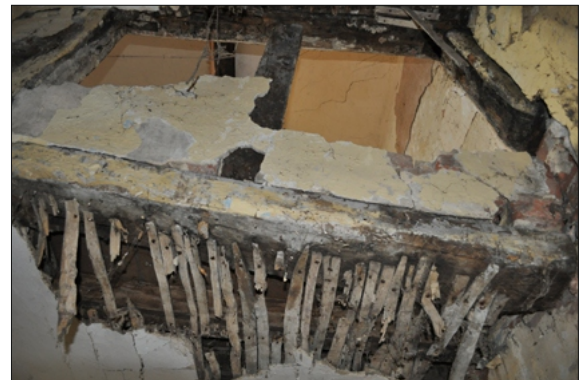
Plate 4. Wall through which staircase
would lead.

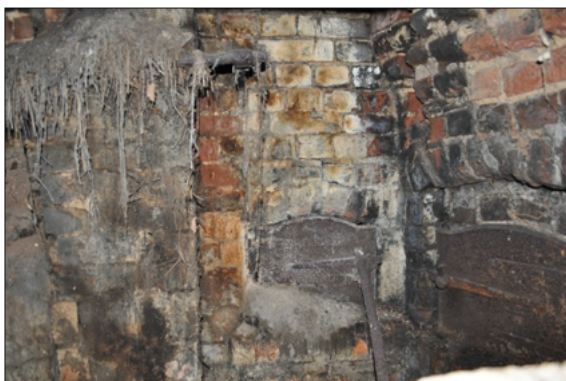
Plate 5. Oven doors inside fireplace.

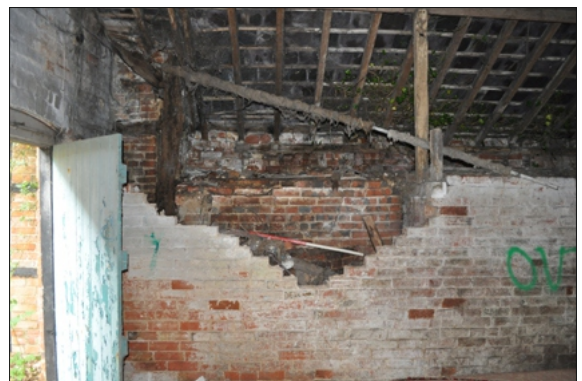
The removal of a 19th century wall in the eastern part of Building 6 has uncovered the remains of a large brick oven, which is attached to the back of the fire-place (Fig. 4, Plate 6). The upper part of the structure is rectangular, but this covers a circular brick feature that has to be the bread oven proper. The dimensions of the bricks used for the semi-circular oven are 230mm x 120mm x

63mm. The oven is likely to be of an 18th century. The upper rectangular structure could be a 19th century rebuild.

Plate 6. Partially uncovered oven.
