HISTORIC BUILDING ASSESSMENT

16 MARKET SQUARE, ABINGDON,

OXFORDSHIRE

OCTOBER 2012

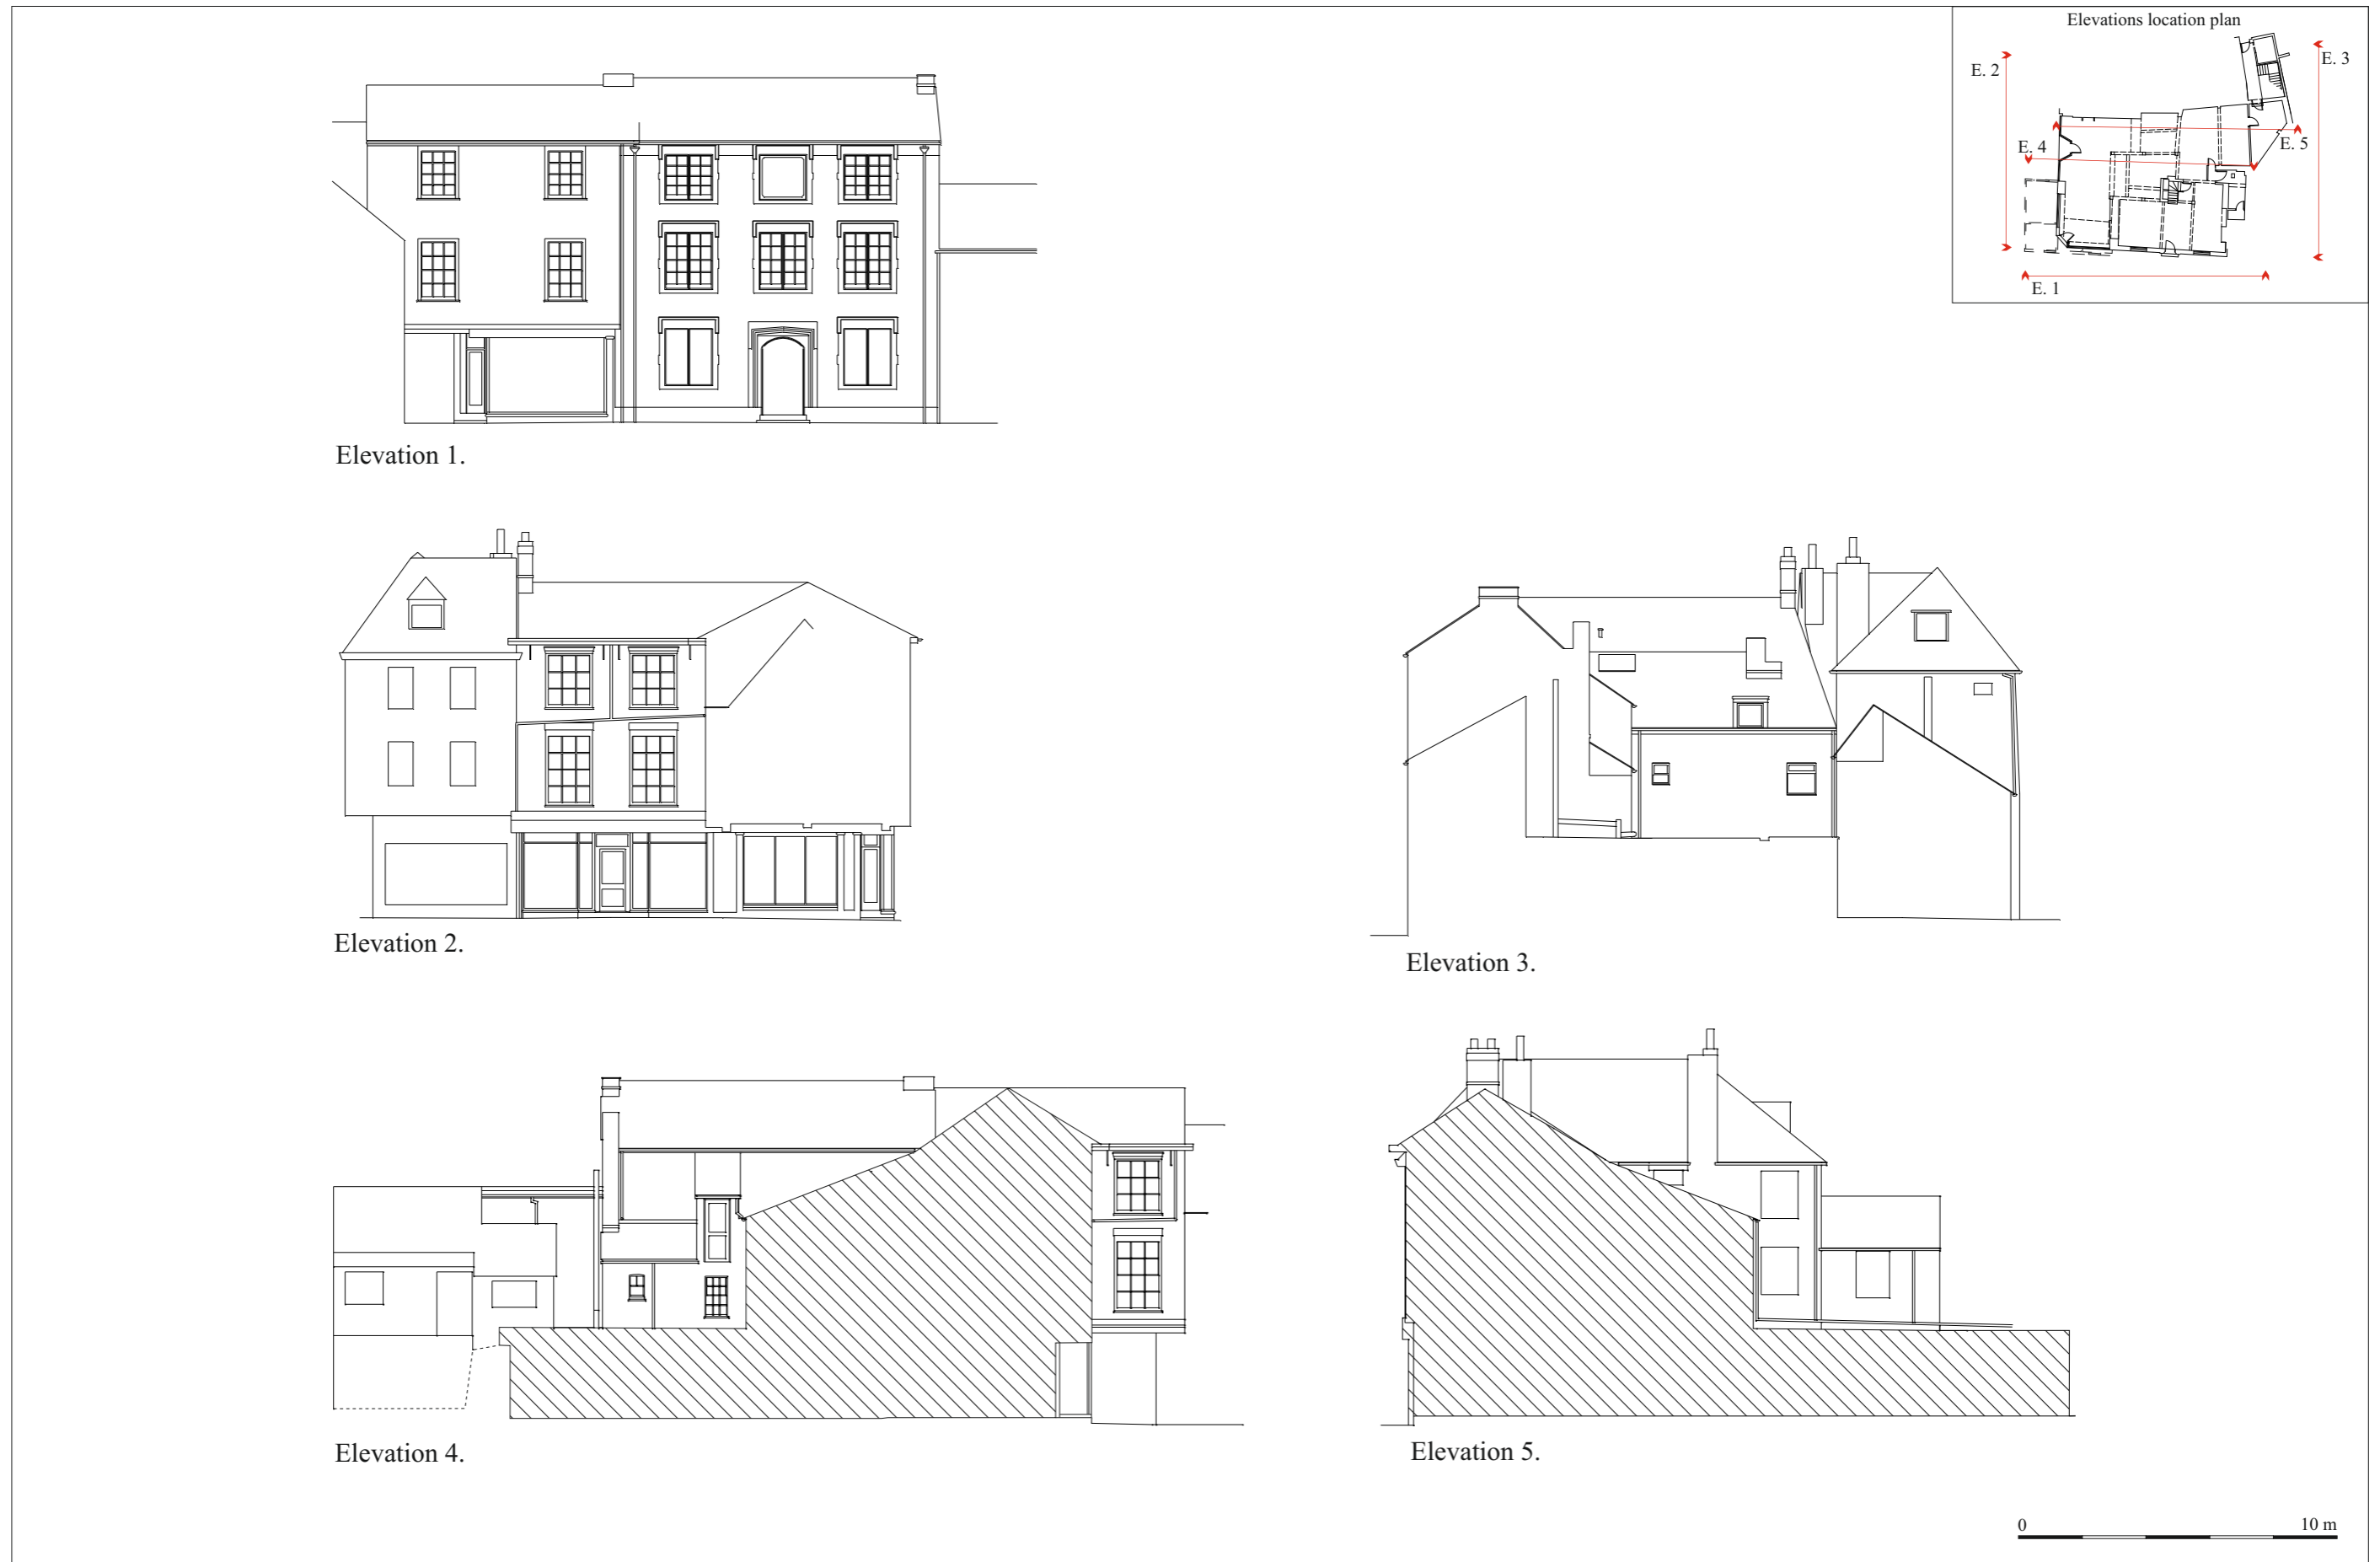
Figure 5. External elevations

The façade can be divided into two component parts, on the left is a timber framed structure, which is rendered and coloured white (Fig. 5 E1, Fig. 6 S3, S4, plates 6-8). The ground floor has a walkway underneath. The other part of the ground floor is shop frontage with a large window pane fronting onto Stert Street and a corner door. The large glazing continues the other side of the door and along the alley. There is a slight jetty between the ground and first floor. The first floor has two square-headed sash windows with twelve panes. The first floor also has square-headed sash windows, but these are smaller in size than those on the lower floor.

The Market Square frontage consists of two walls (Fig. 5 E2, E4, Fig. 6 S1, S2, S3, plates 3-5). The first of these is south facing. The ground floor contains a shop frontage with a central inset door flanked by large panes of glass. There are timber pilaster style designs flanking either end of the windows and a roller awning with iron or steel supports. There is a name board above. There is a black band between the ground and the first floor. The first floor contains two square-headed sash windows with wooden framed architrave. The windows contain twelve panels. The upper storey has two similar windows, but each of the windows has nine panes. There is a cornice, while the cornice of the neighbouring building fits uncomfortably below the line of this structure.

The rear elevation to the Stert frontage shows a small wall space, with a lean-to roof forming the first floor (Fig. 5, E3, E4, E5). There are two irregular sized windows on the first floor, and a door or dropped window on the second.

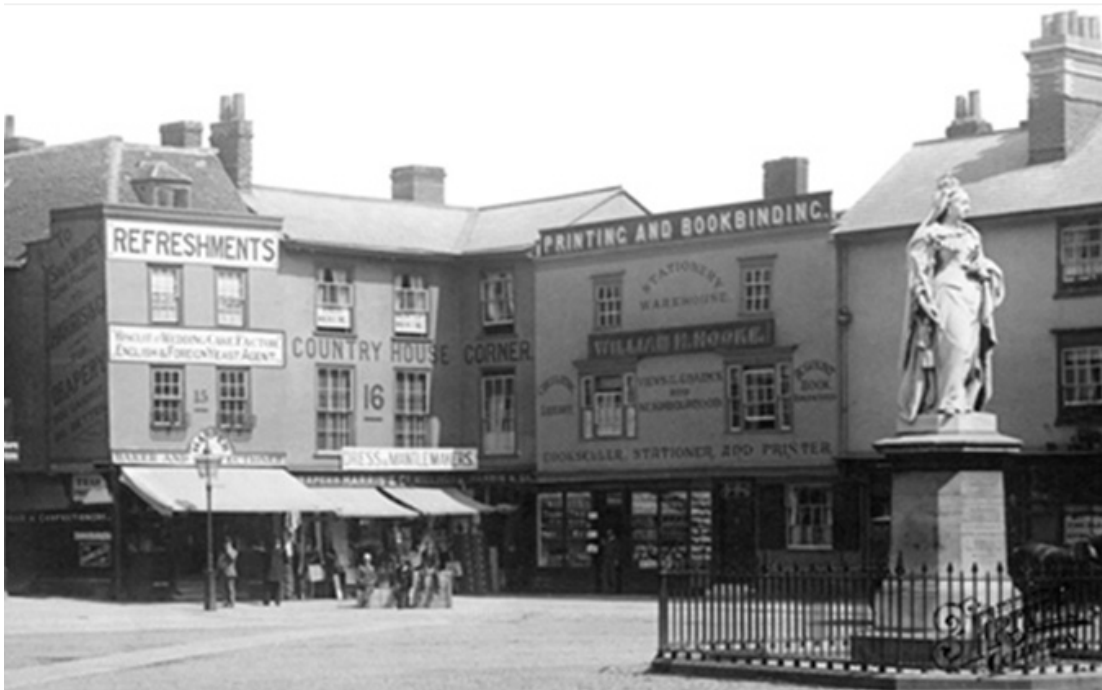
Plate 1. The Market Square in c. 1893

Phase 3 alterations would relate to the 19th century phases of the property. These probably include the front of the Stert Street property, which appears to contain more Gothic components and is presumably to be dated post 1833 when Loudon's *Encyclopaedia of Cottage, Farm and Villa Architecture and Furniture* was released, which reintroduced Gothic to the building profession (Ferry 2010, 66). The shop frontages are certainly a 19th century insertion as demonstrated by the two antiquarian photographs (plates 1-2).

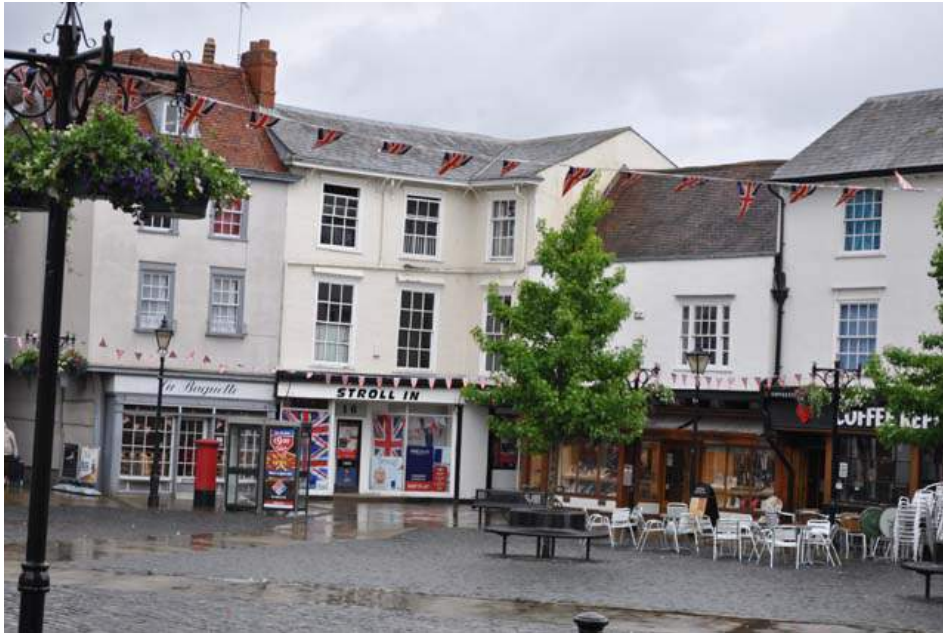
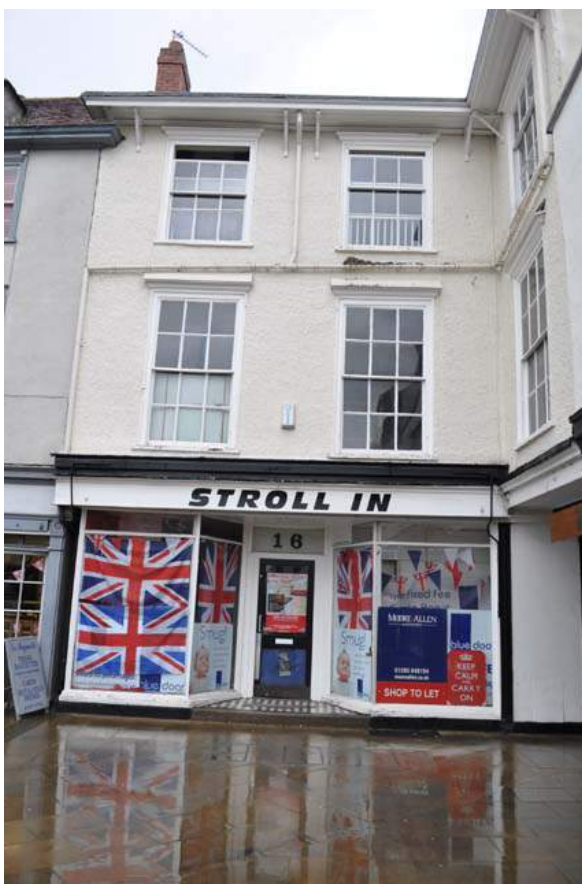
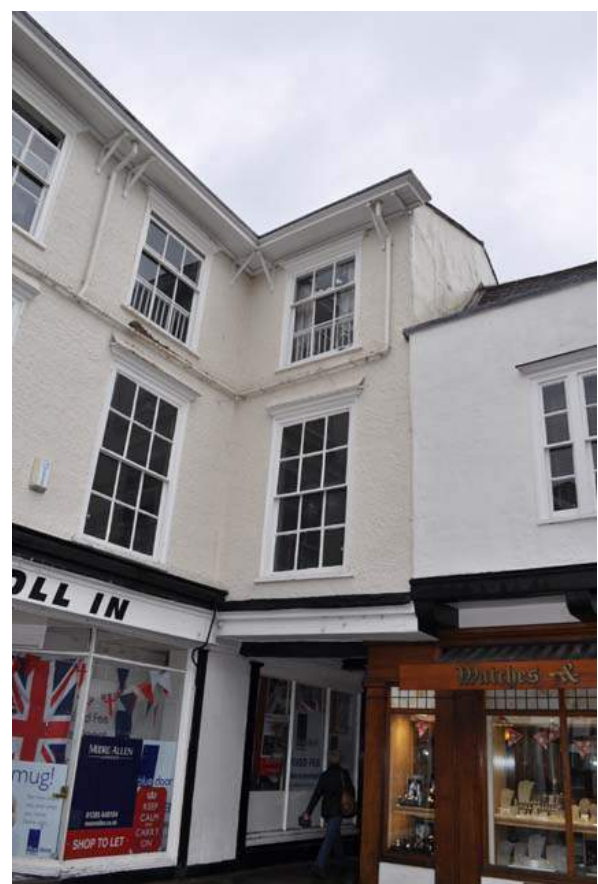
Plate 3. The present Market Square facade

The west facing wall onto the Market Square has a walk-through on its ground level, and on its first floor a window similar in design to that of the first floor of the south facing façade. The second floor window and the white cornice match that of the second storey. On both walls the cornice is supported by angle brackets.

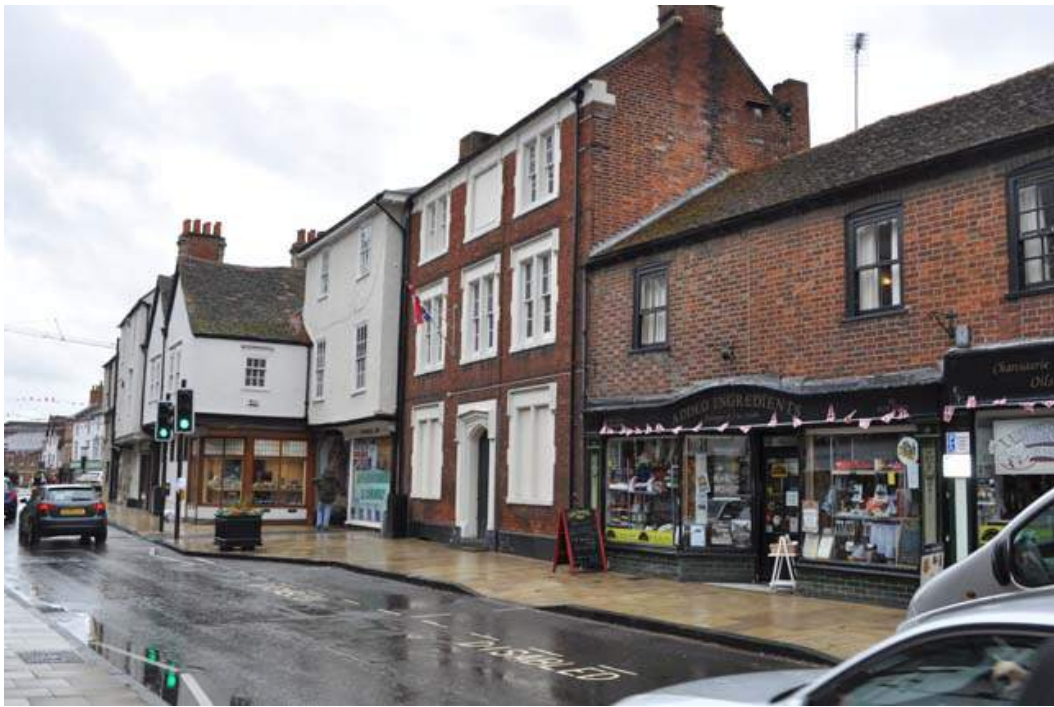
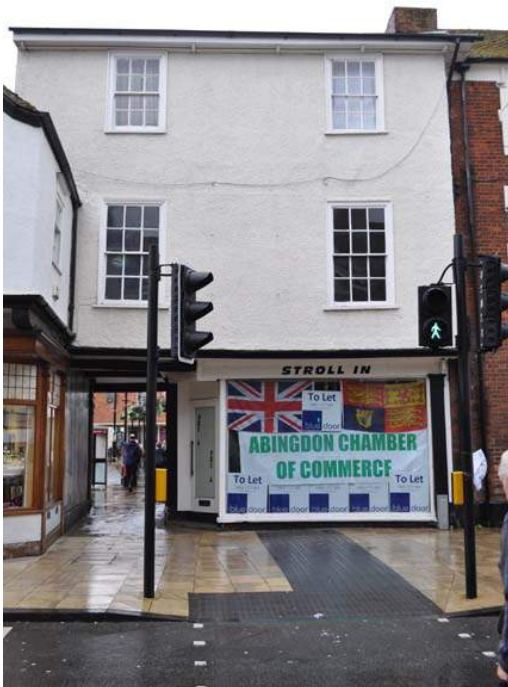
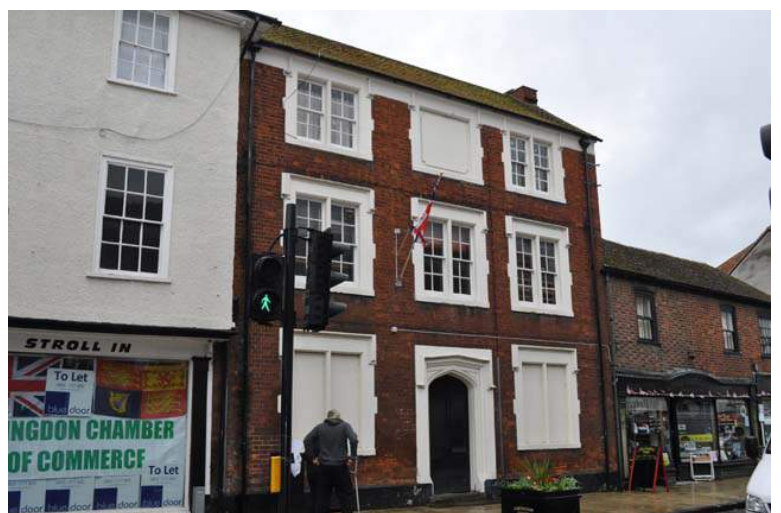
Plate 6. General view of the Stert Street facade

The right hand side of the property is of red brick, probably against a timber frame (see interior description). The ground floor contains a central door with a shallow four-centred arched head in a Perpendicular or late Tudor style. This is set into a square-headed moulding with drip mould with blank terminals. The door is panelled. There is a black painted plinth that is broken by the line of the door. The two flanking windows are square-headed with a central mullion, and also drop moulding. The windows have been blanked out. The first floor shows a series of windows forming three bays with similar designs to the windows on the ground floor. The compound windows use mullion and sash features, the sash windows each have eight panes. The second storey also has three bays, the window casements are of a similar design with drip moulding, but the size of the windows are shortened from the other floors. A plain band runs below the eaves.

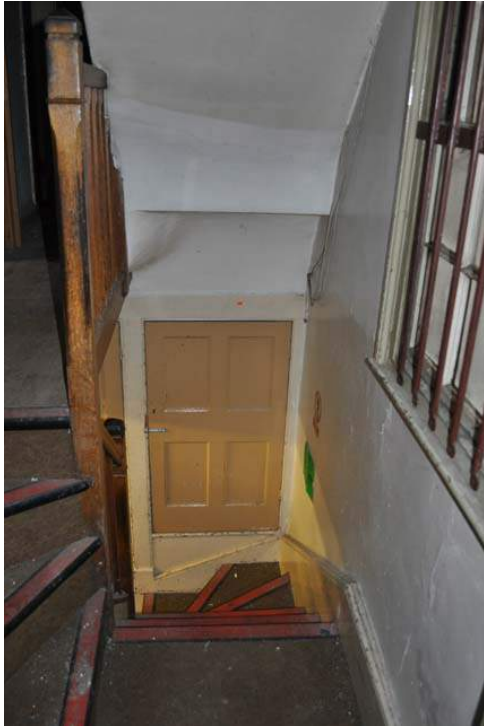
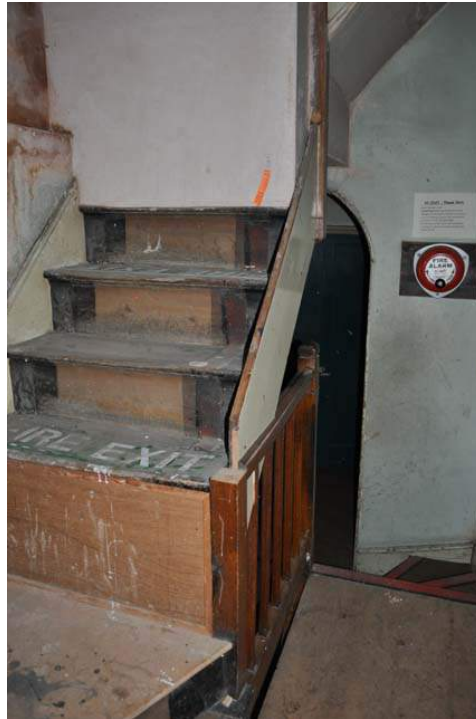
Plate 11. Stairwell

The stairwell contains a series of mixed components (plates 11-12). There is the remains of a framed newel style staircase. However, the reference to style questions the complete originality of the stairs. The posts and balustrades are not square; a feature associated with late 18th to early 19th century stairs, or elaborately carved, which one could attribute an earlier date. They contain simple chamfered corners, a design not common, but perhaps matching ceiling beams of the 17th and 18th century, less so the 19th century. However, it is possible that this may replace earlier features. On the left hand side as one progresses up the staircase there are two panelled doors in architrave, which lead into shallow cupboards, these could be original. The staircase above the first floor level has been replaced with new and non traditional materials.

The ground floor has previously had most of its internal walls removed; the external walls are to be kept. The major loss here is the removal of the current stairwell to the first floor, those to the cellar will be retained. The stairs and stairwell to the first floor is not original and is an unimpressive mid 20th century insertion. The significance of this to the listing of the building is minimal. The stair is to be replaced by a new one located outside but adjacent to the old walls of the former building. Archaeological remains of a Bronze Age to an early post-medieval date may be destroyed. Mitigation strategy would include a watching brief for the excavations of the foundations.

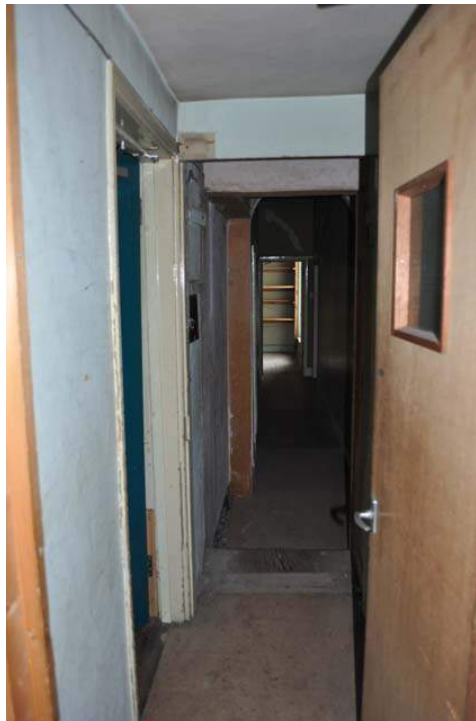
Plate 14. Central corridor

The landing is at the end of a long corridor (plate 14), which runs along the back of the properties fronting onto Stert Street. There are various steps as levels alter between the two properties and some of the flooring is decidedly unsound. There is a door on the east side of the landing, with original architrave (plate 13), which leads into a small lobby from which three doors lead into three rooms. These rooms form the basis of the Stert Street unit. The door on the north side leads into a room with a combination window in the east wall and a chimneybreast with plaster moulded fireplace in the north wall (plate 25). The door on the east side leads into a room with a mullioned sash combination window in the east wall. The door on the south side was blocked. A second door on the east side of the landing, new, leads into a room with a chimneybreast in the south wall and a mullioned combination window in the south wall. The fireplace survives and the surround plain (plate 26). There is evidence of an earlier blocked door back onto the landing. On the west side of the landing a passageway is blocked.

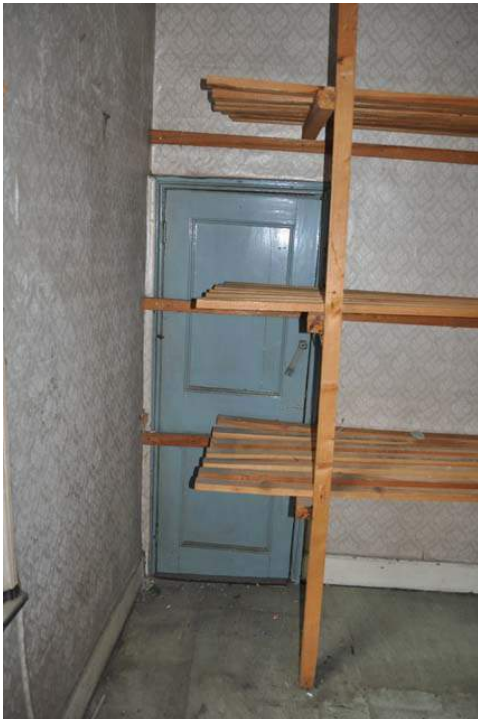
Plate 17. Door details

The main passage running to the rear of the properties from the Stert Street frontage continues through a round-headed opening, which is presumably where the Stert Street unit and the unit between Stert Street and Market Square were joined, towards the remains of a square-headed doorway that has been removed. In the unit between Market Square and Stert Street there is a door in the east wall (plate 15) that leads to a room (a fire-door but with original moulding). There is a square-headed sash window in the east wall (plate 16) and modern fireplace in the north wall. In the south wall there are two blocked panel doors (plate 17-18).

In the unit that lies between Stert Street and the Market Square, the outer structure is to be maintained on both the first and second floor, including the chimneybreast (though no original fireplaces survive). The street frontage is to be retained along with windows, as is the internal evidence for this part of the building having an earlier wall line and jetty that was subsequently removed. Some of the internal walls that survive on the first floor are to be retained (that wall requested to survive by the conservation officer), though others are to be removed. This will cause the loss of three small doors with mouldings (plates 17, 38), which have been photographed.

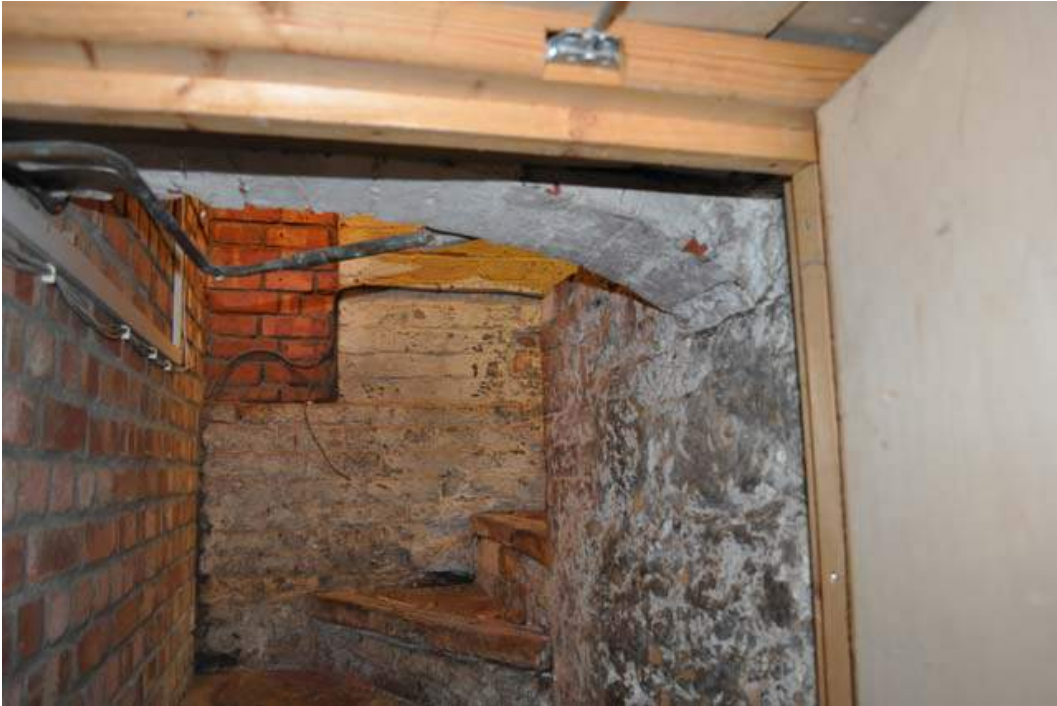
Plate 23. Stairwell into cellar

The staircase to the cellar entered through the rear of the surviving stairwell (plate 23). The stairs twisted in two runs between old stone walls and new brick walls. The wooden treads on

the stairs were worn. There was a partial segmental arch at the base of the stairs and a new fire-door. This opened up into a square room with a wooden shutter in an opening in the east wall, almost certainly the remains of a coal shoot. In the floor on the north side there was a large rounded stone of unknown purpose or use. There are parts of the west wall that have been rebuilt, perhaps to join the cellars through a passage. This rebuild meant that much of the base of the central stairwell had been rebuilt or underpinned.

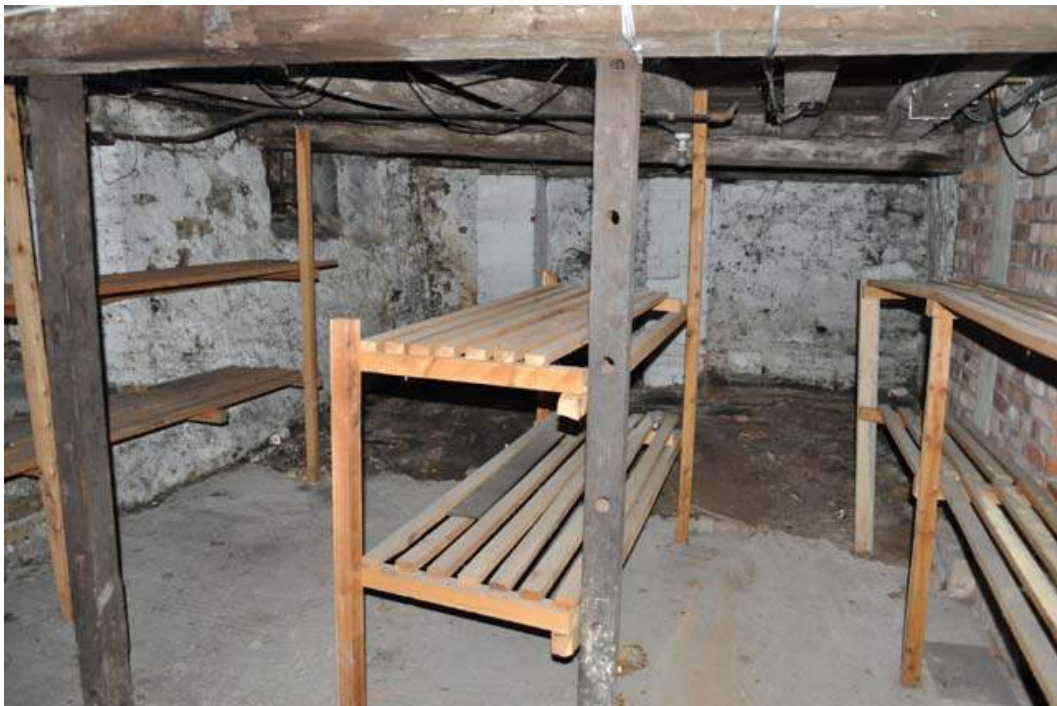
Plate 24. South cellar

The other cellar was a large rectangular shape with stone and brick walls (plate 24). There are indications of window lights previously existing, now blocked on the south side. This cellar is divided by a later brick wall.

The cellars are to be retained as they are.

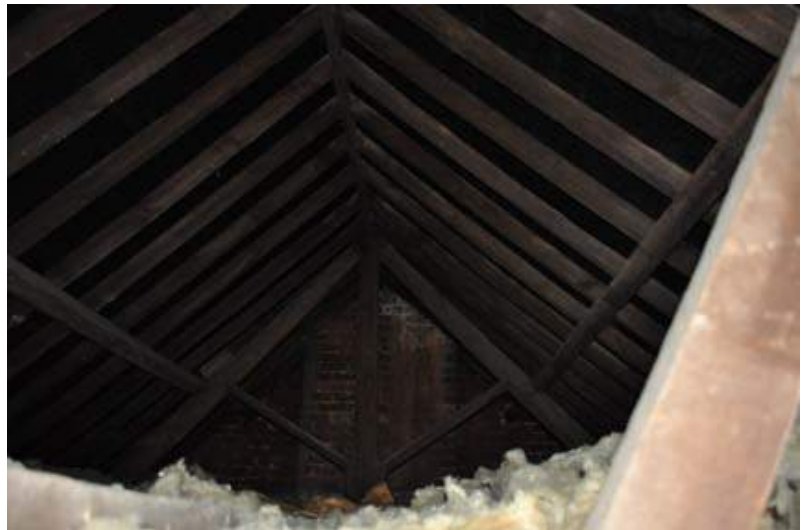
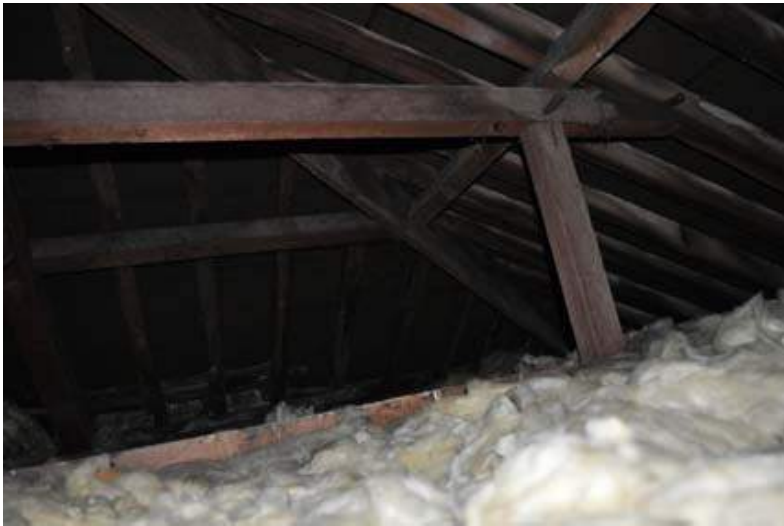
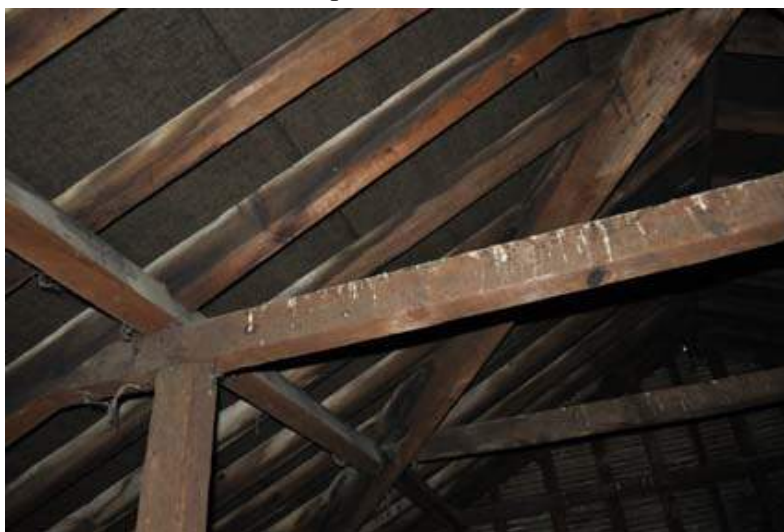
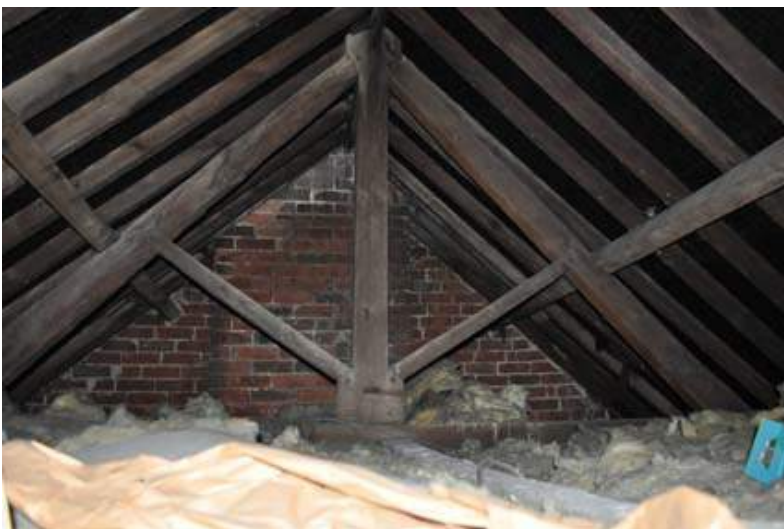
The roof structures were viewed for the two units that overlook Stert Street. In the northern unit that only looks over Stert Street, the roof is supported by trusses with king-posts with side struts (plates 33, 36). The roof over the unit between Stert Street and Market Square and the Market Square unit started off as a larger L-shaped attic. The two unit attics have now been separated by a plasterboard wall (unplastered). The roof is supported by a variety of trusses, some with a collar beam supported by queen struts (plates 34-35). The others with collar beams forming an A-frame truss.

The main roof structures above all three units are to be retained and their timber frames preserved.
