JOHN MOORE HERITAGE SERVICES

**HISTORIC BUILDING ASSESSMENT AND
RECORDING OF
RUSCOMBE HOUSE,
RUSCOMBE ROAD, TWYFORD
BERKSHIRE
NGR SU 79137 76308**

FEBRUARY 2013

JMHS Project No: 2653
Site Code TYRH 12

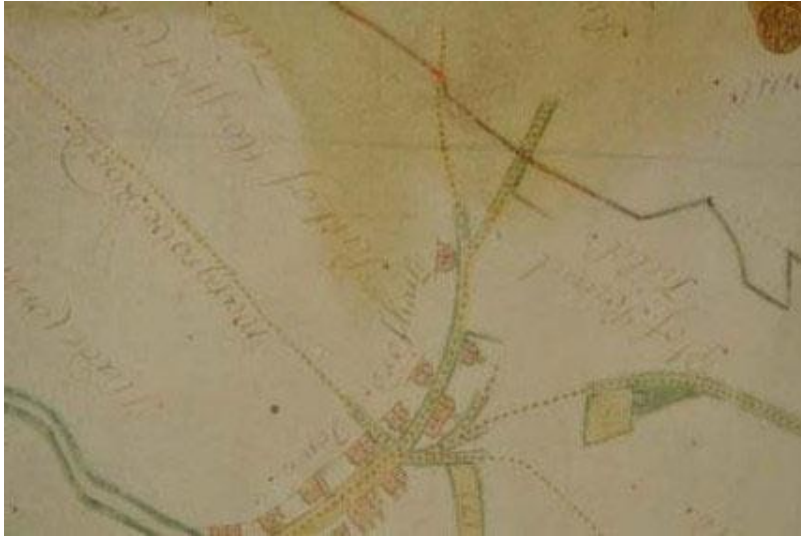
Map 1723 (BRO D/E Z9 P1)

The earliest map (see below for maps) of Twyford is of 1723 (BRO D/E Z9 P1), which shows the area as open fields and lacks the London Road turnpike. Rocque's map of 1761 (BRO PM67/1-2) does show a house on the property in what was part of Common Field. The two later maps dated 1812 (BRO Q/RDC/61A) and (BRO D/E Z9 P2), also show a building on this plot. However the building is drawn against the London Road. One could argue that this is not the same structure, but

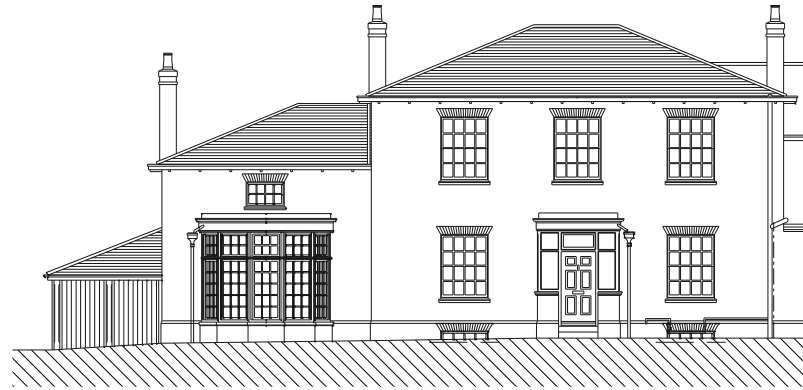
Elevation 1. Southeast facade

The main block dominates the southeast elevation. It contains a symmetrical design with a central front door with glazed porch with architrave and cornice, which is of a style that becomes fashionable in the mid 18th century, but continues in use into the early 19th century. The door is of six panels and two treads take one up to the level of the plinth. This is flanked on the ground floor by a sash window with eight glass panes and brick lintels which has a pitched design moving away from the centre. The first floor has three sash windows of similar design to those on the ground floor, and which are aligned with them. The plinth continues out either side of the porch, and below this line there are spaces for window lights, also aligned with the window settings above. The windows in the basement are three light casements with mullions. The roof is hipped and brick chimneys are evident at either end of the main block of the façade.

To the west is a further addition to the building also in a matching red brick. There is a brick plinth, above which stands a large bow bay window that dominates its wall space. The bay has a similar cornice and architrave to the porch. The window has five casements, which are divided with smaller units above containing six glass panes and twelve panes below. Above this is a small window with brick lintel (matching earlier described lintels) and eight glass panes. The roof is hipped at the west end and a matching chimneystack at the west end.

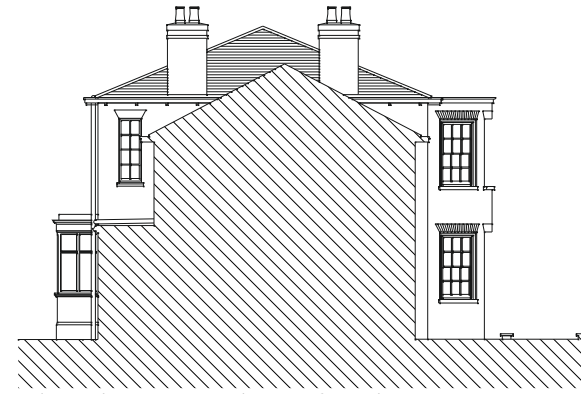
Elevation 2. Northeast facade

Little of the northeast elevation is visible, as it is obscured by the eastern extension (now called The Stables) which is not described in this report. Of Ruscombe House parts of the red brick wall on the main block is discernible. On the south side there is a window with eight lights and a brick lintel. The east side of the porch is visible with windows, cornice, architrave and plinth. To the rear is the large bow bay window.

There are two chimney stacks with water tablets and two pots a piece. The roof is the end of a hipped structure.

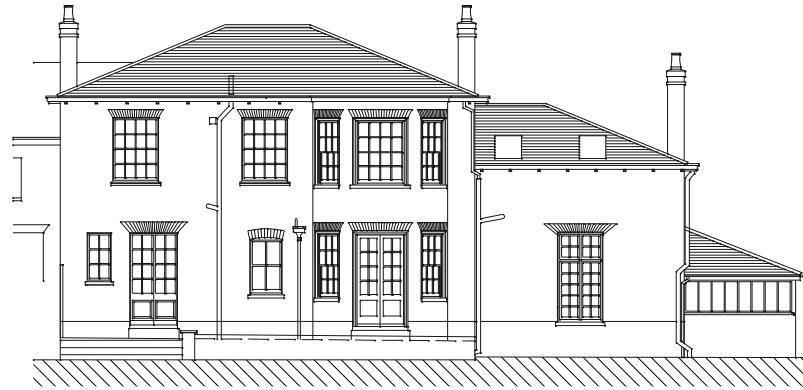
Elevation 3. Northwest facade

The northwest elevation is the rear elevation. The wall is of red brick, in the centre ground floor there is a sash window with four lights; the arch above has a segmental arch. It is the only arch like this in the whole of the exterior. Above this are the remains of a tile set in a gauge in the bricks, which forms the outline of a porch, which is suggestive of this window originating as a door. Above this is the remains of a sash window and lintel that matches those on the front. There are the remains of an earlier lintel adjacent and up to the left, providing evidence of a smaller group of windows originally. On the east side of the central windows are a door and window on the ground floor and a sash window on the upper floor. The double doors on the ground floor have lower panels with eight lights above and a brick lintel. The adjacent window has six lights and no

lintel. The sash window above is similar in design to those on the front. The first floor window and lower door are out of alignment. The bricks around the first floor window are of a different colour and it is probable that this window, or perhaps more likely the lower window and kitchen door have been inserted. The mortar around the lower features appears to have been altered. To the west of the central segmental arch is the large bow bay window, with three large sash windows with brick lintels above (matching most of the other windows in the main block) and two windows flanking a central door on the ground floor (the windows match those above and the door matches that of the kitchen door).

On the west side there is a further red brick wall with a mullioned window divided with horizontal transom. The upper part of the casement contains four panes, and the lower part ten panes. There are two roof lights in the hipped roof above (modern).

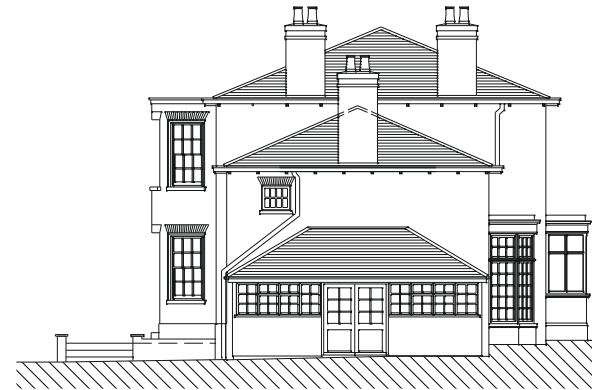
Elevation 4. Southwest facade

Of the main block one can see a blank brick wall, with two chimneystacks with brick water tablets and two pots. The end of the hipped roof is also visible. The side of the front porch (see above) and large bow bay window to the rear and front can partially be seen (see above and below).

There is a lower structure in front of the main block, which comprises the western extension. This wall is also of a red brick, but which has an offset window with brick lintel and a window of eight panes. There is one central chimneystack designed with a similar water tablet to those on the main part of the house.

In front of the western extension is the conservatory or orangery. This is timber framed with white wooden plank panelling, with a hipped roof of a lean-to. There is a central double door with panelling in the lower part and six pane windows above. Either side are four casement windows with eight panes in each.

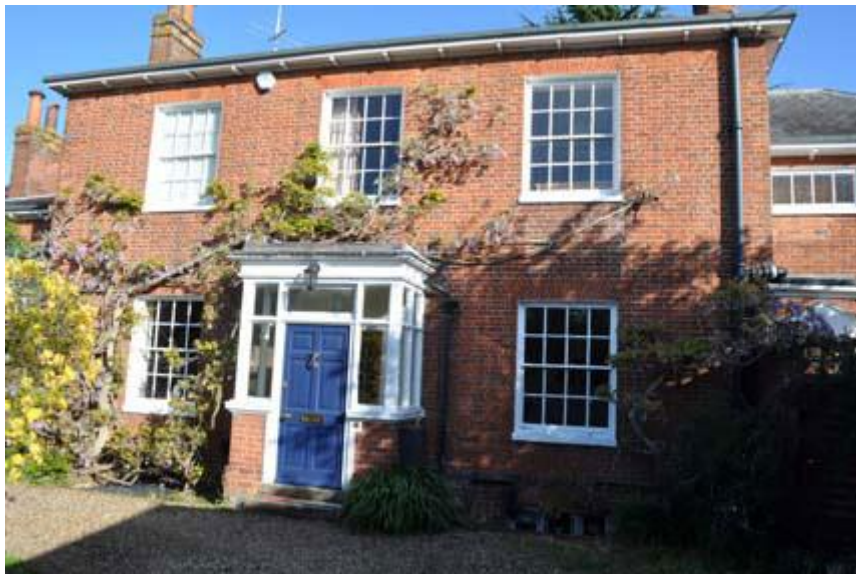
Plate 1. Southeast façade

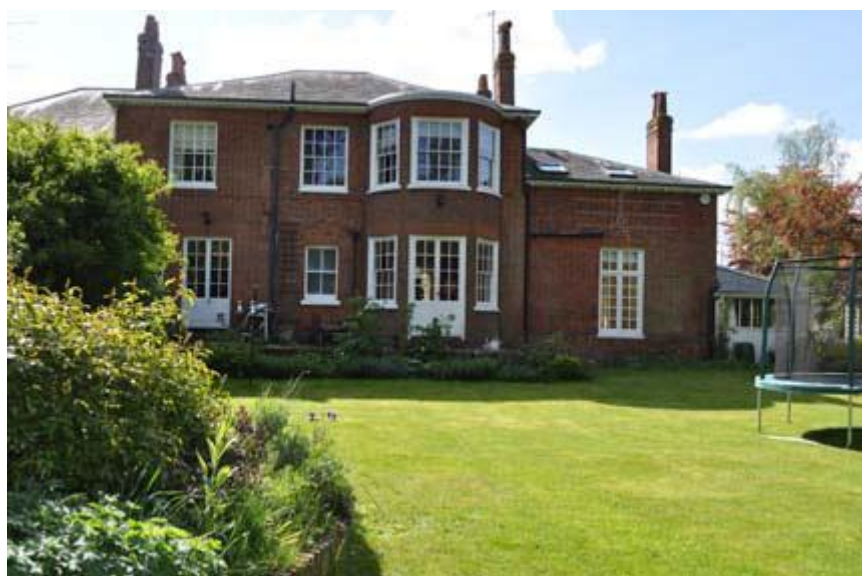
Plate 2. Northwest elevation

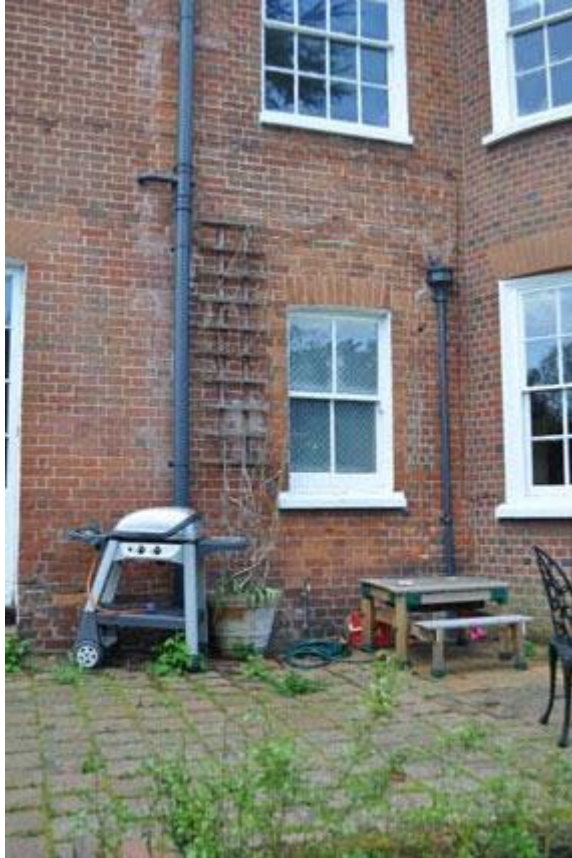
Plate 3. Northwest elevation details

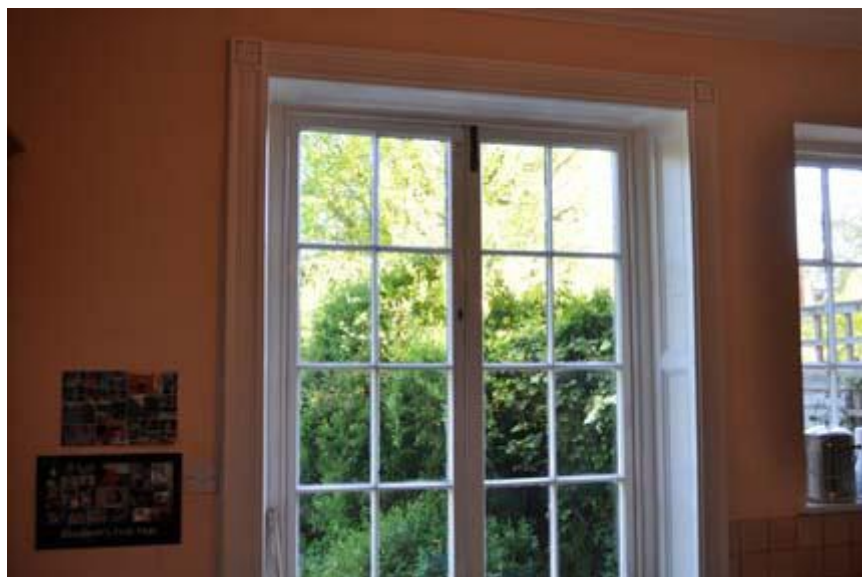
Plate 4. Patio door in kitchen

The rooms to the east contain various details which can be described as early, though later evidence may suggest some is not original. The door into the kitchen is a panel door with a moulding on the kitchen side with fleuron design. The north wall of the kitchen contains a window and a door. The door is double (described externally) that has an early moulding with a fleuron design, if original it is likely to be used from elsewhere in the house. The smaller window adjacent

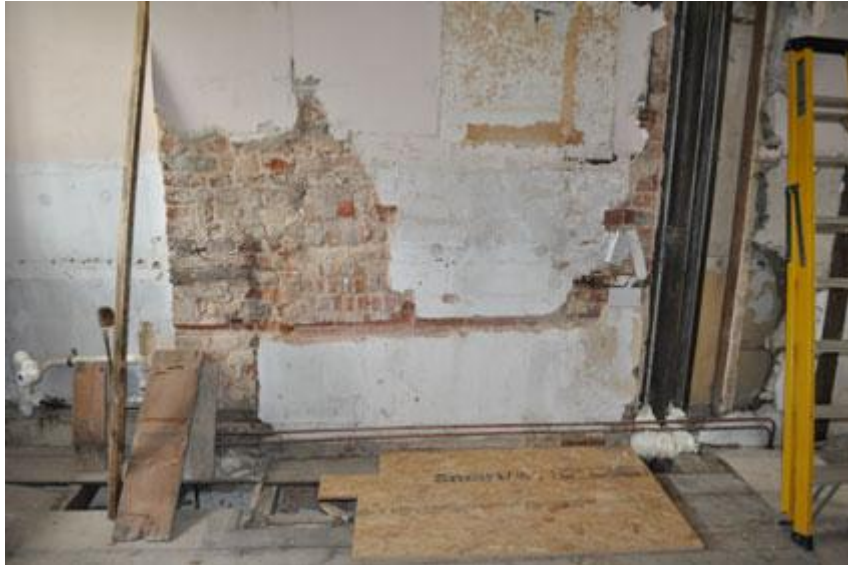
Plate 5. Part of the segmental arch in the kitchen chimneybreast

Observations made by the removal of material in this room has enabled it to be determined that the chimneybreast was not removed, but that its side alcoves were blocked up to carry piping. This means that the moulded ceiling architrave is later. In the blocked space a sample of the original moulding survives with ball flower design. This, therefore, raises questions on the dating of much of the moulding and as to whether it is a later insertion of the Victorian or Edwardian period. The remains of a segmental arch could be seen in the brick chimneybreast. The plaster walls and ceilings were of lathe work. The remains of two large chamfered transverse beams were apparent in the ceiling void, one in each room.

The wall between the two east rooms on the ground floor was removed. This wall had already been removed and replaced in the past, and it is quite evident that the chimneybreast in the kitchen is a mock feature, as the original chimney and fireplace are now evident on the east wall.

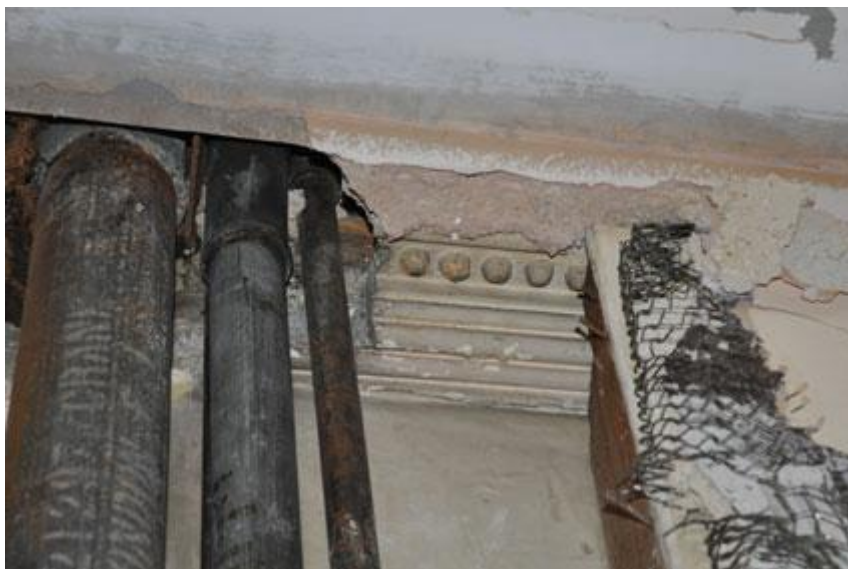
Plate 6. The remaining earlier ceiling plasterwork

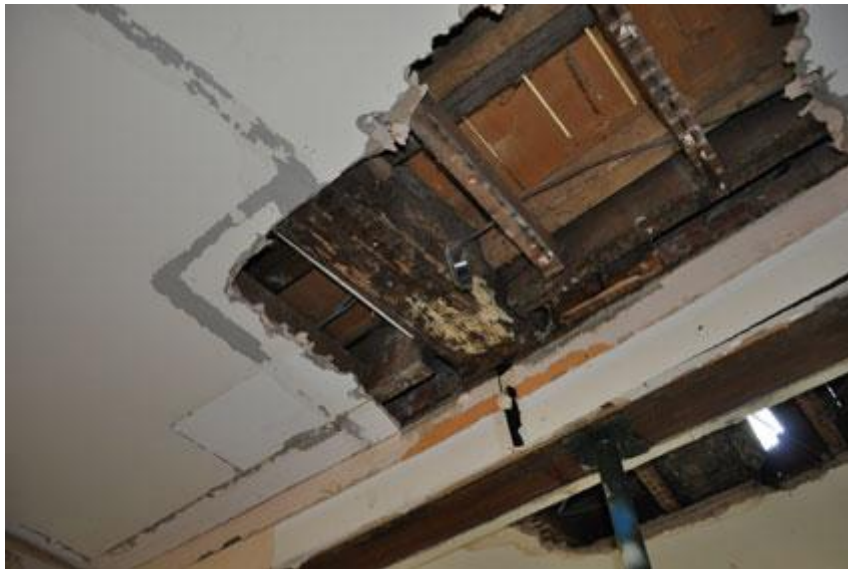
Plate 7. The large chamfered transverse timber beams

Observations made in this room by the removal of plaster and other materials indicate that there was a segmental arch in the fireplace, and that in the ceiling there was also a large chamfered transverse beam. The beam in this room showed signs of axe work, thus implying an earlier date and perhaps reuse. The other joists were smaller and with no sign of chamfering.

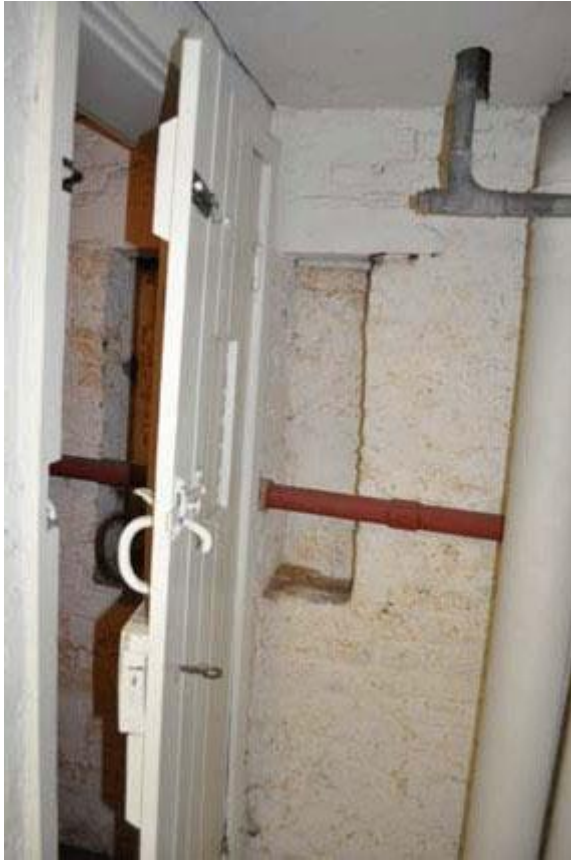
Plate 8. Outline of earlier window in basement

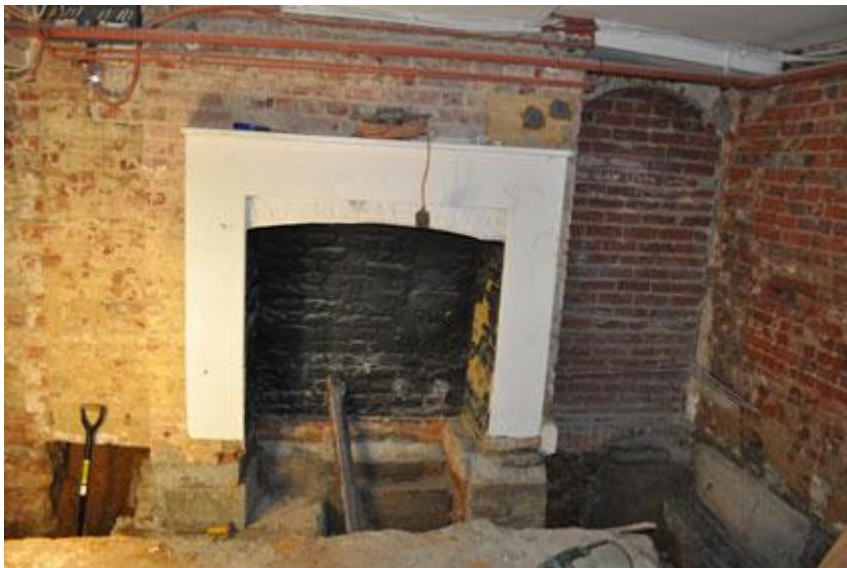
Plate 9. Fireplace in basement, with segmental arch alongside

Observations after mortar stripping in this room revealed the remains of an alcove with a rounded/segmental headed arch to the right of the fireplace and a butt joint in the north wall.

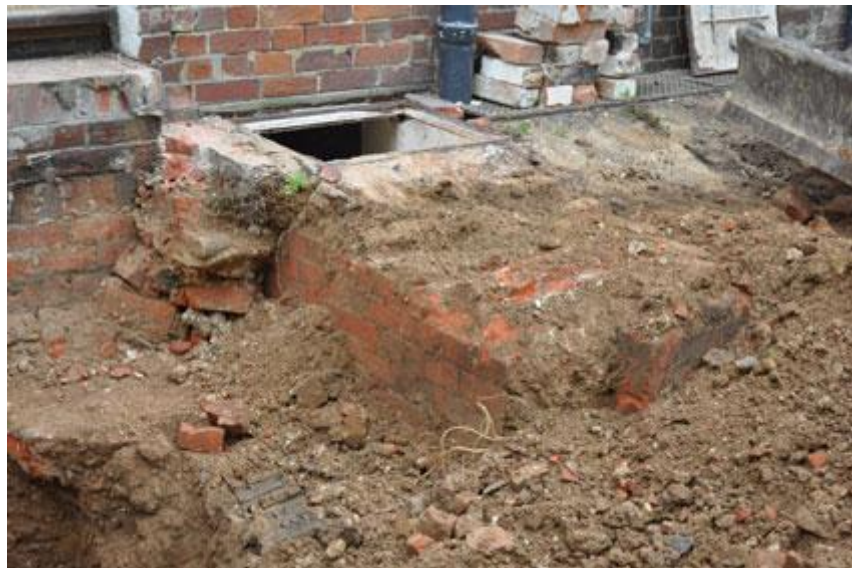
Plate 10. Remains of the brick plinth with coal shoot

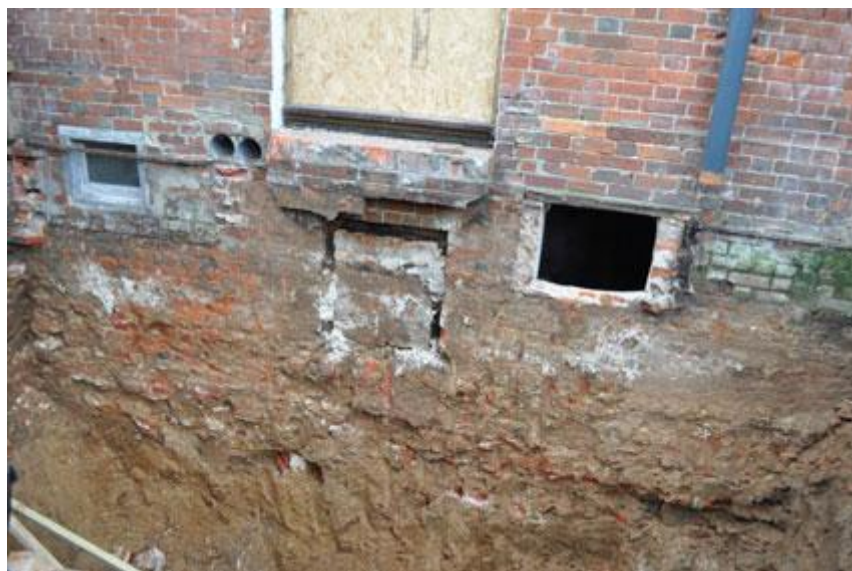
Plate 11. Features below the line of the patio northwest wall

There were masonry alterations 21 to the back wall at this time around the kitchen door where a step extends down the wall covering earlier windows. The patio wall cut 20 butted up to the cut 10 of the main building and was filled by the patio retaining wall 19. Sat between the walls of the patio, bay window, kitchen door rebuild and main wall of the building was a makeup layer (6) a light brown clay with mortar and brick inclusions. The deposit is narrow near the party boundary but becomes deeper and extended around the surviving plinth. This was capped by brick paving 22.
