JOHN MOORE HERITAGE SERVICES

**BUILDING ASSESSMENT**

**POUND FARM, GOOSEY**

**MARCH 2012**

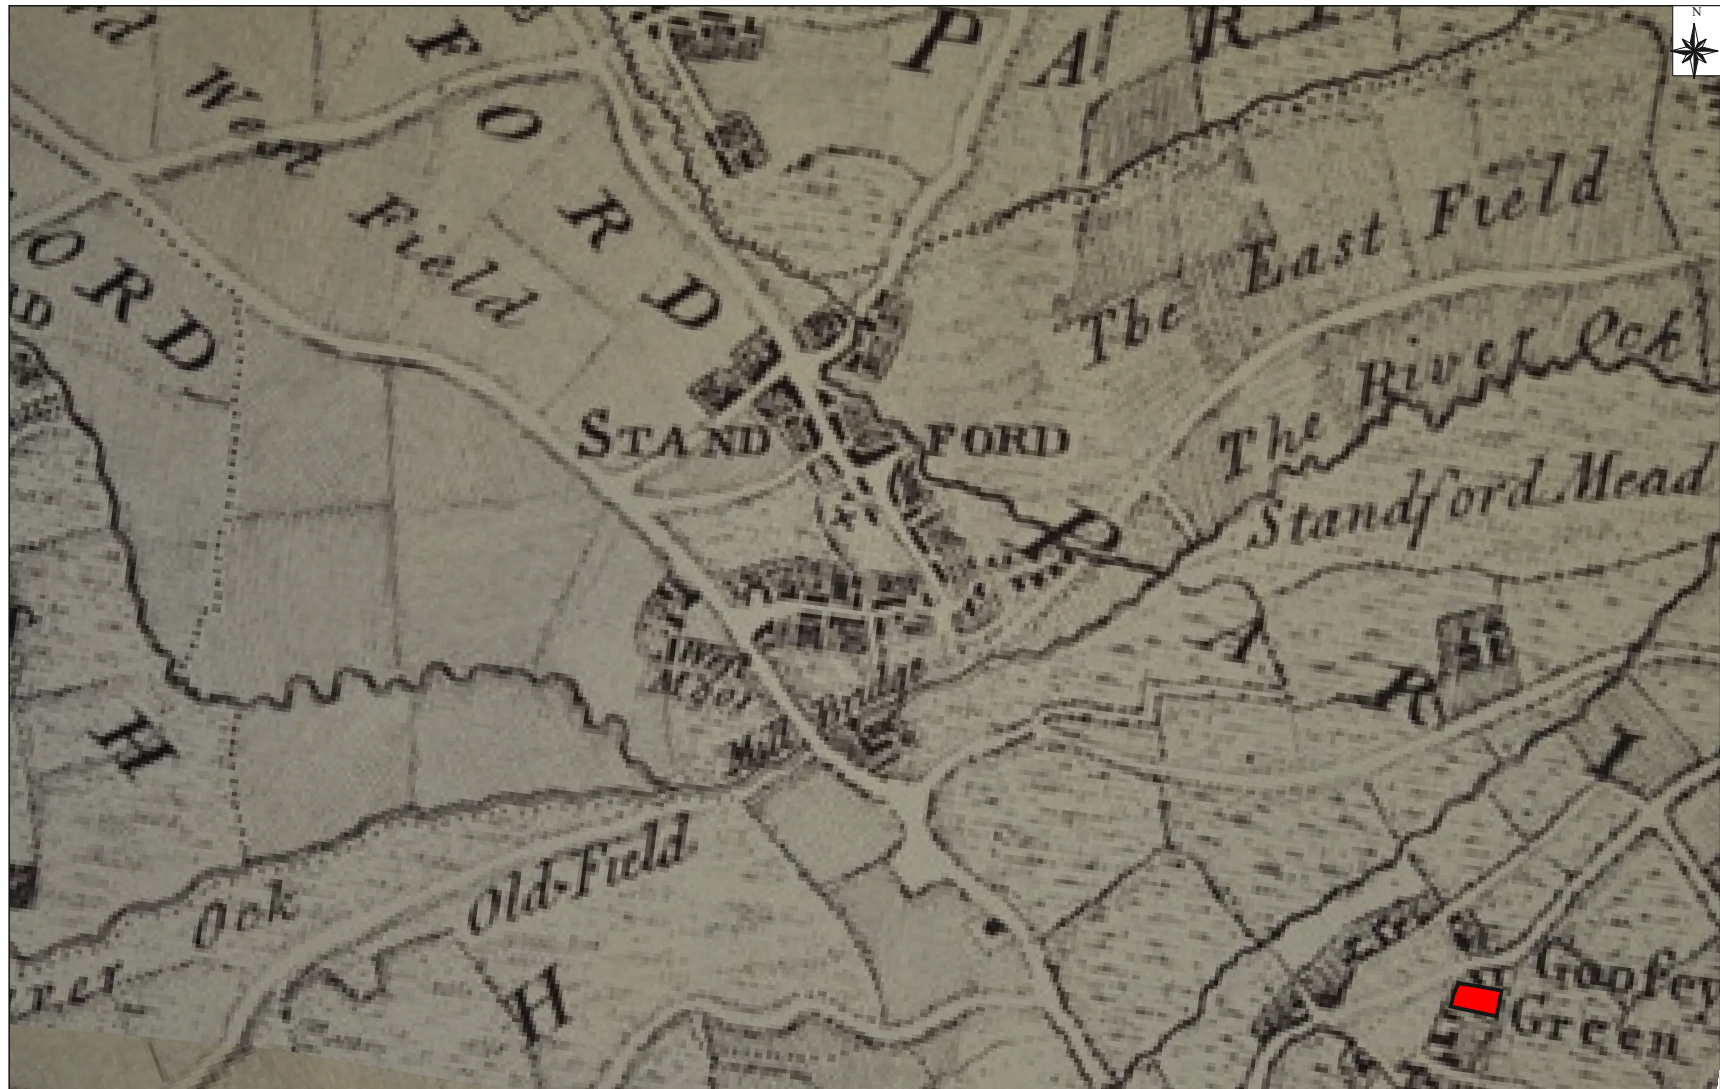
Figure 2. Rocques map of 1761

Pound Farm is shown on three historic maps. The earliest map is Rocque's map of 1761 in which Pound Farm is shown as a rectangular building (Figure 2). The second of these is dated to 1824 (Figure 3) and is a map of the estate held by John Pocock (BRO D/EX 1550/1). The building is drawn in a stylised manner with a main range and two wings. An outbuilding is marked on the structure to the rear, but it is not joined to the farmhouse. There is a group of buildings around a yard to the northeast, one of which may join the farmhouse. The Tithe Map of 1847 (BRO D/D1 118B/1) also shows the farmhouse, but this time there is no wing on the northeast side (Figure 4). This may mean that the earlier wing was dismantled and that a new structure was built on the front of the property between 1847 and 1878. The outbuilding to the rear of the property is shown as being attached. The owner of the farm at this time is still John Pocock, while the occupier is recorded as a Robert Smith.
