**ARCHAEOLOGICAL DESK-BASED AND  
BUILDING ASSESSMENT**

**HAWRIDGE COURT, HAWRIDGE,  
CHESHAM, BUCKINGHAMSHIRE**

**NOVEMBER 2011**

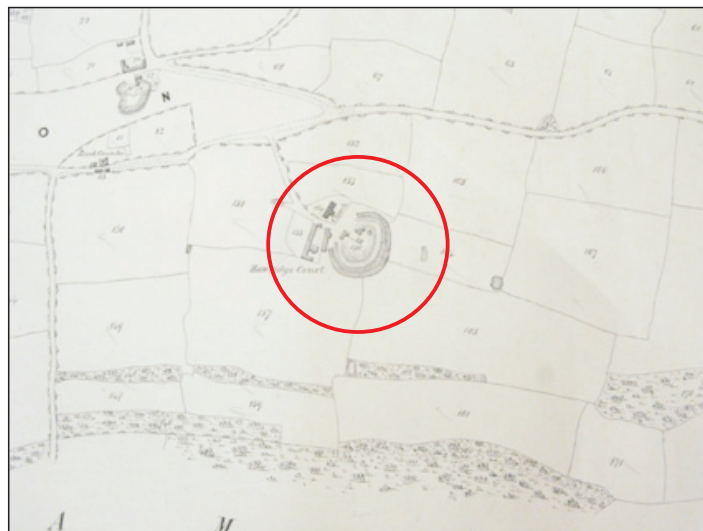
Figure 3. Historical maps

The earliest surviving map of Hawridge is the 1837 Tithe Map (BRO 207). This shows the ringwork and three buildings located inside it. The only break shown through the earthwork is where the building has been placed across the earthworks. This means the other gaps are later landscaping for the garden and not original. These are the present House of Hawridge Court, the granary and the sheds that back into the earthwork on the north side (plate 20). There is a pond located to the northeast of the granary.

The first series Ordnance Survey (c. 1880) shows that the two gaps have now been inserted through the earthwork (BRO D/BMT/54R). The pond of the tithe map has gone. The Hawridge Court building looks as if it has been extended back towards the granary but does not join it. The cartshed has been constructed by this time (plate 21).

The map of 1904 (BRO D/BMT/74.T) appears to show what is on the Tithe Map of 1837 and must be a copy of that date. It seems to omit the apparent alterations that are evident on the first edition Ordnance Survey. The apparent drawing of the map at this date in an antiquarian tradition is of interest as it attempts to portray the court as it was and not what it had become.

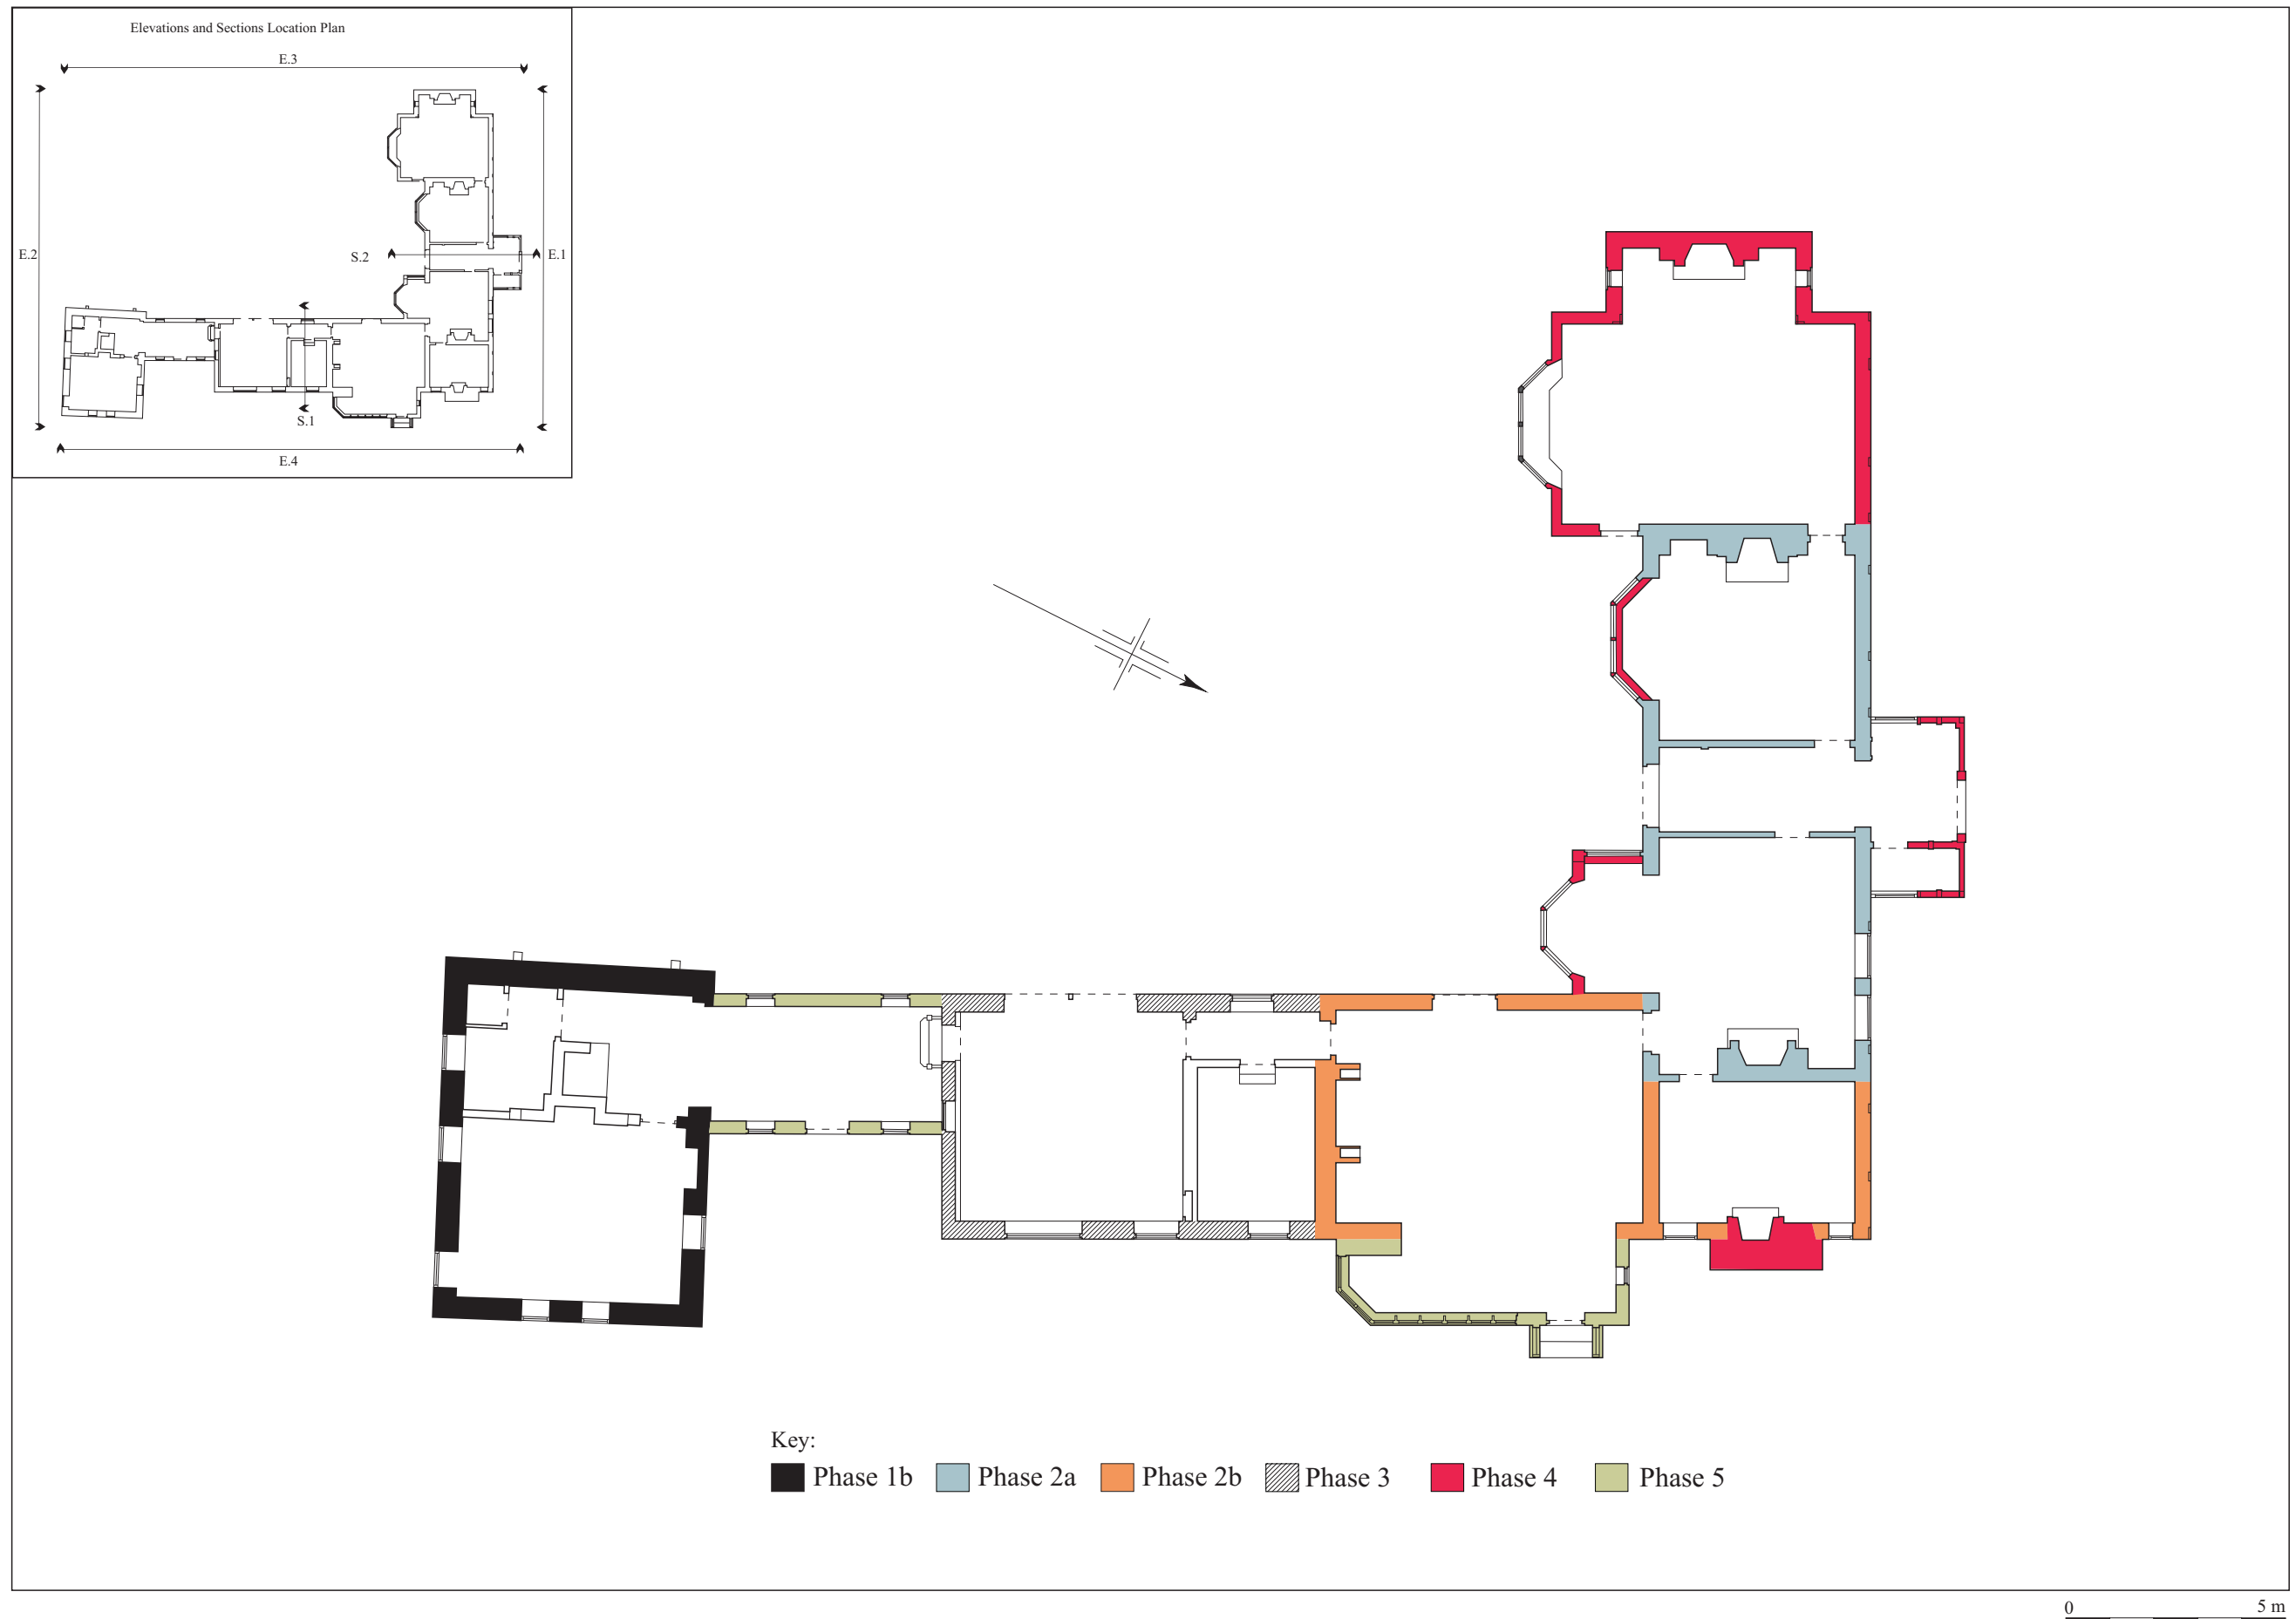
Figure 4. Phased plan of Hawridge Court.

The court building is of an L-shape with two outer facades to the northwest and northeast (Figs. 4-5). The northwest range is the Front Range, while that on the northeast side is the back range. The back range is by far the most diverse and contains some of the oldest and youngest phases.

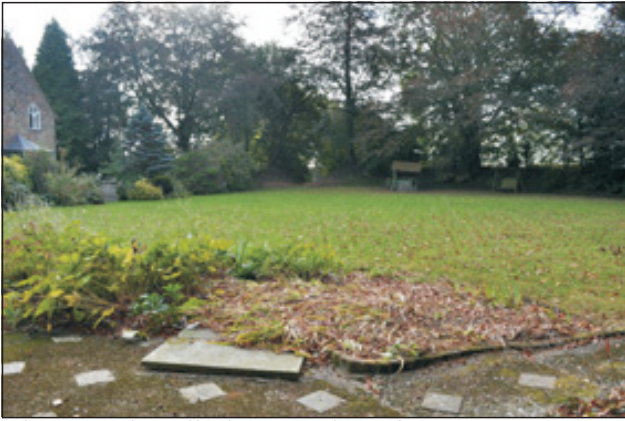
Plate 1. Ring ditch around garden

The site visit observed the surviving ringwork, which where standing is in good condition. The bank is covered in large trees and at present we do not know how much damage is being caused to the archaeology by their roots. The two pathways were observed through the ringwork, but there is no indication from surface features if these are original or later cuttings. The VCH (1925, 367-9) suggest that these are original, but they are not marked on the earliest map of 1837 (BRO 207).

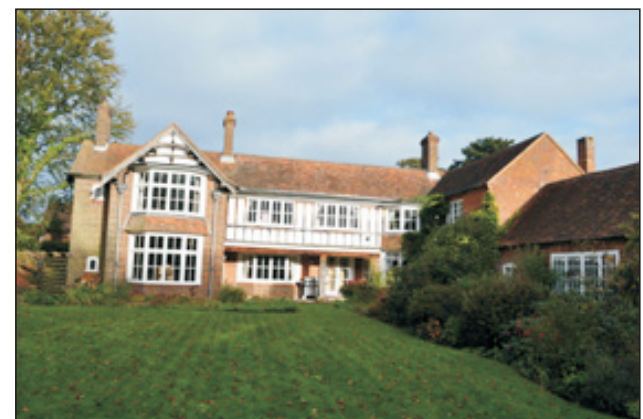
Plate 8. Southeast elevation

The southeast façade shows signs of being extensively altered (Fig. 5 E2, plate 8). Dominating the left hand side are the remains of a jutting gable with bay windows. At the right end of this façade are further extensions containing bay windows, but these are not set in a gable. It is evident that there is a butt joint between this wall and the wall of the back range. Between the gable and bay window the ground floor wall is set back, this is probably the original location of the wall. Reset into the original back wall are further bay windows and a patio door, plate 10 shows where this is butted to the phase 2 building. The first floor juts out over this space being supported by large timbers. The windows here are of four lights and contain four panels divided by tracery.

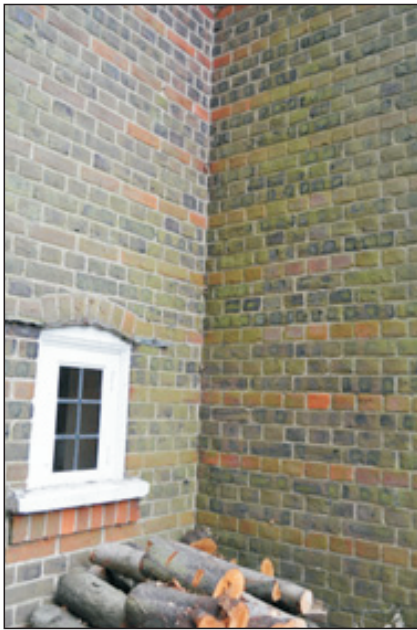
Plate 11. Details of Phase 5  
extension (southwest side)

The southwest facing gable has an extended central section in which the chimneystack is placed (Fig. 5 E3, plates 11, 12, 13). There are two windows in this wall, with flat tops and lead tracery. The walls then step back on either side. In these walls are the small segmental arched windows with lead tracery (Edwardian or later). From these side walls are walls which extend the width of the façade. On the southeast end this forms the extending gable (see above). On the northwest side this extends the wall line out from the former building. The mock Tudor façade can be seen joined to the front wall here.

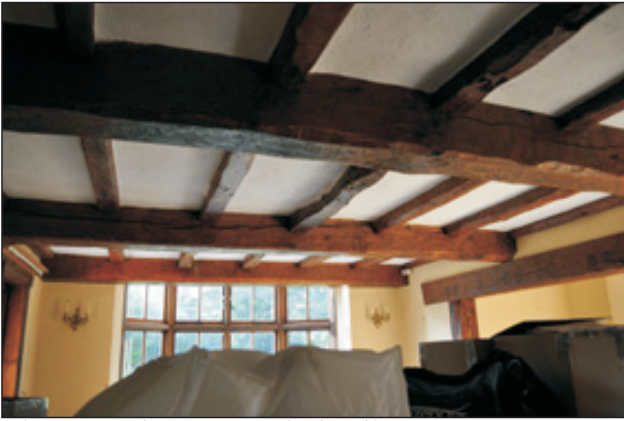
Plate 15. Phase 5 mock details Front Range

The door in the southwest wall enters a large room. The west wall contains timbers built in as supports, through which there is an alcove in which a fireplace is set (plate 16). The ceiling has a number of exposed axial beams with chamfers (plate 15). There is a large bay window at the rear.

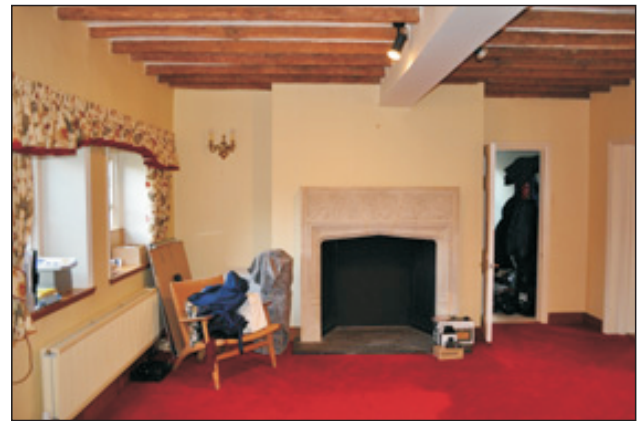
Plate 18. Reworked Phase 2a room in mock fashion

The room to the northeast of the hall has a fireplace in the northeast wall (plate 18). This is of stone and is probably not original on the surface. The axial beam has been replaced probably. There is a bay window looking over the rear garden of the house. On the northwest wall there are mock early windows. This room provides access to two other rooms; the room at the northeast end of the Front Range and the Back Range.
