JOHN MOORE HERITAGE SERVICES

BUILDING RECORDING

52 AND 53 HIGH STREET,

WALLINGFORD

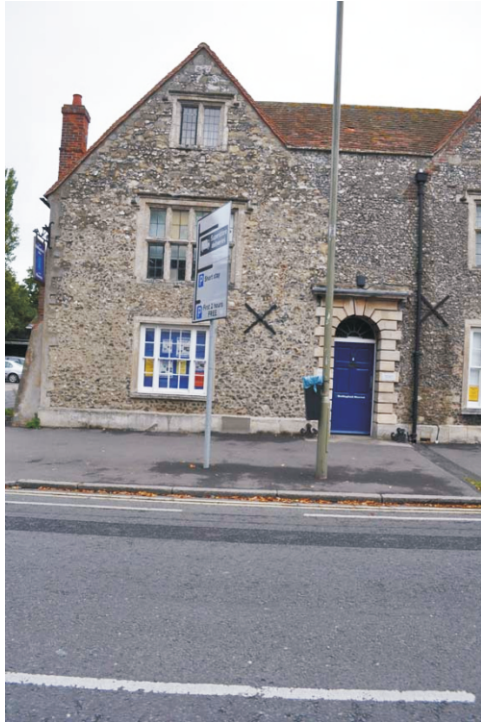
Plate 1: Gable of West Wing

- 3.2.2 The west and east dormer gable show indications that they were constructed before the area was infilled in the middle. Each of these flint and limestone gables show indications of quoins and of the central section being built over this original wall line. The west gable, now part of the museum, has a mullioned window on the 1st and 2nd floor. The window in the ground floor is a later sash window insertion (Plate 1).

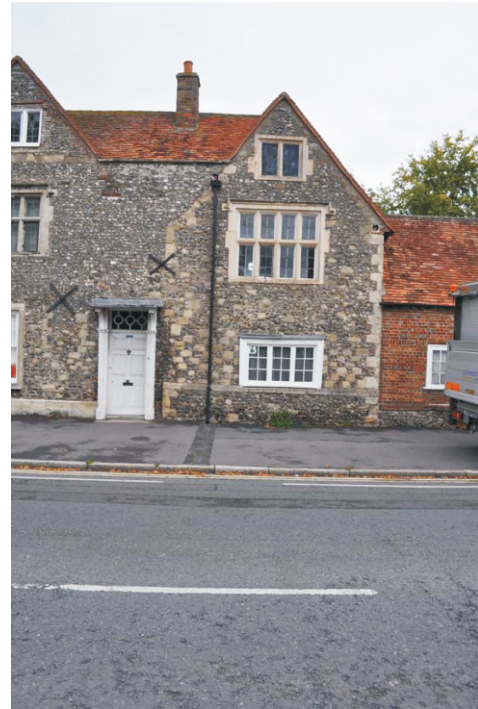
Plate 2: Gable of East Wing

- 3.2.3 The east gable is of a lesser height than the western counterpart, and it like the west gable has mullioned windows on the 1st and 2nd floor (the latter attic Plate 6). The 1st floor window shows signs of being enlarged. On this side the ground floor window is also a mullion window, and below it there is evidence of a flint plinth (Plate 2).

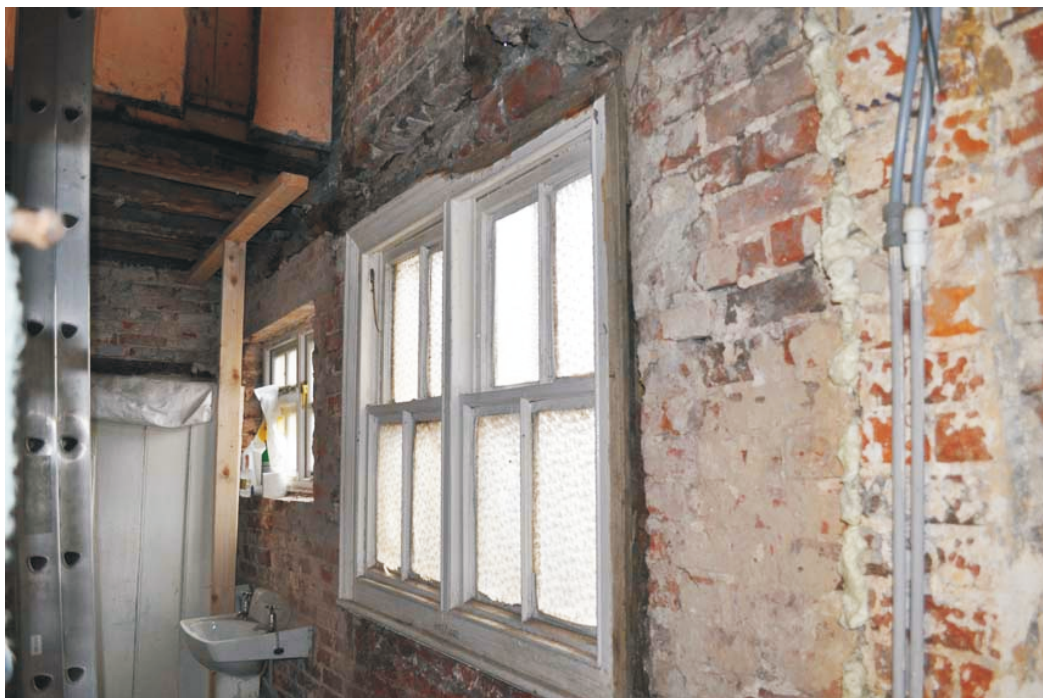
Plate 3: Butt in back wall between East Wing and back wall

- 3.8.6 The stairwell has been placed along the line of the earlier wall, behind it there is a smaller passage, where the timber framing of the rear wall of the central part of the house can be seen. It is apparent that there is a butt joint between this wall and the wall which was thought of as the wall of the east wing.

4.2.1 The visual appearance of the gables in the front wall and the apparent butt of the back wall to the east wing mean that the range in-between the two wings has to have occurred as Phase 3. The new space between the two earlier houses may have started out as a hall strung between the two buildings. The details on the front show that this central section previously had lower walls and that these were added onto. It is possible that a detail such as the oriel window may have been inserted during the move to this phase.

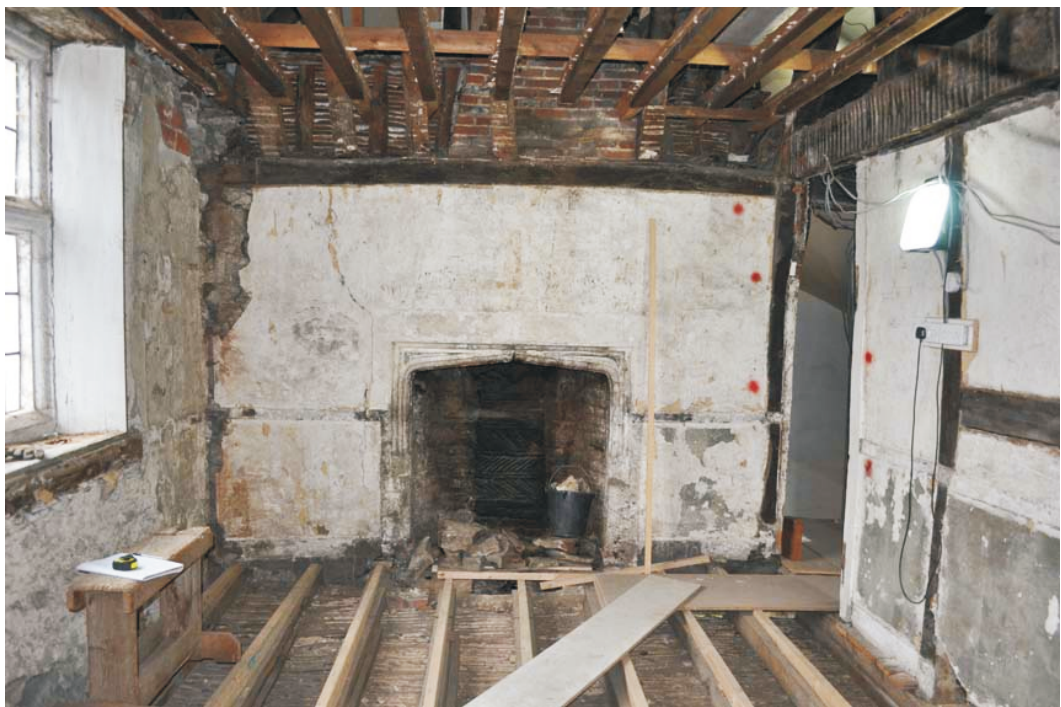
Plate 5: Tudor fireplace

- 3.8.9 The front room on the first floor contained a fireplace on the west wall (Plate 5), with a shallow perpendicular style (Tudor). There was a mullion window in the south wall, which extended above the line of the joists and must be a later insert. The east wall is gone but in the ceiling are the remains of part of a canted bay window also called an oriel window with diamond patterns. This was removed so that access could be obtained to the attic space in the eastern extension. There is one truss in this extension with these being set close the wall.

4.1.4 This building is probably of the 16th century; the oriel window would indicate that the date was the latter part of the 16th century (Brunskill 2000, 145), though this would only be the case if the window were not part of a later insertion. The fireplace opposite can not be so precisely date and may belong to a broader range of the 16th or even later 15th century.

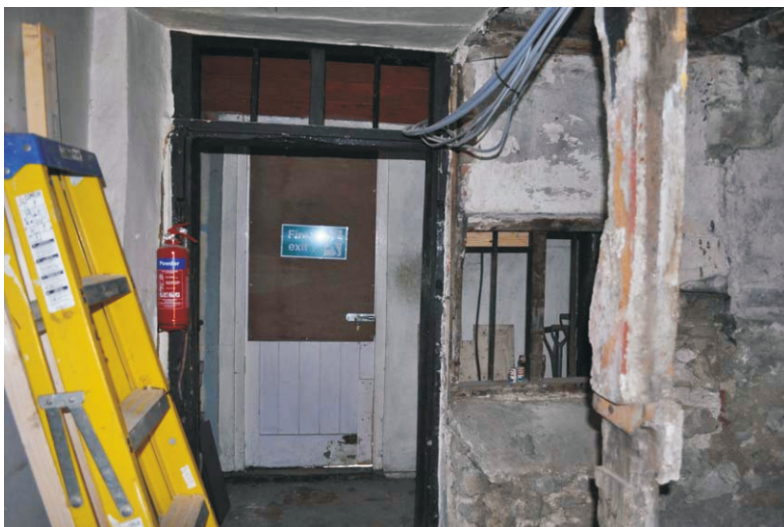
Plate 7: Outshoot containing fireplace
and possible stairs

- 3.5.1 The east elevation is of 53 High Street, Flint Cottage, and at the north end there are indications that there is a timber framed and brick outshoot alongside the chimney located on the gable end (Plate 7). The only reason for this being here is to carry a staircase around the rear of the chimney.
- 3.5.2 The wall to the south of this chimney and outshoot is in its lower courses a flint wall, above the wall is of brick. The ground floor window is a segmental arched feature with considerable evidence of reworking. There is a modern porch passageway constructed on

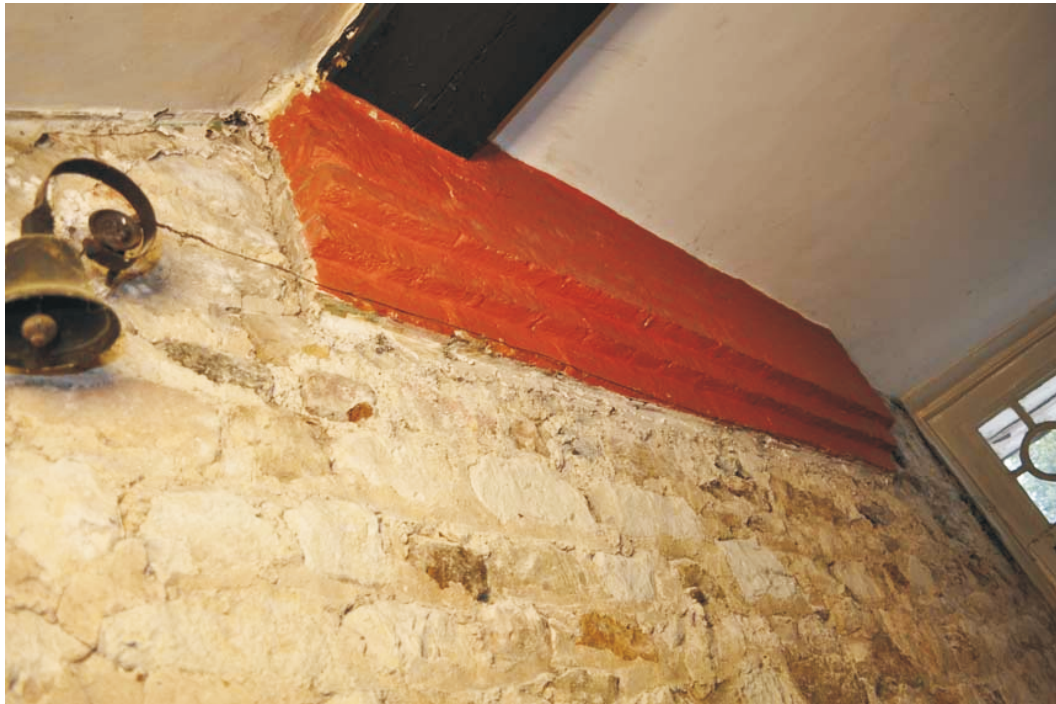
Plate 9: Projecting first floor chimney, originally external feature

- 3.8.2 The hall started off as a passage running from the front door to the stairwell, and had evidence of a substantial wall on its east side. Towards the ceiling in this wall there was evidence of a chimney projection at the first floor. The stairwell is located in an area where part of the original wall of the building has been removed. Here the hall runs at an angle to a passage running east to west, heading towards a timber framed doorway. There is a small central room in the building, with evidence of timber frame walls with wattle and daub infill. Alongside this a small flight of brick built stairs descends to a brick cellar. There is a blocked window in the east wall, and an arch set in each of the other walls. The floor is covered in a brick tile with dimensions 230-240mm square.

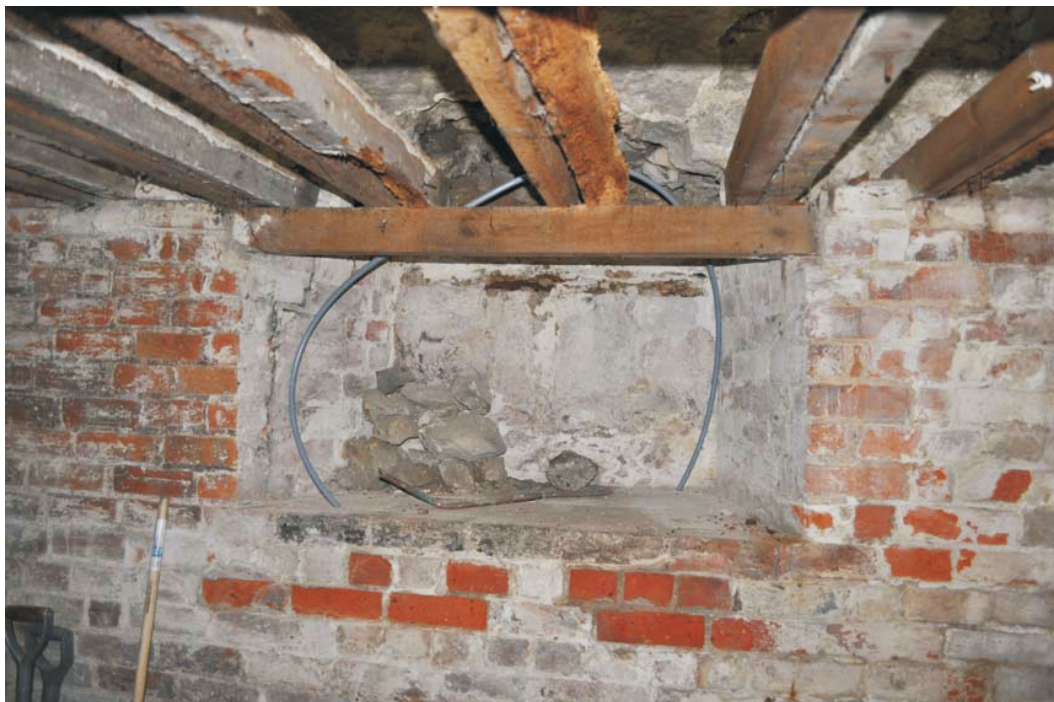
Plate 10: Blocked up window in the cellar

4.3.2 The cellar must also have been added at this time as the brick sizes are probably more indicative of this phase and it must also have occurred so that the cellar window on the east could receive light.
