**AN ARCHAEOLOGICAL WATCHING BRIEF**

**CASTLE DENE, CASTLE STREET,**

**DEDDINGTON, OXFORDSHIRE**

**February 2005**

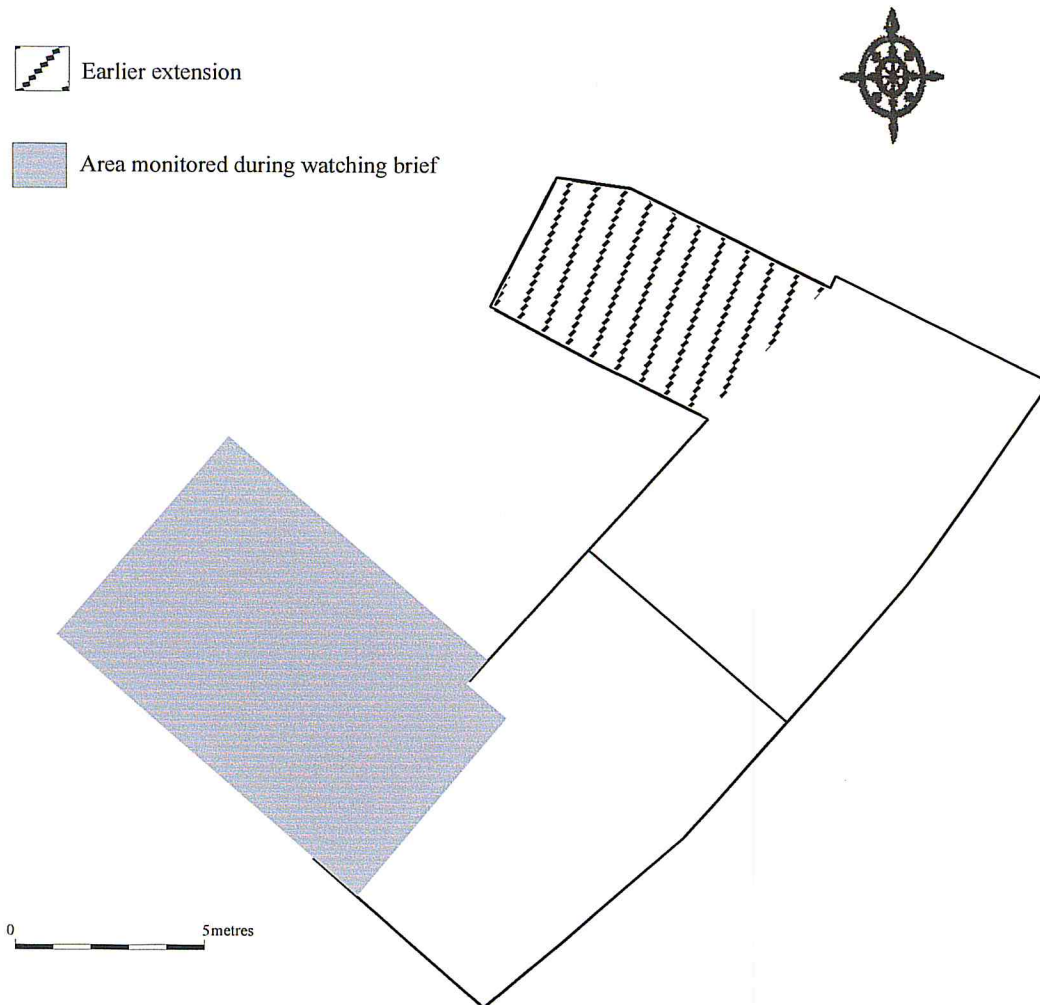
Figure 2. Detailed plan

Natural deposits associated with the Marlstone Rock Bed were the lowest deposit seen. These comprised brown-orange clay with large patches of small fractured Marlstone Rock and small lenses of blue-grey clay (03). Overlying these was a

250mm thick deposit of brown-orange clay, which was slightly dirty in appearance in places (02). This last was only present external to the former barn. The uppermost deposit, overlying 02 externally and directly overlying natural deposits within the former barn, was a layer of made ground (01). This included a make-up layer for a former surface in the barn building and brown-orange slightly silty clay with rubble outside of the barn. This was *c.* 200mm thick and where it formed the upper deposit in a heavily disturbed yard it contained late post-medieval and recent finds including bricks, breeze blocks, and bottles.

Deposit 02 is considered to be a cultivation deposit to the rear of the former barn. If there was medieval settlement along this part of Castle Street it was fronting the road

and any associated rubbish pits or 'backyard' activity was further to the rear of the site.
