The History and Structural development
of
68 CARLTON HILL
ST JOHN'S WOOD
London NW8

K A Rodwell
for
JOHN MOORE HERITAGE SERVICES

July 2008

**The History and Structural development
of
68 Carlton Hill, St John's Wood, London NW8**

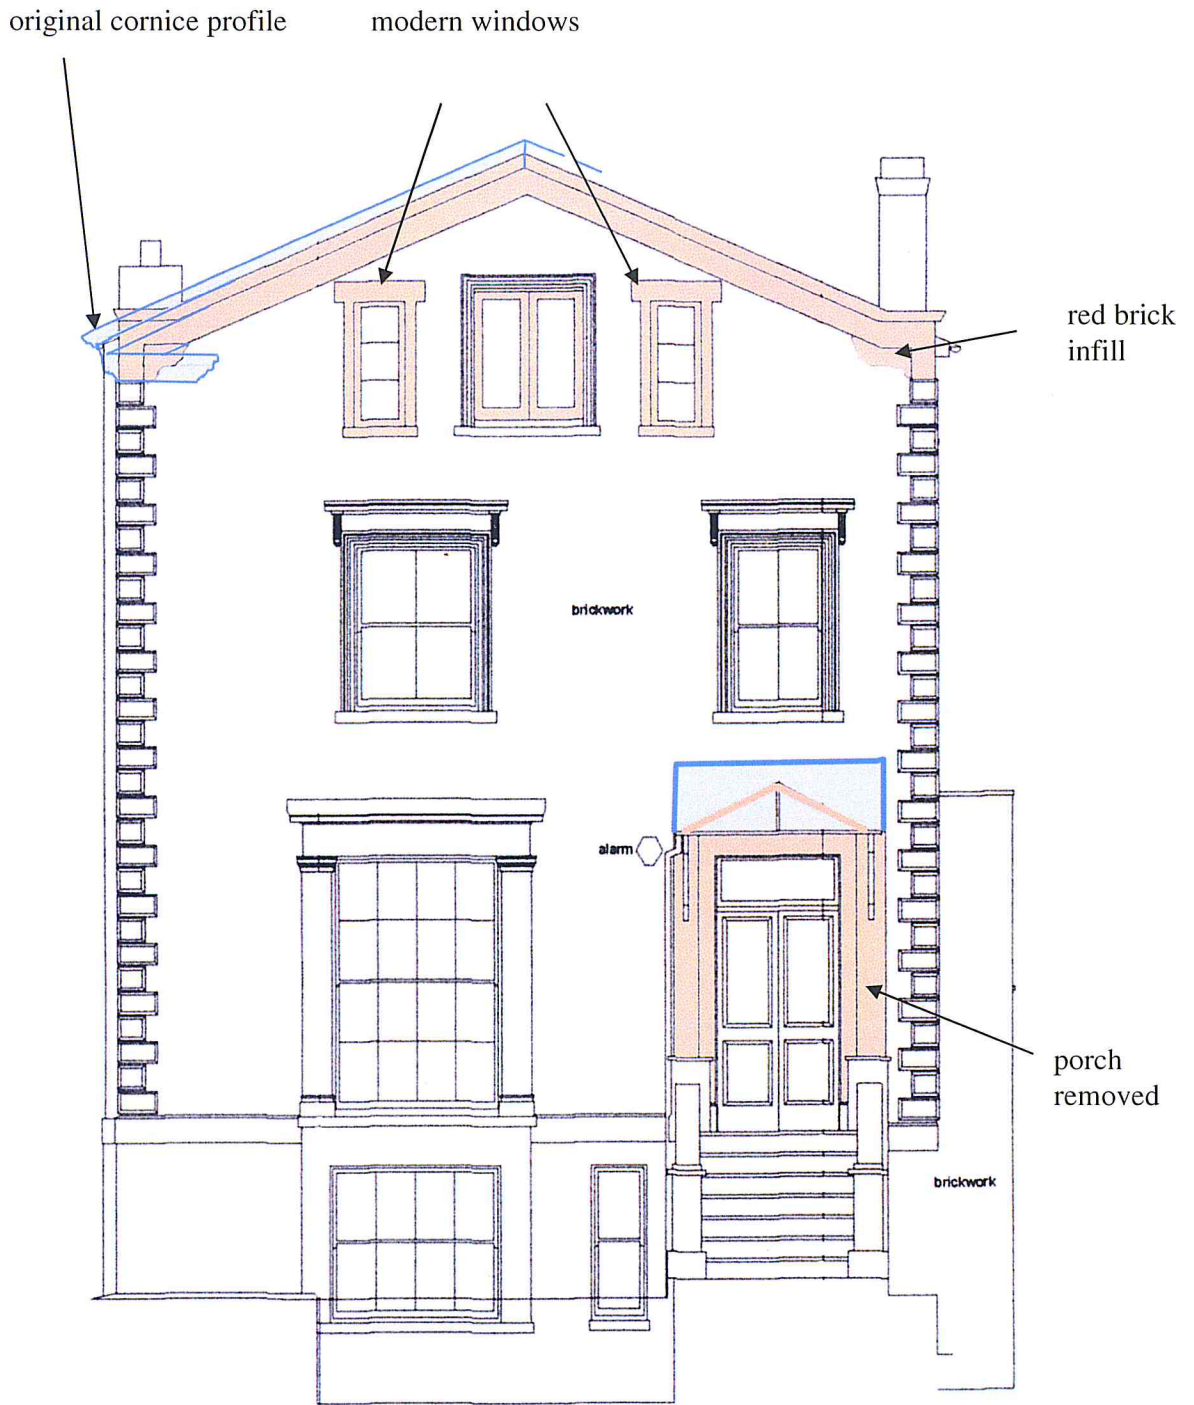
Fig 2 South-east elevation

20th century alterations in orange
original cornice & porch profile in blue

The house is a detached villa set back from the street frontage and facing south-east. It has an asymmetric two-bay front elevation four storeys high, consisting of a half-basement, emphasised ground floor, first floor and attic with a low-pitched gable. The main part of the façade is yellow London stock brick above a stuccoed basement and the dressings are also stuccoed. The basement has a large sash window set below the over-size ground floor window which has stuccoed pilasters carrying a plain cornice. The double front door is set close to the corner of the building and approached by a flight of steps; it has a plain surround with a modern glass canopy where there was formerly a porch. The two first floor windows are of unequal size and disproportionately small in relation to the ground floor. They have narrow raised surrounds with cornices on console brackets and two-light plate glass sashes. The central attic window has a surround of the same pattern but without a cornice and is now a two-light casement. It is flanked by a pair of single-light windows with unmoulded eared surrounds; the photograph of c.1950 shows these to be later 20th century insertions.

The façade has alternating rusticated quoins which stop some 0.6m short of eaves level and are continued as a plain stuccoed band which returns below a narrow projecting parapet to the gable. In the angles below the eaves there are triangular patches of red bricks where the wall has been made good. These represent alterations made since c.1950 when the original bolder and deeper gable moulding was removed and the profile altered at eaves level to create flattened terminals. The attic storey has been repointed, possibly in conjunction with the inserted windows but there are no other significant variations in the brickwork suggesting alterations to the façade.

At some point in the second half of the 20th century, probably the 1960s or 1970s, the original gable moulding was removed and replaced with a new plain and narrow parapet course flattened at the eaves. The gaps were filled with brickwork of a different colour and a pair of side windows inserted. Probably at a more recent date the roof structure was very largely replaced.

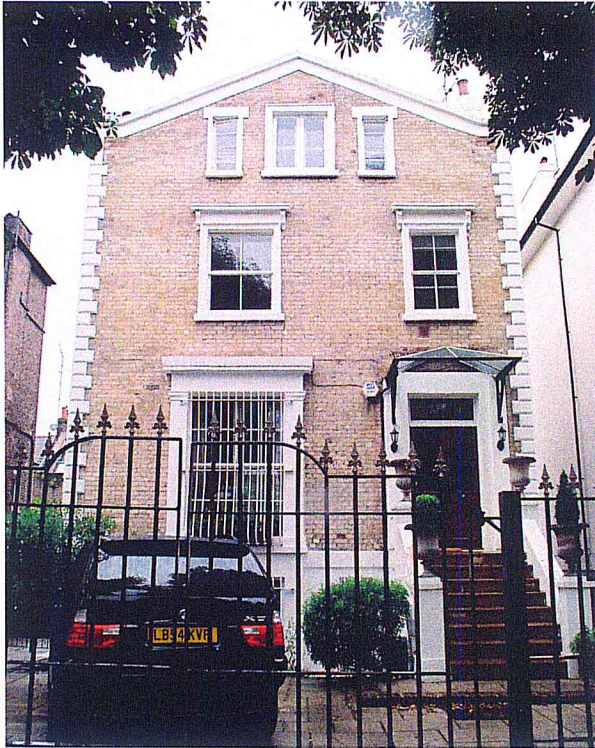
Principal elevation

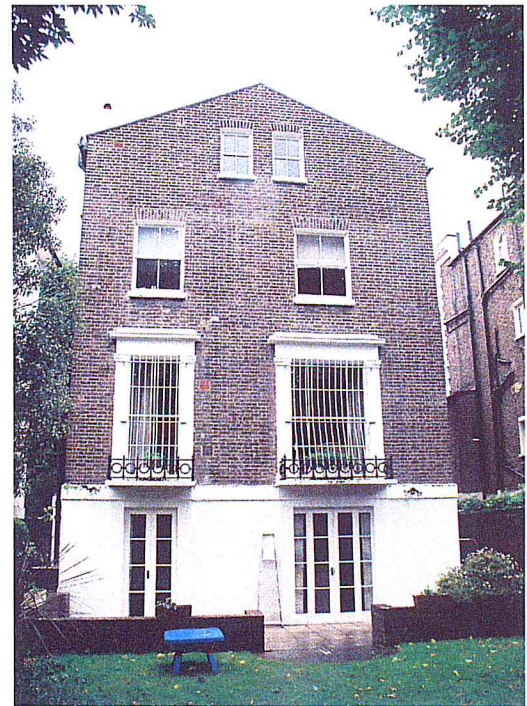
Rear elevation

The rear elevations are built of brown brick and the side elevations are largely blank walls, serving to house the slightly projecting chimney flues whose stacks rise from eaves level. The gabled north-west elevation mirrors the proportions of the front. The basement windows have been altered to form French doors and the principal emphasis is at raised ground floor level where the heavy stuccoed architraves match the front of the house. The first floor windows are disproportionately small with plain brick

surrounds and at attic level there is a pair of small sash windows under the apex of the gable; these appear to be original. There are no quoins or stuccoed bands and the roof has a narrow parapet course. There are no indications in the brickwork of alterations to the fabric on this elevation.

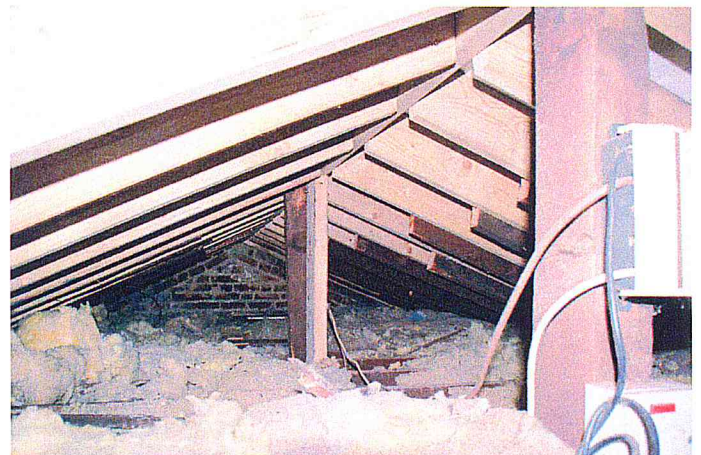
Eaves detail showing red brick infill
