JOHN MOORE HERITAGE SERVICES

ARCHAEOLOGICAL WATCHING BRIEF

16-18 BATH STREET,

ABINGDON, OXFORDSHIRE

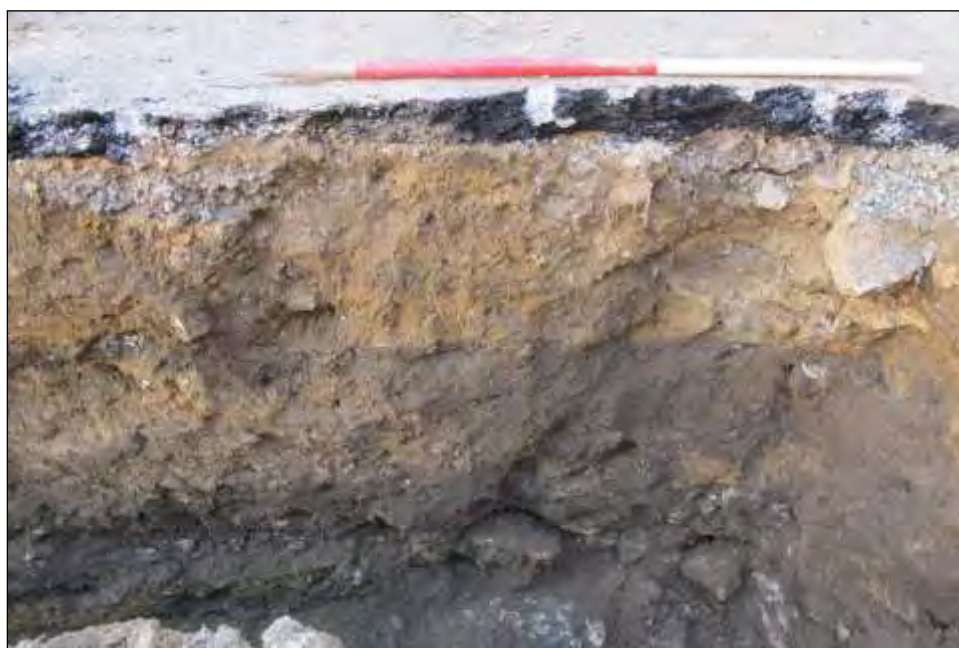
Plate 1: *Section 2, showing walls 18, 19 and pit 16, looking SE.*

In the south west corner of the footings trench (14) was truncated by possible wall **18** and associated construction cut 21. This wall was constructed from roughly hewn limestone blocks, ranging in size from 300mm x 150mm x 100mm to 100mm x 100mm x 80mm. There was no evidence of coursing and the stones were earth bonded with a mid grey clayey silt. In the trench the feature was 0.9m in length and 0.2m in width, with a height of 0.2m; the wall was present in the base of the footings trench and extended beyond the limit of excavation to the south (Fig. 2; Plan 1, Section 2 and Plate 1).

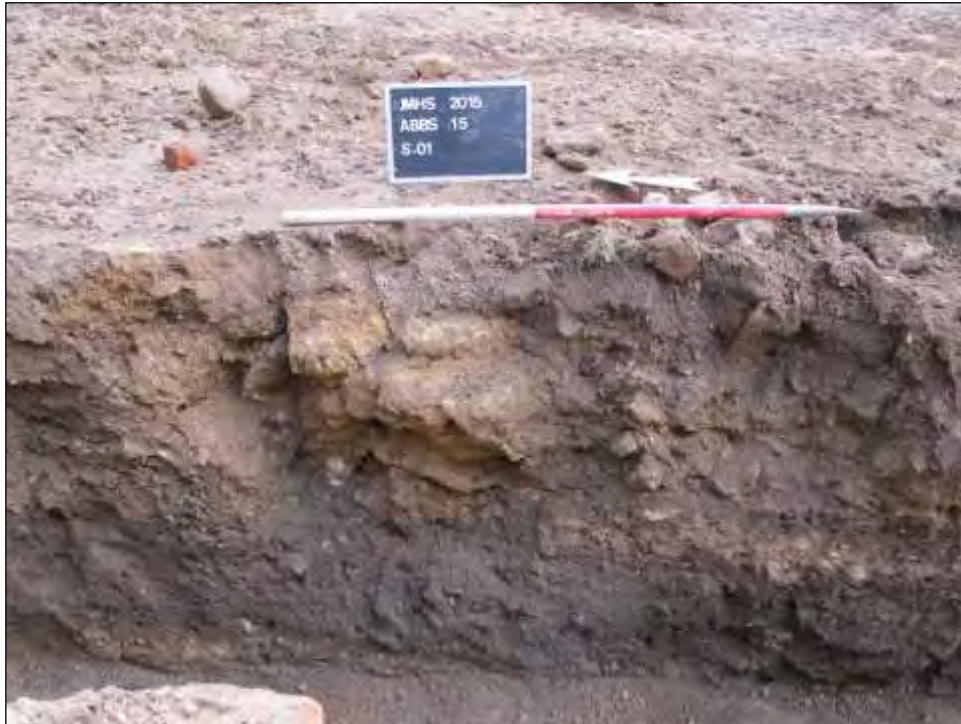
Plate 2: *Section 1, showing wall 4, looking NE.*

Layer (11) was truncated by a series of features. Wall **4**, built from roughly hewn limestone blocks with dimensions of 200mm x 150mm x 100mm. The stone was randomly coursed and bonded with a light greyish yellow mortar. The wall was aligned north east – south west, ran for 14.5m in length, visible at several points within the trench, 0.46m in width and 0.5m in depth. It was built within construction cut 3, a cut with sharp break of slope at top and base, vertical sides and a flat base (Fig. 2; section 1. Plate 2).

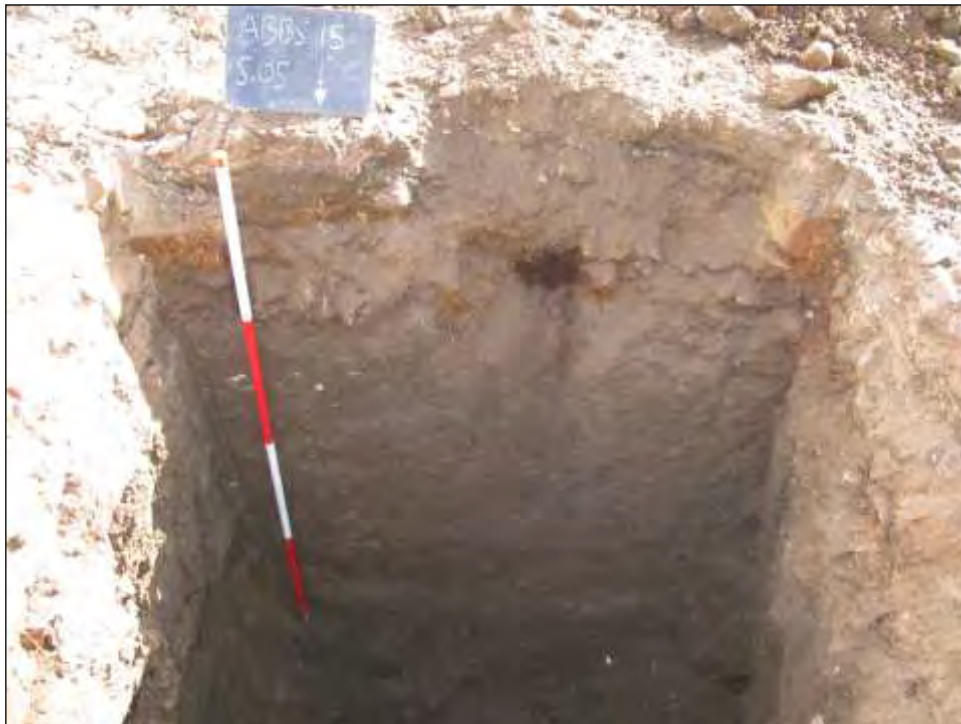
Plate 3: *Section 5, showing garden soil layer (15) in soakaway trench, looking SE.*

The geological horizon was not encountered during excavation; instead the lowest deposit encountered was (15) (also recorded as (09)), a soft dark brownish grey clayey silt with occasional sub-angular stone under 50mm in size (Fig. 2; Sections 1-5, and Plate 3). The deposit had a thickness of over 1.02m and was present across the whole site. One sherd of Medieval Oxford Ware was recovered from this context, providing a *terminus post quem* of late 11th century.
