JOHN MOORE HERITAGE SERVICES

BUILDING ASSESSMENT

7 NORHAM GARDENS, OXFORD

AUGUST 2015

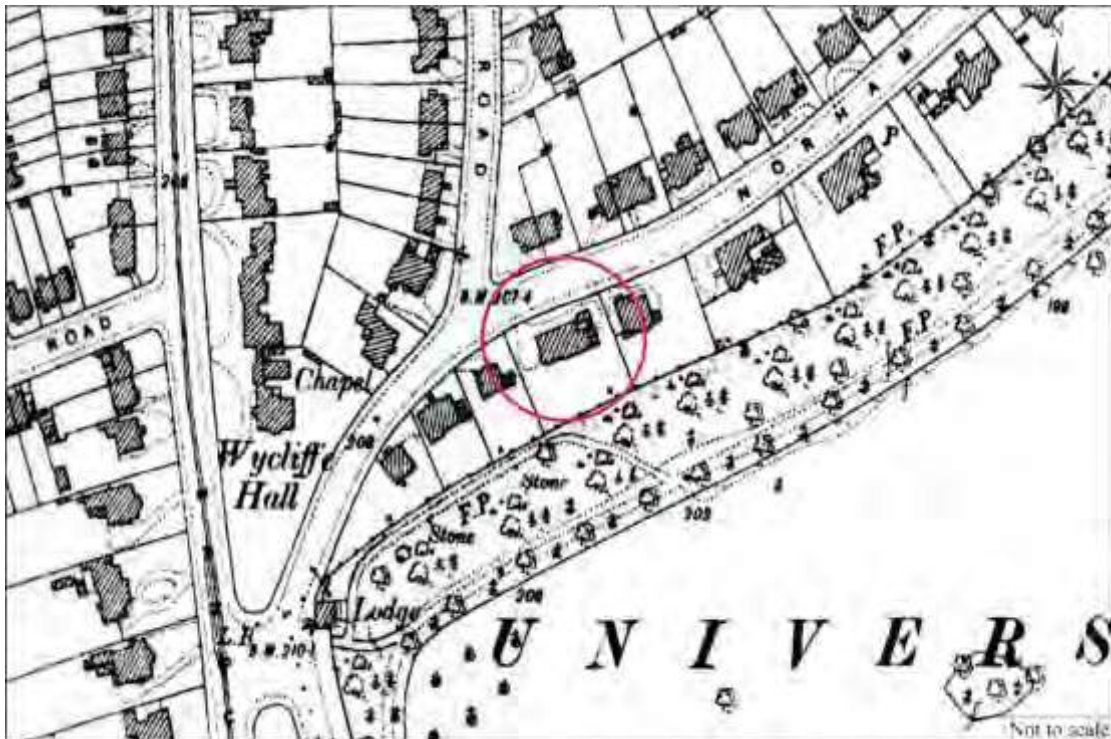
Figure 3 Ordnance Survey second edition 1: 2,500 map of 1900

The subsequent history of the property has been discussed in two reports; firstly by Doggett and Fisher (2010) and secondly by Miele and Markham (2012). These reports identify six phases of the building, two of which are major, while most are minor alterations. The following account gives a brief account of these alterations based on these reports. The house was purchased by Max Muller, Professor of Philology, in 1867, and it is he whom is considered to have a large eastern extension made to the property (Phase 2). The next phases have been recognised from Ordnance Survey map detail alterations. From the plan of the building on the First Series dated 1876 at 1: 5,000 (Fig. 2) and the Second Series dated 1900 at 1: 2,500 (Fig. 3), three alterations are noted in this period, but the exact date of one of these alterations is not known. Phase 3 saw building work by S Hutchinson with the insertion of a northwest pantry. An alteration at this time saw the building of the conservatory. An L-shaped structure is either added onto the northeast part of the structure by 1900, which is either a rebuild or a reworking of what previously existed there; it was built in such a way as to enclose a small yard.

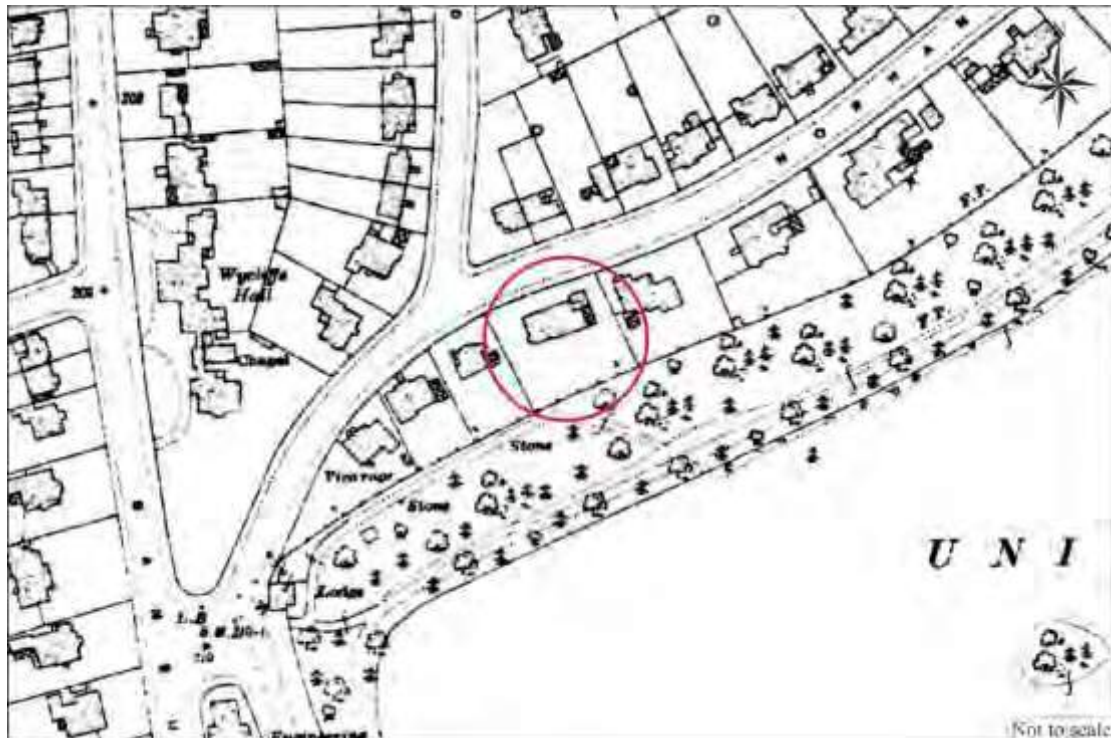
Figure 4 Ordnance Survey third edition 1: 2,500 map of 1921

The plan of the building remained the same on the Third Series Ordnance Survey map of 1921 (Fig. 4) and the Fourth Series map of 1939 (Fig. 5). Planning permission was given in 1951 for the change of use of the building to a school (Doggett and Fisher 2010), an act that causes further alterations. The differences in the shape of the building shown on the Ordnance Survey map of 1939 and 1957 enable a further number of alterations to be identified. The L-shaped building on the northeast side had been demolished and rebuilt. There is a planning application of 1951 at the Crescent School, which mentions alterations and not build. This information implies a demolition and rebuilding from 1939 to 1951. Alterations were also made to the conservatory from 1939 to 1957 as the canted southern end is shown for the first time on the later map. The brick plinth is considered to have been reused and the timber frame rebuilt.

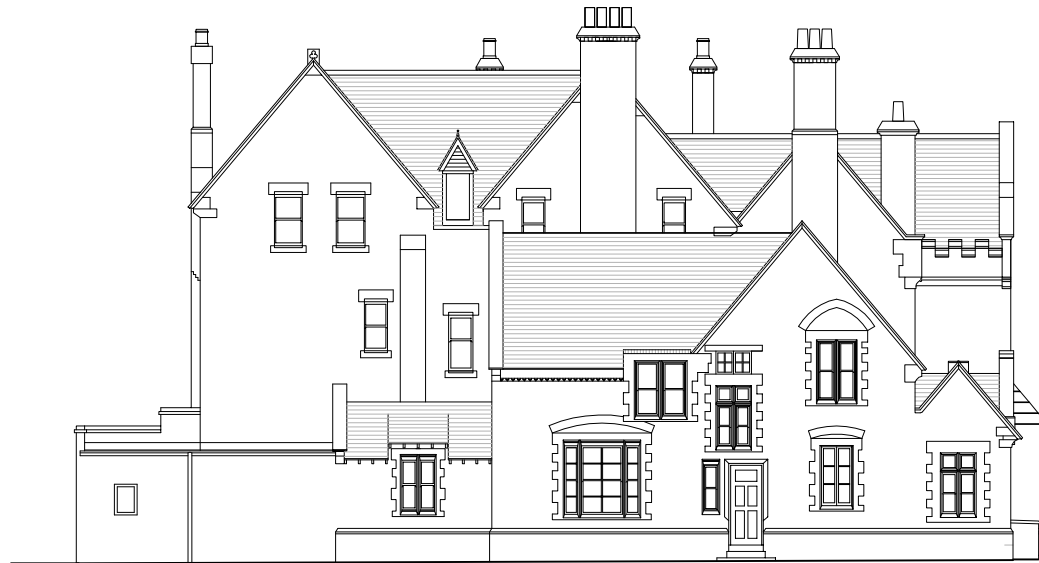
E. 1: North-West Elevation

The northwest façade is an eclectic mix (plate 4). The back part of the façade contains three gables, the right hand two contain gable end chimneys, with the centre gable having a two light window either side of the chimney and the other gable blank. The left hand gable contains two windows with two lights in its upper storey. There is one window with two lights on the first floor. In the area between the two gables there is a brick buttress on the gable. Between the left gable and central gable there is a hipped dormer window in the attic and in the first floor a two light central window.

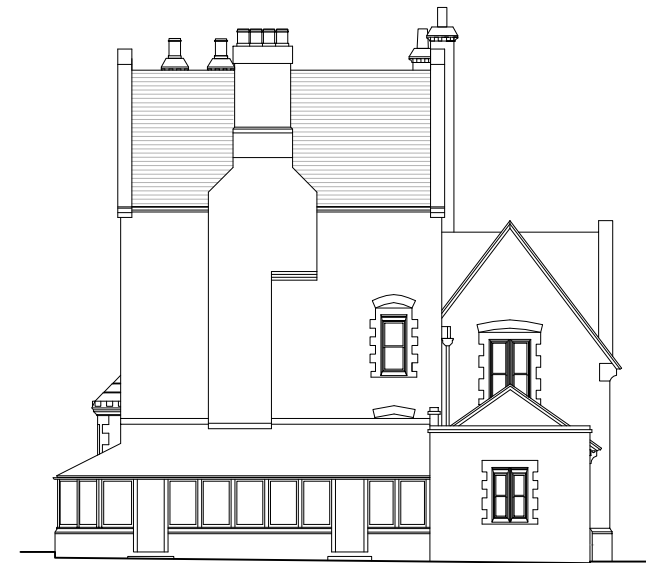
E.2: North-East Elevation

The northeast façade is dominated by a lateral chimney on a side wall and pitched roof (plate 6). To the right of the chimney there is a square-headed two light window with limestone dressing and a segmental brick arch above on the first floor. Below this is a conservatory with a brick plinth (plate 5), with a canted window to the left. Above the line of the conservatory there is the remains of a segmental brick arch.

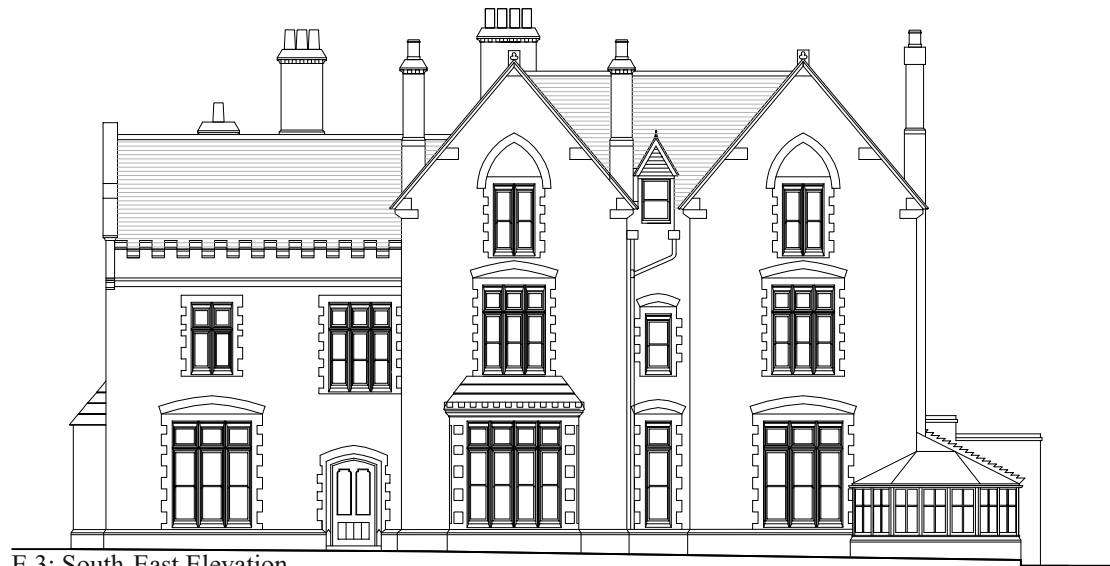
E.3: South-East Elevation

The southeast or main façade faces the park (plate 1) and the location of an earlier trackway, which ran along the park and parish boundary. This façade is of brick with a plinth and two gables, some of the dressing uses ashlar limestone. Centrally to the façade is a gable, the most elaborate, with a limestone dressed brick plinth, rectangular bay on ground floor, with limestone dressing and some brick detail. The window contains 12 lights arranged in four vertical groups of three, divided by mullions, with the upper lights separated by a transom. Above the bay window the ashlar is carved to give the impression of a hipped tile roof above a small frieze with vegetation motifs. The roof of the bay tapers back to a nine light window on the second floor arranged in three groups of three, with the top lights separated by a transom. Above the window and lintel is a slightly pointed segmental arch in brick. In the attic stage there is a further window with a four light window with ashlar surrounds and a central mullion. This is surmounted by a decorative pointed Gothic arch in brick. The line of the gable is capped with limestone with a central finial with a trefoil design. The gable is crowned by a central chimney and there are also two chimneys set laterally in the lines of the walls of the gables.

To the right of the central gable, there is a second gable of a similar design to the first. The difference is evident on the ground floor where the bay window has been replaced by a nine light window, with ashlar surrounds, mullion divides and the upper lights separated by a transom. On the right hand side there is a lateral chimney above a conservatory on a brick plinth, with a canted south end. Between the two gables there are a series of narrow lights, on the ground floor a three light window with dressing and transom, and segmental brick arch set above the lintel. On the first floor there is a two light window with dressing and a segmental arch in brick above the lintel. On the attic storey there is a two light window with a hipped dormer.

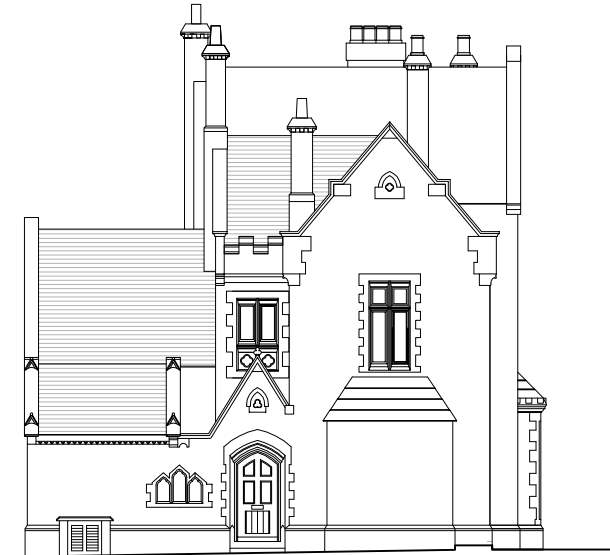
E.4: South-West Elevation

The southwest elevation is dominated by a gable on the right hand side (plate 2). The façade has a limestone dressed brick plinth. On the ground floor of the gable there is a protrusion mocking the bay window on the southeast side of the building, but in which

there are no window lights. On the first floor there is a four light window with mullion and transom. The gable is capped with limestone dressing, parapet ends, no finial, and a small decorative design with an arch above a quatrefoil. Above this gable there are a series of roofs with six chimneys. To the left of this on the ground floor there is a Tudor Gothic door with a four centred arch and limestone dressing (plate 3). There is a gable above with a trefoil motif, and an English lancet style window to the right of the door. In the wall to the right of this there is evidence of two butt joints below a corbel line. Above the door gable and stepped back is a two window light with mullion, with decorative panels below containing quatrefoil designs. There is a crenulated parapet above and two roofs to the left.

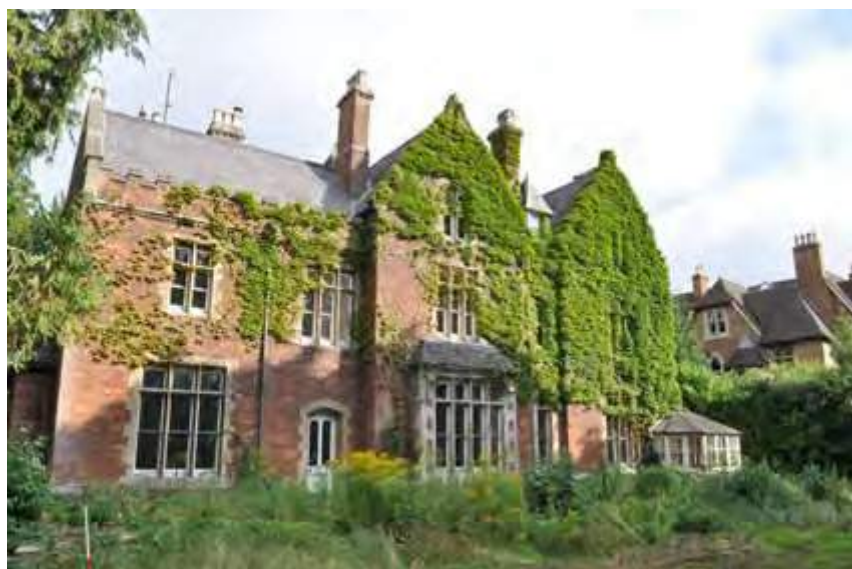
Plate 1: SE façade

To the left there is an extension, also with a limestone dressed brick plinth. On the ground floor on the right hand side there is a door with a shallow pitch Tudor perpendicular style four-centred arch, which has a limestone dressing. On the left is a large window of nine lights arranged in three groups of three divided by mullions and with the upper lights separated by a transom. There is a segmental brick arch above the lintel. On the first floor located above the door there is a nine light window, smaller in scale but arranged in a similar fashion. To the left of this there is a four light window with mullion and transom and limestone dressing. Above this there is a crenulated parapet. On the left end of the building there is a protrusion, a bay without windows, with standard plinth and a limestone roof imitating a tile design.

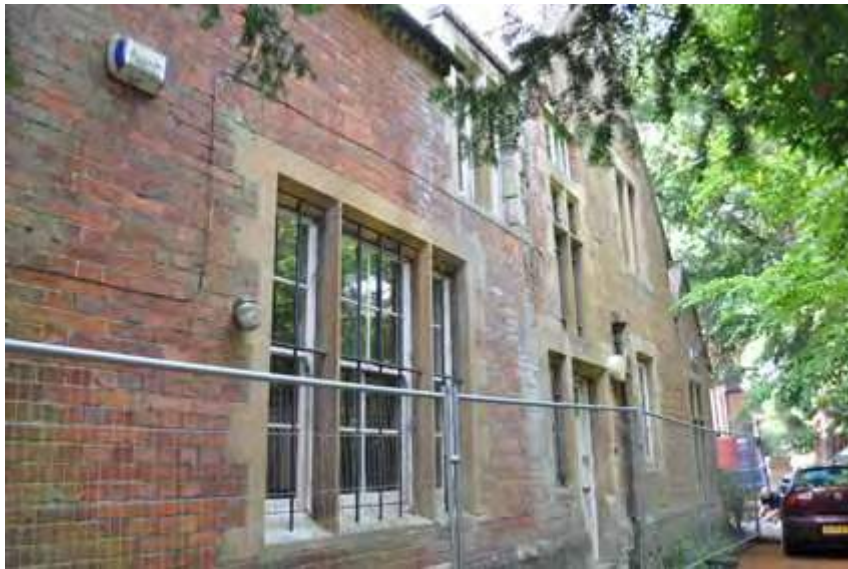
Plate 4: NW façade

In front of this is a single storey with part of it having a first floor attic arrangement. There is a lower brick plinth along some of the length of the back façade. The part with the attic floor has a gable on the right and a central square-headed arched panel door. To the left of the door is a square-headed two light window. To the right of the door and set in the gable is a six light window with limestone dressing and a segmental arch

in brick above. In line with this and above is a four light window with a limestone dressing and a brick two centred arch. To the left of the door on the ground floor is a twelve light window with two mullions and limestone dressing, with a segmental brick arch above. Above the central door there is a group of three window casements with an unsightly arrangement. Immediately above the door is a six light square-headed window with mullion and transom. Above this is a small casement window. To the right of these is a square-headed four light window, with a dormer. There is a corbel to the left of this. To the right of the first floor attic storey there is a small gable of a single storey with a six light limestone dressed, mullioned and transomed window. To the left of this there is a single storey with a pitched roof and plinth, with a four light mullioned and transomed window. This is set in a dormer roof. There is a single storey extension to the left of this that has a window light on the left hand side.

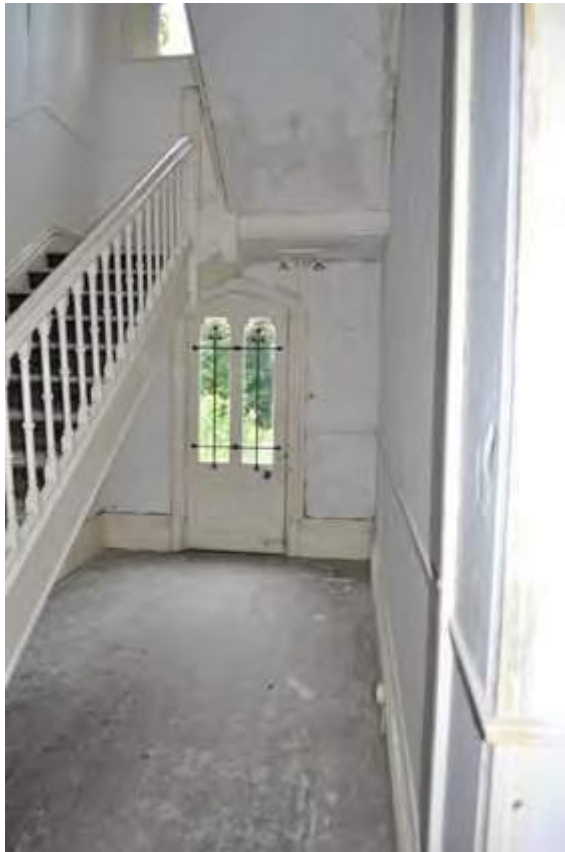
Plate 7: Room G3

The *main hall G3*: is also L-shaped and contains the remains of the doglegged stairs ascending to the first floor (plate 7). The stairs are probably original or repaired to look like the original. Under the stairs is an external door with a pointed arch, a panelled door with glazed upper parts containing iron fittings. The skirting is high with moulded tops, though the design may be original or replicate an original design; there is evidence of a blocked door in the north to south wall between rooms G3 and G4. There are indications that a dado rail has been removed at some point. In the north arm of the hall as one comes from the entrance hall there is an open pointed arch in the west wall (perhaps a later opening). In the north wall there is an original stone fireplace (plate 8) and a square-headed door leading to room G5. The detail on the fireplace reflects the tile roof design found on the south bay window and west wall extension. In the south wall of the north arm is a further square-headed door leading into room G4. Some ceiling moulding survives in the north part of this room.

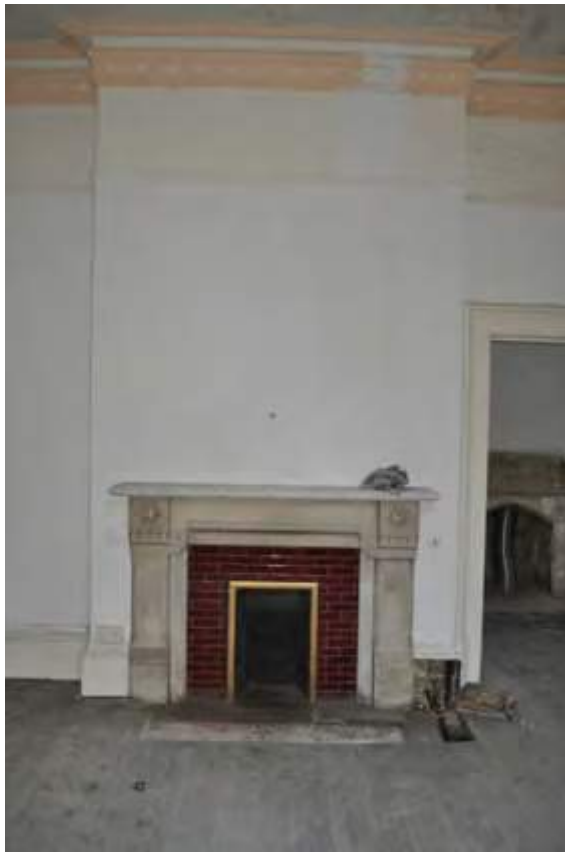
Plate 9: Room G4

Room G4: contains a fireplace and door in the north wall (the door is possibly not original due to the design of the room with a feature dominating each of the four walls

perhaps representing a principal of some kind). The fireplace is original and of a limestone surround with marble mantle piece, with maroon tile interior representing a stretcher brick coursed pattern, with a cast-iron fireplace (plate 9). The door has a wide moulding, which could have been used from elsewhere. There is evidence of a blocked door in the east wall. In the south wall there is a mullioned and transomed window, and in the west wall a large recess (plate 10). The room contains an ornate coving moulding containing a frieze of quatrefoil motifs below which is a rail.

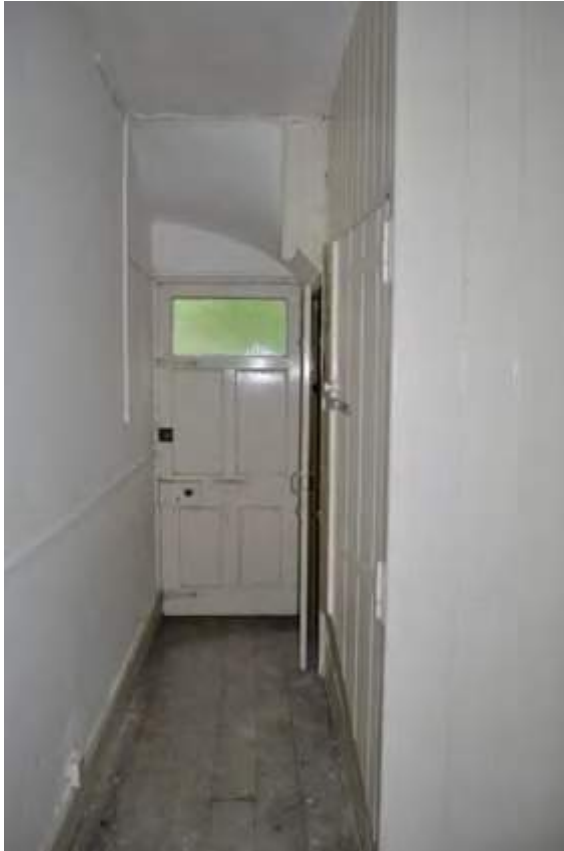
Plate 11: Passage G5

Passage G5: is of a basic rectangular shape with the remains of a built in stairs located in the northeast of the space (plate 11). The stairs are concealed by walls of vertical planked panelling and square-headed plank doors (original). There is a square-headed door in each of the east, south and west walls. In the north wall there is also a square-headed panelled door with glass upper panelling. There is a dado rail around some of the walls. The door sits in a larger partial segmental arch which raises questions about the original design and layout of rooms G5 and G6 and may be suggestive of them once being part of a common space.

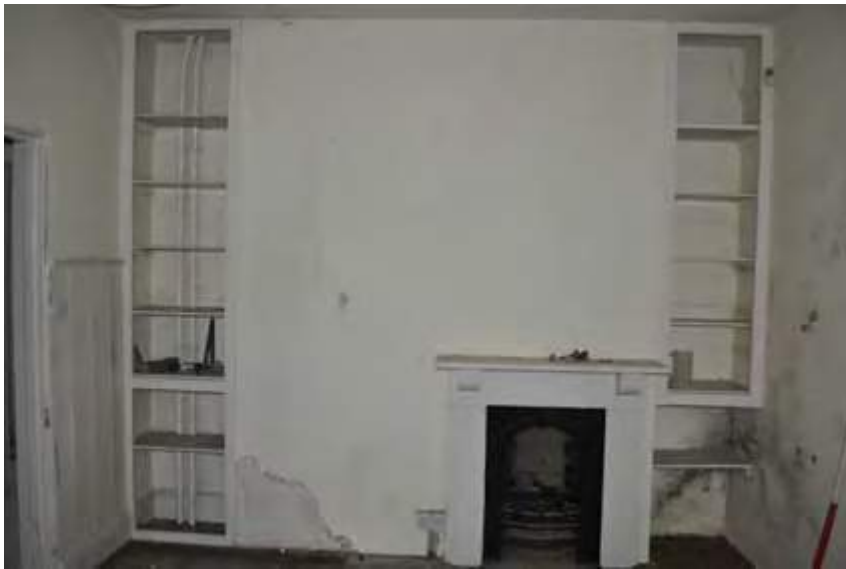
Plate 12: Room G6

G6: contains the remains of a fireplace and chimneybreast in the south wall (plate 12). The fireplace surround is of timber and there is a cast iron fireplace and offset to the breast, the chimney is shared with one in room G3. There is shelving either side of the chimney breast, which if not original imitates a design we would expect for that date. There is a six light window in the north wall. Doors are located in the east and west walls. Some of the walls have a high dado rail with a vertically planked dado below (possibly an original design but there are question marks about the wall between G5 and G6).

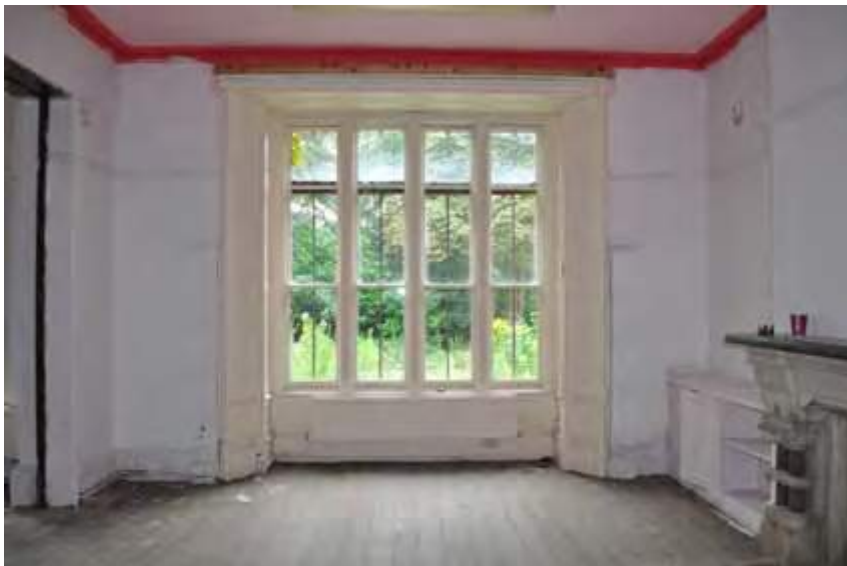
Plate 14: Room G9

at least two rooms, subsequently referred to as G9 east and G9 west. G9 west contains a bay window with mullioned and transomed window in the south wall with timber surround (plate 14). The west wall contains one of the chief original fireplaces in the building with a limestone surround, contrasting black stone (Purbeck marble?) mantle and decorative columns (plate 13); with tile interior surround and a cast iron fireplace. Either side there are low inbuilt units probably not original. The north wall blocks this room from passageway G8. The wall has a central door above which are a series of window panels to allow natural light into the central passage. The east wall now contains a large opening which has connected G9 west to G9 east. The room contains coving moulding around the ceiling line and an upper rail on some walls. If the suggestion that room G10 of the original building was the kitchen then one should note that the original G9 west and G8 were the only high status room which would have been directly joined to that room. This would imply that this room was the original dining room into which food could have been directly brought. That the dining room was the largest room on the ground floor would in an Oxford University social life calendar make sense as the college style dinner and entertainment would dominate and possibly be emulated on a personal and private level by professors.

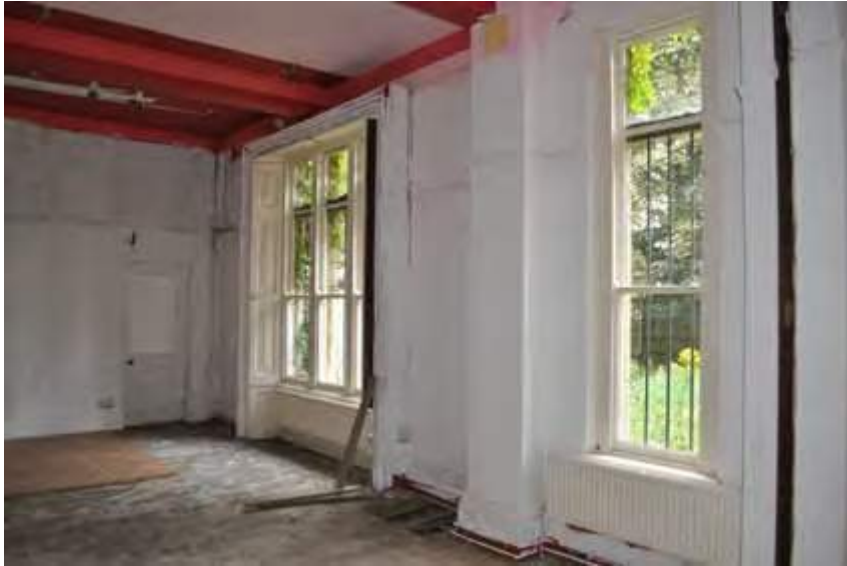
Plate 15: Room G9

G9 east contains two windows in the south wall, the larger east window a mullioned and transomed window with internal timber surrounds (plate 15). The west window on the other hand is a tall narrow feature. The north wall contains a door in its west side, the wall is considered to have been moved in the past to create a larger space in the passageway. This means that if the broad mouldings are original they have probably been reused here. In the east door there are the remains of a blocked fireplace and a door on its right side, which is evidently a later insertion (evident from the door and also from the lack of a segmental arch on the outside wall).

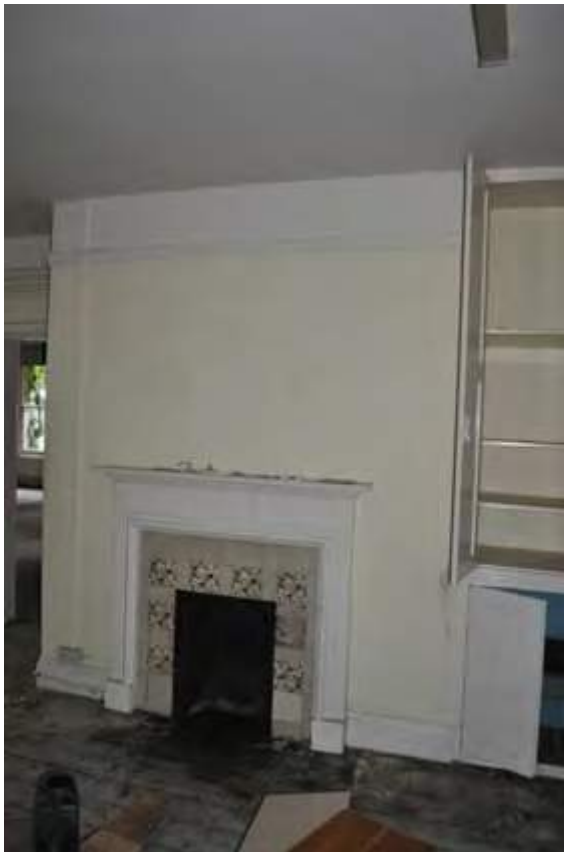
Plate 16: Room G10

Room G10: has previously been suggested as the original location of the kitchen. In the

north wall there is a composite mullioned window. The south wall contains a fireplace with wooden surround and mantle, with tile interior and fireplace (plate 16). The skirting is not elaborate enough on the fireplace. The size of the chimneybreast, which is the largest, has led to the suggestion that this is the location of the original kitchen and that the chimney could have taken an agar. To the left of the fireplace is a square-headed door and to the right shelving. In the west wall and east walls there are square-headed doors. A rail runs below the ceiling level.

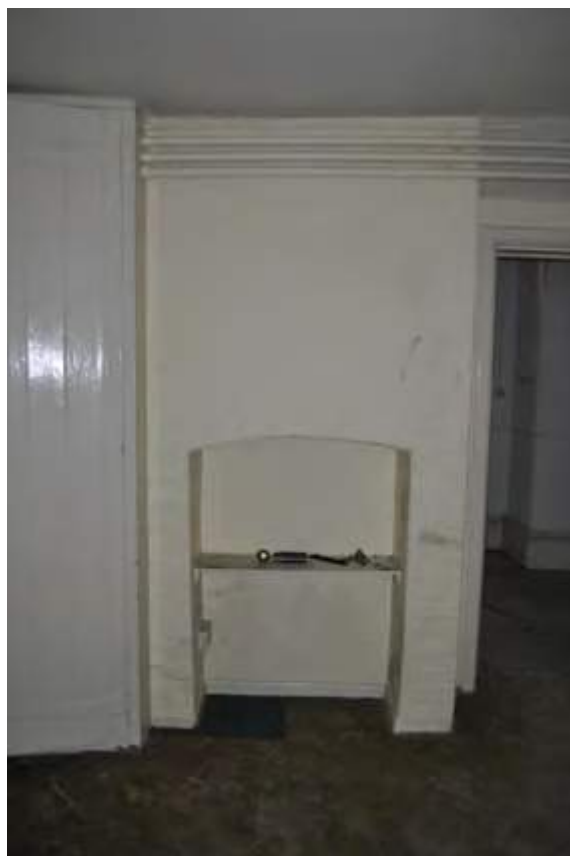
Plate 17: Room G11

Room G11: contains the remains of a mullioned window in its north wall. In the south wall there is a brick fireplace with segmental arch (plate 17), a plank door cupboard to the left and a square-headed door to the right.

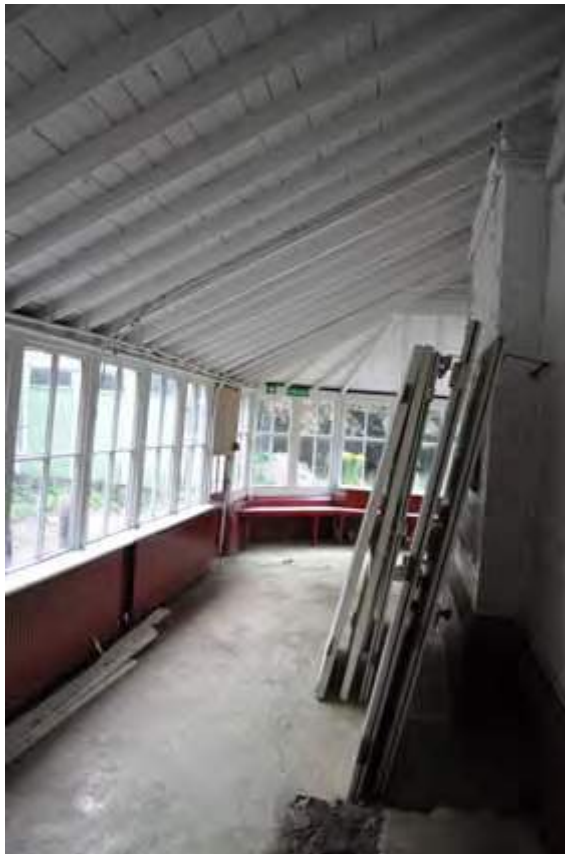
Plate 19: Room G15

The conservatory G15: is a later addition and possibly of two phases or of a rebuild (plate 19). The east wall contains two doors; the north one original and the other a more recent insert. There is also the remains of a chimneybreast. In the north wall there is a square-headed door into room G14. The east wall contains a brick dwarf wall with glass panelling above and two doors. The south wall forms part of a canted window. The ceiling is mainly part of a single pitched timber affair with plank panelling on common rafters and this design is continued around the canted window area.

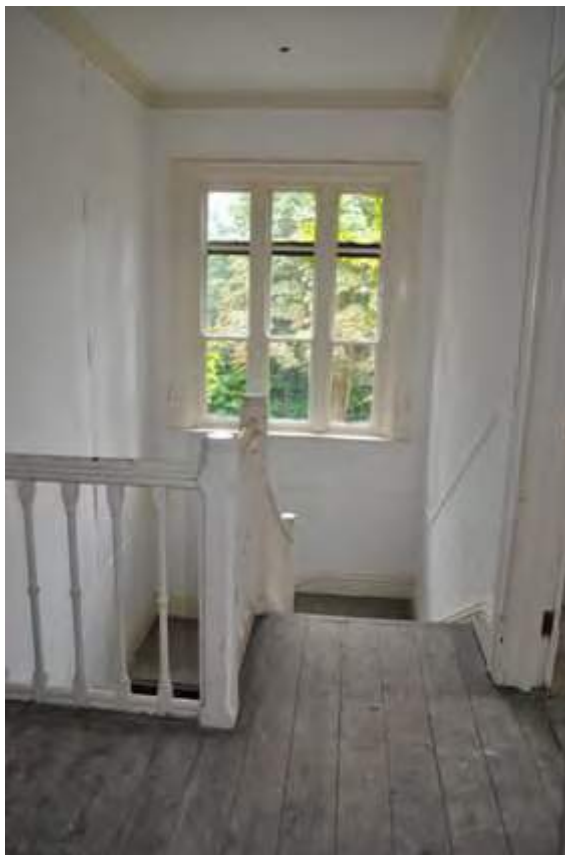
Plate 20: Room F1

Landing F1: has a dog legged stairs in its southern part with a large mullioned window above the stairs (plate 20). In the west wall there are two square-headed doors with broad moulded surrounds. The north wall has a passageway into the landing F3. In the east wall there is an alcove, which is unexplained, in a staggered wall with a square-headed opening into landing F7. The skirting is high and moulded but may not all be original. Considering the division of the 1862 house and the 1867 addition it is apparent that there has to be an earlier access to the two original rooms in the attic of the house. Such an access could only have originally been located as extending from the unexplained recess in landing F1, or was somehow located in room F7.

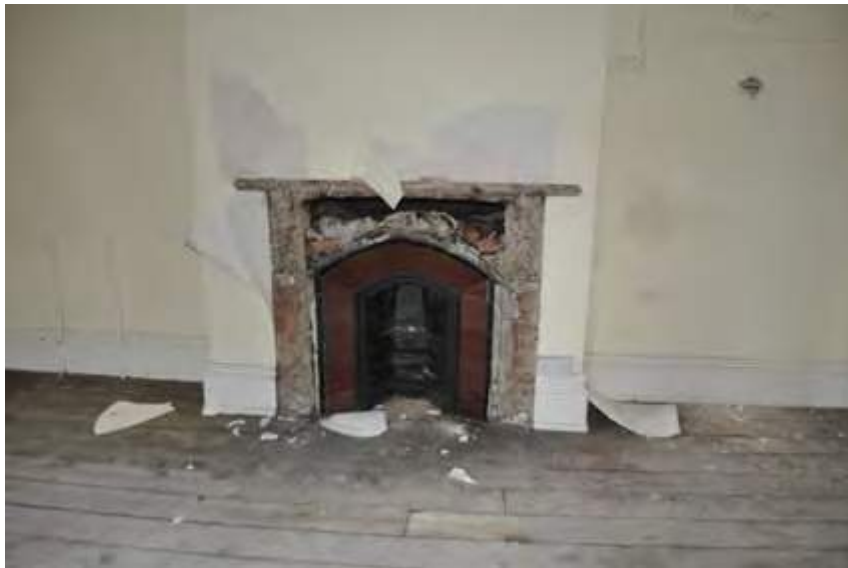
Plate 21: Room F2

Room F2: has a mullioned window with original wood surround in the south wall. There is a similar window in the west wall. A fireplace and chimneybreast are located in the north wall; the surround of the fireplace has been removed and all that remains is the cast iron fireplace with tile surround (plate 21). The removal of the surround revealed a void between the cast iron fireplace and the lintel, which may imply that this was not an original fitting. The ceiling has moulded coving and there is a moulded rail line below (plate 22).

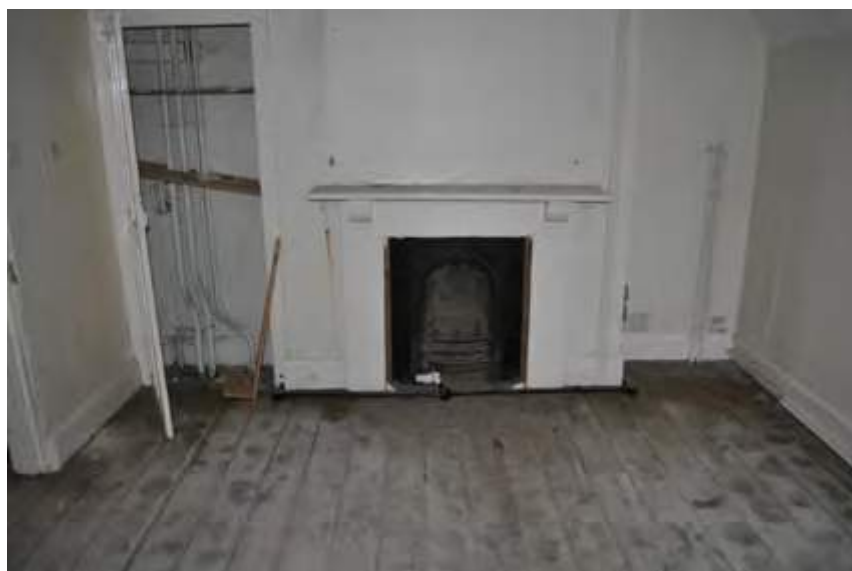
Plate 23: Room F4

Room F4: contains a fireplace in the south wall with a simple timber surround and a cast iron fireplace (plate 23). There is a cupboard to the left with a panelled door. In the north wall there is a four light mullioned window. The room is located in the first floor attic space so the ceiling on the west side slopes.

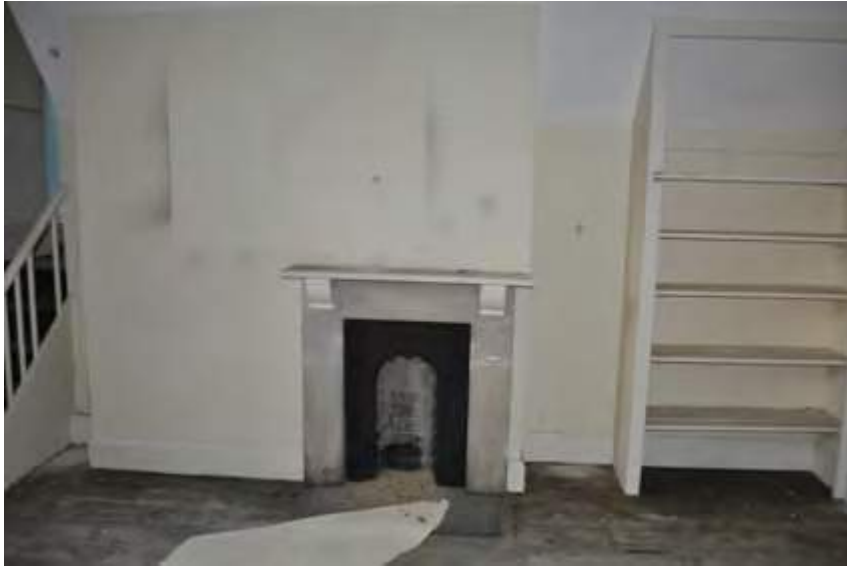
Plate 24: Room F6

Room F6: is part of an attic room on the north side of the building. In the south wall a small flight of stairs lies to the left of a fireplace. The fireplace has a simple timber surround with cast iron fireplace (plate 24). In the west wall there is a square-headed door. In the north wall there is a mullioned window, composite with timber sash which from the outside looks like a later insertion as the window breaks up the harmonious design of the wall. In the east wall there is a mullioned composite sash window.

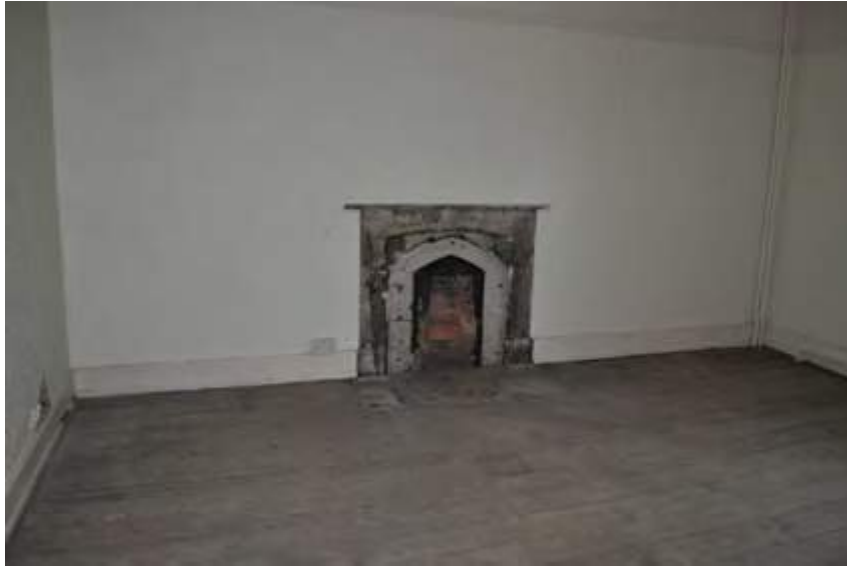
Plate 25: Room F10

Room F10: contained a fireplace in the east wall, but this has been stripped out leaving a visible segmental arch (plate 25). In the south wall there is a square-headed mullioned and transomed window with presumably original surround or repaired surround. The wall has an upper moulded rail, while the skirting board is rather bland. There is a square-headed door in the north wall. A door has been inserted through the west wall into room F9.

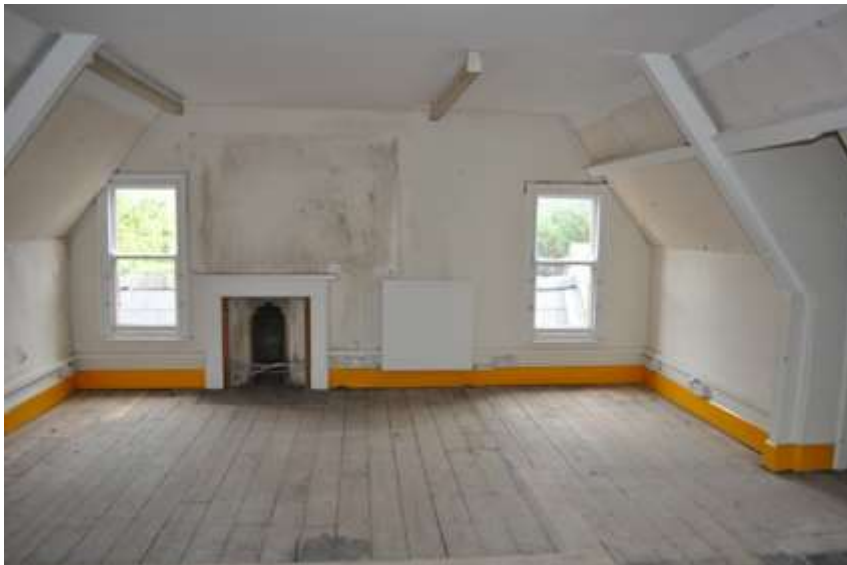
Plate 27: Room A1

Attic room A1: is now the main room in the attic space, but was previously two rooms, which have subsequently been joined. Room A1 north contains a central chimneybreast in the north wall, which is flanked by two sash windows (plate 27). The east and west walls are steeply pitched in places inside the roof space. In the west wall there is a door. The line of an original wall appears to be marked by the line of a board running across the normal direction of the floor boards. To the south of this demarcation line is the room which would have originally been room A1 south, which has a fireplace and chimneybreast in the west wall (plate 26). The fire surround is similar to that found in the rest of the attic but the cast iron fireplace is different, probably newer. On the left hand side there is a cupboard with panel doors. To the right of the fireplace is a small

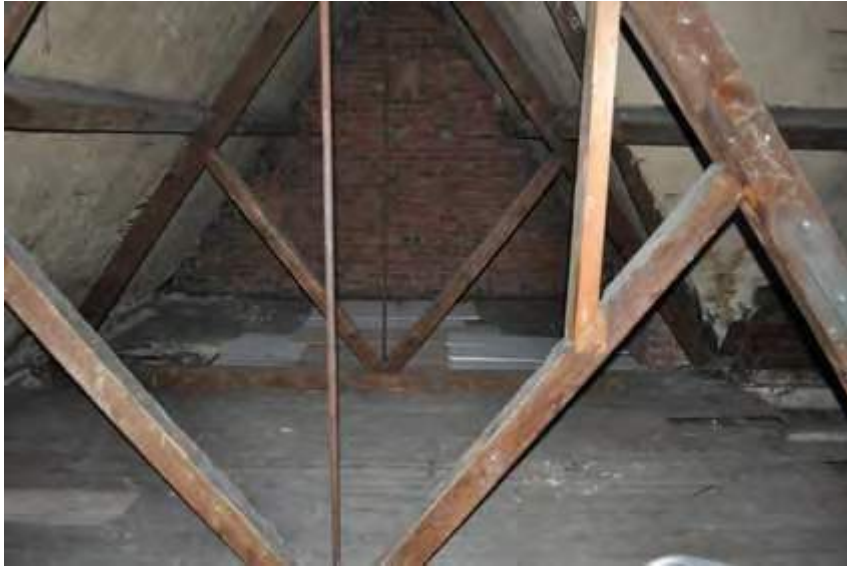
Plate 28: Attic A2

Attic room A2: could be described either as an L-shaped or possibly T-shaped piece of roof space. This attic space occupies the west end of the house where there is less height to the attic space. The roof trusses contain two struts and an iron rod in the place of a king post (plate 28).

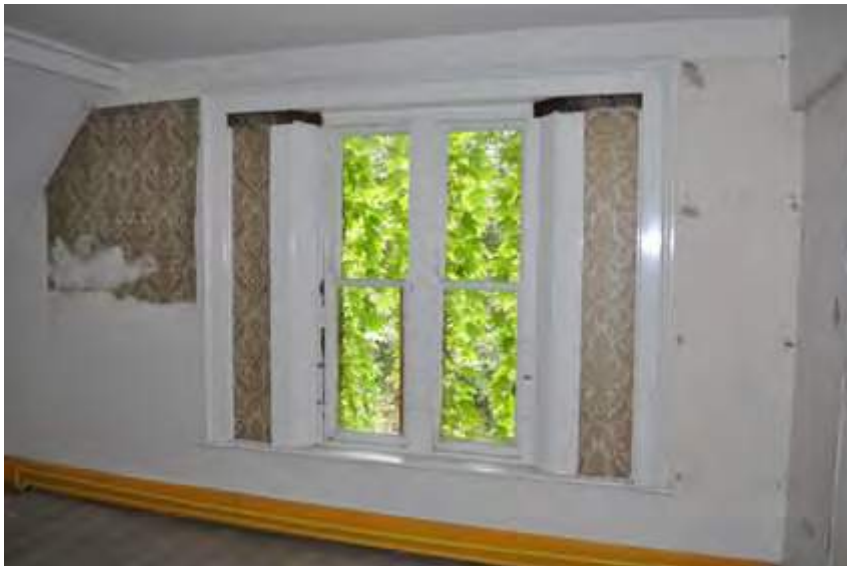
Plate 29: Room A4

Room A4: is an attic room with sloping ceilings on the east side. In the south wall there is a mullioned four light window with a moulded timber surround (plate 29). In the north wall is a square-headed door with insignificant moulding. In the east wall is a fireplace and chimneybreast (plate 30). This has a chamfered outer surround and a cast iron fireplace. The skirting board is plain.

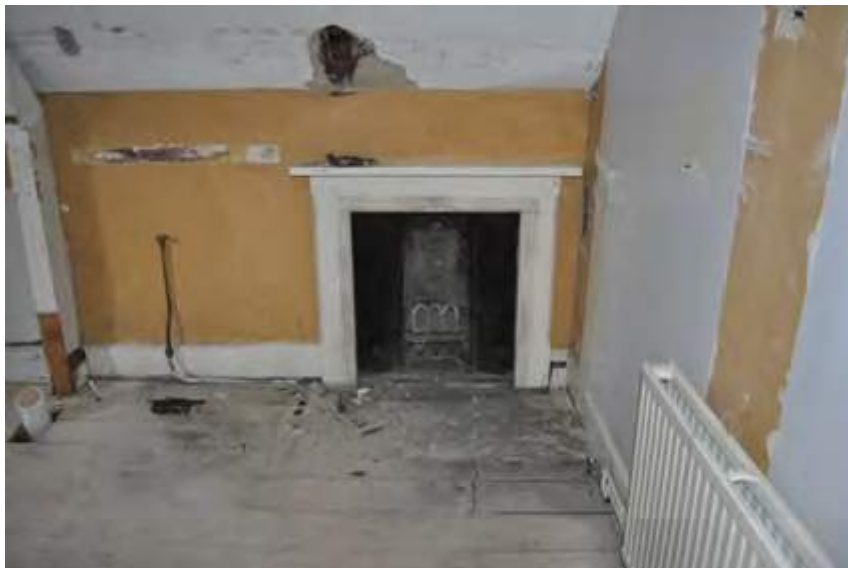
Plate 31: Room A7

Room A7: has a fireplace and chimneybreast in its east wall (plate 31). The outer surround is chamfered and there is a cast iron fireplace. In the north wall there is a sash window with a moulded timber surround. In the west wall is a square-headed door. On the east side the roof is pitched to fit into the attic space and extends to the purlin.

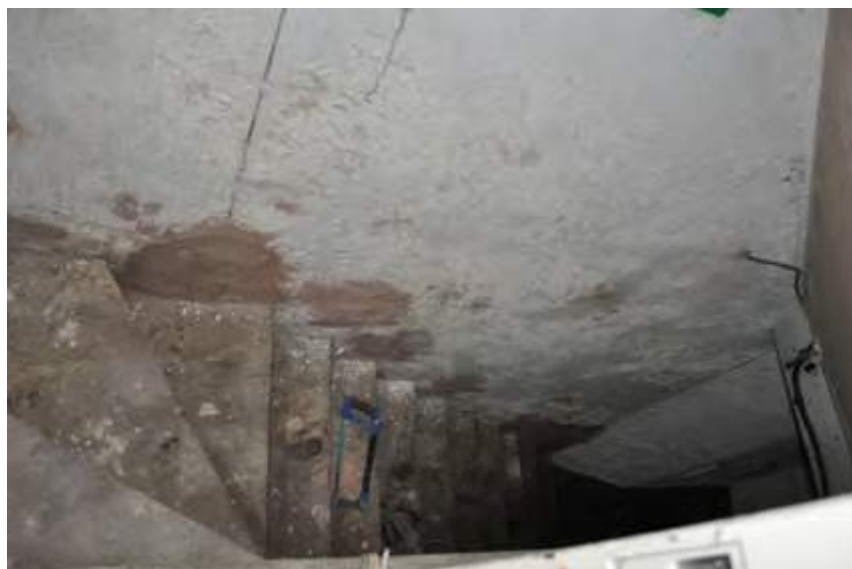
Plate 32: Stairs B1

The basement lies under the northwest part of the 1862 building and is entered from the original backstairs from room G5. The walls of the basement appear predominantly to be of brick.

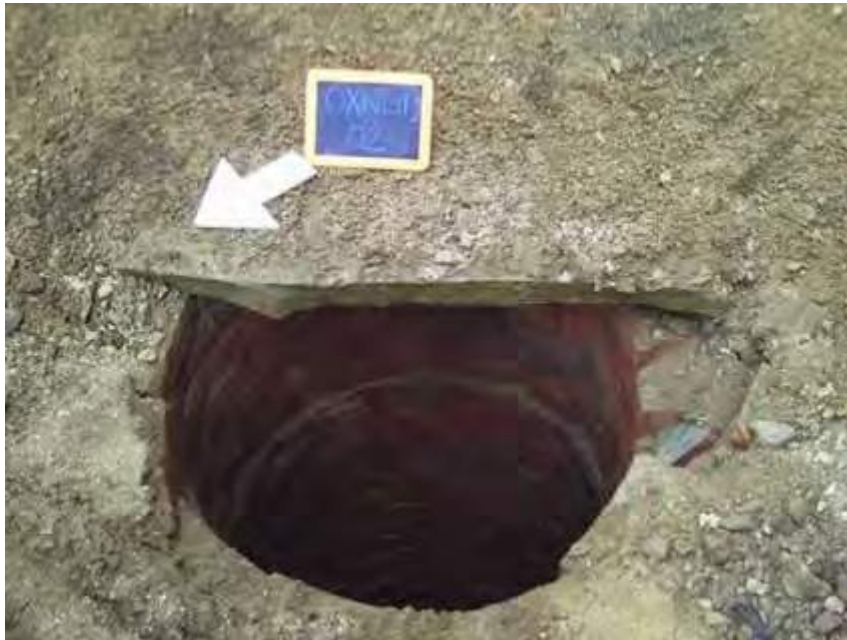
Plate 33: Well 02

Cut 04 was round in shape with a diameter of 0.85m. The sides were vertical and the base was not identified. The well 02 was constructed of bricks that measured 200mm x 120mm x 80mm, being bonded by a sandy mortar (plate 32). The internal dimension of the well was 0.7m. The exact depth of the well was unknown but it exceeded 3.5m.
