**AN ARCHAEOLOGICAL DESK-BASED ASSESSMENT
(INCLUDING BUILDING ASSESSMENT)**

SUMMERHILL VILLA, 333 BANBURY ROAD,

OXFORD

MAY 2013

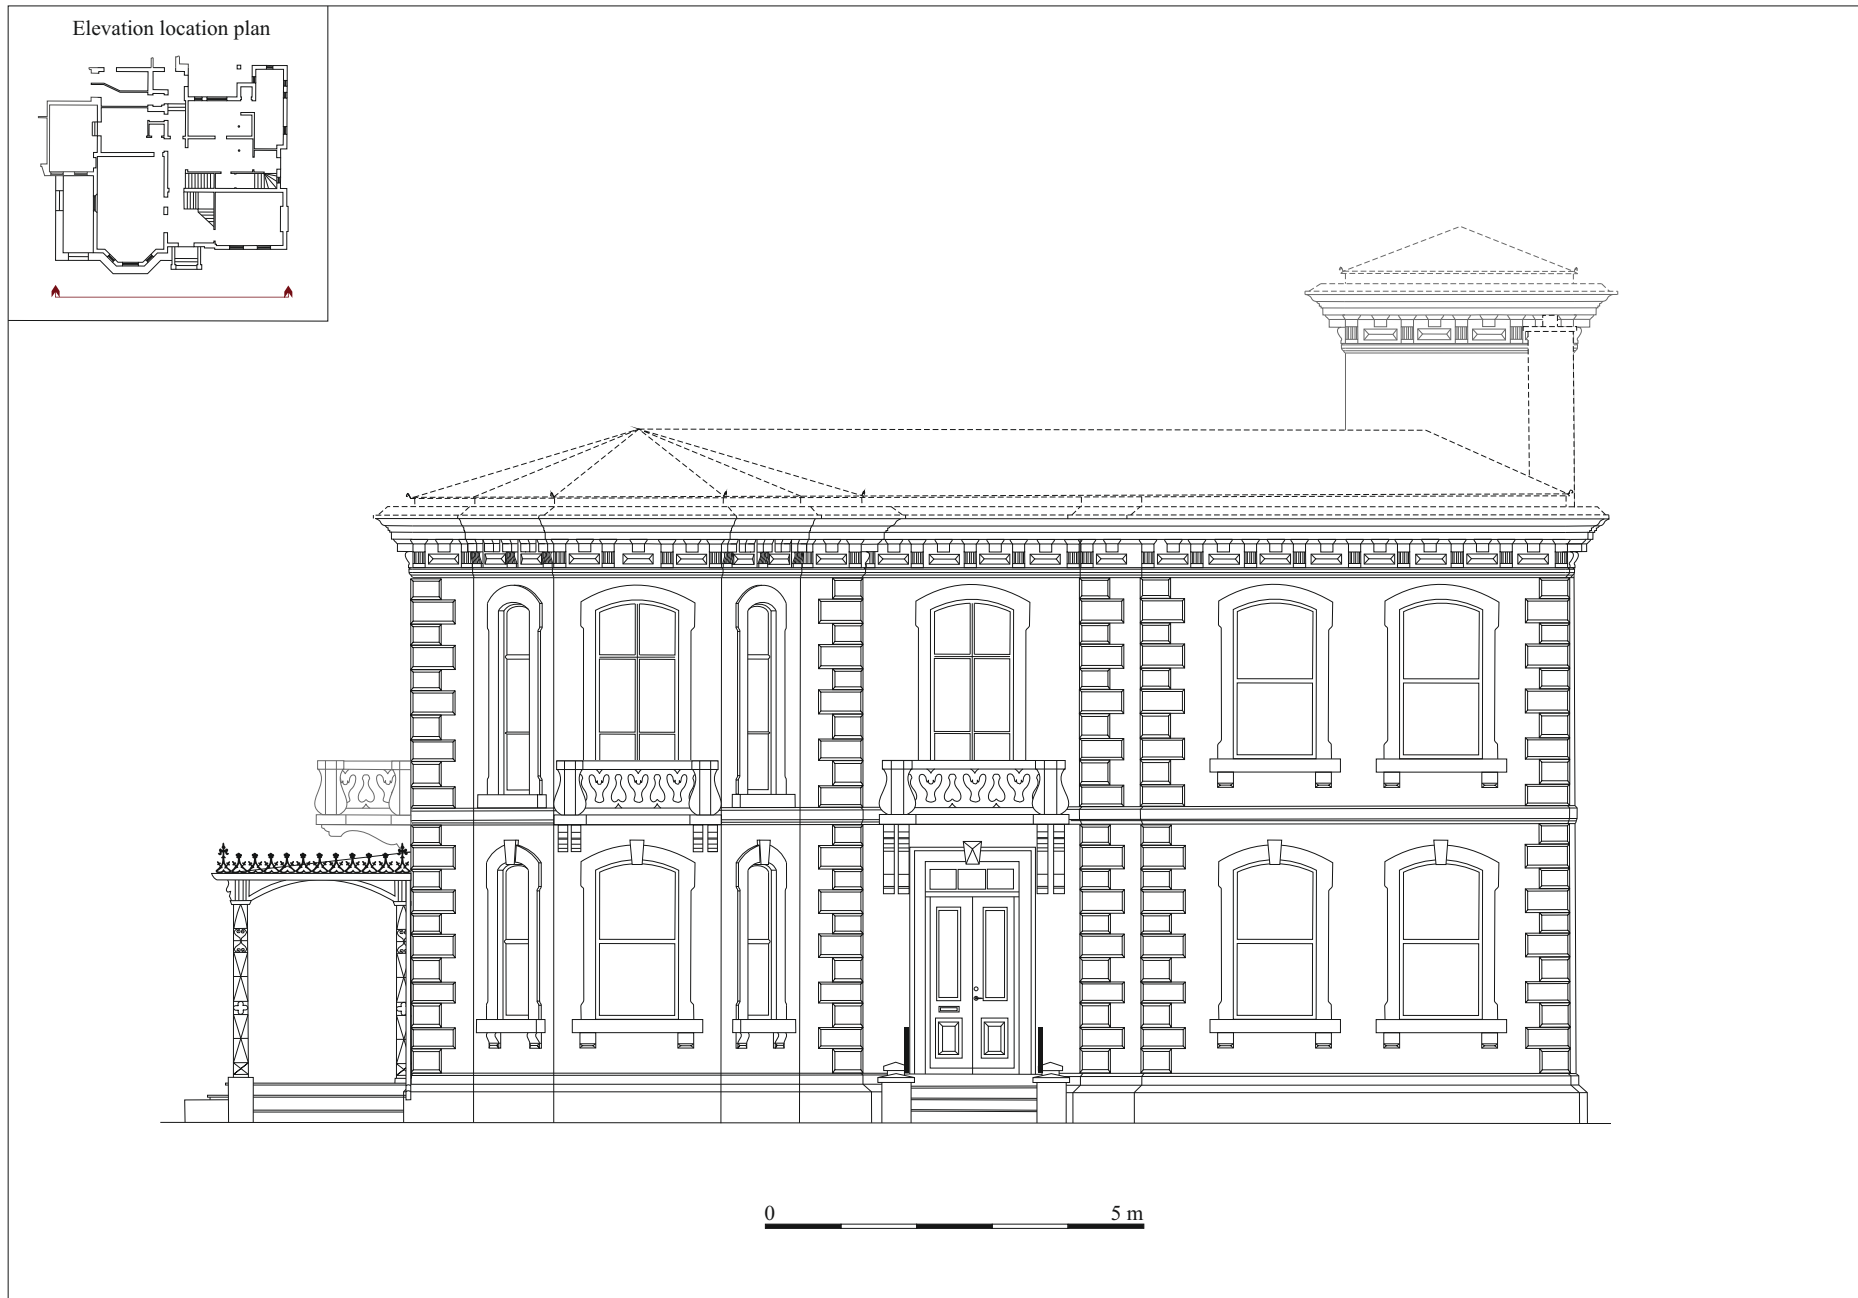
Figure 6. South elevation

The south façade consists of three vertical components running across two stories (Fig. 6, Plate 1). These are broken at the base by a plinth, and centrally by a raised band and above by an elaborate cornice design. Slightly off centre and to the west are steps leading up to a large door with panel and glass design, painted black. The arch is square headed with a keystone and moulded surround. Above the door is an ornate balcony with S shaped scroll designs and brace supports. On the first floor is a segmental arched door with patio window of six large glass panels. The door, porch/balcony, is set back between two protruding but slight wings.

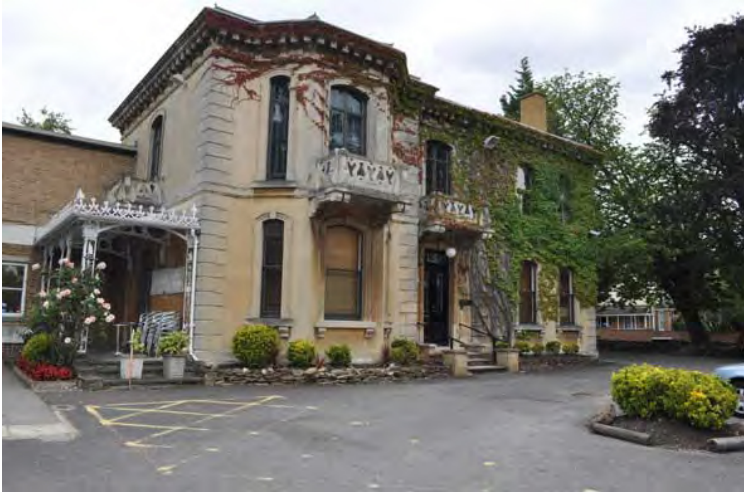
Plate 1. South elevation

The west façade is now partially obscured by the modern extension, and only the south side of this elevation is now wholly visible (Plate 1). This contains a continuation of the central band and elaborate cornice. The plinth is here replaced by a veranda or covered walkway patio. The veranda roof is supported on an elaborate cast wrought iron frame. Access onto the veranda is obtained through a segmental headed door with moulded surround. Above this is a window or door with a segmental arch and moulding with access onto a stone balcony, similar to the two on the front of the house. The veranda and vinery were once more extensive being lost in the 1960s.

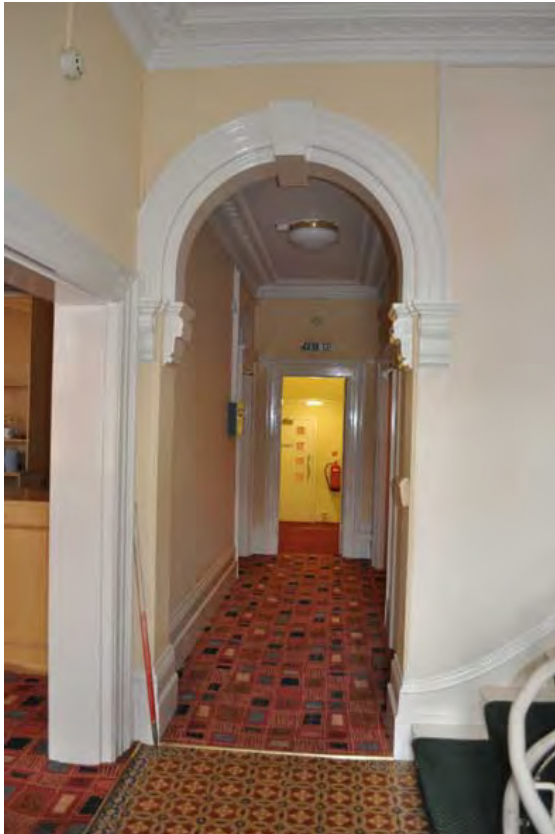
Plate 7. Details from hall

The main entrance to the ground floor would have been through the hall. This is a rather elaborate showy affair, which has seen some alterations in the past. The main door still retains moulded features (Plate 7). There is a timber staircase with cast iron balustrades on the right hand side as one enters the hall through the front door. The underside of the stairs contains moulded plaster. This sweeps round to a main ceiling, which is elaborately moulded, with a border butting to the wall and a large oval feature around a suspended light fitting (Plate 7). The decoration contains scroll motifs. Straight ahead there is a round headed opening with mouldings of grandeur emulating a keystone and jambs (Plates 8-9). In the east wall below the staircase is a door with original moulded surround, but new fire-door. On the west wall there are two large openings, both of which are either new or widened, but have in effect been carried out in a sympathetic manner. There is a patterned tiled floor, the skirting is probably original.

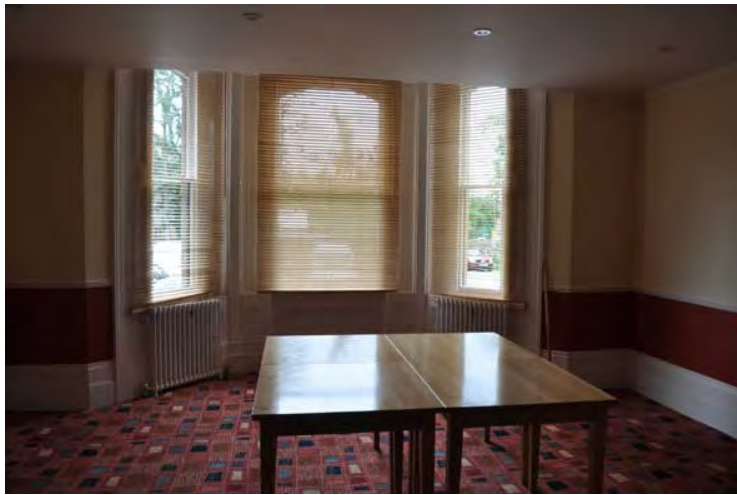
Plate 11. Details ground floor southwest room

The new openings to the west from the hall lead into what is now the bar. This has the bay window on the south side with sash windows and moulded and panel surrounds. There is a door in the west wall which also has a moulded surround. A further moulded door of the period is found in the right-hand corner of the north wall. The ceiling here has been lowered, this is apparent as the moulding in the tall bay windows and west door continue up above the false ceiling (Plate 11). This is in line with a planning application.

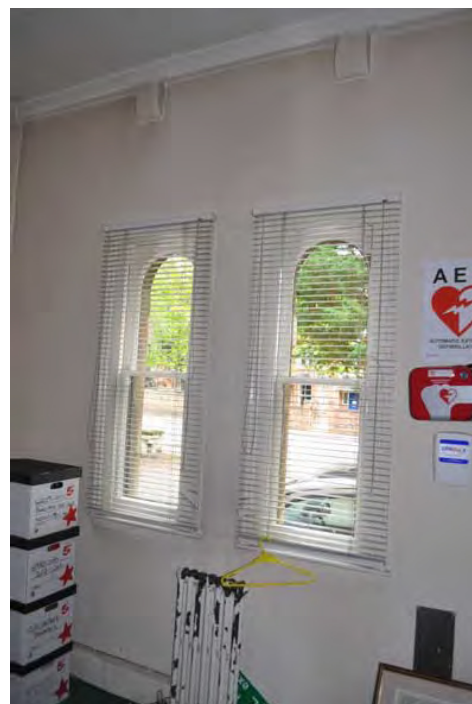
Plate 13. Details ground floor southeast room

The southeast room is a large rectangular room with moulded ceiling, and a dado rail (Plate 12). The fireplace has been removed, but not the chimneybreast. There are two sash-windows on the south side with panelled and moulded surrounds, original (Plate 13). The skirting is probably original although sympathetically treated where the fire has been removed.

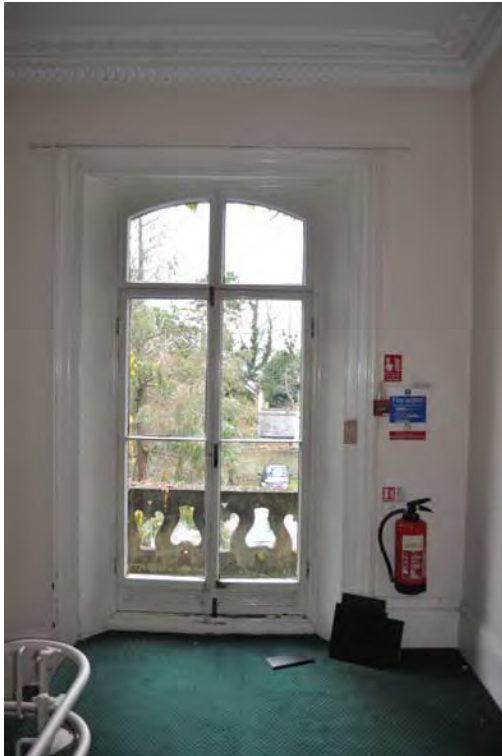
Plate 14. Details ground floor northeast room

The modern door on the north wall enters an office area with a large square headed window and a segmental arched window in the north wall. In the northeast corner of the room there is a wall extending obscuring two doors. The doors are both panelled. The one on the north leads into a cupboard. The one on the east leads into a long narrow office with. The west wall has a door and a rounded headed sash window. The north wall has a round headed sash window. The east wall has two rounded headed sash windows to the left (Plate 14) and a segmental arched window to the right.

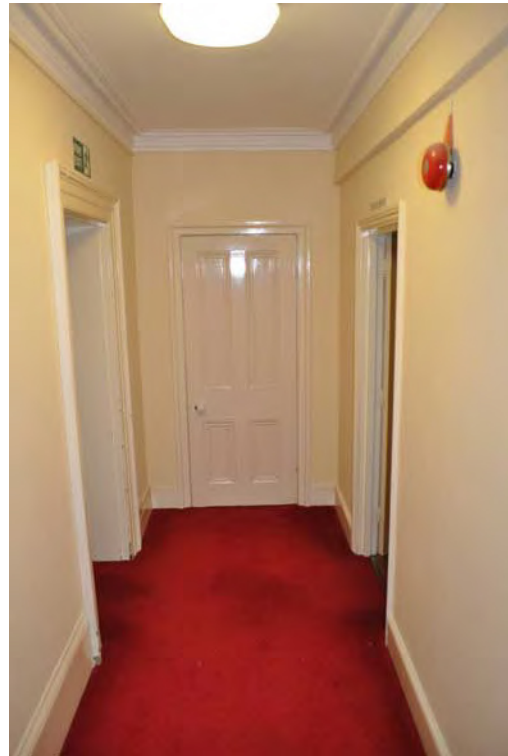
Plate 15. First floor landing details

The front hall staircase provides access to a landing with a segmental headed glass panelled door on the south side, with moulded surround (Plate 15). There is an original panelled door in the north wall with square head and moulded surround. The ceiling also contains decorative moulded features around its edge. There is no access from this hall to the southeast or southwest rooms, although a blocked door leads to the temple room.

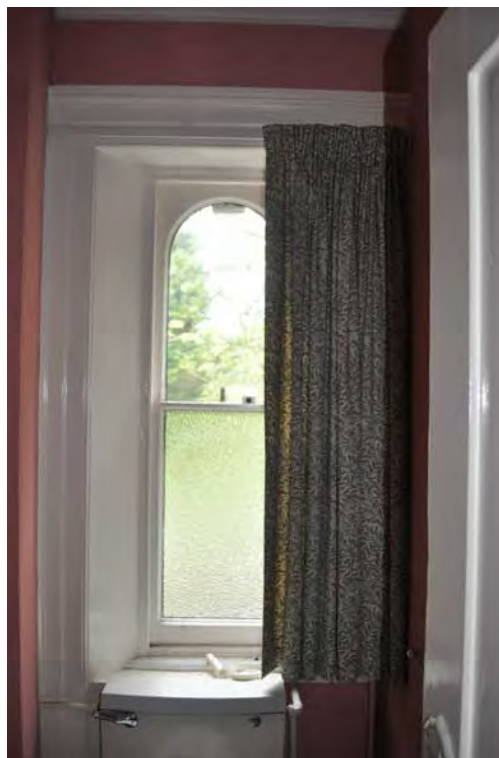
Plate 19. Details above back stairwell

The double door is a Masonic insertion to separate the caretaker's room from the boardroom. This opens up into a long passage at the head of the backstairs. Above the backstairs in the west wall is a round-headed recess (Plate 19). Midway along the passage is a round-headed arch. At the north end of the passage, the ceiling is raised to provide access to the tower, through a panelled door. There are two doors in the east wall on the first floor; these enter a toilet, which have a continuation of a heavily moulded ceiling, and round headed window (Plate 20). The northern door enters a small passageway, with angled wall at end. The door on the south of this wall enters a shower-room, with a round-headed sash-window in the east wall. The partition here is modern. The door on the north enters a room through a panelled door with moulded surround. Plans indicate that the location of the door may have been moved and that if so the door may have been reused. In the east wall there are two round-headed sash-windows. In the north wall there is a fireplace and chimneybreast. The fire surround is of stone. The staircase originally giving access has been removed.
