JOHN MOORE HERITAGE SERVICES

BUILDING ASSESSMENT

96 WALTON STREET,

OXFORD, OXFORDSHIRE

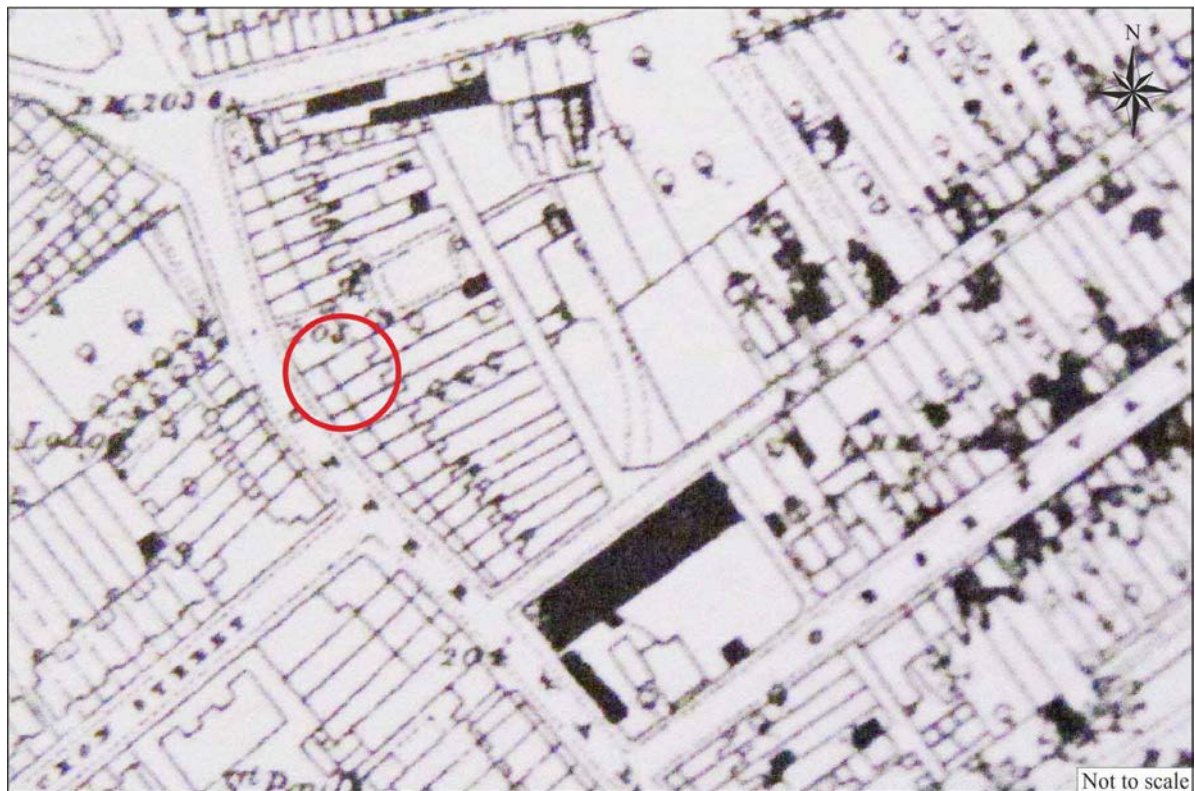
Figure 2: 1881 First Edition Ordnance Survey map

As part of the investigation into the historical development of the building and the area a series of historical maps were examined. The maps examined included maps which predated the Ordnance Survey maps; however, the maps did not depict any activity with the proposal site. The earliest map which depicted activity within the proposal site was the First Edition Ordnance Survey map from 1881 (Oxon 33.15), which depicted the building as the end terrace within a built-up area (Fig. 2). The Third Edition Ordnance Survey map from 1921 (Oxon 33.15) and the Fourth Edition Ordnance Survey map from 1939 (Oxon 33.15) depict the same as the First Edition map (Fig. 3 and Fig. 4).

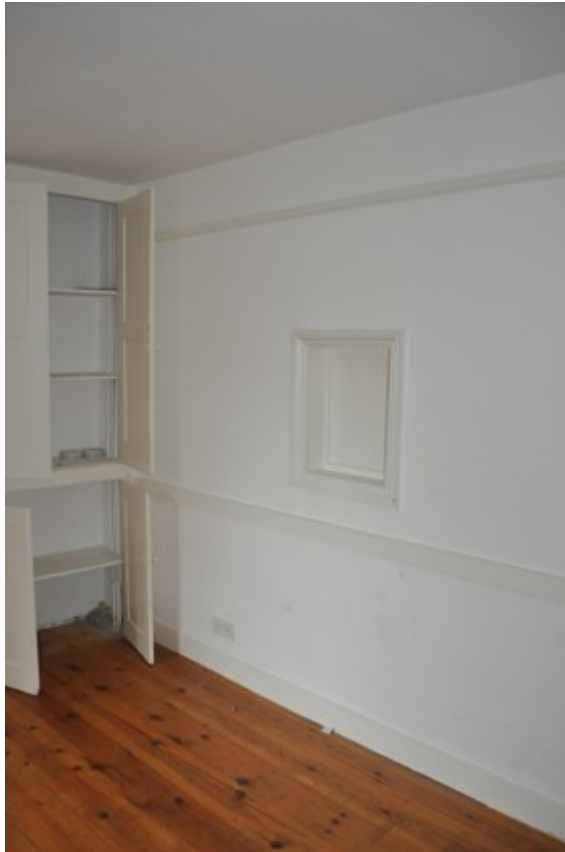
Plate 6: Hatch in southwest wall

At the base of the stairs in room G1 there is an original panel doorway which leads into the dining room (G3); a roughly square room. In the southeast wall there is a chimneybreast with a blocked up fireplace. This is flanked by two alcoves of which one has a built in cupboard, probably of the period. In this room parts of the picture rail and dado rail survive (Plate 6). Also the northwest wall is covered with panelling up to the picture rail which is original and associated with the stairwell. There is a window in the northeast wall (Plate 7).

Alterations to room G3, will see the removal of the rear wall, creating an opening (as stated in previous paragraph, Plate 7) and also the insertion of a new stud wall and downstairs toilet facilities. In this room the built-in cupboard and fireplace are to be retained (Plate 6).

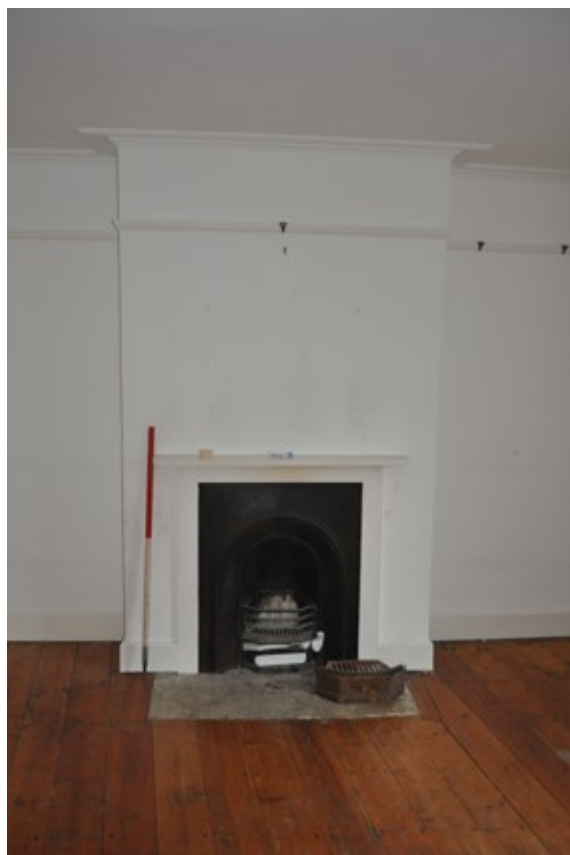
Plate 8: Fireplace in living room (G4)

At the front of the property is the living room (G4) entered through an original panel door. The southeast wall contains an original fireplace with a plain lintel, flanked by alcoves (Plate 8). There is a picture rail running along each of the walls, as with G3 and on the northeast wall is the hatch, which was also visible in G3. There is a sash window in the southwest wall with a pelmet set over the top. The northwest wall has been covered by shelving. In contrast to G3, there is coving around the ceiling.

In room G4 the built in fireplace is to be retained (Plate 8). Dry lining will be carried out on the existing external wall.

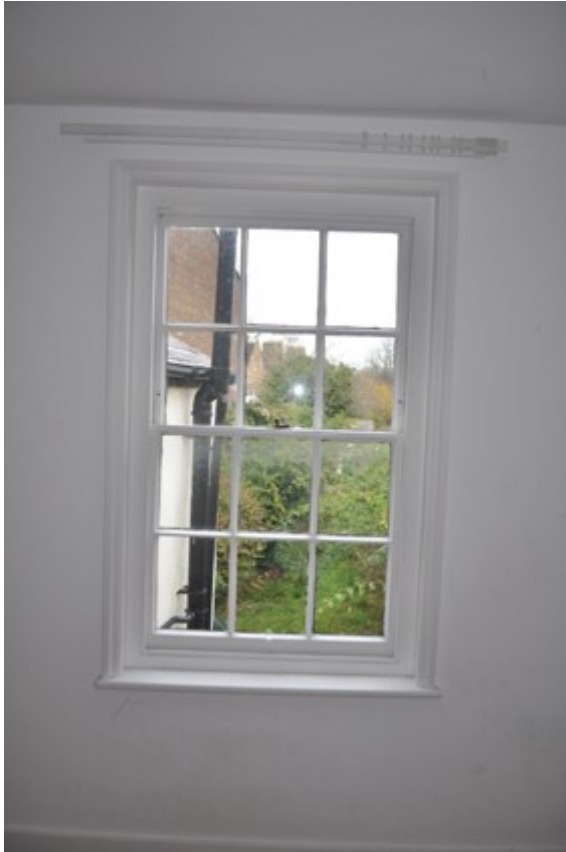
Plate 9: Sash window in bedroom 1 (F3)

The door on the southeast side of the landing enters room F3. The room is L-shaped with a single sash window in the northeast wall (Plate 9). Within the southeast wall there is a

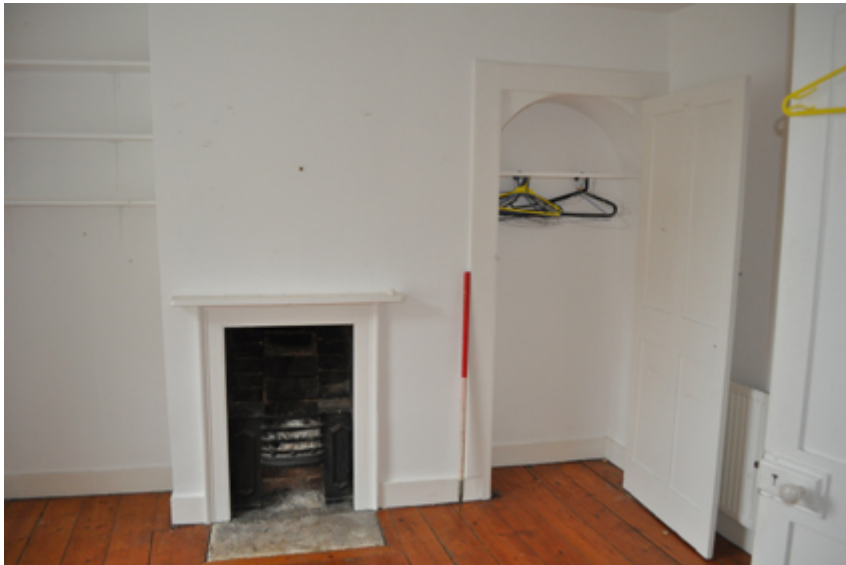
Plate 10: Alcove and fireplace in bedroom 1 (F3)

chimneybreast with fireplace flanked by alcoves (Plate 10). On the southwest side of the fireplace the alcove is arched, to support the chimney arrangement, and has been used as a cupboard with a square headed door.

In room F3 the fireplace (Plate 10) and sash window (Plate 23) are to be retained, but the proportions of the room will be lost as the room is to be divided to create two bathrooms. A new aperture in the east wall has already been noted in the previous paragraph. A stud wall will be added between the two bathrooms.

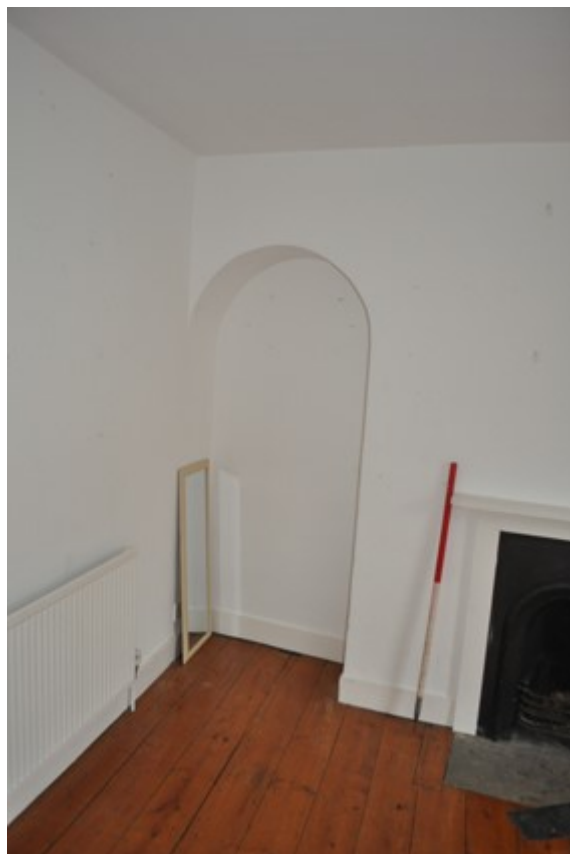
Plate 11: Alcove in bedroom 2 (F4)

Room F4 is accessed by the south door on the northwest wall of room F1. The door is an original panel feature. This room also has a chimneybreast with fireplace in the southeast wall, with a plain lintel and is flanked by alcoves (Plate 11). In contrast to room F3, there

is an arched alcove on the northeast side of the fireplace. The room also has a single sash window in the southwest wall with a six over six light arrangement.

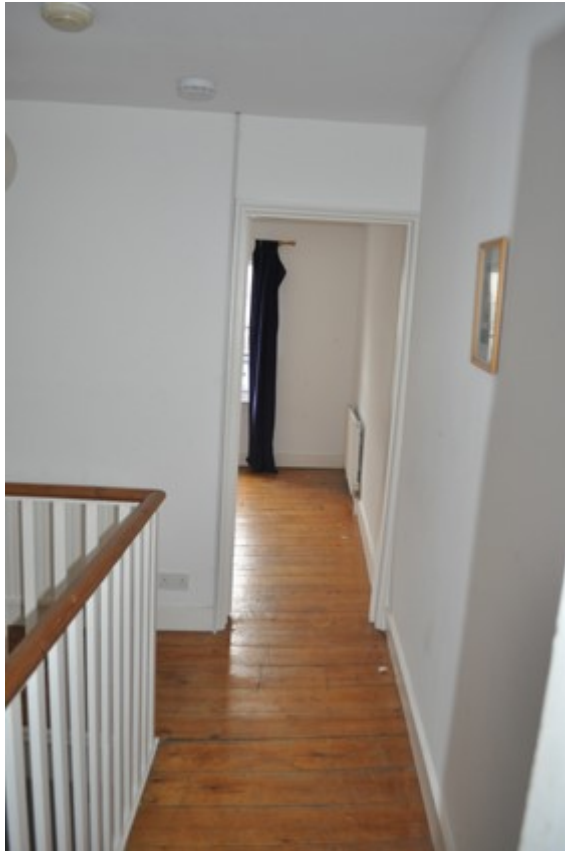
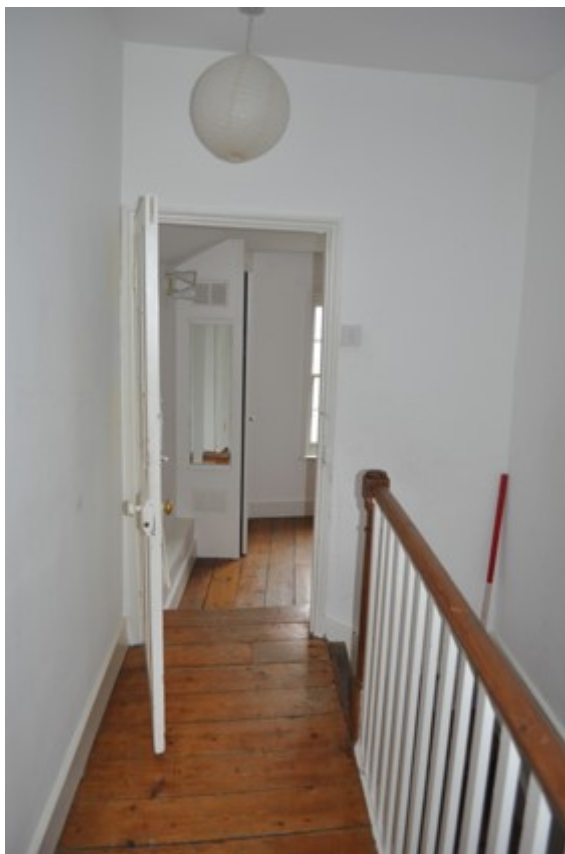
Plate 19: F1 view to the south

Plate 20: F1 view to the north

A further series of alterations will be made to the first floor. The landing will see alterations to its north to south arm (Plate 19 and 20), but here the original doors are to be retained and reused. The locations of two of the doors are moved to account for internal alterations.
