**AN ARCHAEOLOGICAL EVALUATION**

**96 WALTON STREET, OXFORD**

**(NGR SP 506 072)**

**DECEMBER 2015**

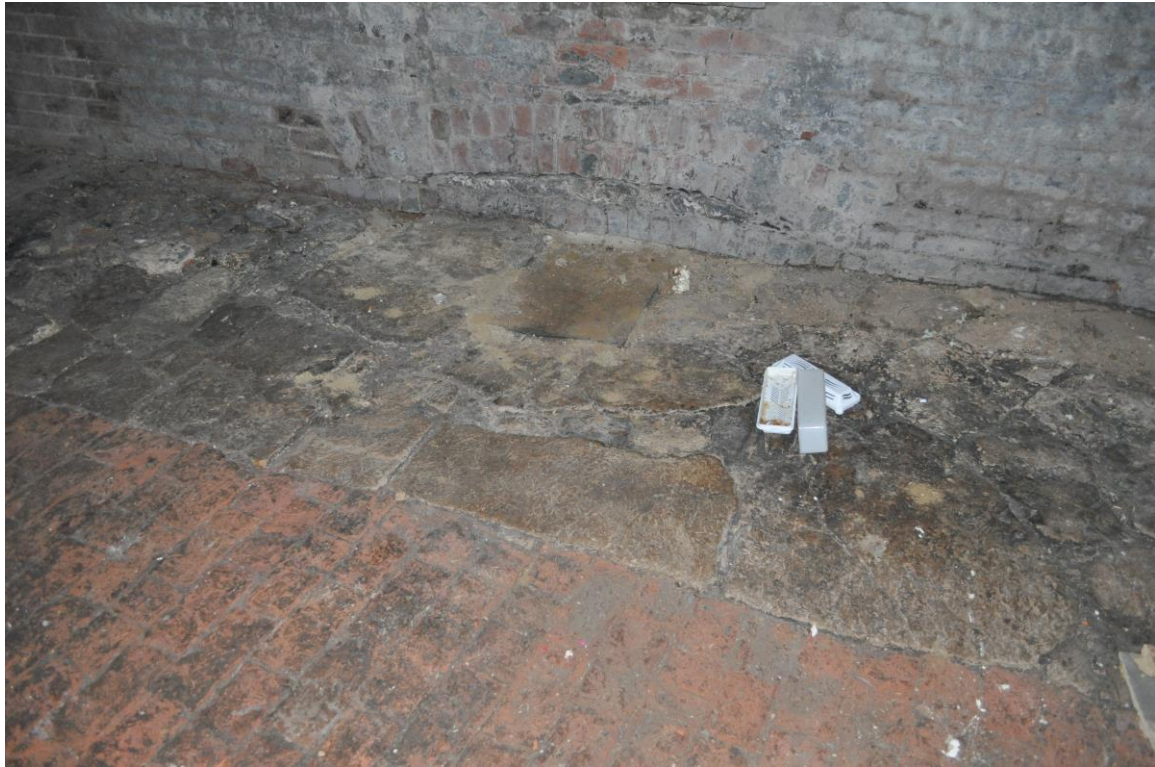
Plate 1. Trench 1 Pre-excitation, showing upper course of 1/05 brick arch

Brick relieving wall arch 1/05 was incorporated in the lower cellar wall at the front of the property (Plates. 1 & 2) (Fig. 2) It comprised a two course thick Victorian brick shallow arch that had a two course thick brick arch situated on-top of it. Relieving arch 1/05 was 2.5m long and was visible to a depth of 0.25m below the cellar floor.

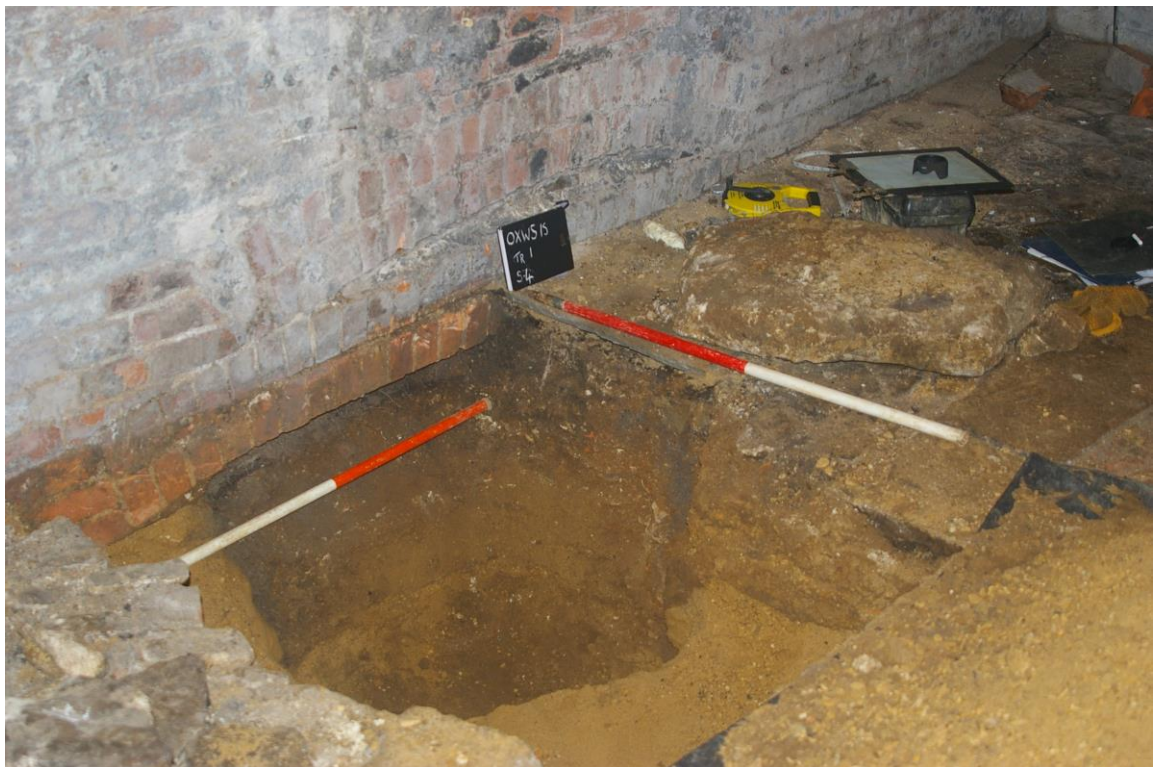
Plate 2. Trench 1, Pit 1/03 and brick arch 1/05

Layer (1/01) overlay a further layer of made ground consisting of redeposited natural gravels (1/02) that was 0.35m thick and contained no finds. The made ground layers overlay pit 1/03, where only the southeastern quadrant was exposed. Pit 1/03 (Fig. 2) was cut into the natural sand (1/06), it was 0.7m long and 0.7m wide and excavated down to a depth of 0.45m (not bottomed), sub-circular in shape with vertical sides. It was filled by a brown grey silty clay (1/04) that contained fragments of limestone and brick together with two fragments of 19<sup>th</sup> century pottery, roofing slate and an iron nail.

Pit 1/03 in trench 1 was possibly a backfilled borrow / quarry pit resulting from the extraction of the natural sand that the pit was cut into during the construction of the row of houses in the 19<sup>th</sup> century. The natural sand present on the site was fine grained and suitable for construction purposes. During the building works it may have been decided to extend the terrace to include no. 96. Thus brick relieving arch 1/05, was probably constructed to spread the weight of the house foundations across the backfilled pit at the front of the property.
