## **ARCHAEOLOGICAL EVALUATION**

# FORMER COOPER CALLAS SITE

# **15 PARADISE STREET, OXFORD**

AUGUST 2015

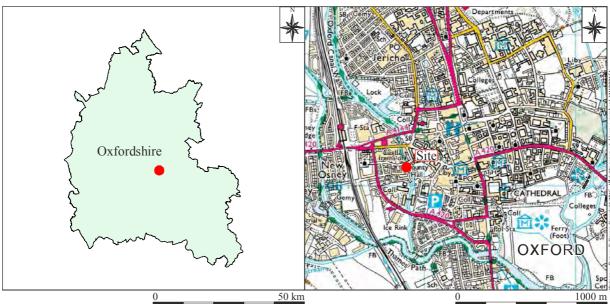
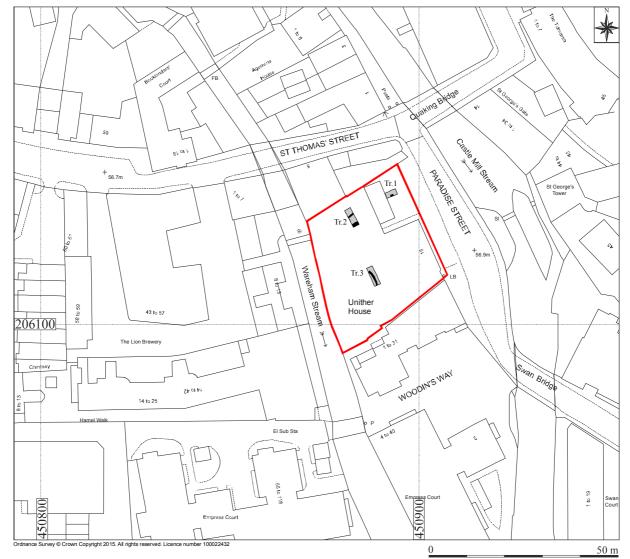
Figure 1: Site location

The site is located at 15 Paradise Street in Oxford (NGR SP 5089 0612) and lies within in a medieval suburb of Oxford, immediately to the west from Oxford Castle. Topographically the site is reasonably level, and lies between Wareham Stream and Castle Mill Stream at an approximate height of 57m OD. The bedrock geology is Oxford Clay Formation and West Walton Formation (undifferentiated), and superficial deposits of Northmoor Sand and Gravel Member – sand and gravel (BGS). The site is currently occupied by the former Cooper Callas warehouse, which is not in use.

Trench 1 was 3m long and 1.5m wide orientated east-northeast to west-southwest. It was located in front of the warehouse (Fig. 1 & 2: Tr. 1). The trench was excavated down to 1.08m (55.78m OD) below the concrete surface.

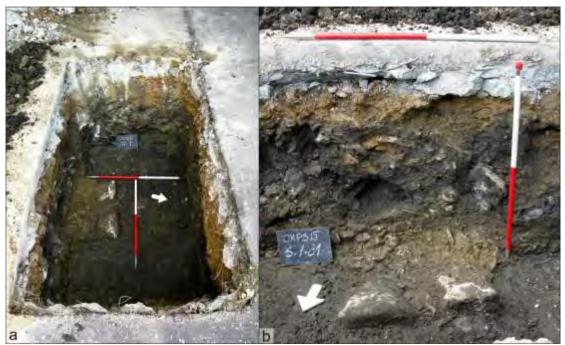
Plate 1: Trench 1, looking WSW, and section 1.1, looking SSE

The lowest deposit encountered within Trench 1 was mid bluish grey silty clay with small fragments of sandstone and mortar (1/07) (Fig. 2: Tr. 1, S. 1.1; Pl. 1a, b). The deposit was very wet, which indicates that the bottom of the trench was close to the water table. The pottery sherds dating from  $13^{\text{th}}$  to mid  $14^{\text{th}}$  century (see 5.1) and animal bone (5.4) were recovered from the deposit (1/07). It was interpreted as a late medieval occupation layer.

Cut into layer (1/07) was one course high sandstone wall foundation 1/05 measuring  $0.74 \times 0.55 \times 0.12$ m, presumably set within a not clearly visible construction cut 1/04 (Fig. 2: Tr. 1, S. 1.1; Pl. 1a, b). The wall foundation seems to represent the terminus of late medieval or early post-medieval wall.

The wall foundation were overlaid by demolition layer (1/06) containing mortar and small sub-angular sandstones (Fig. 2: S. 1.1; Pl. 1b). This layer seems to be directly related with the demolition of the wall.

Demolition layer (1/06) was truncated by 0.49m thick deposit of dark grey silty clay (1/03), which contended high percentage of demolition material (roughly worked sandstones and ceramic building material (CBM). The deposit presumably represents a late  $19^{\text{th}}$  / early 20<sup>th</sup> century make up / levelling layer (Fig. 2: S. 1.1; Pl. 1b).

The upper two deposits were related with 20th century access to the loading ramp. The deposit (1/02) represents the bedding for the concrete surface, and deposit (1/01) represents existing a reinforced concrete surface (Fig. 2: S. 1.1; Pl. 1a, b).

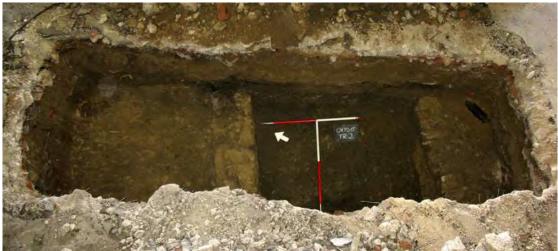
Plate 2: Trench 2, looking ENE

Trench 2 which was 5m long and 1.7m wide, orientated north-northwest to southsoutheast, was located within the north area inside of the warehouse (Fig. 1 & 2: Tr. 2; Pl. 2). The trench was in general excavated down to 1.20m (56.24m OD) below the present concrete floor.

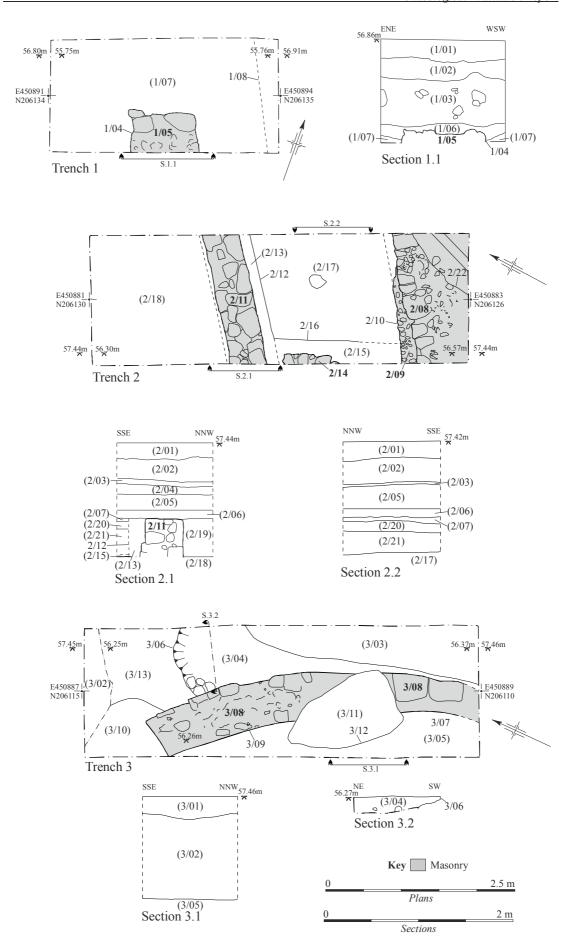
Figure 2: Trenches 1, 2 and 3 - plans and sections

Deposit (1/03) was cut by a 20<sup>th</sup> century service cut 1/08 located at the east-northeast end of the trench (Fig. 2: Tr. 1). Within the cut was set a ceramic pipe, and from the backfill (1/09) were recovered residual 13<sup>th</sup> century pottery sheds (5.1) and animal bones (5.4).

The lowest deposit reached was mid grey sandy silt (2/17) with occasional small and a single large sandstone (Fig. 2: Tr. 2, S. 2.2; Pl. 4). No find were obtained from this deposit; however based on the stratigraphic relationship it possibly represents a medieval occupation layer.

Deposit (2/17) was cut by linear cut 2/16 (Fig. 2: Tr. 2; Pl. 3). Five sandstone pieces 2/14 aligned north-northwest to south-southeast were set within cut 2/16. The backfill of the cut was dark grey clayey silt (2/15), with a single pottery sherd dating from  $13^{\text{th}} - 14^{\text{th}}$  century.

Possible wall remains 2/14 was overlaid by two successive deposits. Lower deposit (2/21), dark grey sandy silt with occasional fragments of sandstone was interpreted as possibly late medieval or early post-medieval occupation layer. Upper deposit (2/20) was a light orange brown fine sandy gravel and perhaps represents a post-medieval levelling layer (Fig. 2: S. 2.1, S. 2.2; Pl. 4).

Construction cut 2/12 was 1.7m long, 0.62m wide and 0.4m deep. It was aligned northeast to southwest and located approximately in the middle of the Trench 2 (Fig. 2: Tr. 2, S. 2.1; Pl. 6a, b). Set within the cut was wall foundation 2/11, built of roughly worked sandstone ( $260 \times 390 \times 80$ mm) bounded with light yellowish brown sandy lime mortar. From the mortar were recovered two fragments of clay tobacco pipes (5.2).

The lowest deposit was (3/13) a firm light yellowish brown sandy clay (Fig. 2: Tr. 3) which seem to be contemporary with a deposit of dark brown sandy silt (3/10). Both deposits presumably had anthropogenic origins; however the exact date of those deposit was uncertain.

Probably cut into deposits (3/10) and (3/13) was the curved wall foundation 3/08 built of roughly worked sub-angular sandstones (c.  $300 \times 300 \times 160$ mm) and bonded with sandy lime mortar. The wall foundation was set within cut 3/09=3/07(Fig. 2: Tr. 3; Pl. 7). The wall foundation 3/08 may possibly represent internal circular or semi-circular structure within the brewery dated to  $19^{\text{th}}$  century.

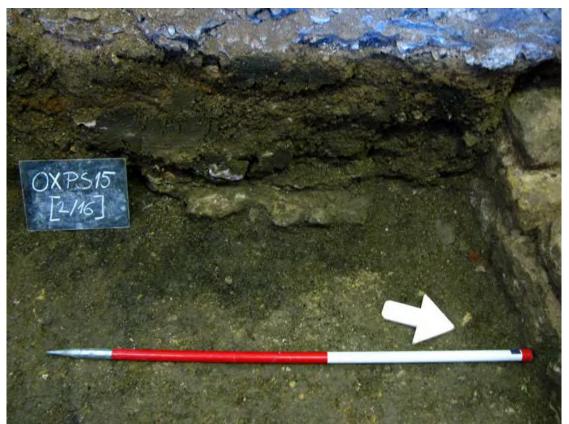
Plate 3: Cut 2/16 and possible wall remains 2/14, looking WSW

The dating evidence suggests that cut feature 2/16 may possibly represent the remains of a medieval wall.

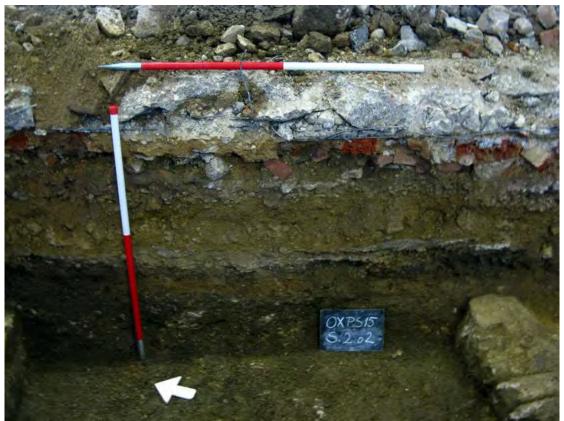
Plate 4: Representative Section 2.2, looking ENE

The wall foundation 2/11 was overlaid by 0.09m thick concrete surface (2/06) which covered the entire area of the trench (Fig. 2: S. 2.1, S. 2.2; Pl. 4). The surface presumably represents a late  $19^{\text{th}}$  / early  $20^{\text{th}}$  century yard surface related to adjacent brewery. It was disturbed by  $20^{\text{th}}$  century service 2/22 located at west corner of the trench and overlaid by five successive layers.

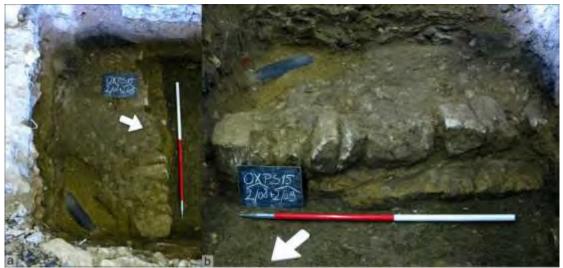
Plate 5: Wall foundation 2/08-2/09, scale 1m

The wall foundation 2/08-2/09 was overlaid by 0.07m thick firm layer of dark grey clayey silt and gravel (2/07), interpreted as a surface related to a yard or internal floor within an uncertain structure, presumable of late post-medieval in date (Fig. 2: S. 2.2; Pl. 4). Surface (2/07) was cut by wall construction cut 2/12.

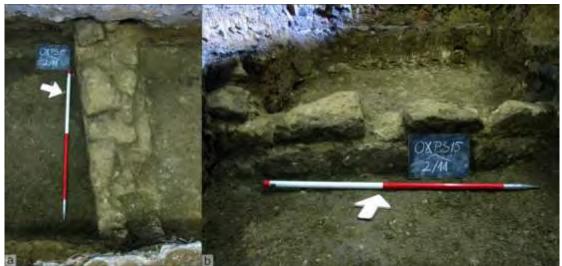
Plate 6: Wall foundation 2/11, scale 1m

At the north-northwest side of the wall foundation 2/11 were encountered two successive deposits. Due to the fact that construction cut 2/12 was not clearly visible in plan or section (Fig. 2: Tr. 2, S. 2.1; Pl. 6a, b) the stratigraphic relationships were unclear. However there is possibility the lower deposit (2/18) predated the wall foundation and upper deposit (2/19) may possible represent raised ground within the structure and could be contemporary with construction of wall.

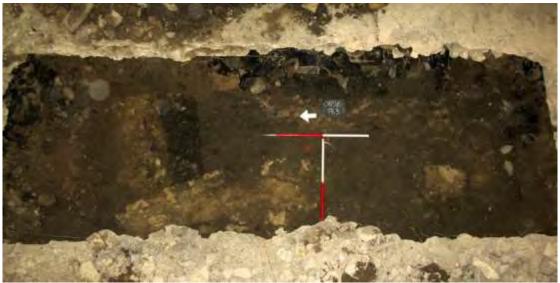
Plate 7: Trench 3, looking ENE

Trench 3 was 5.2m long and 1.7m wide, and aligned north-northwest to southsoutheast. It was placed across the south area inside of existing warehouse (Fig. 1 & 2: Tr. 3; Pl. 7). Due to the fact that trench was mechanically excavated down to the safe working depth 1.2m (56.25m OD), only limited excavation of features within the trench was undertaken.

In the area northeast of wall foundation 3/08 was a deposit of very dark brownish grey clayey silt (3/04) with occasional small sub-angular stones (Fig. 2: Tr. 3, S. 3.2; Pl. 7). This possibly represents a fill of a large sub-oval pit 3/06 or deposit of material built up against the wall foundation. From the deposit (3/04) were recovered fragments of clay tobacco pipes (5.2), CBM (5.3), animal bones (5.4) and glass (5.6), 19<sup>th</sup> century in date.

In the area southwest of the wall foundation 3/08 was a deposit of firm dark brown silty sand (3/05) (Fig. 2: Tr. 3; Pl. 7). Originally this deposit was interpreted as a possible fill of an irregular feature 3/07; however it more likely represents made up ground of the inner side of the wall foundation. From the surface of the deposit were collected fragments of clay tobacco pipes (5.2), CBM (5.3) and one iron nail (5.5), presumably 19<sup>th</sup> century in date.

The wall foundation 3/08 and deposit (3/05) were truncated by very compact dark brown gravely sandy silt (3/11) (Fig. 2: Tr. 3; Pl. 7). Although, cut number 3/12 was assigned to this deposit, it possibly represents a surface rather than fill of a cut feature. Whether this surface was related to some changes within the internal layout of the brewery or was related to demolition activities was unclear. From the surface (3/11) was obtained a fragment of glass (5.6). A relatively large area of the trench was covered by modern concrete surface (3/03) which was related to the foundation of a standing internal pillar of the warehouse (Fig. 2: Tr. 3; Pl. 7). The base of pillar was visible in the section of the trench, measuring 1.8m in length/wide and 0.6m in high (Pl. 8b).

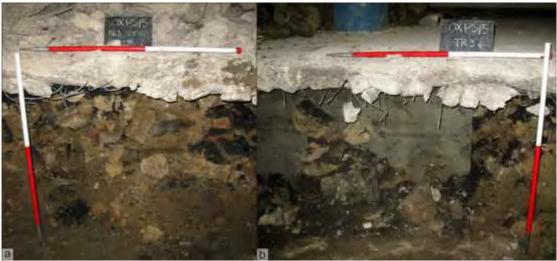
Plate 8: Trench 3, representative sections, scale 1m

Deposit (3/02) was 0.85m thick mid to dark brown sandy silt with high percentage of demolition rubble, representing  $20^{\text{th}}$  century made up ground and was sealed by concrete floor (3/01) (Fig. 2: S. 3.1; Pl. 8a).
