JOHN MOORE HERITAGE SERVICES

**ARCHAEOLOGICAL WATCHING BRIEF**  
**ON**  
**THE WALLED GARDEN AT GREAT TEW ESTATE,**  
**GREAT TEW, OXFORDSHIRE**

**NGR SP 3970 2906**

**OCTOBER 2015**

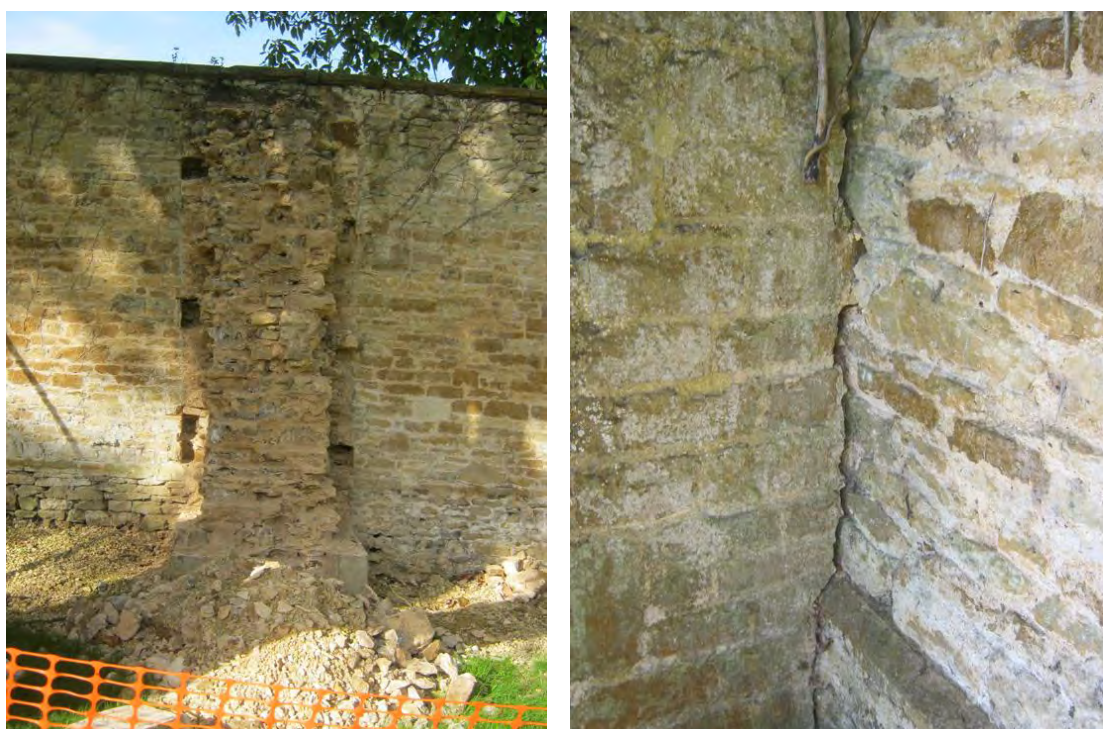
Plates 1 & 2: Detail of buttresses on eastern wall

The wall runs the entirety of all three gardens. Towards the northern end, from roughly half-way along the wall are five unevenly spaced buttresses. These buttresses are later additions; irregular holes have been excavated into the wall facing to allow a form of bonding to take place; however, the majority of the buttress is butted against the wall. These buttresses are ashlar with an uneven coursed rubble core.

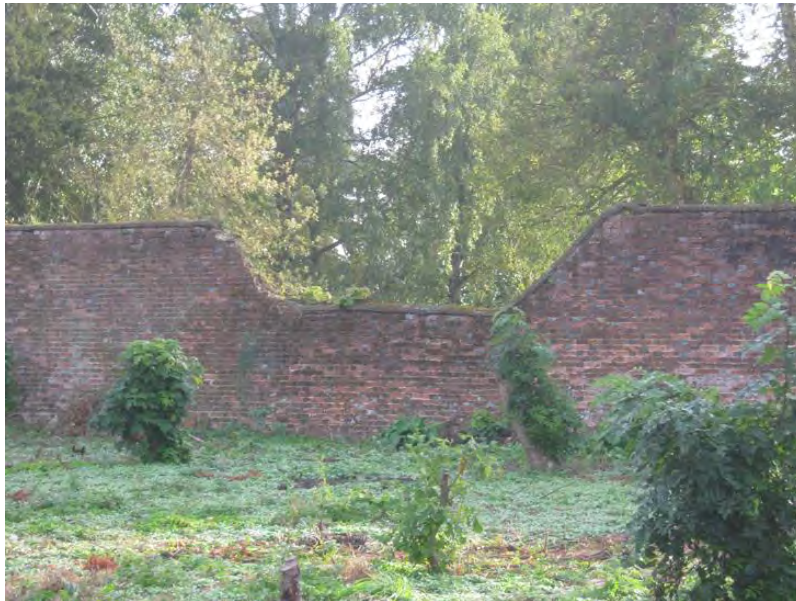
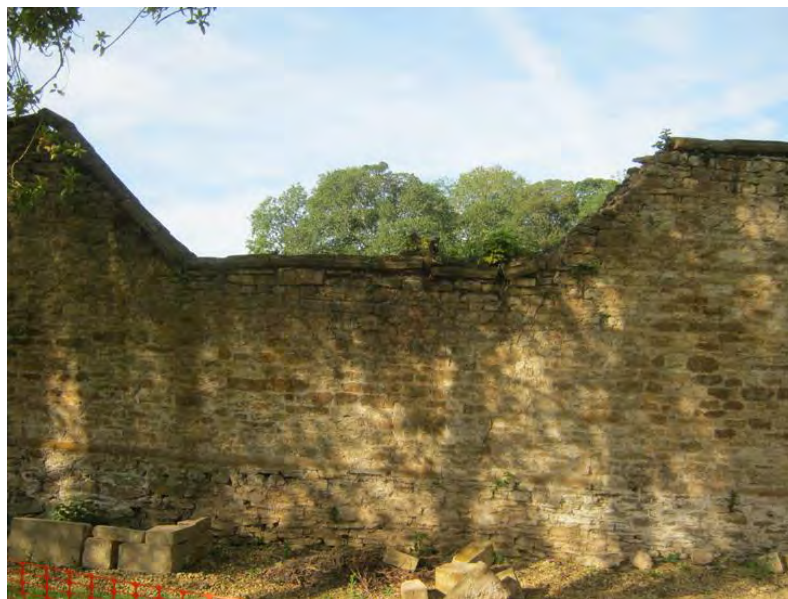
Towards the centre of the wall section within the northern garden is a portion that has been lowered by roughly 1m. The sides of this lowered section are at roughly 45°. The upper 0.5m of the wall in the northern garden appears to be repaired or rebuilt; this work appears under the lowered section possibly indicating the lowering took place during this repair. The section has capstones the same as the rest of the wall and it is

possible that the entire wall was recapped at the same time as the lowered section would require more stones than a straight run. It is also possible this feature was an original aspect of the wall.

Plate 3: Clairvoyance viewed from inside the northern garden

Plate 4: Exterior view of clairvoyance

It is speculated this lowered feature is a “clairvoyance” to allow a better view of the church from the northern garden. If so, the best viewing spot is not from the centre of the garden or the northern garden entrance, but from the northwest corner where there was a glasshouse and the entrance to the back shed.

Modifications and repairs to the garden masonry structure have been carried out. These include the addition of five unevenly spaced ashlar block buttresses on the external side of the eastern wall. Towards the centre of the eastern wall section within the northern garden is a portion that has been lowered by roughly 1m. The sides of this lowered section are at roughly 45°. The upper 0.5m of the wall in the northern garden appears to be repaired or rebuilt; this work appears under the lowered section possibly indicating the lowering took place during this repair. The section has capstones the same as the rest of the wall and it is possible that the entire wall was recapped at the same time as the lowered section would require more stones than a straight run. It is also possible this feature was an original aspect of the wall. It is speculated this lowered feature is a “clairvoyance” to allow a better view of the church from the northern garden.

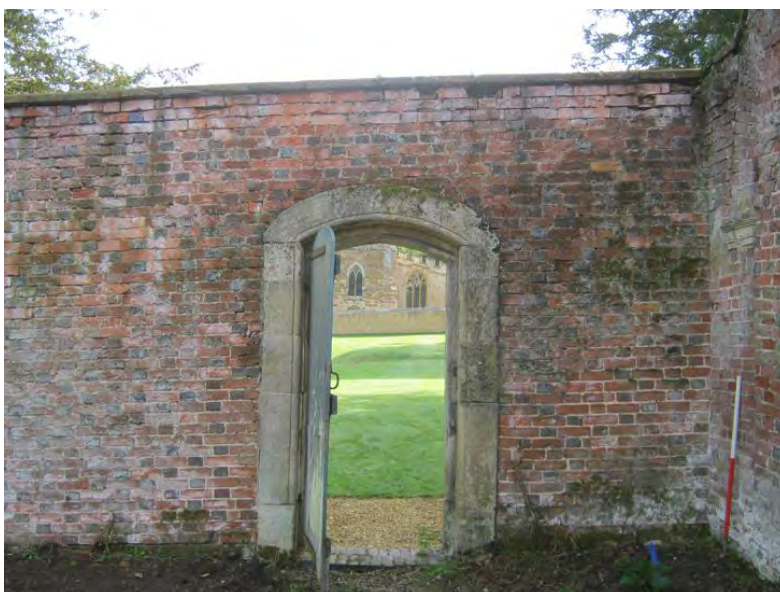
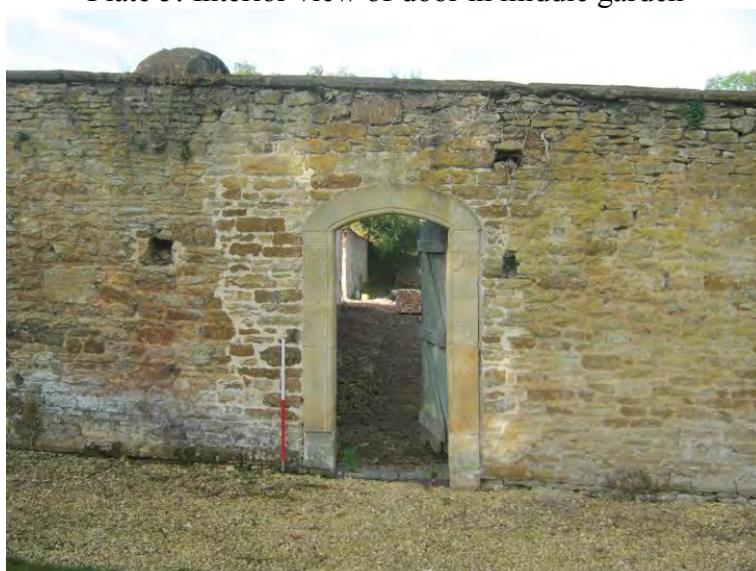
There is a single doorway in this wall that is located just south of the centre of the wall in the southeast corner of the middle garden. It has sandstone ashlar jambs with a moulded arched lintel.

Plate 5: Interior view of door in middle garden

Plate 6: Exterior view of doorway to middle garden

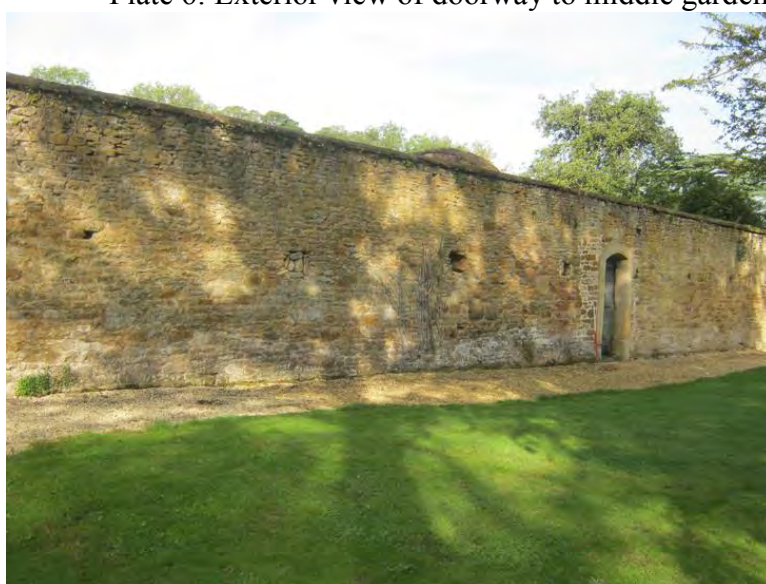
Plate 7: View along eastern wall showing series of small holes

Either side of this doorway, on the exterior wall face, are a series of small square holes that appear to be later in date than the wall itself. These features are approximately 1.5m above present ground level and are likely to be related to two structures recorded on the 1881 1:2,500 OS map.

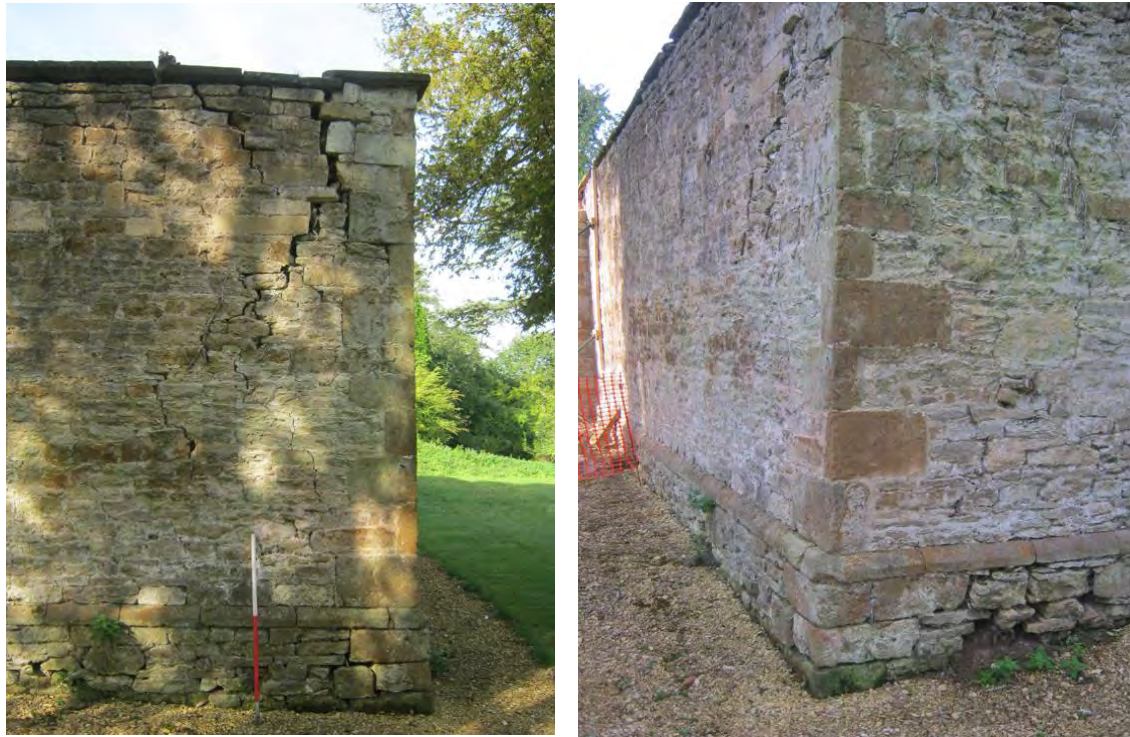
Plates 9 & 10: Corner of eastern and northern walls

line between the lower stonework and that which fills the arched space above the lintel.

The brick archway mimicked the arches seen on the internal walls (see below) and is likely to be contemporary. To the east of the entrance the wall appears to have been raised roughly 1m higher with stone butting against the lower portion of the arch. To the west the wall may have had further rebuilding work done to it, as the character of the stone was not the same as to the east.

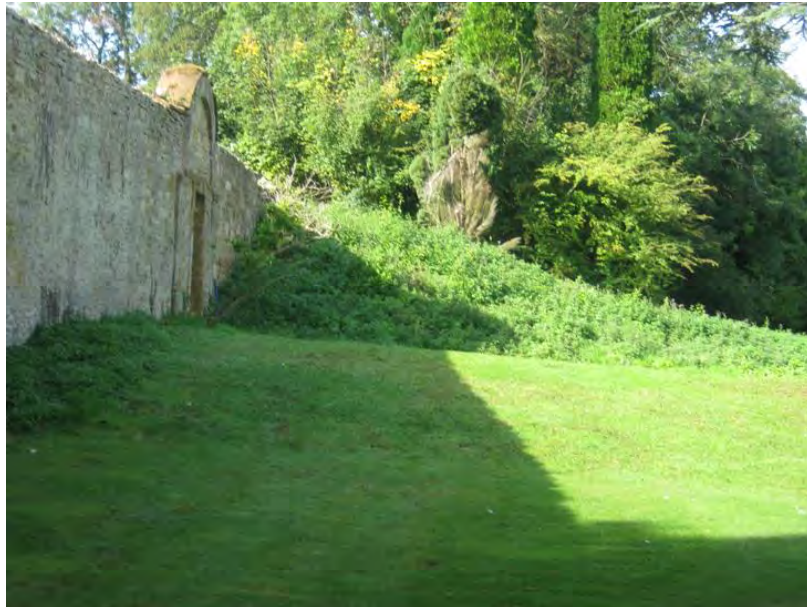
Plate 12: Mound to the west of the entrance

The majority of the wall to the west of the entrance was obscured by a large mound of earth at the time of the initial site visit (Plate 12). This mound also obscured the

external corner with the western wall. This mound is not marked on the 1881 OS map (Plate 8).

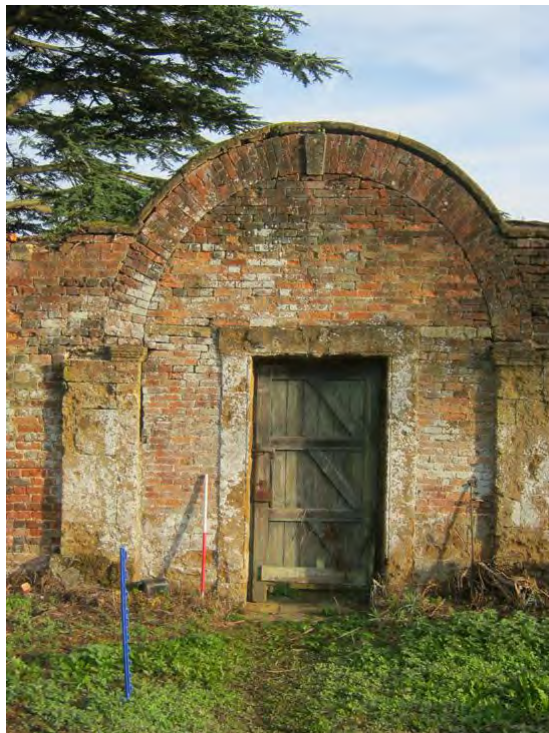
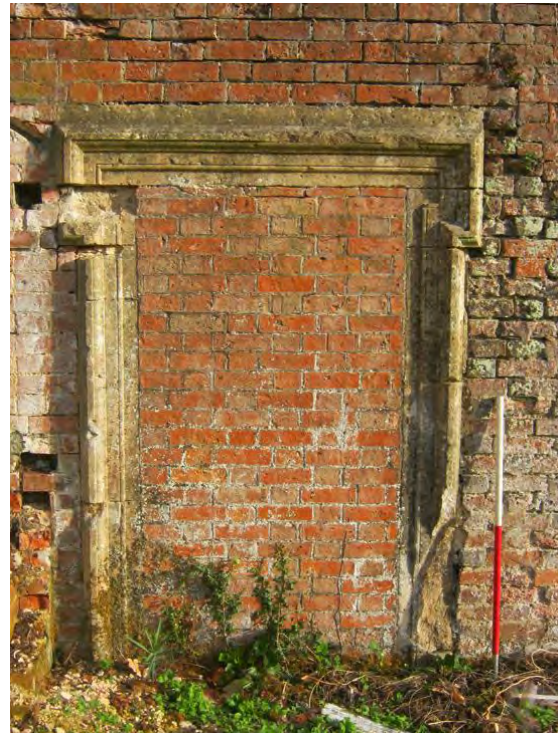
The interior of the wall was constructed of brick in the same manner as the eastern wall. To the west of the main entrance was a blocked door. The frame was moulded sandstone in a Tudor style and may represent a reused element of the earlier manor house (Plate 14).

Plate 13: Northern entrance (internal)

Plate 14: Blocked door

This doorway was blocked with brick and unfortunately was removed by site workers without monitoring. It is unknown if this was originally an access way or had been

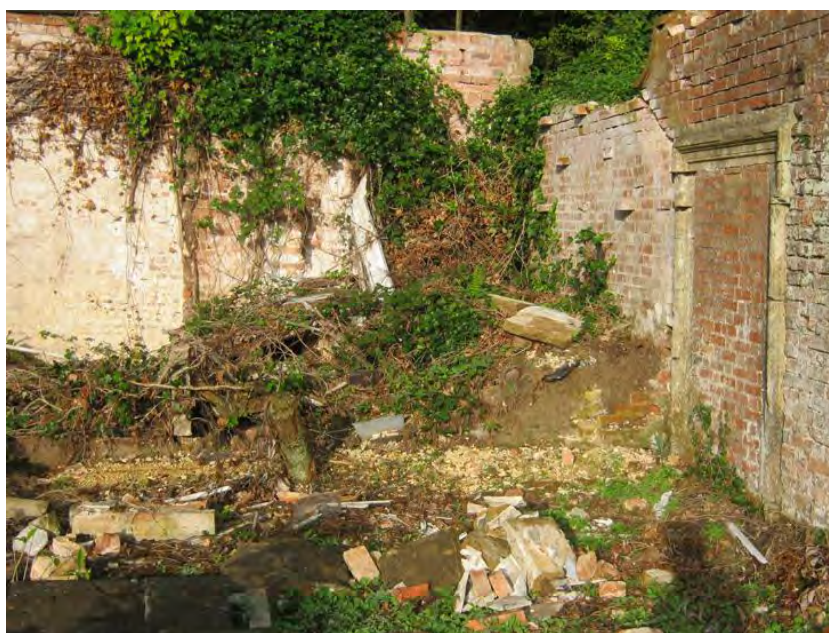
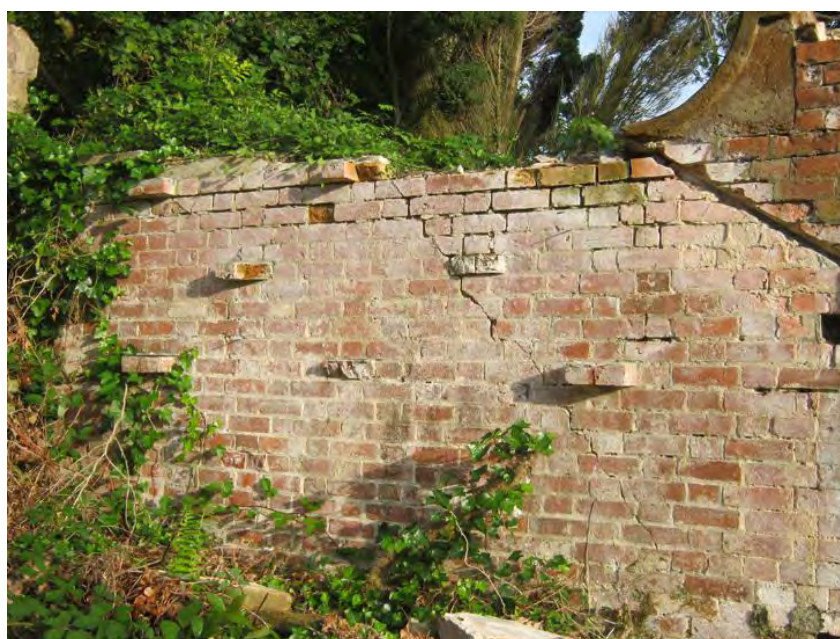
In the north western corner of the northern garden where the northern and western wall met was the remains of a glasshouse (Plate 15). The northern wall at this point may have had the brick lining rebuilt to accommodate this building. Internal to the glasshouse pairs of bricks had been set on end so they protruded from the wall surface. The roof of the glasshouse had also been accommodated by a groove cut into the north wall through the brick lining (Plate 16).

Plate 15: The Glasshouse

Plate 16: North wall inside Glasshouse (showing roof line)

The wall facing the garden of this glasshouse was originally 0.8m high, the rest of the structure would originally have been a wooden frame. The northern wall was reduced in height at the point (Plate 17). A moulded ironstone block formed a sweeping curve from the higher eastern section to the lower western one: a drop of c. 5 brick courses.

In the north western corner of the northern garden where the northern and western wall met was the remains of a glasshouse, the only one observed during the works. The apparent absence of others is one of the probable explanations for the new Kitchen Garden which incorporated them and heating structures. Another reason is the increase in size to approximately 1 hectare.

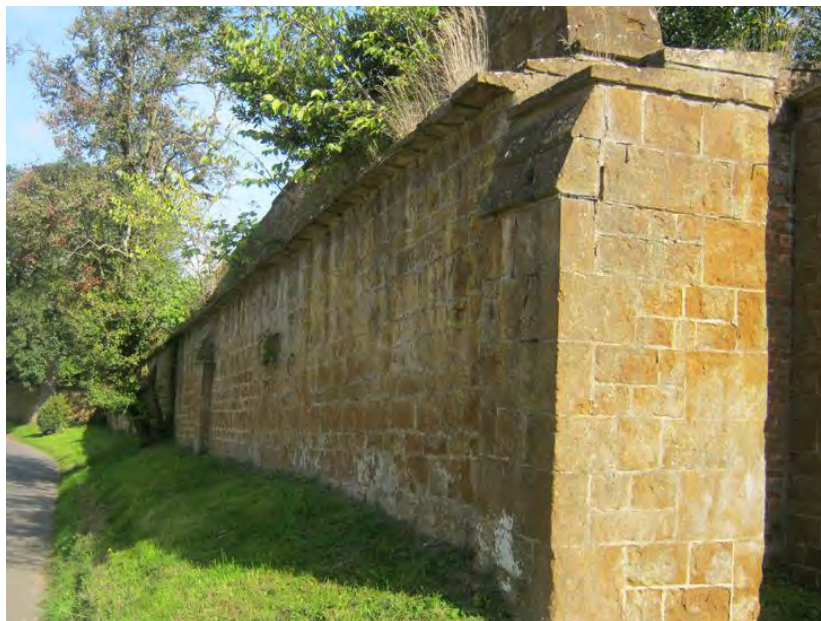
Plate 18: Exterior of western wall

Its external face is ashlar ironstone masonry. The western wall was designed to be seen from the road and the exterior is different to that of the other exterior walls (Plate 18), being of higher quality.

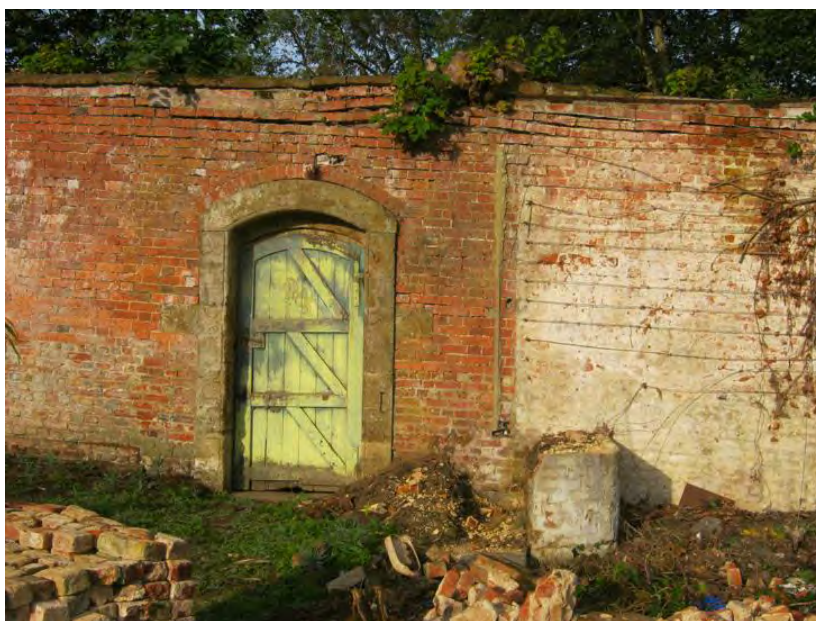
Plate 19: Interior view of doorway in northern garden

Close to the northern corner, just after the end of the glasshouse is a doorway providing access to a back shed on the western side of the garden (Plate 19). It has sandstone ashlar jambs with a moulded arched lintel and is very similar to that seen in the eastern wall in the middle garden.

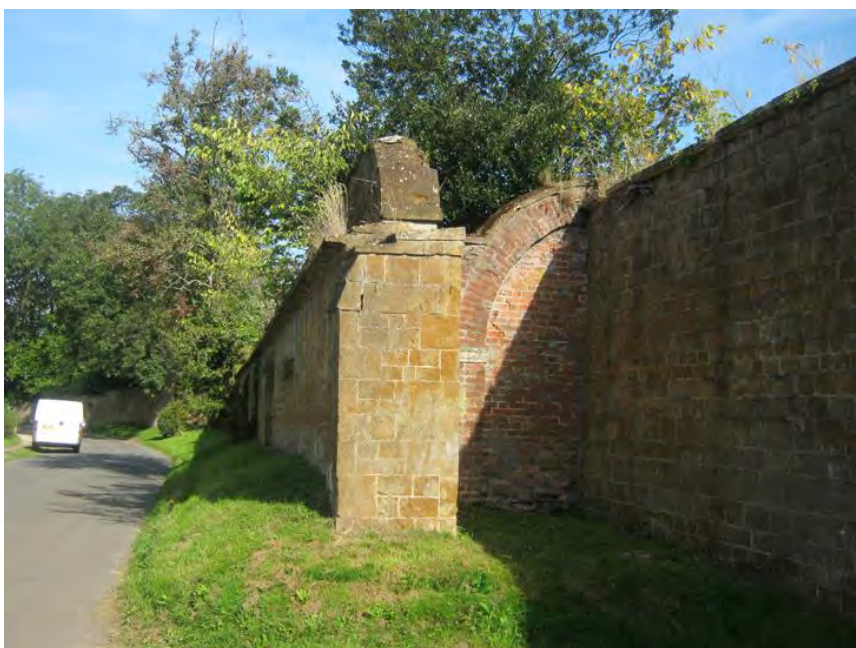
Plate 20: The break in the western wall

The southern section of the western wall has been removed presumably during widening of the road. The upper portion of the wall curves down to the level of the overhanging tabature capping stones and the wall finishes in a stub just beyond the level of the southern garden internal wall (Plate 20).

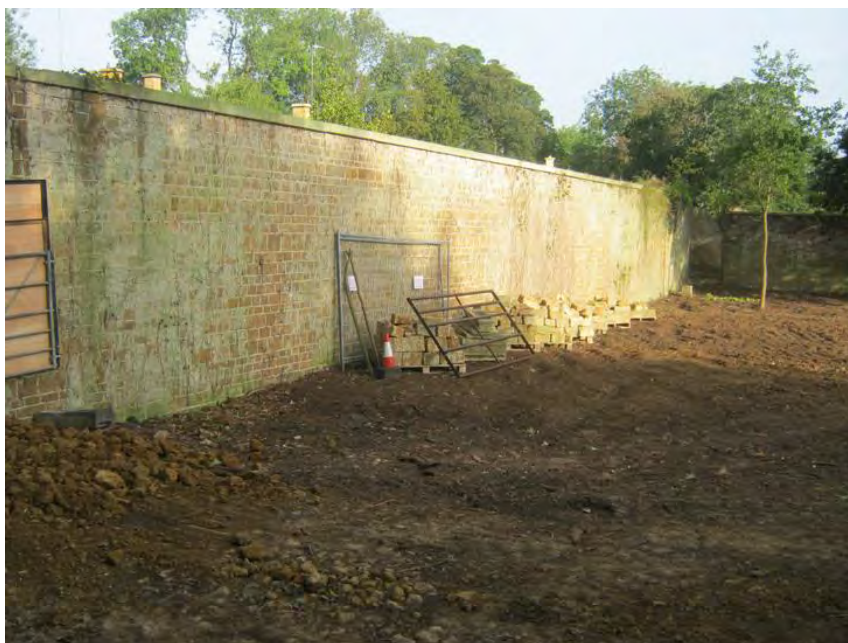
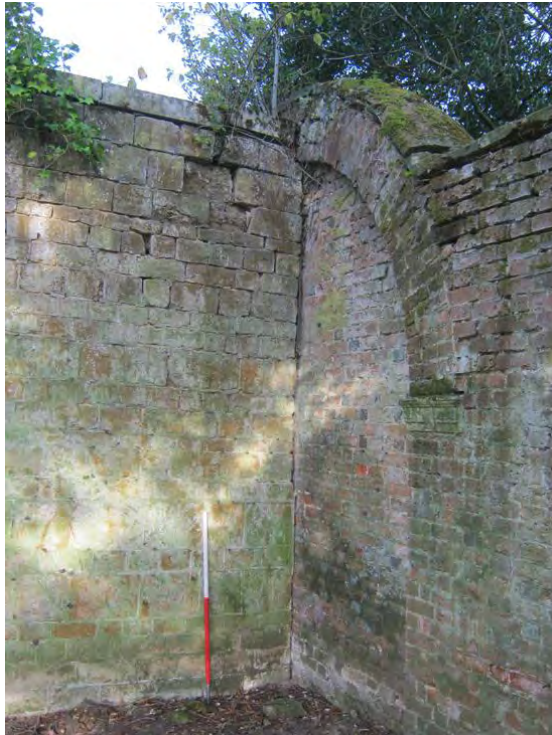
At this point the western wall has been rebuilt in ashlar ironstone with no internal brick lining (Plate 21). The continuation of the western wall butts against the southern internal wall archway (Plates 20 and 22).

Plate 21: Internal view of the southern end of the western wall

Plate 22: West wall butt joint

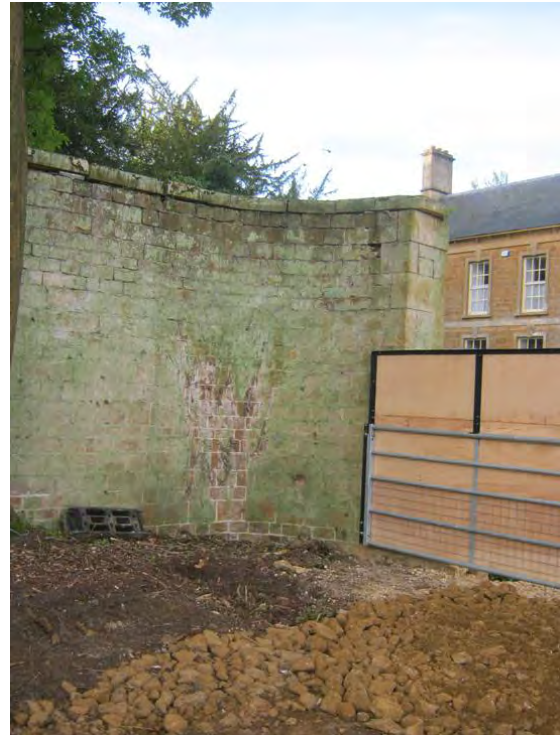
Plate 23: South-western corner

The western wall turns a smooth curved corner to continue into the southern wall (Plate 23). The southern wall had been rebuilt along roughly half its length. This rebuilding was presumably contemporary with the western wall. However, an access way had been broken through the western wall just north of the corner so it was difficult to ascertain the exact relationship.

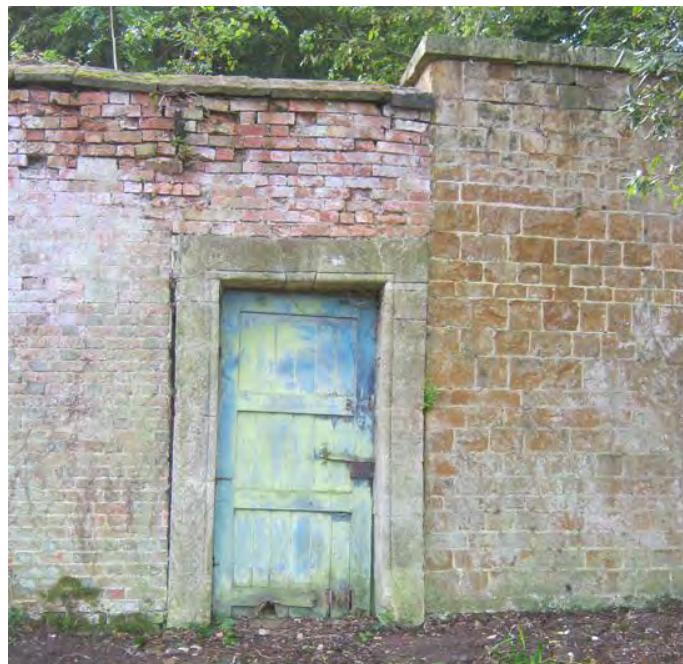
Plate 24: Southern doorway

In the centre of the southern wall is a doorway. The frame and horizontal lintel are squared off with minimal moulding and probably of a 17<sup>th</sup> century date. The entire length of the southern wall had been rebuilt in ironstone ashlar to the west of this doorway and was slightly higher than the original wall (Plate 24).

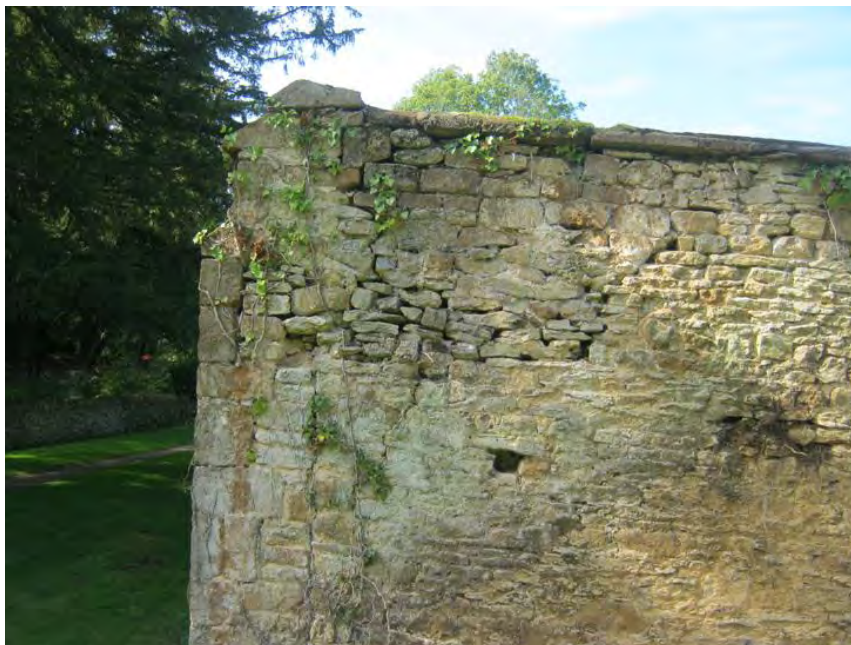
Plate 25: South-eastern corner (looking west)

To the east of the doorway the original southern wall was of similar construction to the eastern wall. Its external face is of smooth-faced rubble ironstone masonry in uneven courses. The internal face is red brick in a Flemish bond. The bricks appear handmade and measure on average 215mm by 100mm by 65mm. The eastern wall appears to butt against the southern wall at the south-eastern corner (Plate 25).

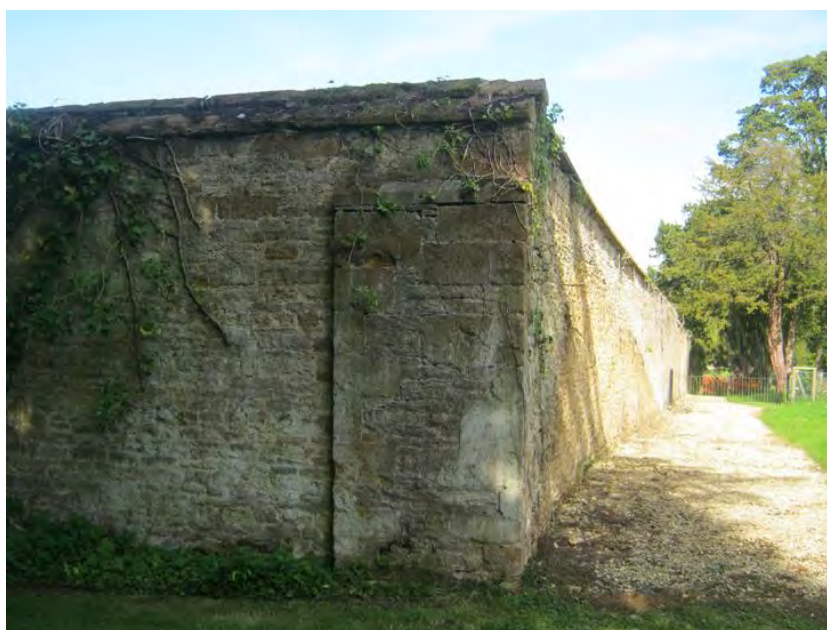
Plate 26: South-eastern corner (looking north)

There was a narrow buttress built to the south of the south-eastern corner. The southern wall was capped with ironstone corbelling (Plate 26), not the curved ironstone caps seen on the other walls.

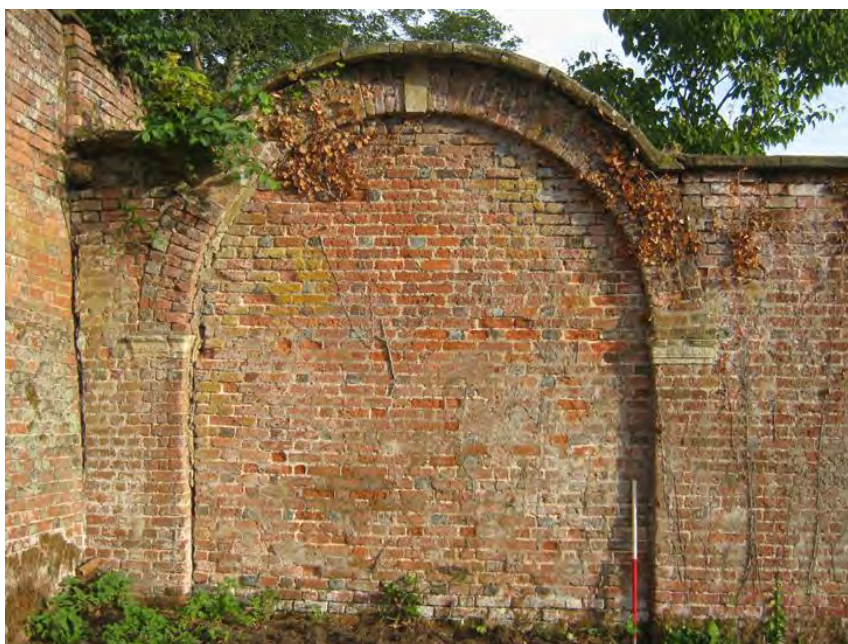
Plate 27: Arch of internal wall inside middle garden looking north

These two walls subdivided the garden into three roughly equal spaces. Both were of similar brick construction. These walls were capped with curved ironstone capstones as seen on the exterior walls. Each had an arch in the centre allowing access between the gardens and also had an arch at either end where the internal wall butted against the outer walls. The arches sat on top of brick built piers and sprang from moulded marlstone pier-caps. The two outer arches were later filled with bricks a single brick thick. This infilling noticeably butted against the piers of the arches (Plate 27). In places this infilling was quite crudely executed with large gaps left. Foundations of this wall were the entire width of the garden and present even under the area of the arches, although not as deep.

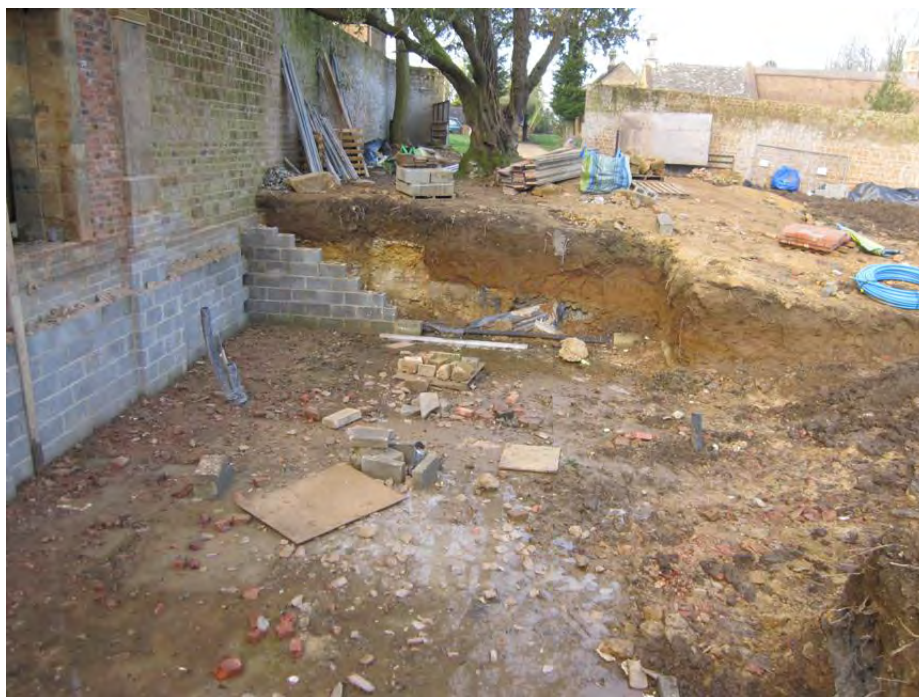
Plate 28: Unmonitored excavation and underpinning

The ground level of the garden sloped down from south to north prior to the excavation taking place (Fig. 2). Ground work was undertaken within the garden in stages; however the final stage saw the considerable reduction of ground level and a flattening of the area, prior to construction work and landscaping using imported soils. Some of this ground reduction, including underpinning work on the south wall, was undertaken without monitoring as JMHS were not informed that work was taking place (Plate 28).

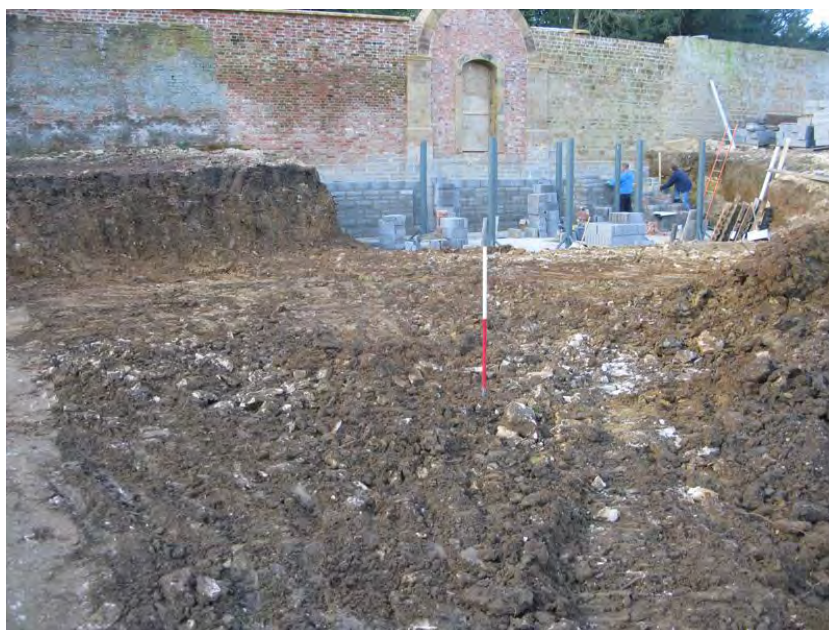
Plate 29: Ground reduction in the southern garden.

The southern entranceway had been rebuilt without monitoring. The door now had an arched lintel and was set into a larger arch (Plates 24 and 29). The eastern section of the southern wall was raised in height to match the western and both sections recapped.

Due to the methodology of excavation and the problems with unmonitored work it was difficult to ascertain the nature of the soil sequence seen in the southwest of the garden. It is possible this was the result of the filling of a large pit, although a possible cut could be seen in section and the sequence may be part of a deep planting bed (Plate 28).

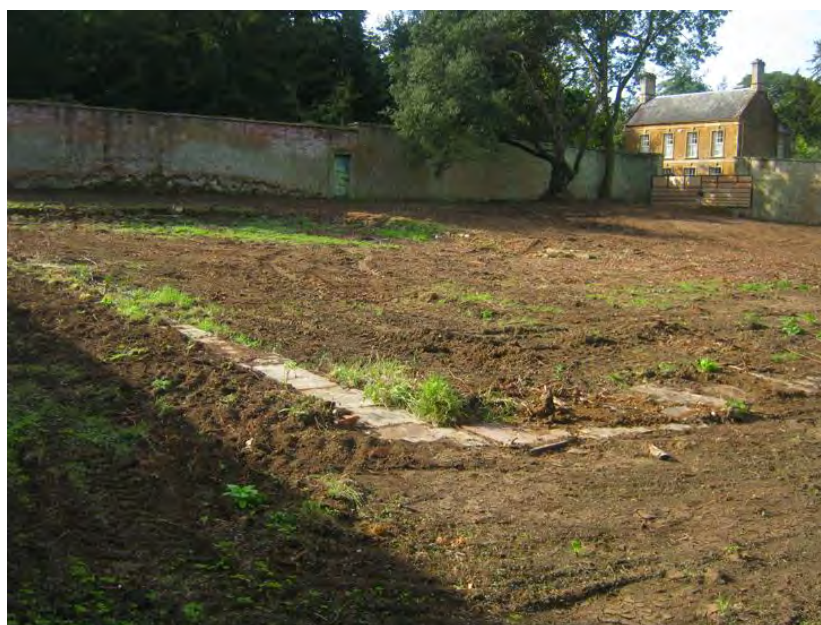
Plate 30: Southern garden prior to excavation

The last garden features preserved were a large rectangular planting bed with stone slab surround to the east of the garden and the remains of a brick built raised planting bed to the west of the central path (Plate 30 and Fig. 2).

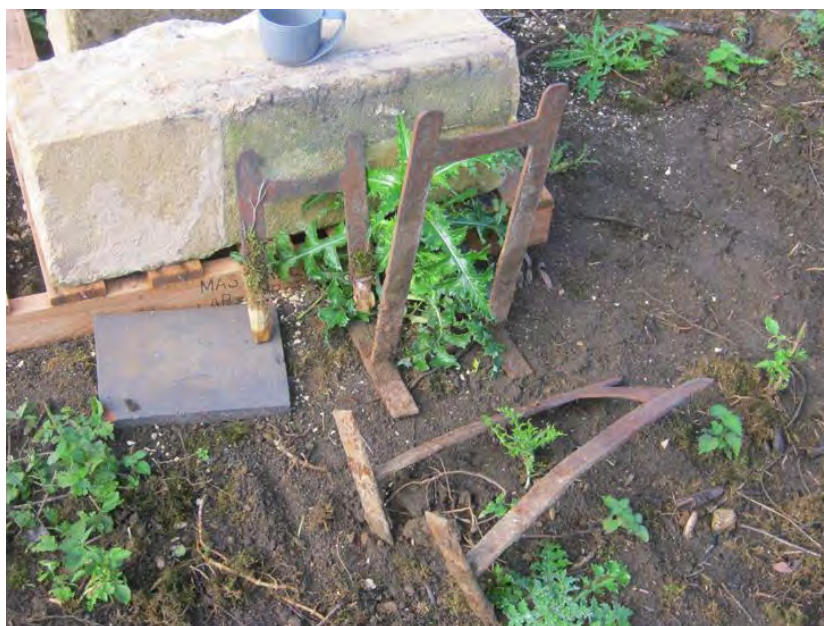
Plate 31: Three boot-scrappers recovered during soil stripping

Two large rectangular planting beds either side of a central path were recorded within this garden. They both measured roughly 30m by 20m and appeared to be cut through deposit (302). The western bed 353/355 was at least 0.5m deep with straight vertical sides. It was filled with a mid-dark orange-brown sand-loam (354)/(356) that also contained 19<sup>th</sup> century red and white earthenwares. The eastern bed 357 was similar, again it was filled with a mid-dark orange-brown sand-loam (358) that also contained 19<sup>th</sup> century pottery sherds. These planting beds matched the final phase garden layout and were inside surrounding pathways (Fig. 2), boot-scrappers were seen close to the paths (Plate 31).

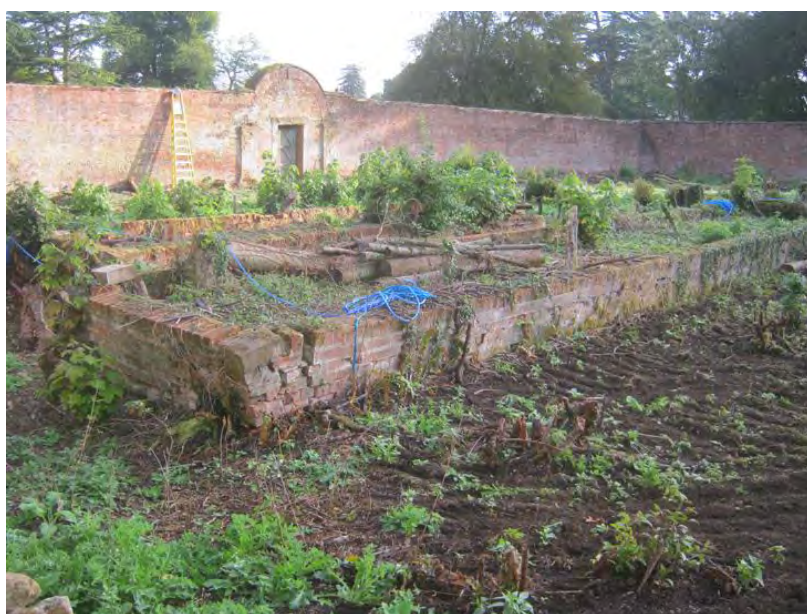
Plate 33: Northern garden prior to redevelopment

Two large rectangular brick built raised planting beds were present in the western side of the garden along with an irregular stone built raised bed that accommodated the pump at the northern end (Fig. 2 and Plate 33).

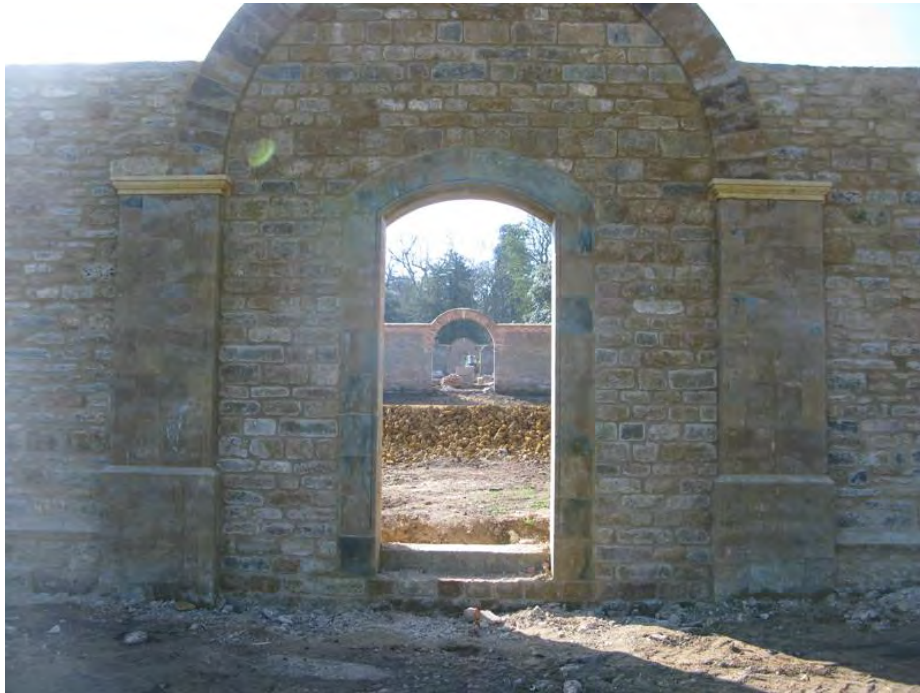
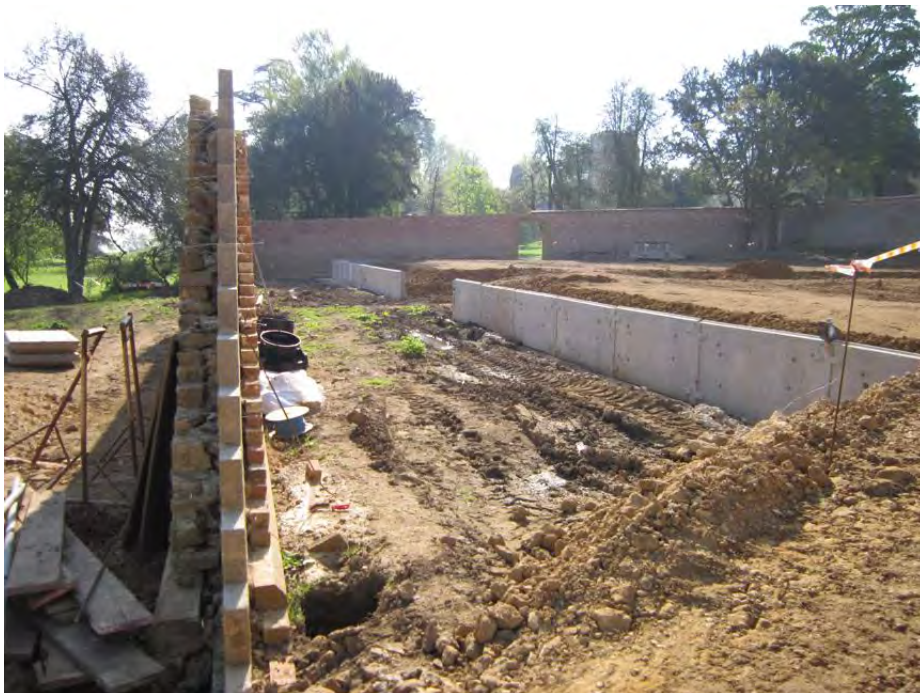
Extensive work had been undertaken in the northern part of this garden. JMHS were not informed of this prior to it taking place and it was only seen after work had been completed. New drainage trenches had been excavated, two new internal retaining walls had been built and the entire northern wall and sections of the eastern and western wall had been taken down new foundations lain and the sections rebuilt (Fig. 6) with a breeze block core (Plates 34 and 35).

Plate 34: The rebuilt northern entrance (see Plate 11)

Plate 35: New internal walls and rebuilt northern wall

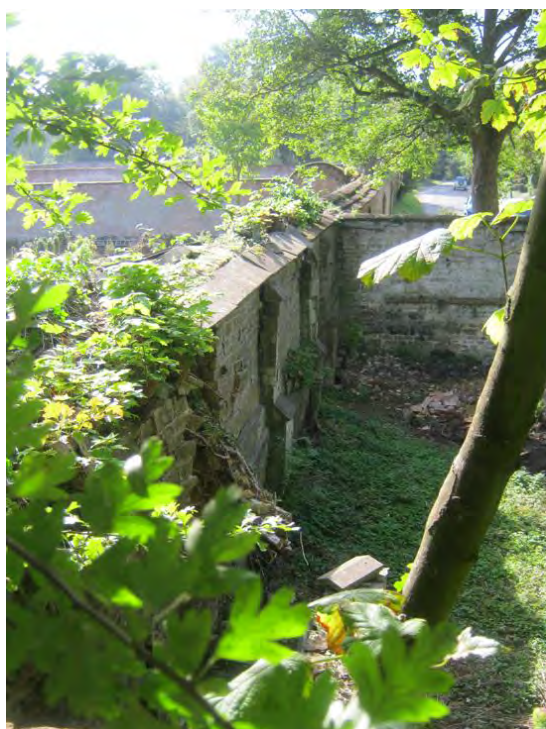
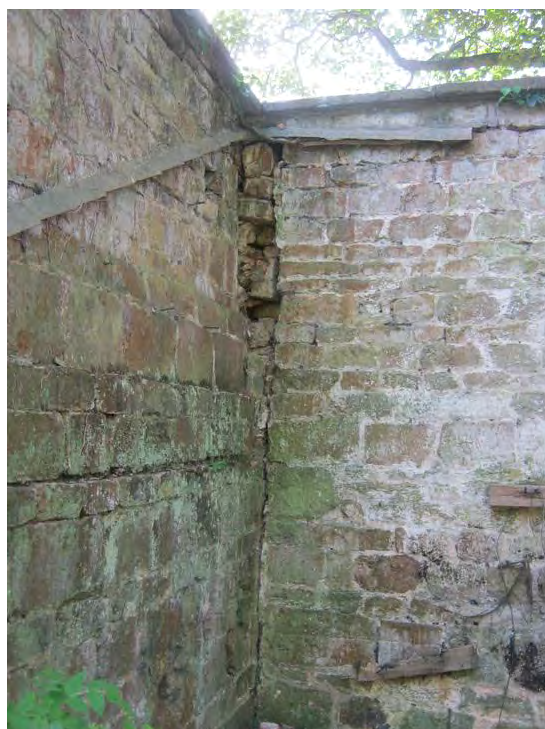
To the west of the walled garden was a back shed accessed through the western door in the northern garden (Plate 36). This was a later addition as the southern wall of this structure clearly butted against the main western wall (Plate 37).

Plate 36: Shed area (looking south)

Plate 37: Shed wall butting garden wall

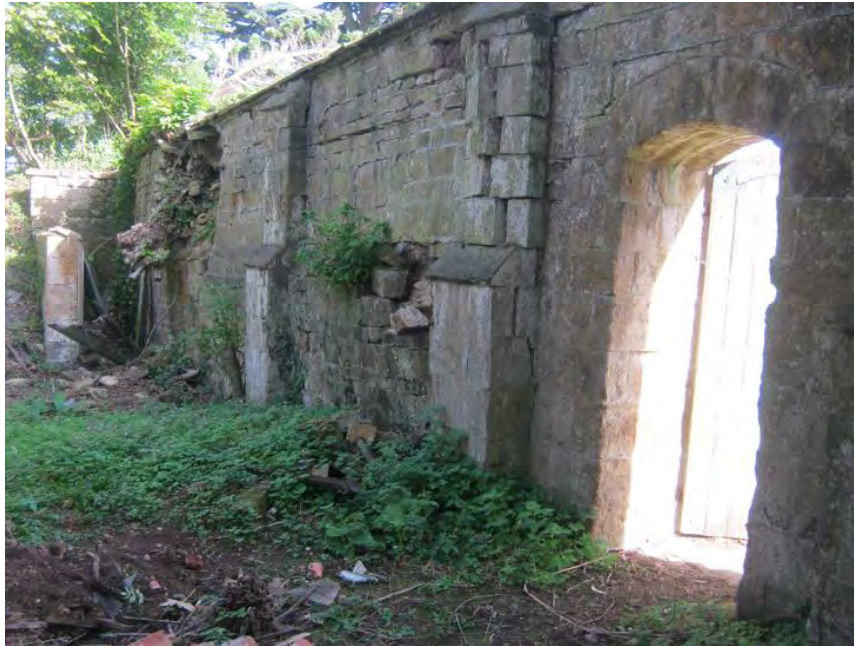
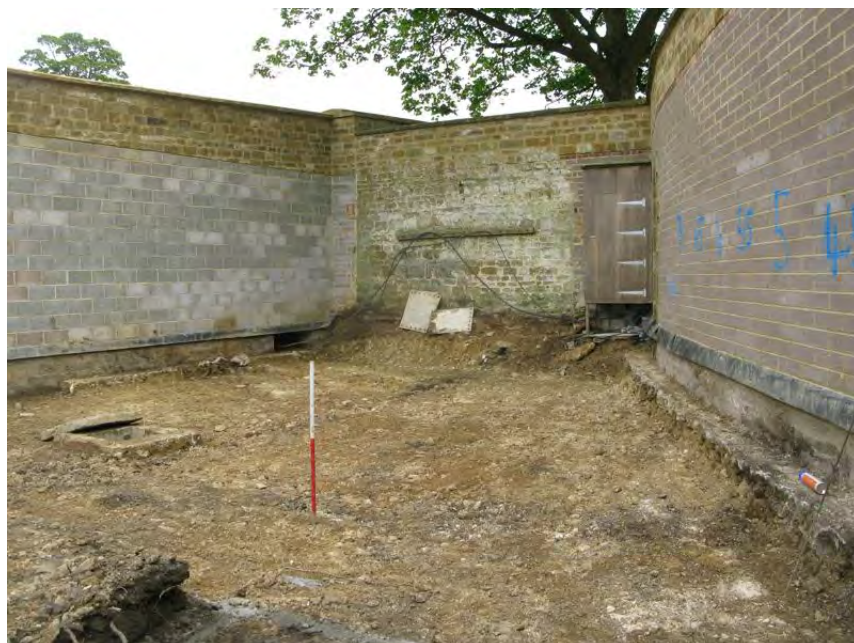
Plate 38: The western garden wall internal to the back shed area

A small wall stub was present aligned north to south and parallel to the western garden wall (Plate 38), possible bonded to the northern wall extension; it was not possible to full investigate it during the initial visit, and it had been removed without monitoring by the time of the next visit (Plate 39).

Plate 39: Shed area after demolition and rebuild of walls

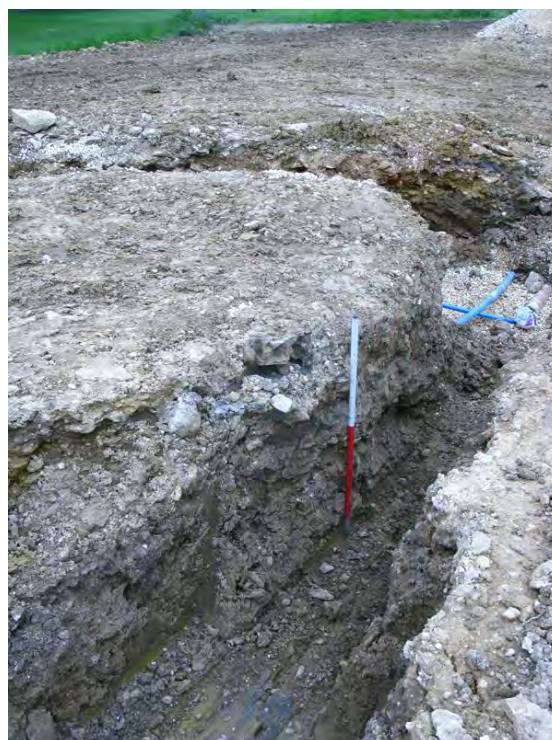
Plate 41: Soil sequence outside garden

A series of drainage and service trenches were monitored in this area (Plates 41 and 42), including pipe access under the southern shed wall. A small pit 322 was recorded that pre-dated the construction of the shed (Fig. 6). This pit or posthole was 0.3m in

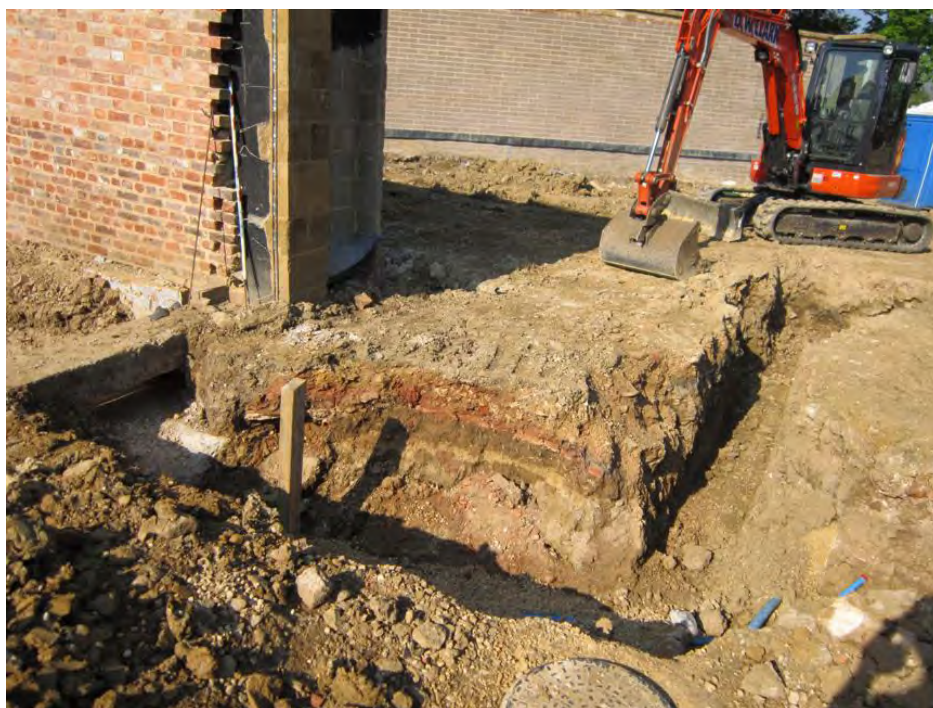
Plate 42: Surface (333) in section

Prior to the redevelopment of the garden a large earthen mound was present against the north-western corner of the garden and the back shed (Plate 12). The antiquity of this mound was initially questioned; unfortunately it was removed without notification. The subsequent identification of surface (333) that was located under it

allows a more recent date to be assigned to this mound. Back sheds are usually arranged along the northern side of south-facing kitchen gardens (Campbell 1998) and would seem likely that the mound represents the demolition material from such sheds and surface (333), the remains of the floor of one such structure (Plate 42).

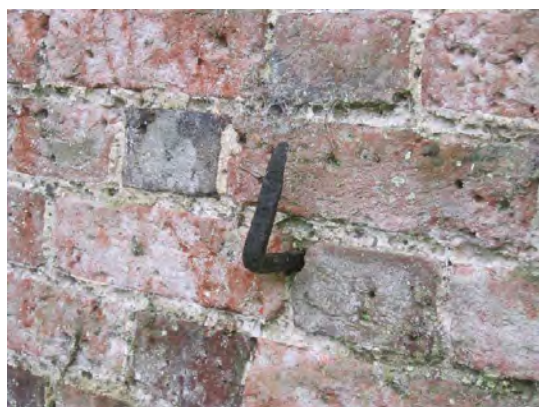
Plate 43: Iron hook

The brick lining of the main walls and the brick interior walls all displayed multiple nail holes from fixing support wires; some iron nails were still *in situ*. These appear to be square sectioned and hand-made. Simple L-shaped iron hooks were also noted (Plate 43).

The brick lining of the main walls and the brick interior walls all displayed multiple nail holes from fixing support wires; some iron nails were still *in situ*. These appear to be square sectioned and hand-made. Simple L-shaped iron hooks were also noted. Also present on some walls were triangular lead tags stamped with a number. These presumably refer to a planting patch or specific variety of plant grown. The position of these numbers was plotted and it is possible that Estate records preserve planting information that would relate to them.
