JOHN MOORE HERITAGE SERVICES

**ARCHAEOLOGICAL WATCHING BRIEF**  
**ON**  
**THE WALLED GARDEN AT GREAT TEW ESTATE,**  
**GREAT TEW, OXFORDSHIRE**

**NGR SP 3970 2906**

**OCTOBER 2015**

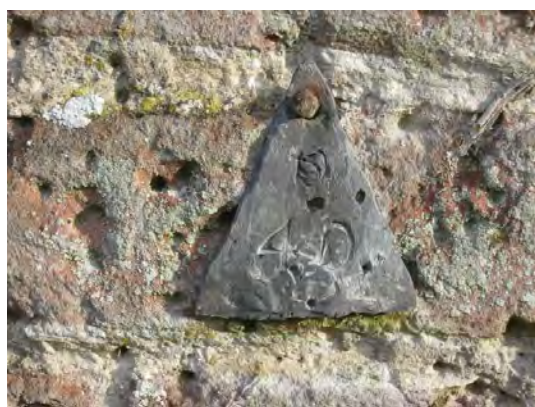
Plate 44: Lead tag

Also present on some walls were triangular lead tags stamped with a number (Plate 44). These presumably refer to a planting patch or specific variety of plant grown. The position of these numbers was plotted and it is possible that Estate records preserve planting information that would relate to them (Fig. 7).

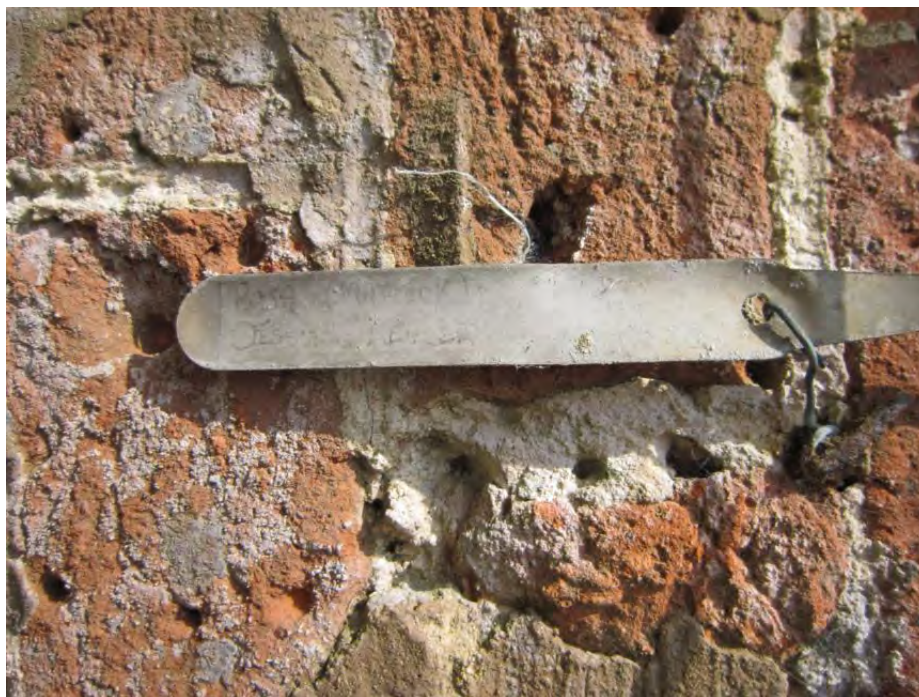
Plate 45: Late 19<sup>th</sup> century plant tag

A metal plant tag was recorded that had been written on, possibly in indelible pencil (Plate 45). This tag read “Rosa (Mattock)” and under this where two other words that were too difficult to make out. Rosa Mattock probably refers to Mattock’s Roses of Nuneham Courtney that was established in 1875 selling superior quality roses. This was attached to the interior southern wall in the south garden and indicates by the late 19<sup>th</sup> century this garden was no longer used as a kitchen garden.
